BLUELINE

Mercerwood – Buchan 9118

Mercer Island, WA

Storm Drainage Report

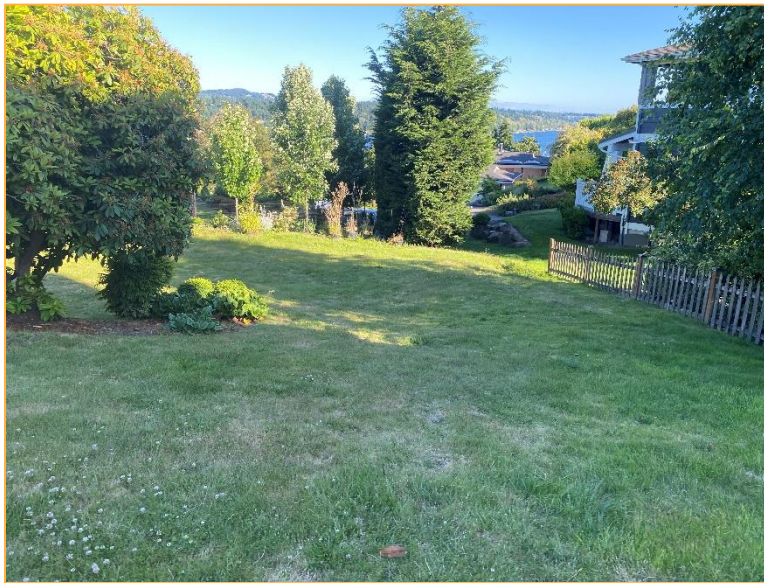
Photo 1 – Facing southwest on the rear of the lot. Onsite runoff sheet flows southwest.

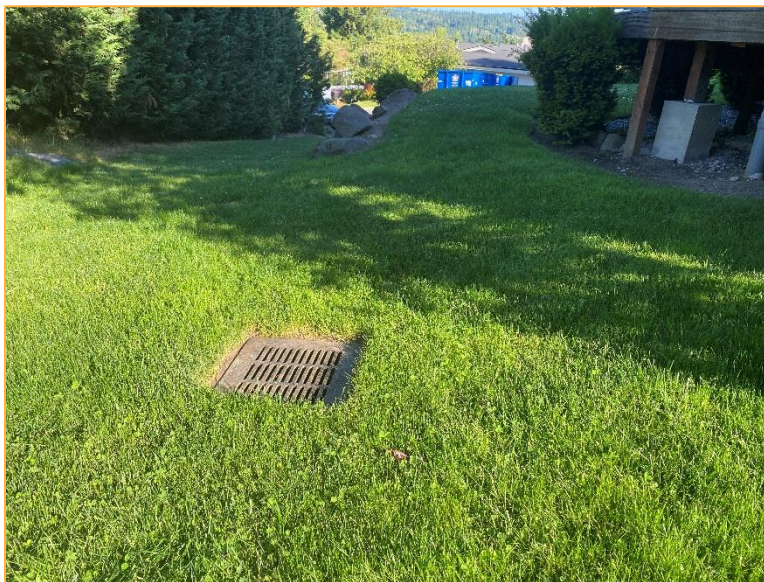
Photo 2 – Facing southwest along the southwestern portion of the property. Runoff sheet flows to a privately owned catch basin within the storm drainage easement and continues southeast.

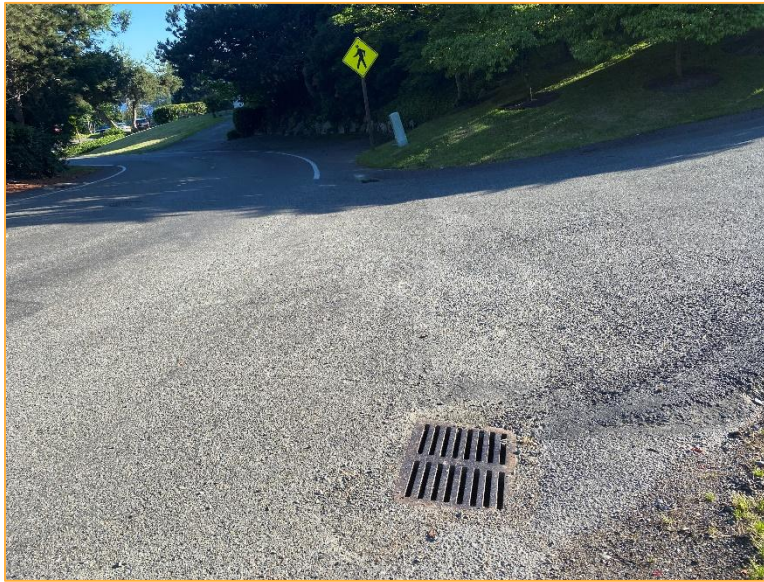
Photo 3 – Facing southeast on the north corner of Mercerwood and SE 43rd PI. Runoff enters a catch basin and continues southwest.

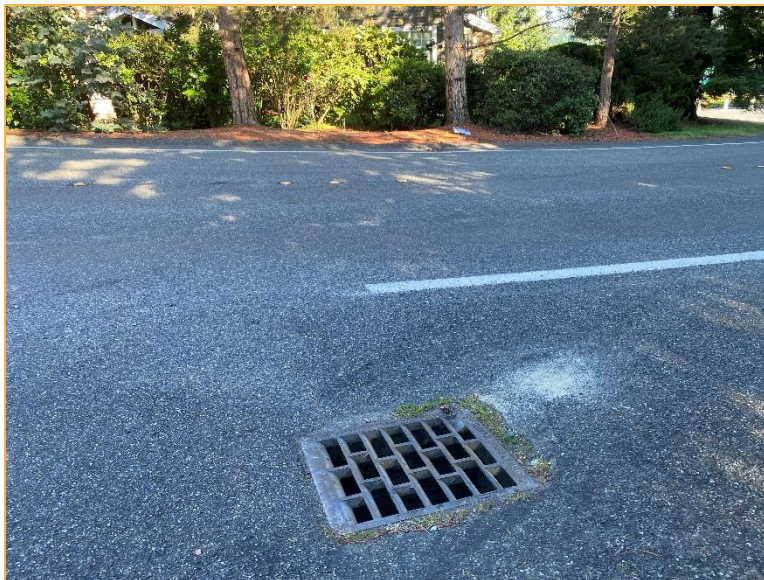
Photo 4 – Facing east on the south corner of Mercerwood and SE 43rd PI. Runoff enters a catch basin and continues east.

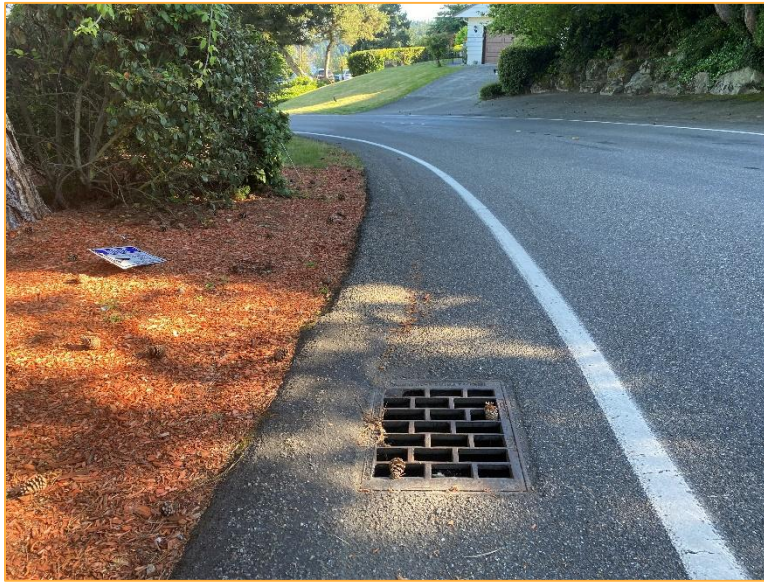
Photo 5 – Facing east side of Mercerwood. Runoff enters a catch basin and continues southeast.

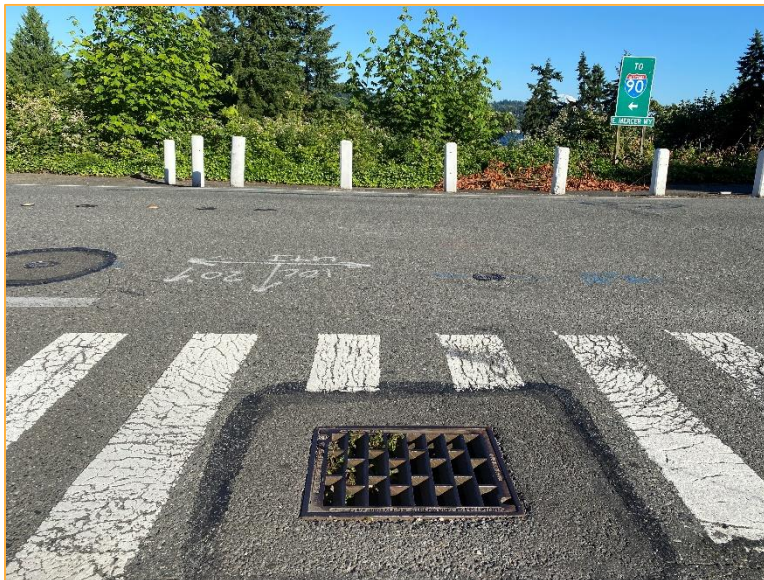
Photo 6 – Facing southeast along the west side of E Mercer Way. Runoff is collected by a catch basin and continues southeast through a tennis court.

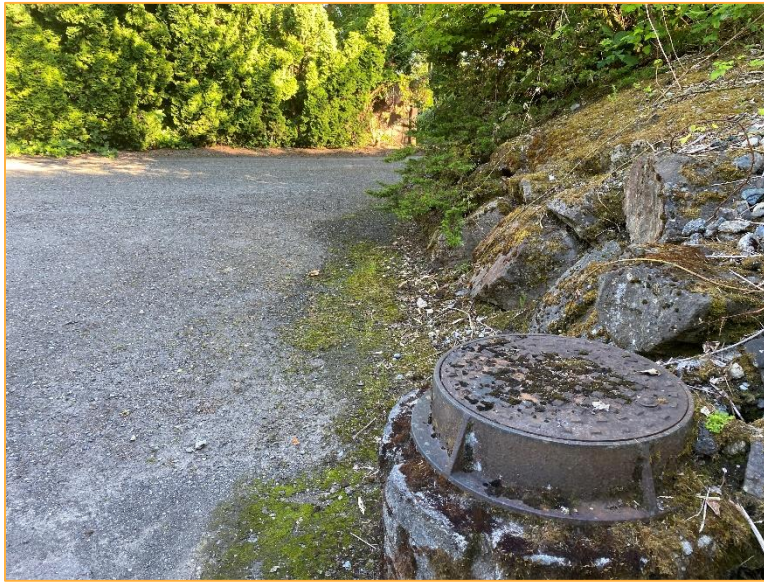
Photo 7 – Facing southeast along the north side of 100th Ave SE. Runoff is conveyed to a catch basin and continues southeast.

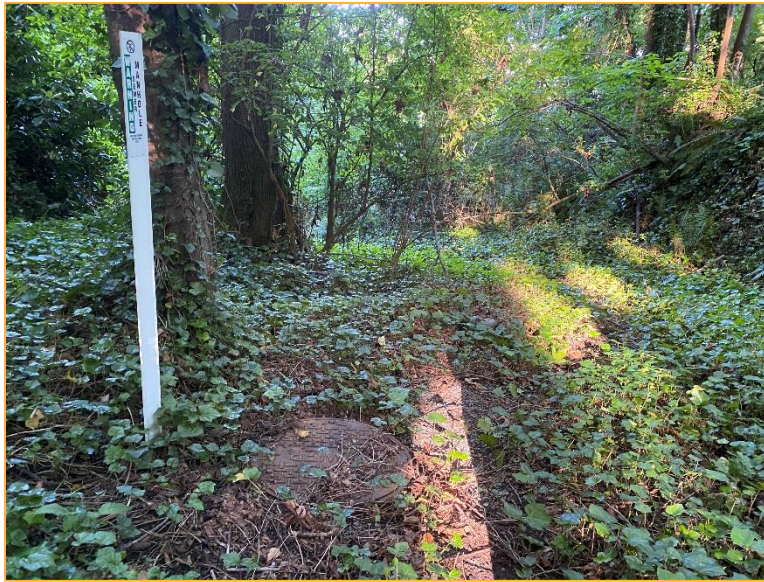
Photo 9 – Facing southeast within private lot. Runoff is conveyed southeast to a manhole and continues southeast.

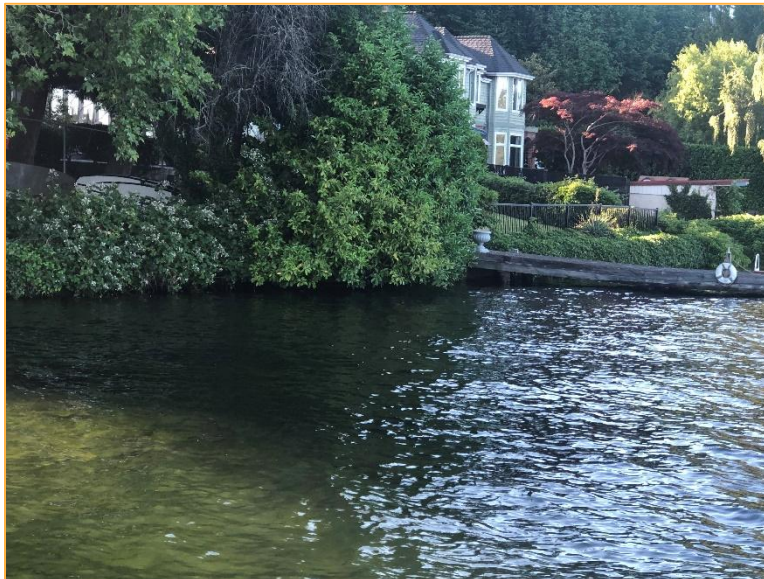
Photo 10 – Facing north along a dock on Lake Washington. Flows outlet into Lake Washington which ends the downstream analysis.

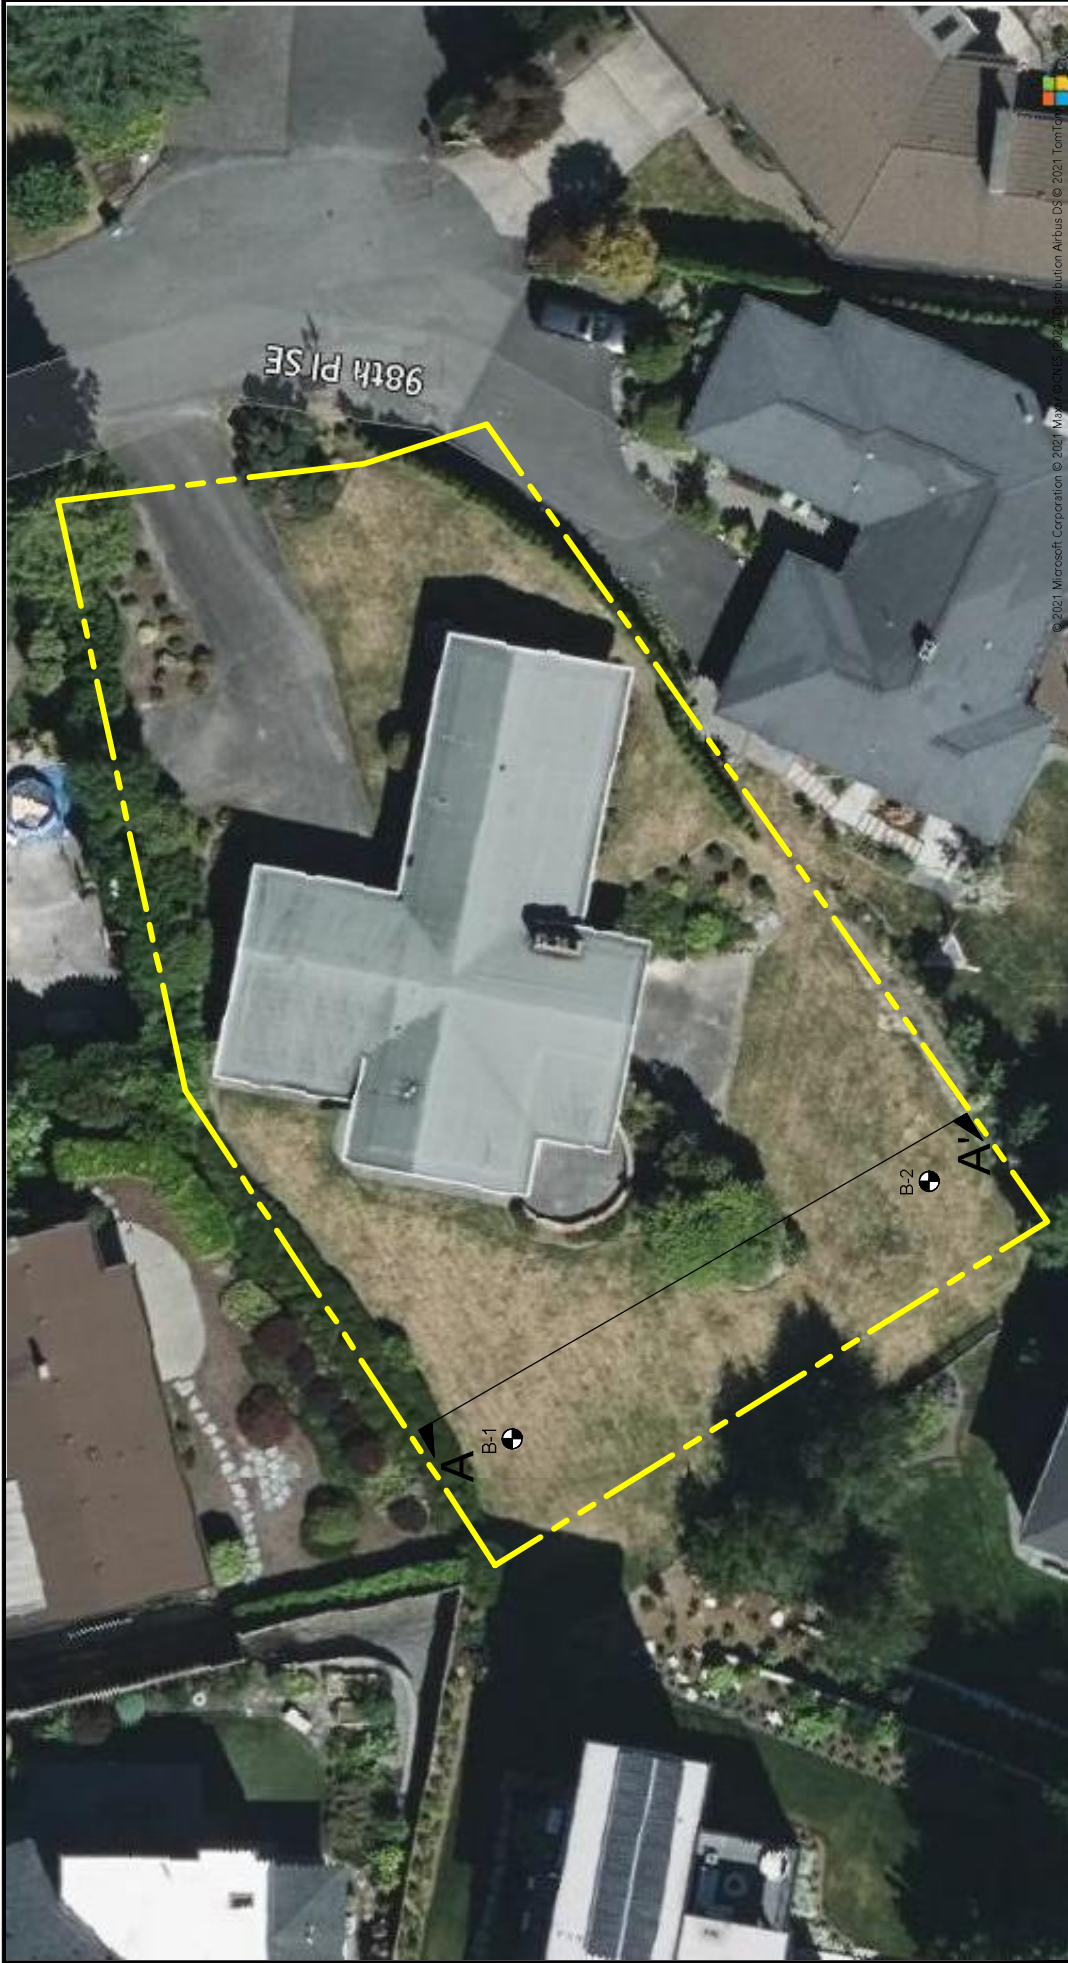
Proj. No. T-8528 Date: JUNE 2021 Figure 2

EXPLORATION LOCATION PLAN
 BUCHAN 9118
 MERCER ISLAND, WASHINGTON

The preceding discussion is intended to be a general review of the soil conditions encountered. For more detailed descriptions, please refer to the Test Pit Logs in Appendix A. The approximate location of the test pits is shown on the Exploration Location Plan, Figure 2.

The western portion of the proposed development will include developing near the crest of the western slope with a concrete patio. In accordance with the City of Mercer Island requirements, we have completed a slope stability analysis to determine the effects of the new building loading on the existing slope. The analysis was performed at the location designated as Cross Section A-A' using the computer program Slide 2. The approximate cross section location is shown on Figure 2.

On April 26, 2021, we completed our site exploration by observing soil and groundwater conditions at two test borings drilled to maximum depths of approximately 20 feet below existing site grades. Test boring locations were determined in the field by measurements from existing site features. The approximate location of the test borings is shown on the attached Exploration Location Plan, Figure 2. Test Boring Logs are attached as Figures A-2 and A-3.

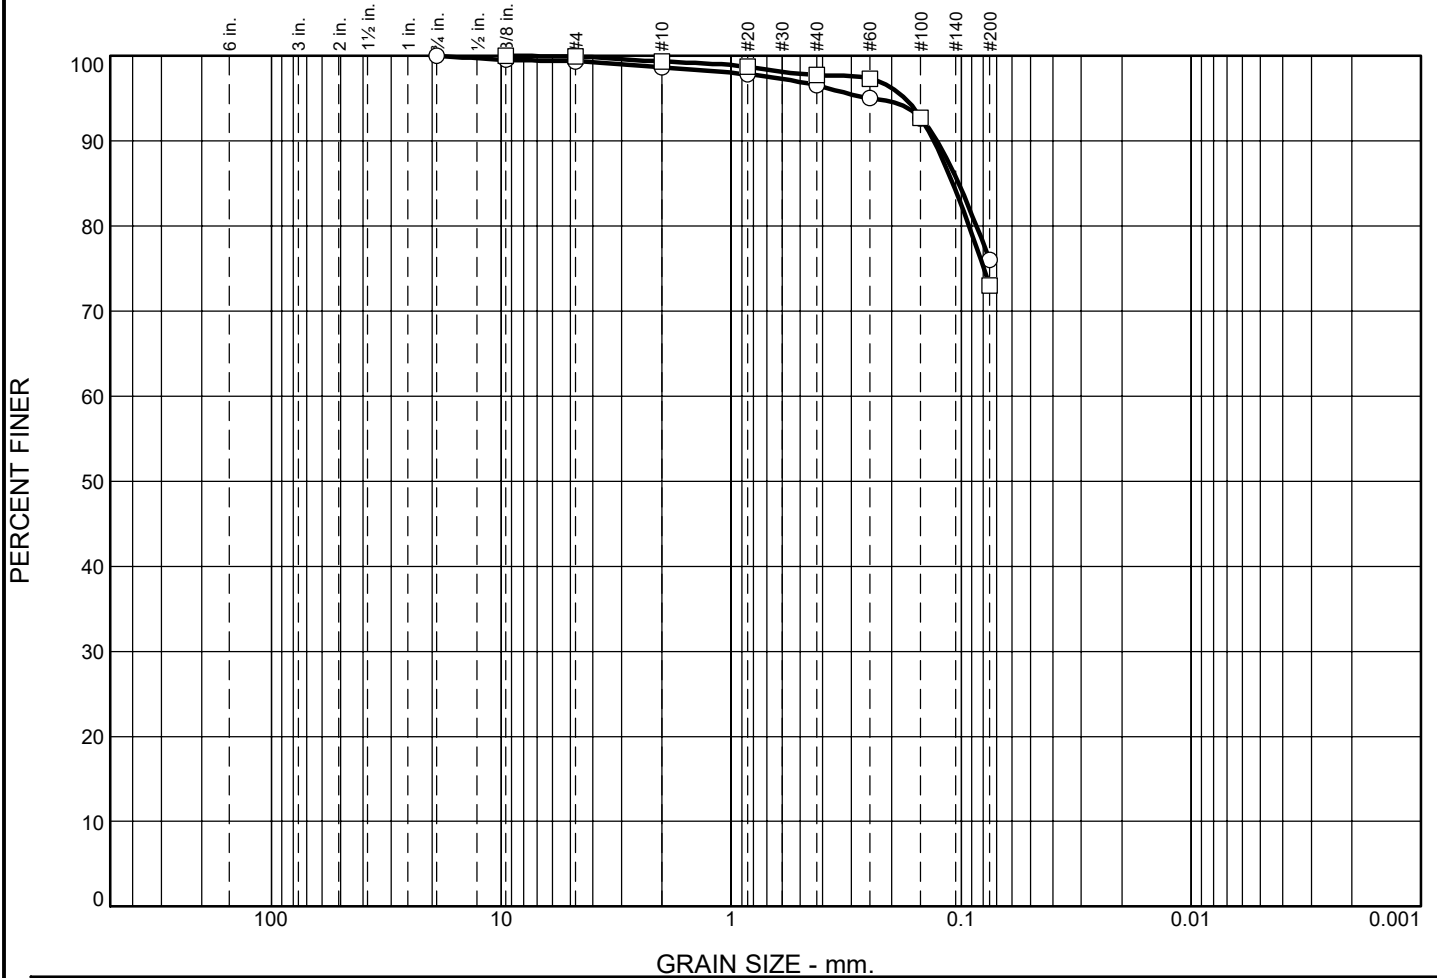
Particle Size Distribution Report

% +3"	% Gravel		% Sand			% Fines	
		Coarse	Fine	Coarse	Medium	Fine	Silt	Clay
○	0.0	0.0	0.7	0.7	2.1	20.5	76.0	
□	0.0	0.0	0.1	0.6	1.6	24.7	73.0

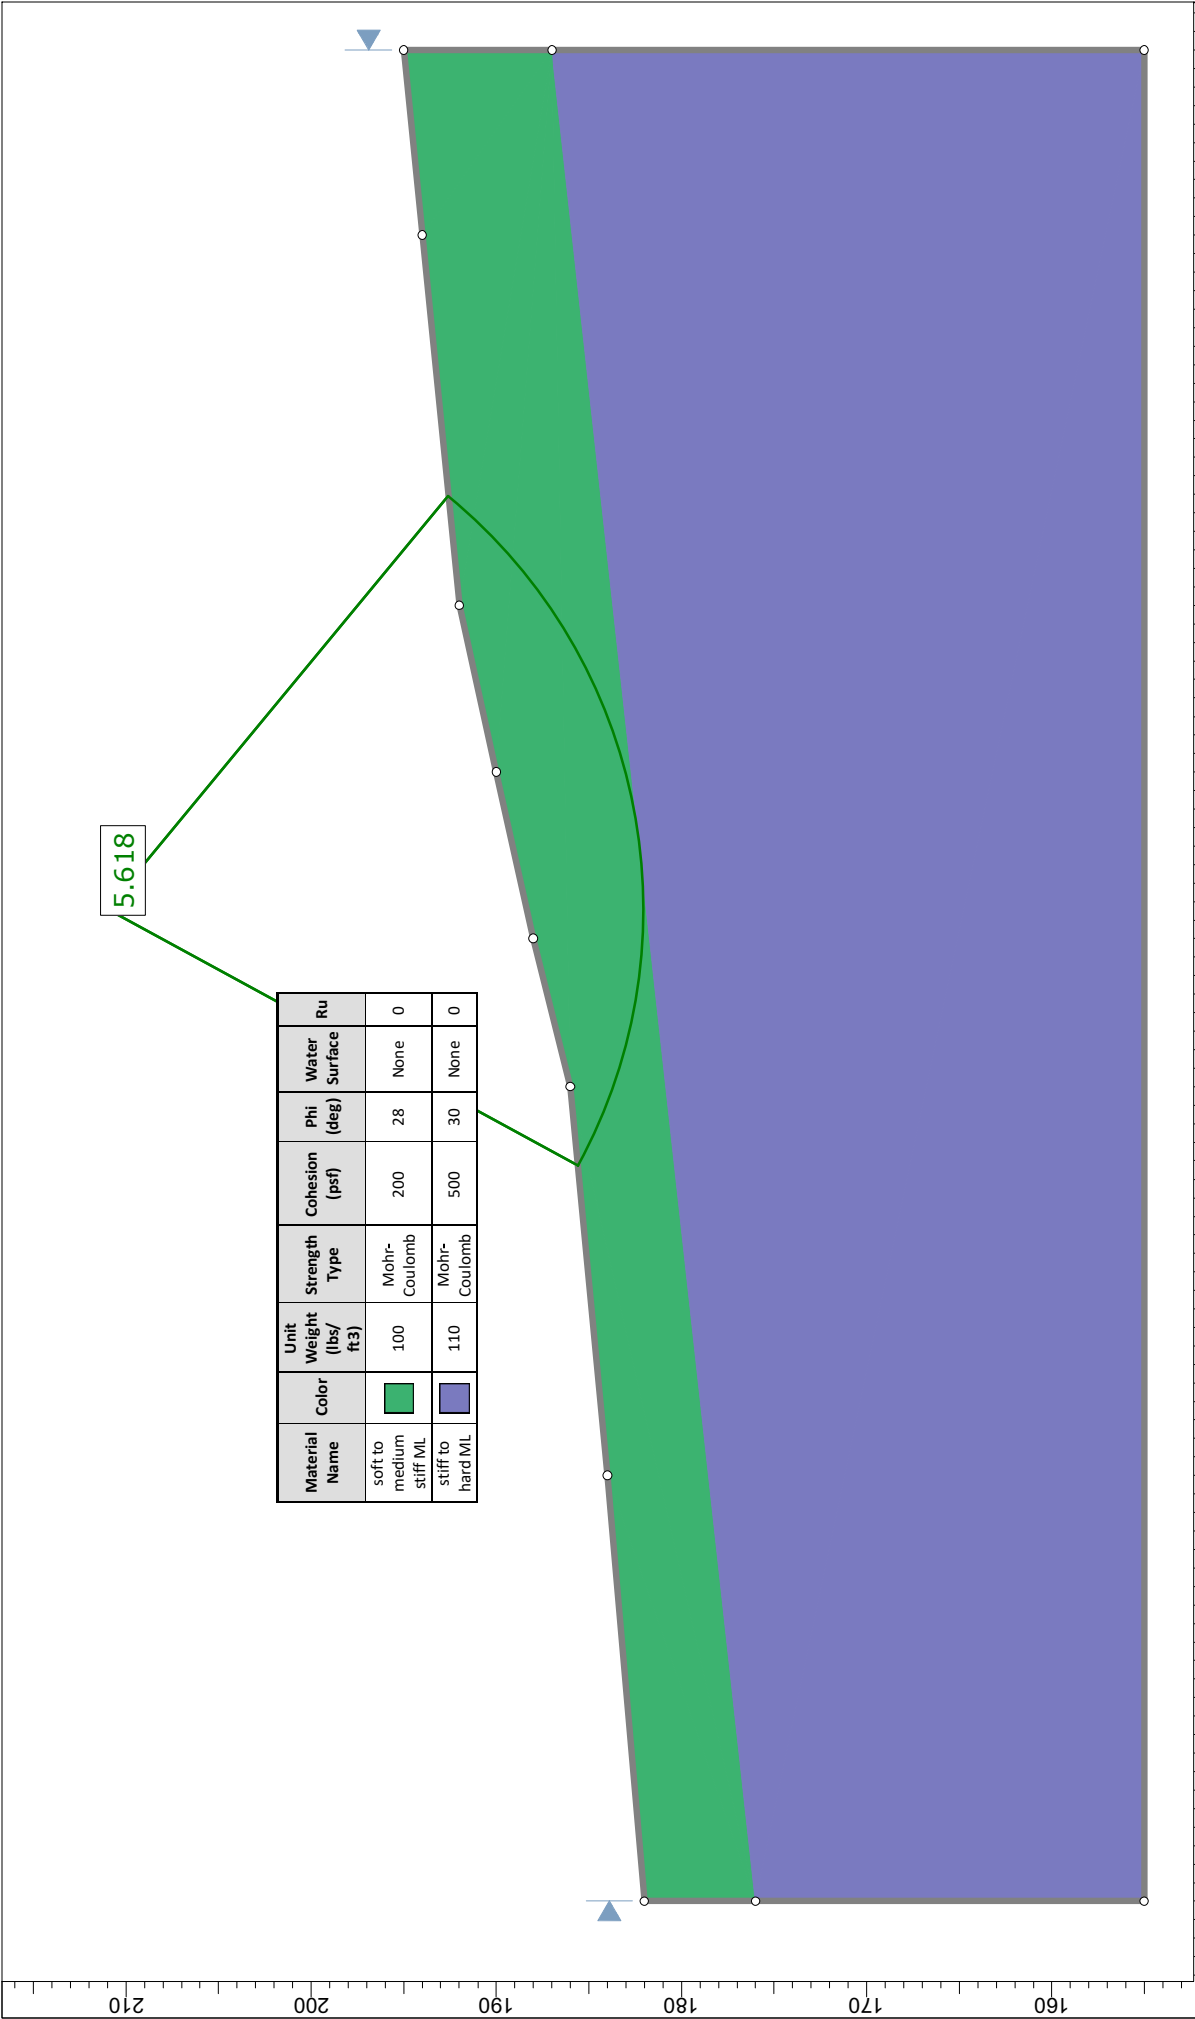
Project		Existing - Static		Master Scenario	
Group	MJX		Company	Terra Associates, Inc.	
Date	4/26/2021, 3:12:50 PM		File Name	A-A' revised.slm

100	Mohr-Coulomb	200	28	None	0
stiff to hard ML	 	110	Mohr-Coulomb	500	30	None	0

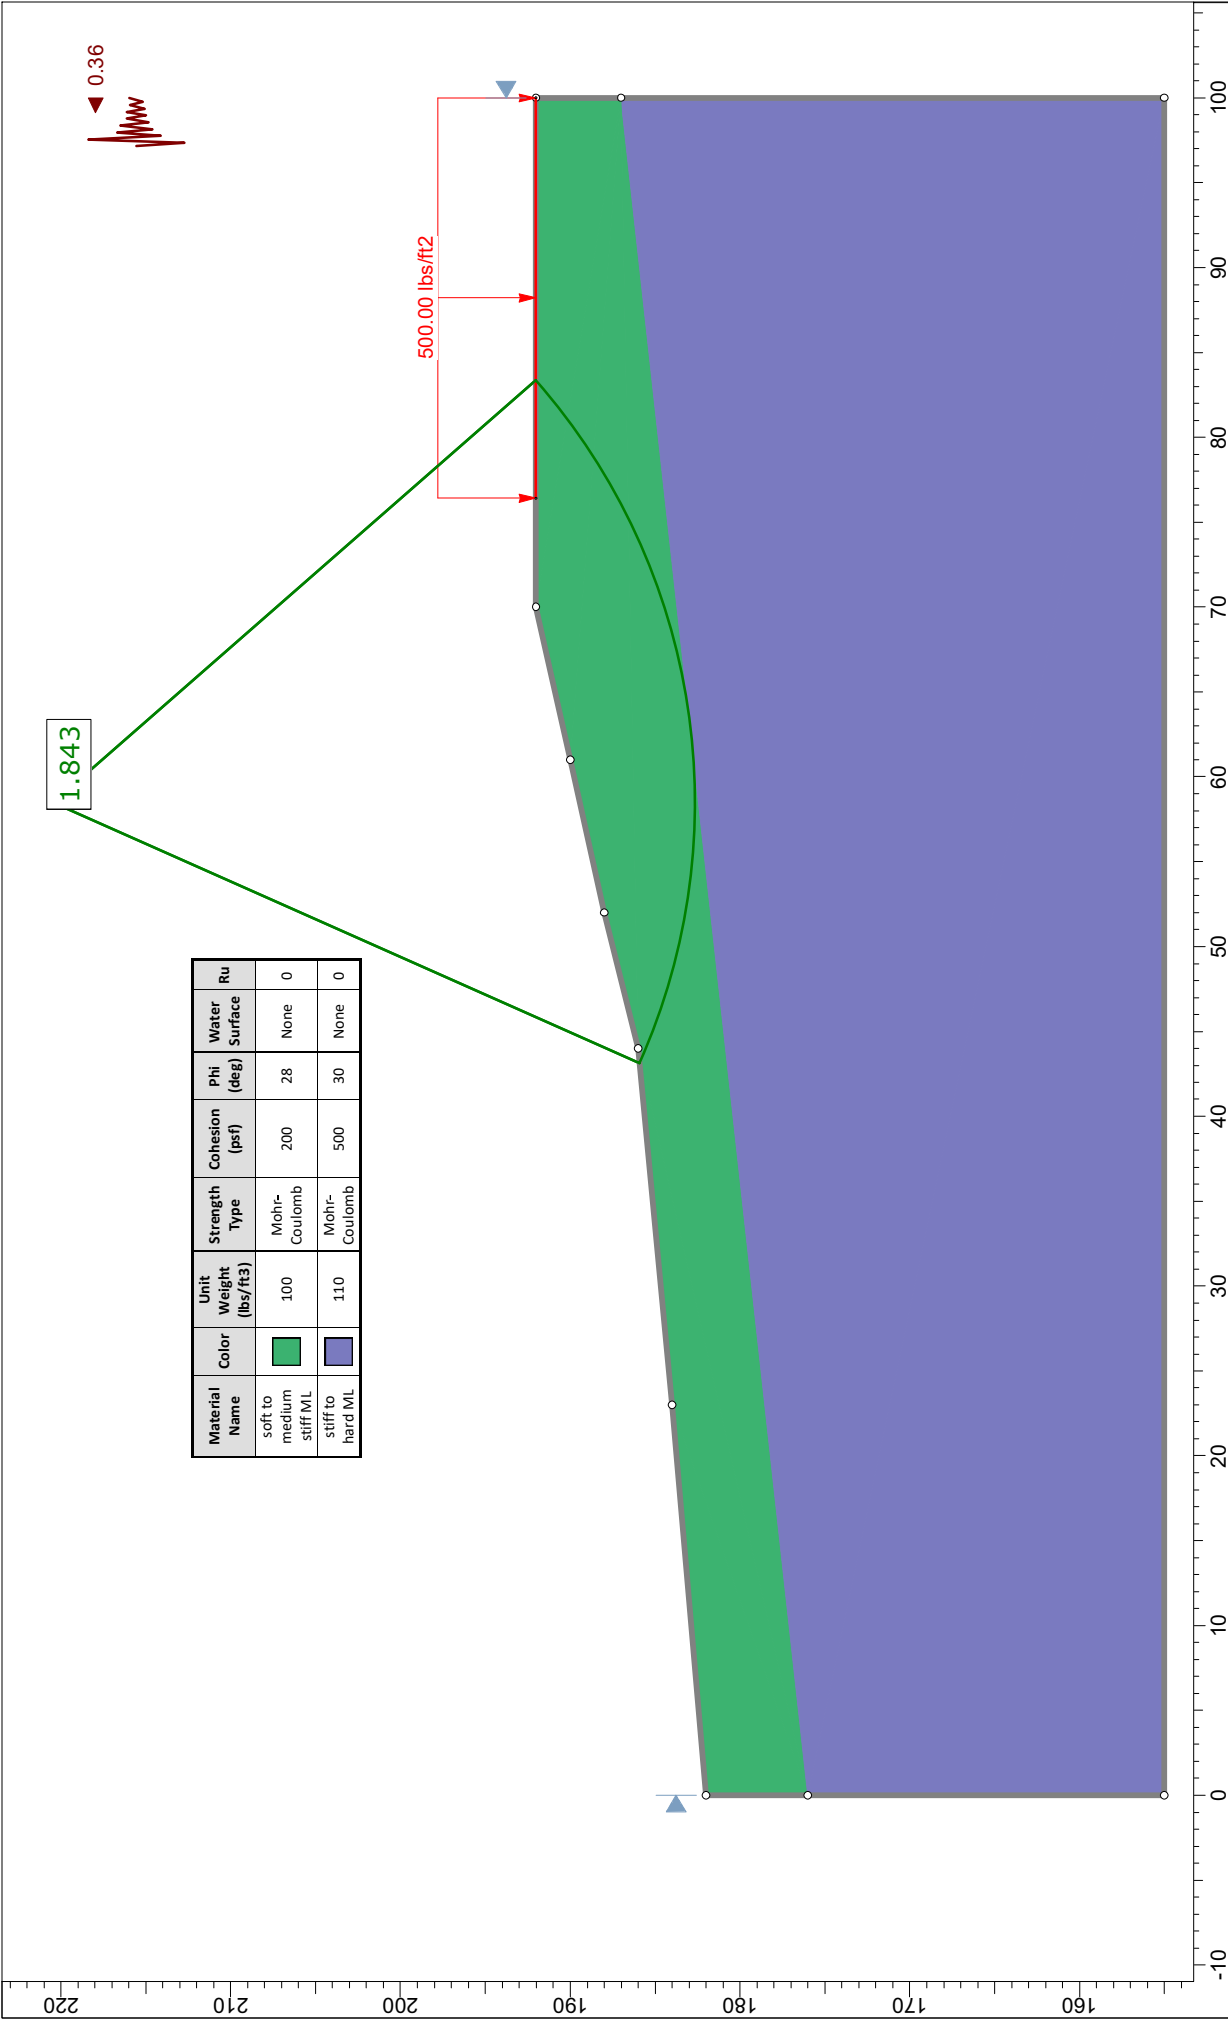
Material Name	Color	Unit Weight (lbs/ft3)	Strength Type	Cohesion (psf)	Phi (deg)	Water Surface	Ru
soft to medium stiff ML	■	100	Mohr-Coulomb	200	28	None	0
hard ML	■	110	Mohr-Coulomb	500	30	None	0
