GEOTECHNICAL REPORT

**Buchan 9118
4215 Mercerwood Drive
Mercerwood, Washington**

Project No. T-8528

Terra Associates, Inc.

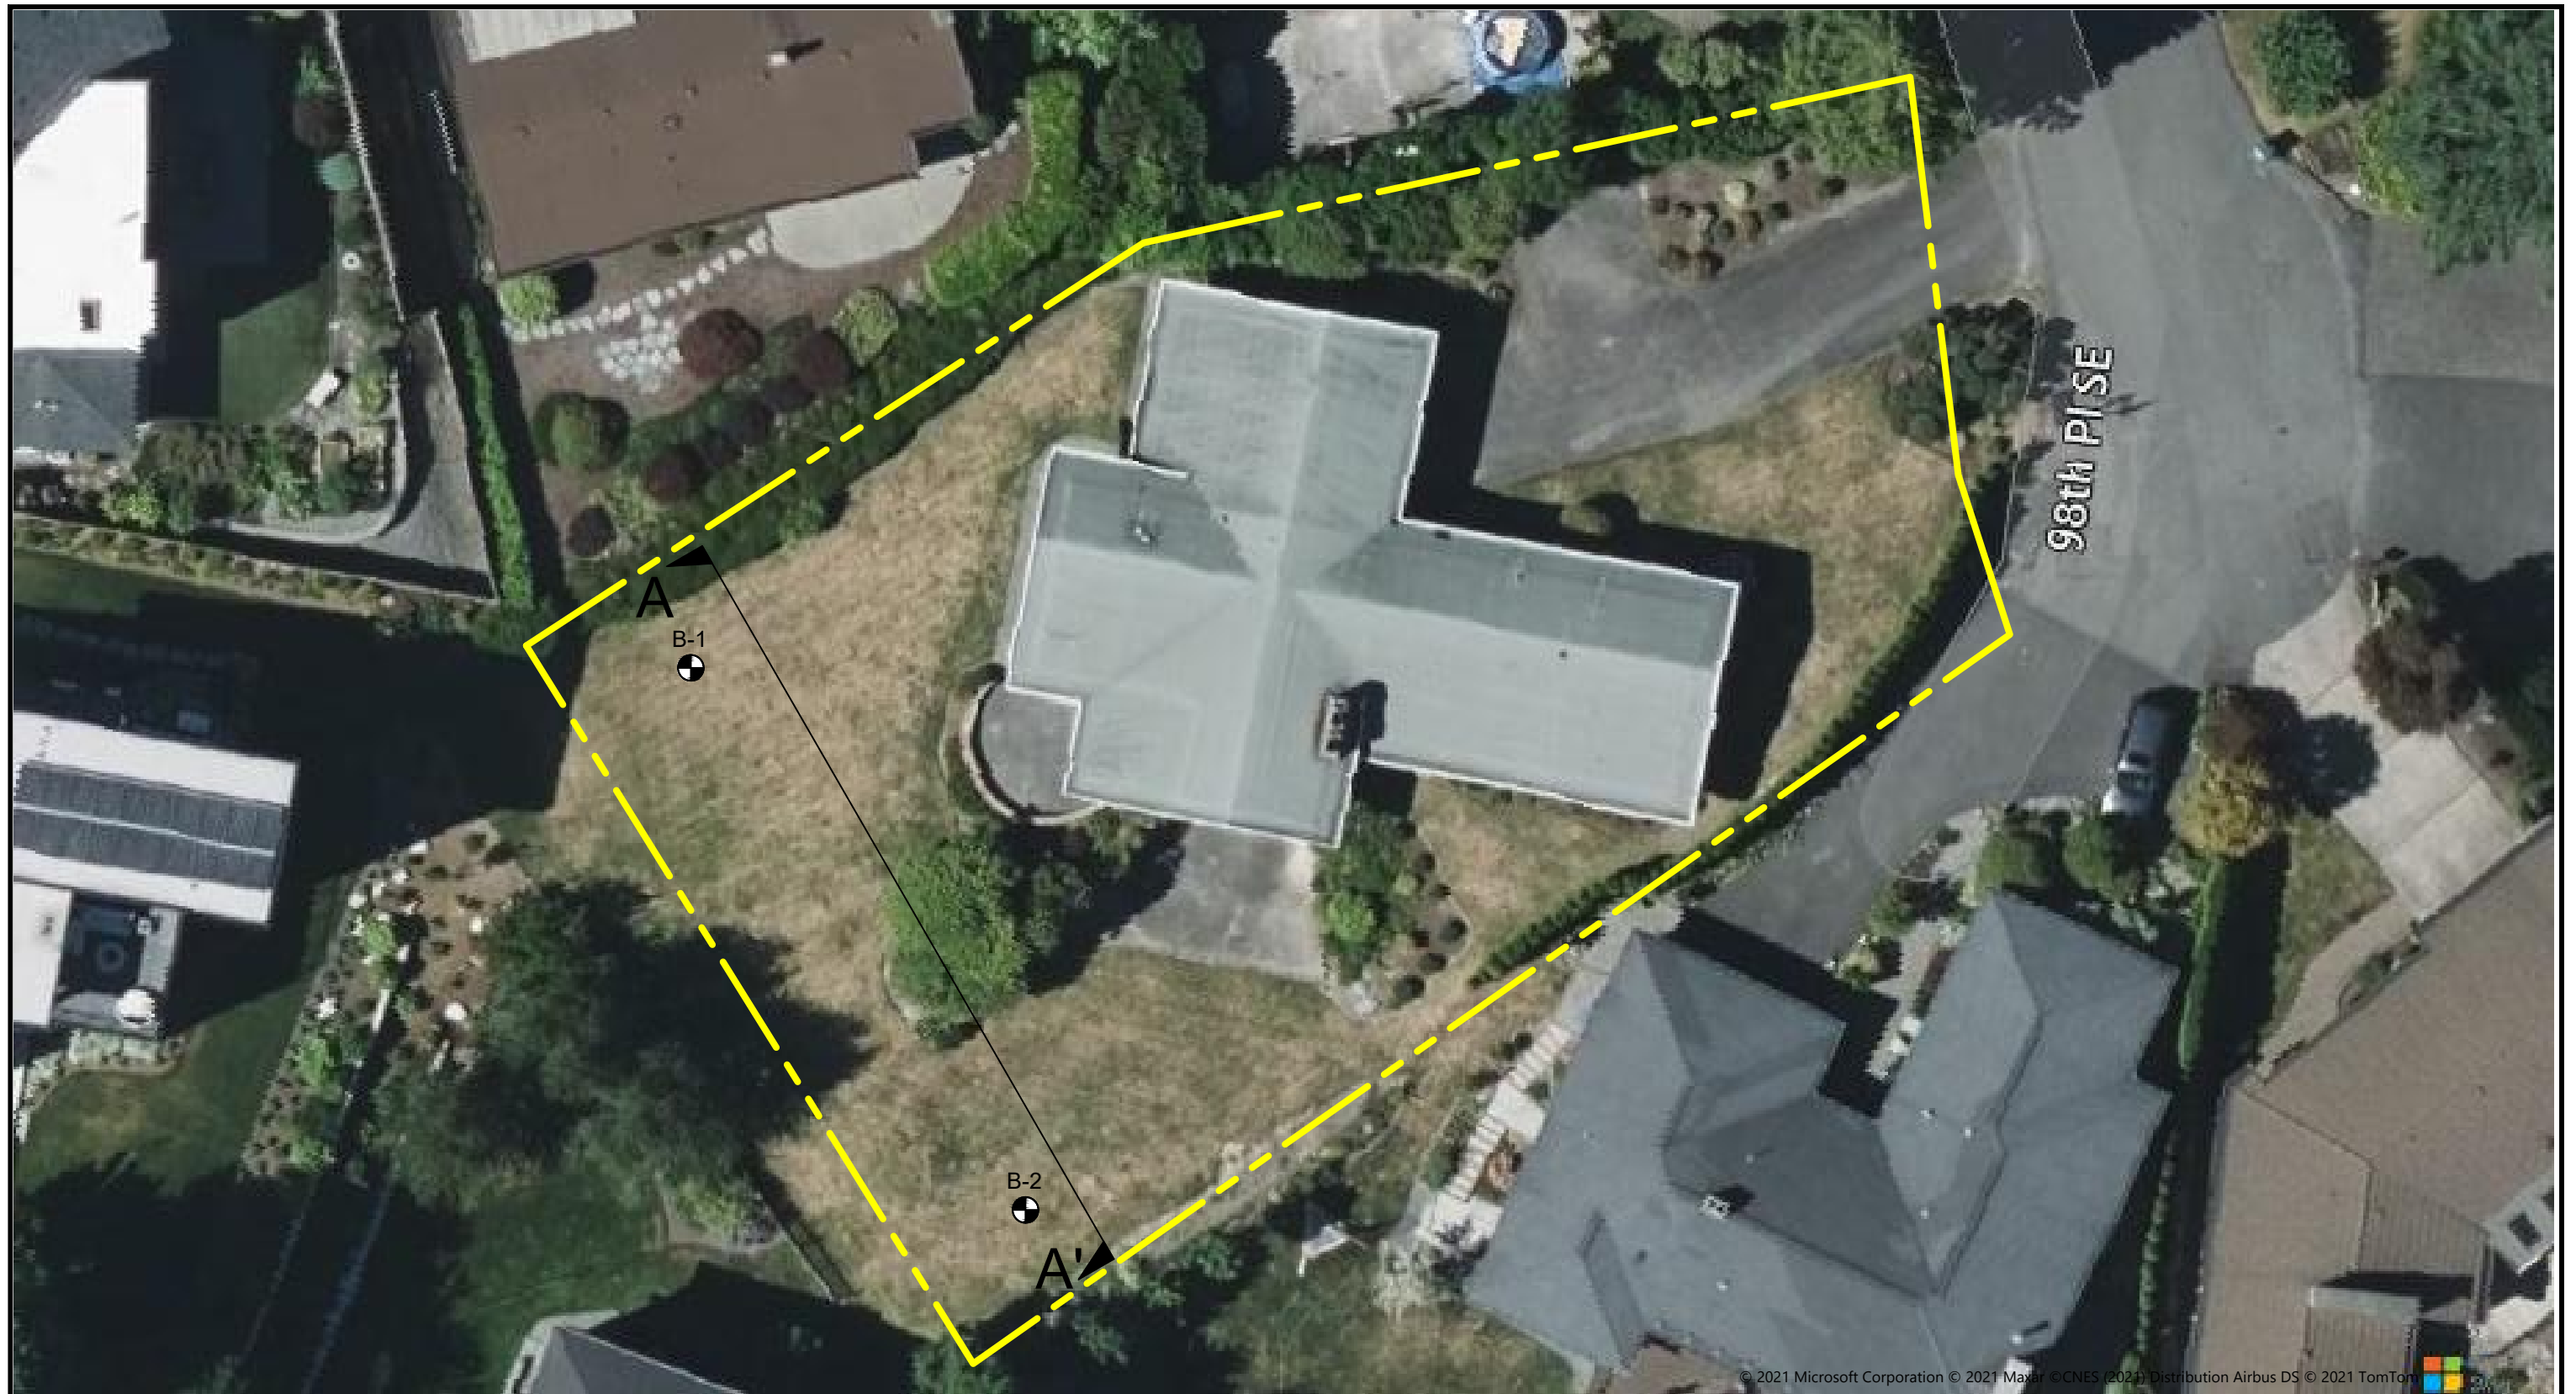
Figure 2

THIS SITE PLAN IS SCHEMATIC. ALL LOCATIONS AND DIMENSIONS ARE APPROXIMATE. IT IS INTENDED FOR REFERENCE ONLY AND SHOULD NOT BE USED FOR DESIGN OR CONSTRUCTION PURPOSES.

The preceding discussion is intended to be a general review of the soil conditions encountered. For more detailed descriptions, please refer to the Test Pit Logs in Appendix A. The approximate location of the test pits is shown on the Exploration Location Plan, Figure 2.

The western portion of the proposed development will include developing near the crest of the western slope with a concrete patio. In accordance with the City of Mercer Island requirements, we have completed a slope stability analysis to determine the effects of the new building loading on the existing slope. The analysis was performed at the location designated as Cross Section A-A' using the computer program Slide 2. The approximate cross section location is shown on Figure 2.

On April 26, 2021, we completed our site exploration by observing soil and groundwater conditions at two test borings drilled to maximum depths of approximately 20 feet below existing site grades. Test boring locations were determined in the field by measurements from existing site features. The approximate location of the test borings is shown on the attached Exploration Location Plan, Figure 2. Test Boring Logs are attached as Figures A-2 and A-3.

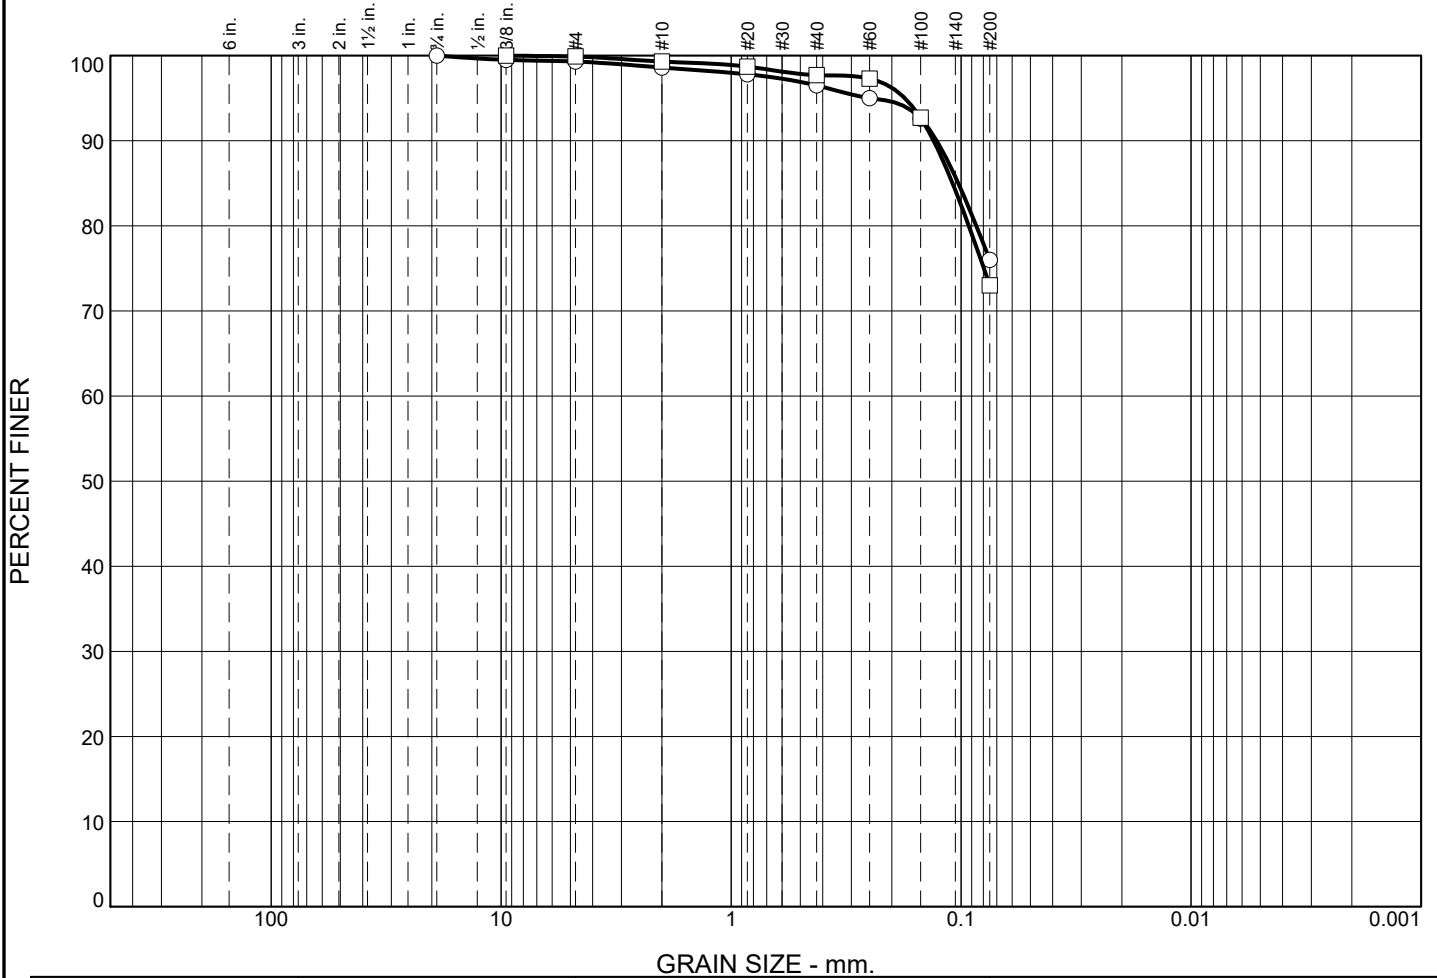
Particle Size Distribution Report

% +3"	% Gravel		% Sand			% Fines	
		Coarse	Fine	Coarse	Medium	Fine	Silt	Clay
○	0.0	0.0	0.7	0.7	2.1	20.5	76.0	
□	0.0	0.0	0.1	0.6	1.6	24.7	73.0

LL	PL	D85	D60	D50	D30	D15	D10	Cc	Cu
○			0.1029							
□			0.1089

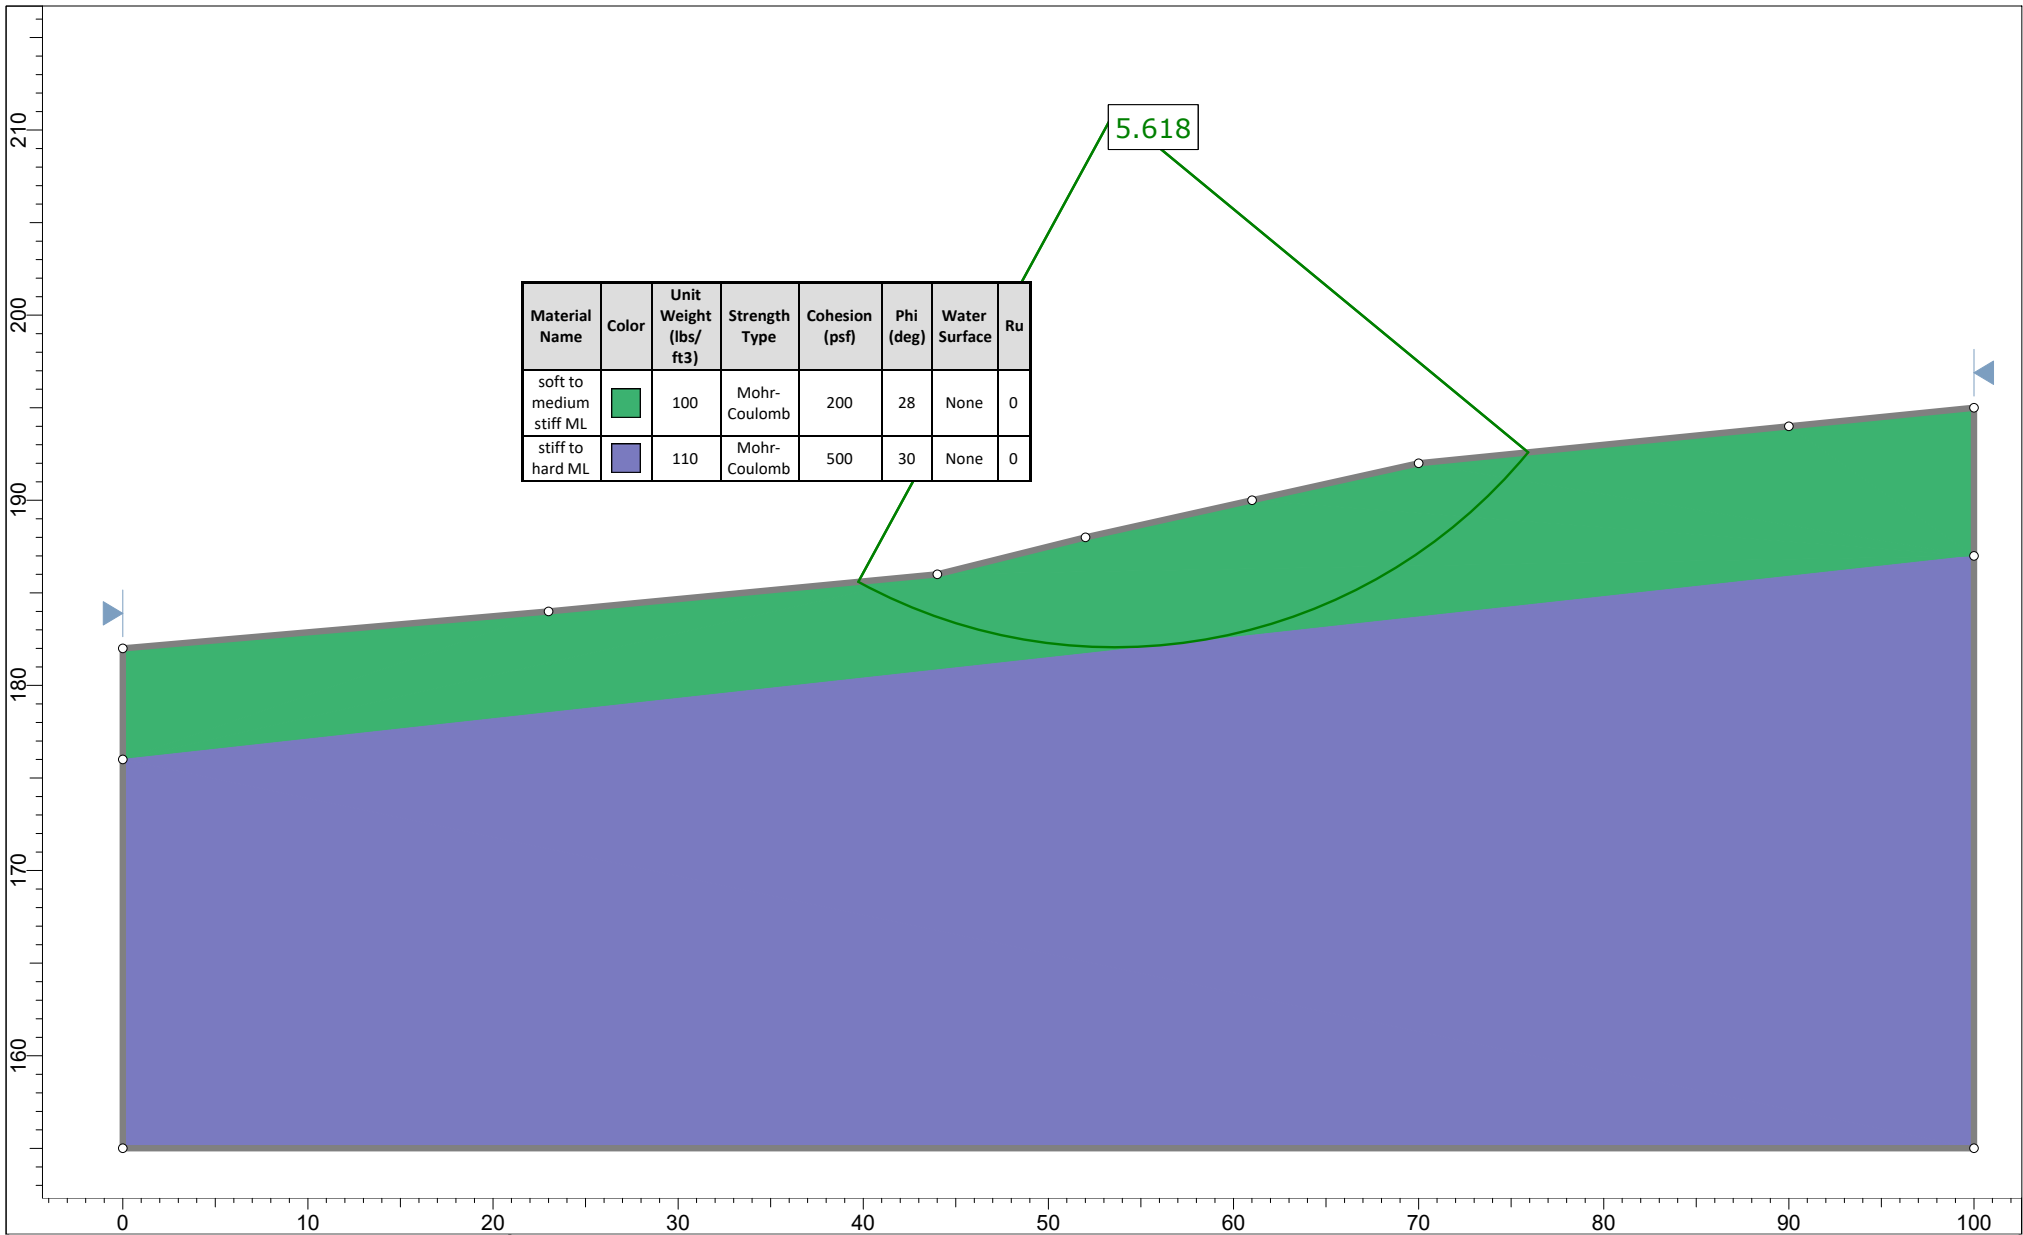
Material Name	Color	Unit Weight (lbs/ft ³)	Strength Type	Cohesion (psf)	Phi (deg)	Water Surface	Ru
soft to medium stiff ML	Green	100	Mohr-Coulomb	200	28	None	0
stiff to hard ML	Purple	110	Mohr-Coulomb	500	30	None	0

5.618

Project		SLIDE - An Interactive Slope Stability Program	
	Group		Existing - Static	Scenario
	Drawn By		MJX	Company
	Date		4/26/2021, 3:12:50 PM	File Name
				A-A' revised.slmd
<small>SLIDEINTERPRET 9.008</small>

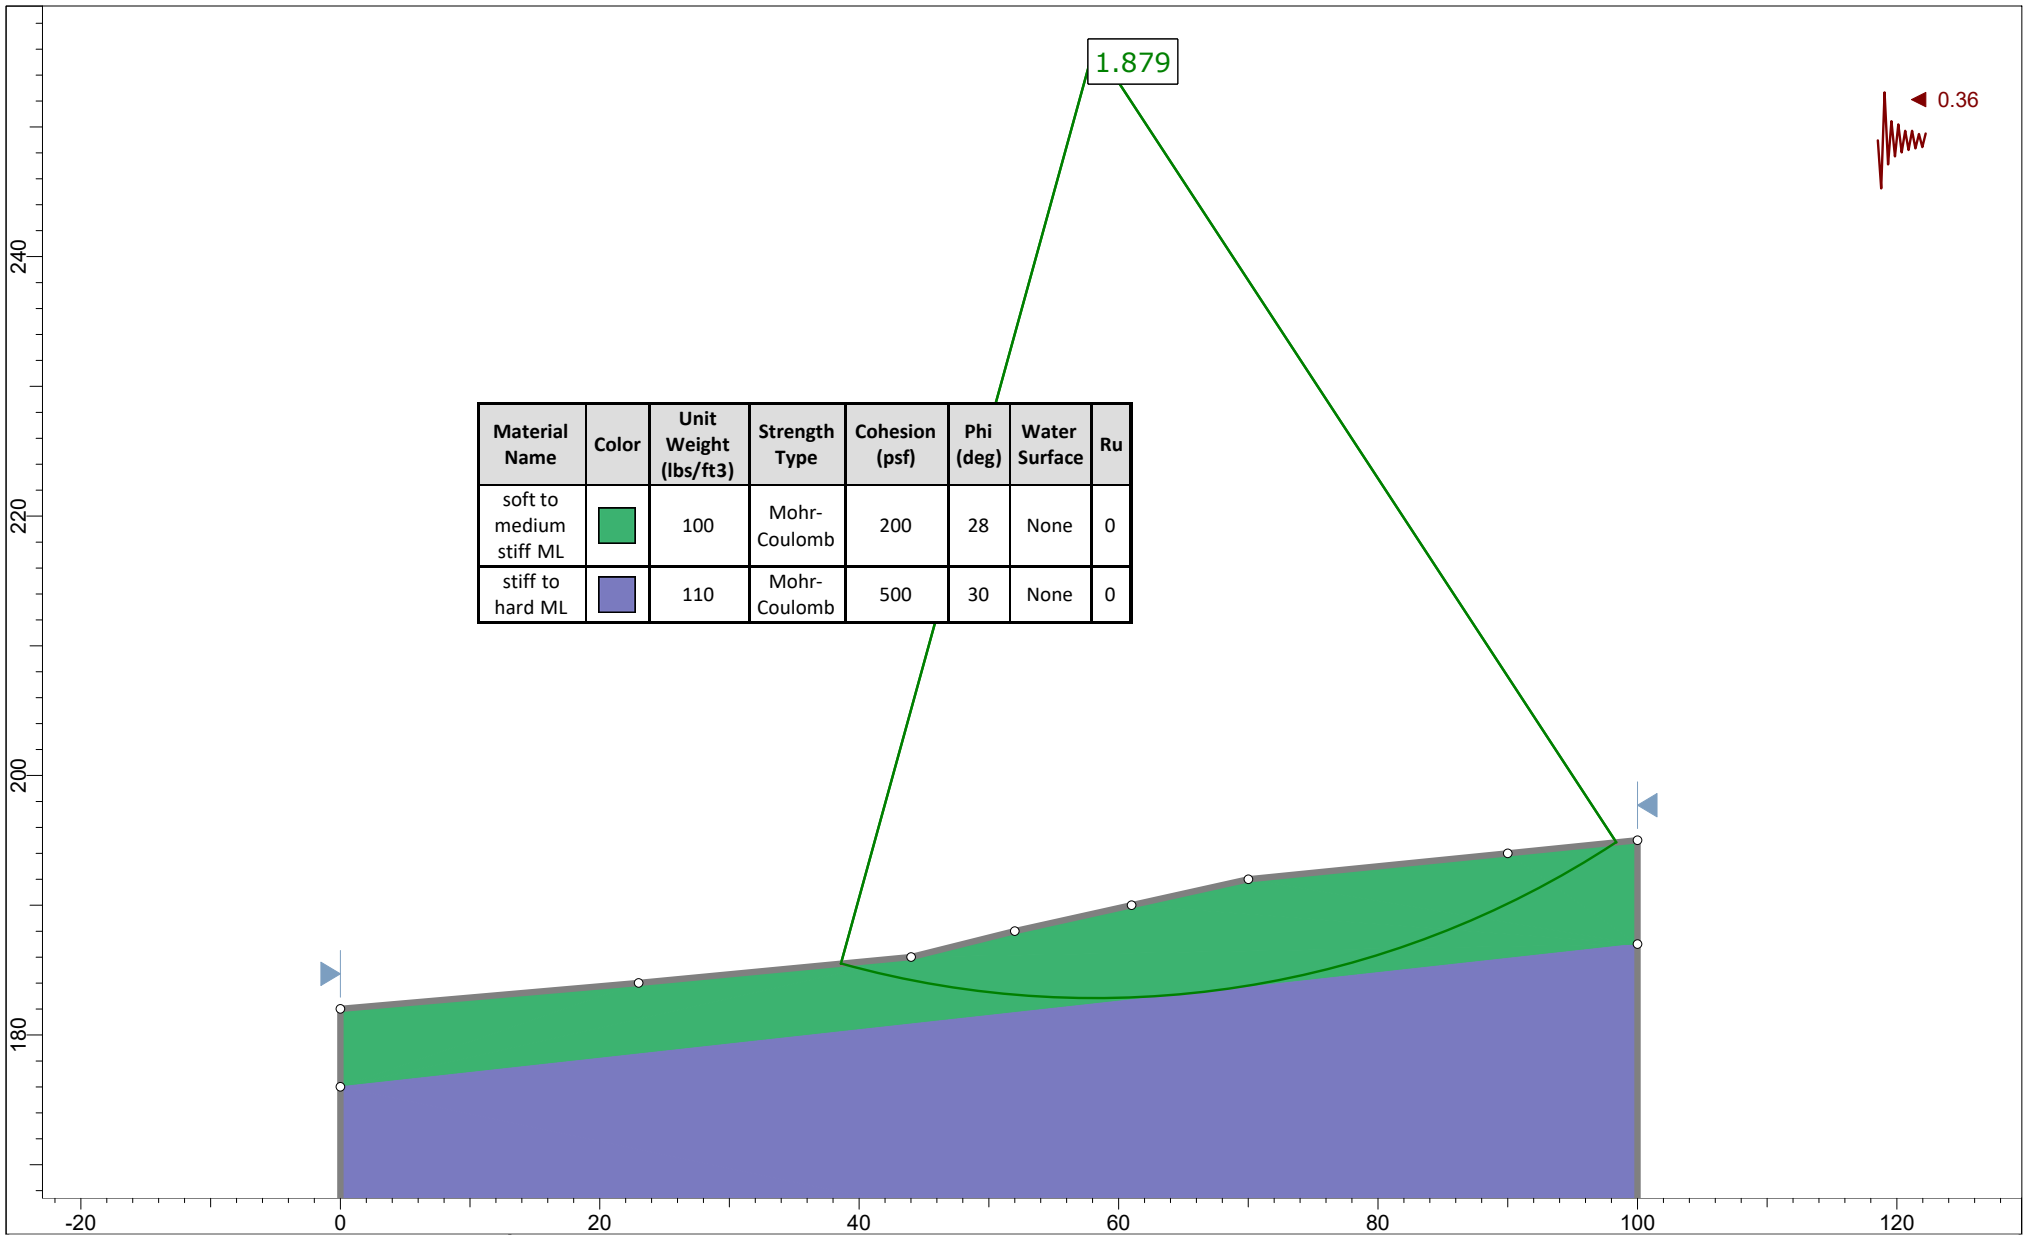
Project				SLIDE - An Interactive Slope Stability Program			
Group		Existing - Static		Scenario		Existing - Sesimic	
Drawn By		MJX		Company		Terra Associates, Inc.	
Date		4/26/2021, 3:12:50 PM		File Name		A-A' revised.slmd

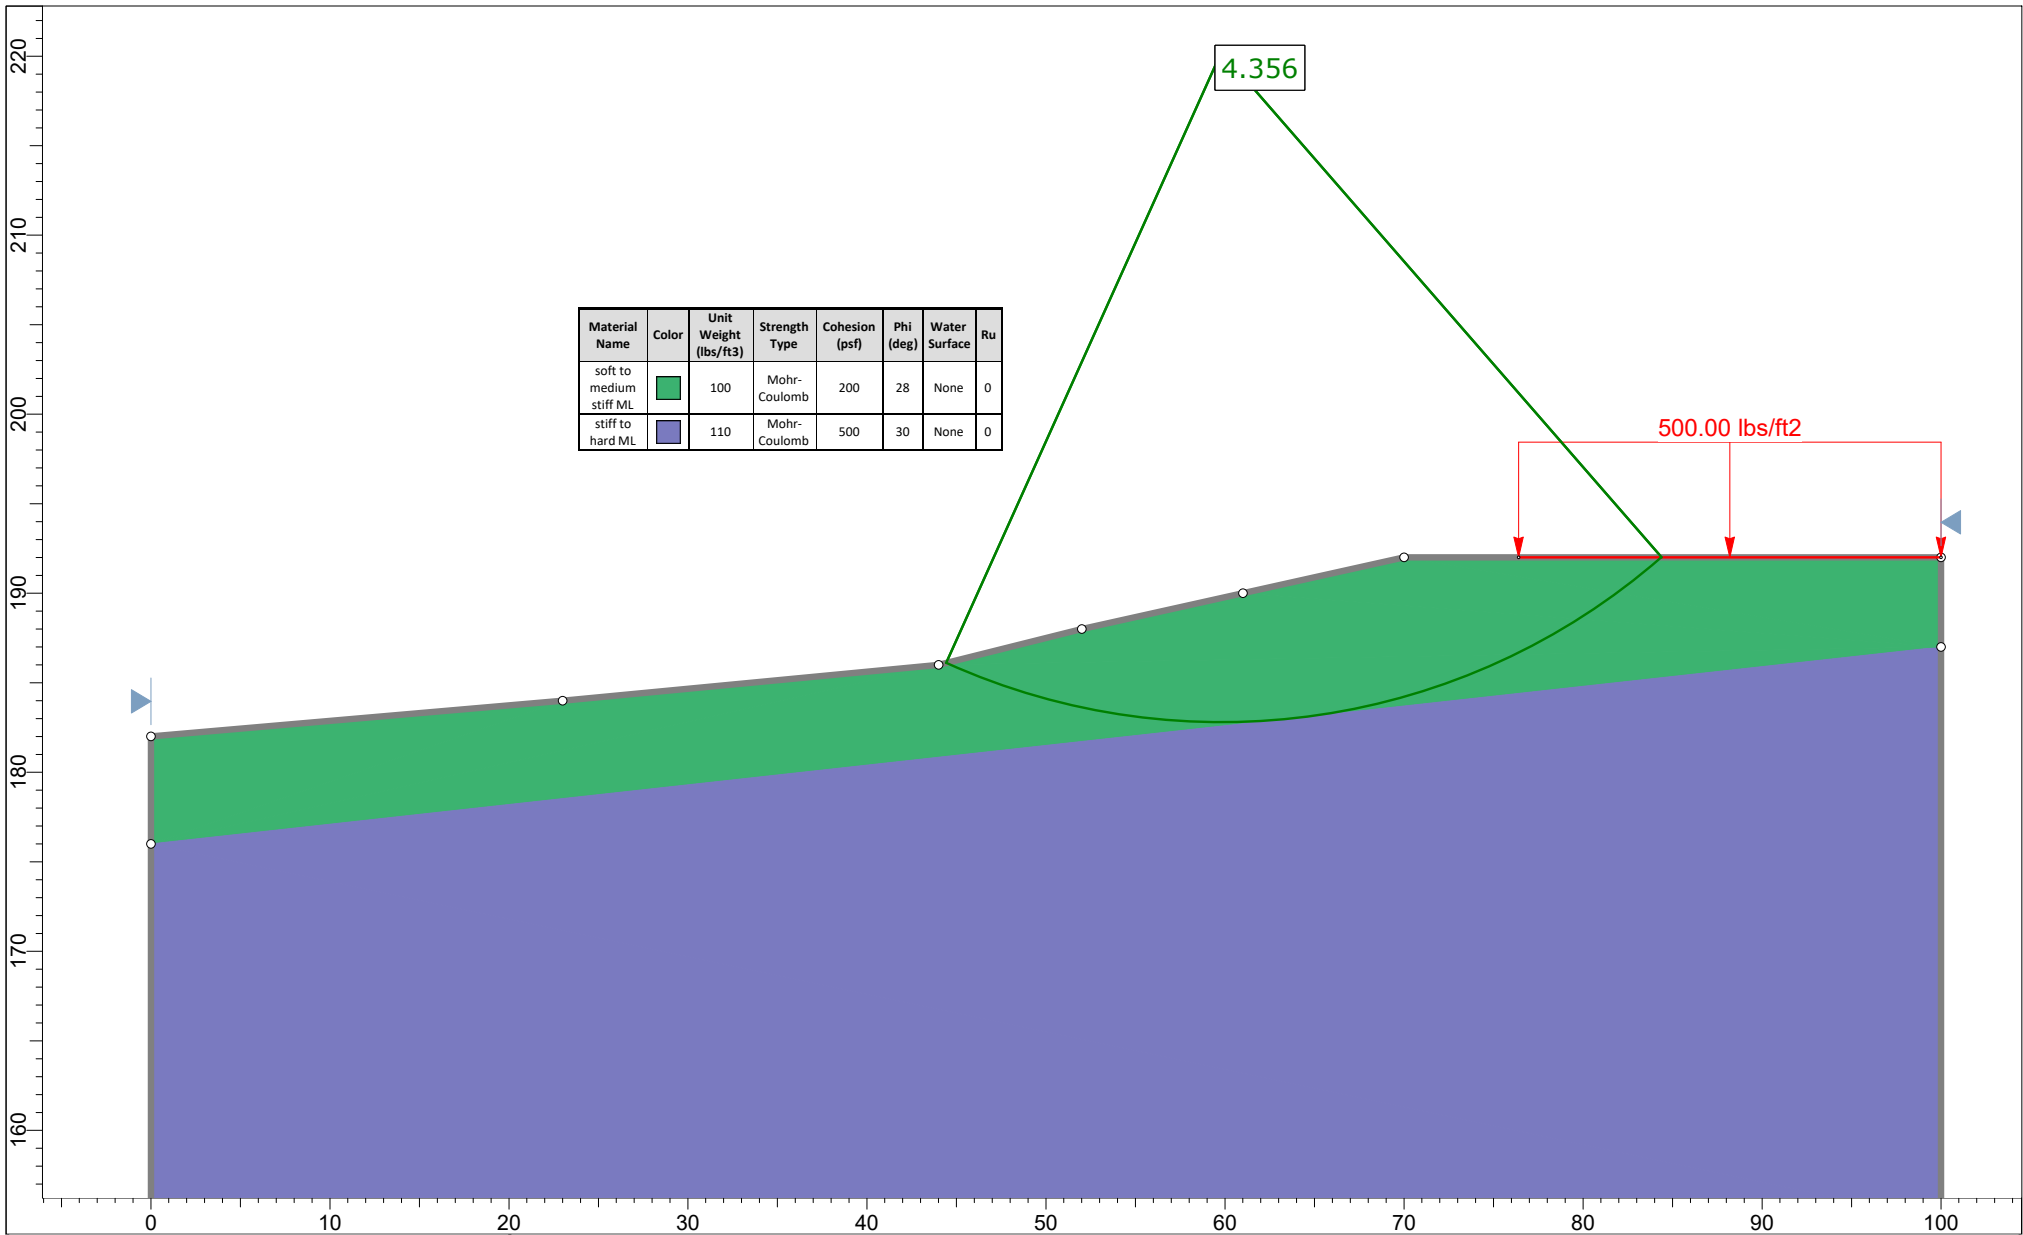
Material Name	Color	Unit Weight (lbs/ft3)	Strength Type	Cohesion (psf)	Phi (deg)	Water Surface	Ru
soft to medium stiff ML	Green	100	Mohr-Coulomb	200	28	None	0
stiff to hard ML	Purple	110	Mohr-Coulomb	500	30	None	0

<i>Project</i> SLIDE - An Interactive Slope Stability Program	
	<i>Group</i> Post Construction	<i>Scenario</i> Master Scenario
	<i>Drawn By</i> MJX	<i>Company</i> Terra Associates, Inc.
	<i>Date</i> 4/26/2021, 3:12:50 PM	<i>File Name</i> A-A' revised.slmd
	<small>SLIDEINTERPRET 9.008</small>

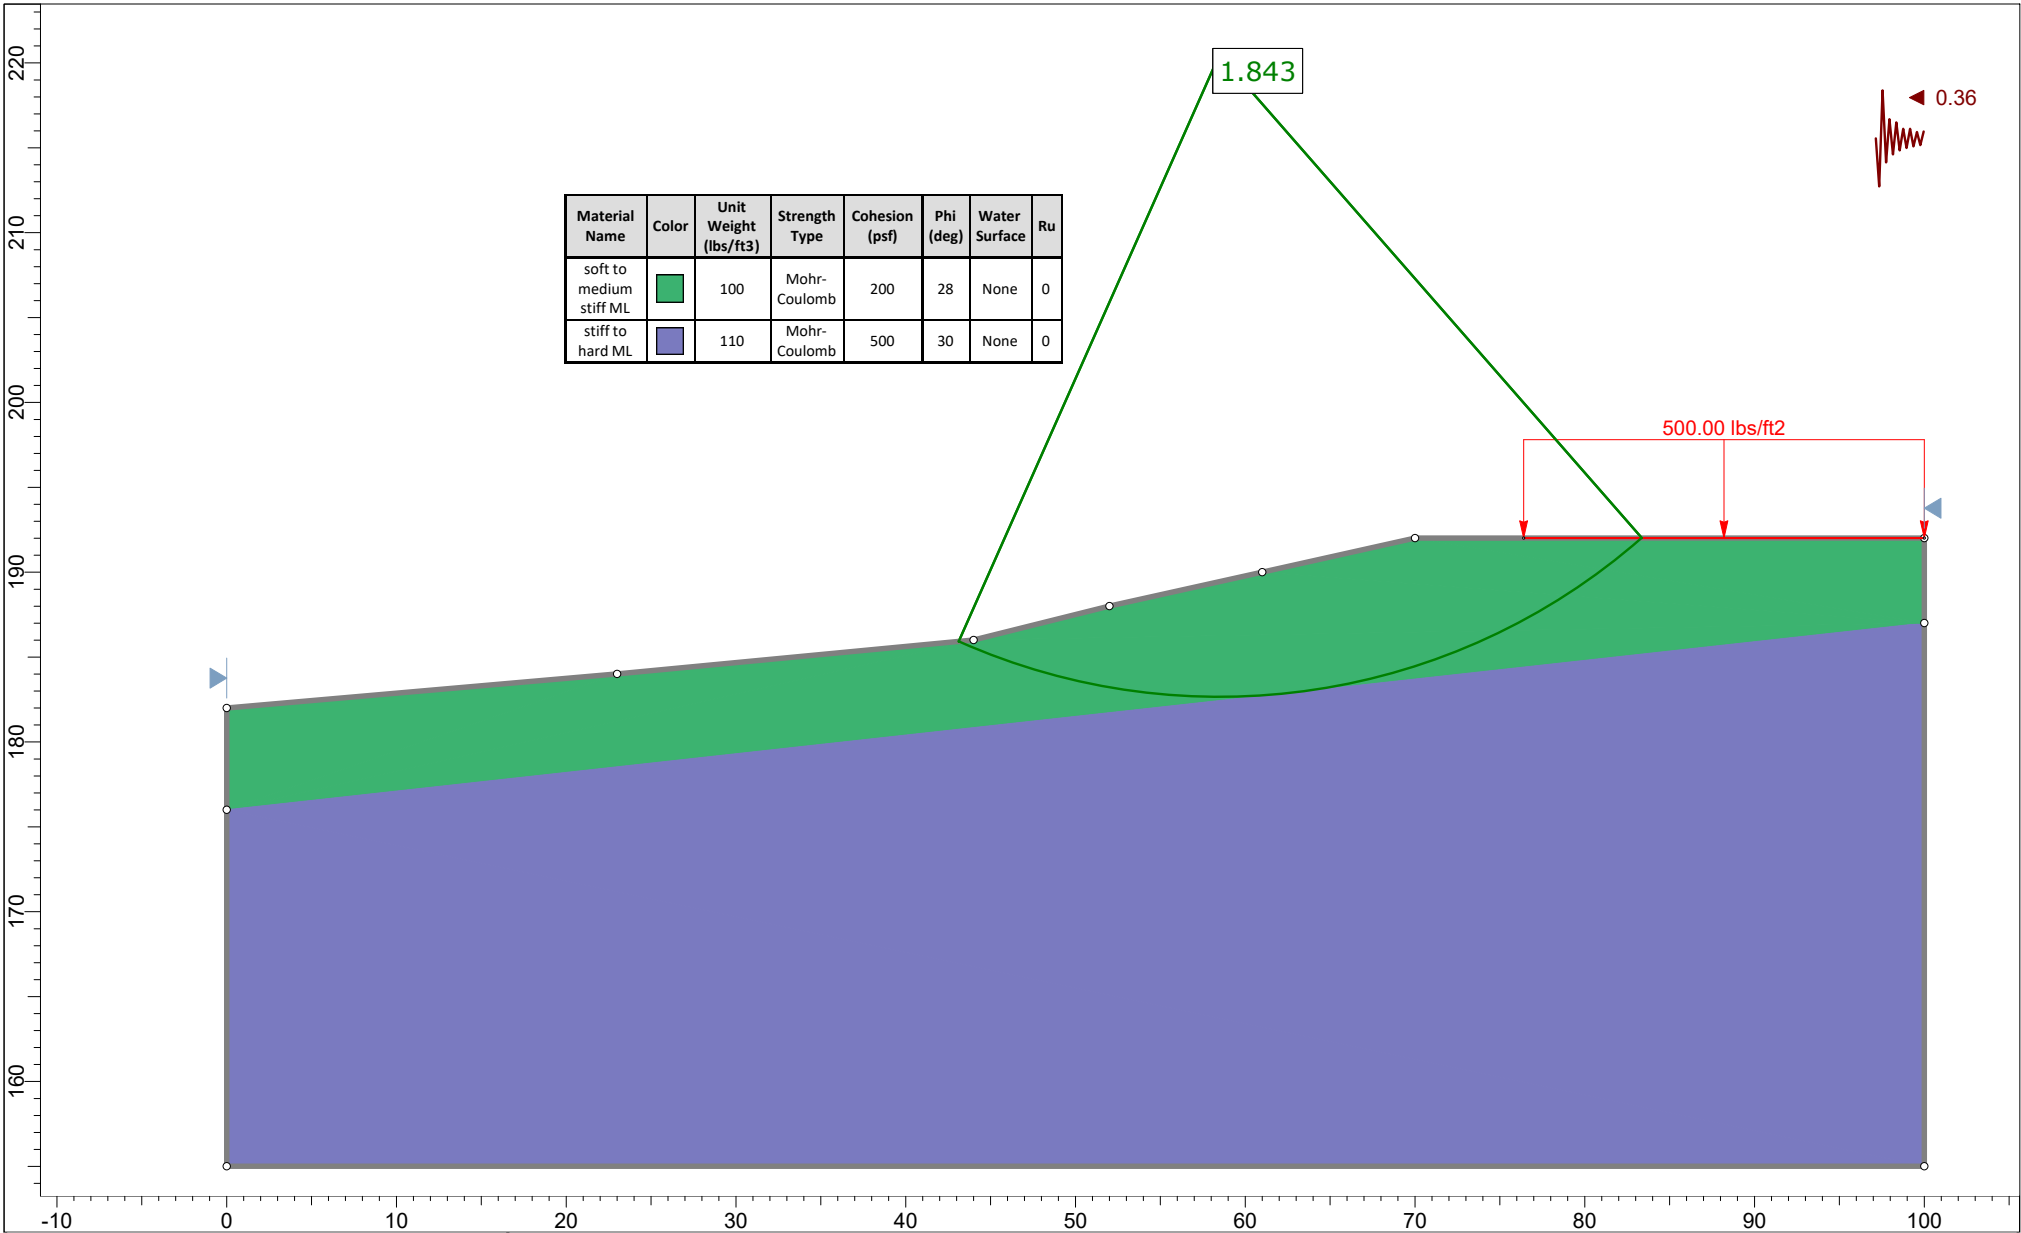
Material Name	Color	Unit Weight (lbs/ft3)	Strength Type	Cohesion (psf)	Phi (deg)	Water Surface	Ru
soft to medium stiff ML		100	Mohr-Coulomb	200	28	None	0
stiff to hard ML		110	Mohr-Coulomb	500	30	None	0
