# **GEOTECHNICAL REPORT**

**Buchan 9119  
9017 SE 60th Street  
Mercer Island, Washington**

**Project No. T-8644**

**October 27, 2021  
Revised May 25, 2022**

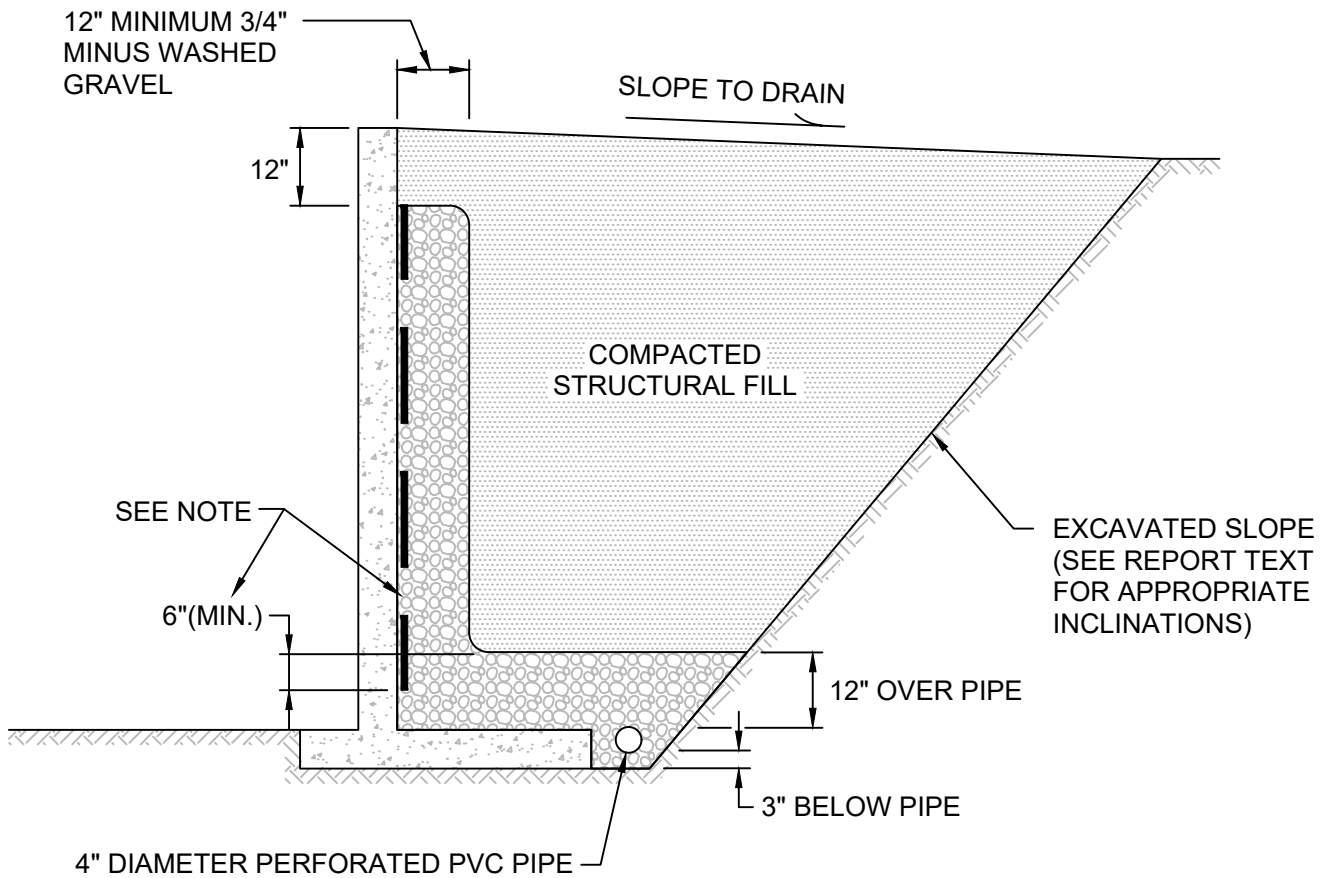
**NOT TO SCALE**

Vicinity Map.....	Figure 1
Exploration Location Plan.....	Figure 2
Typical Wall Drainage Detail.....	Figure 3

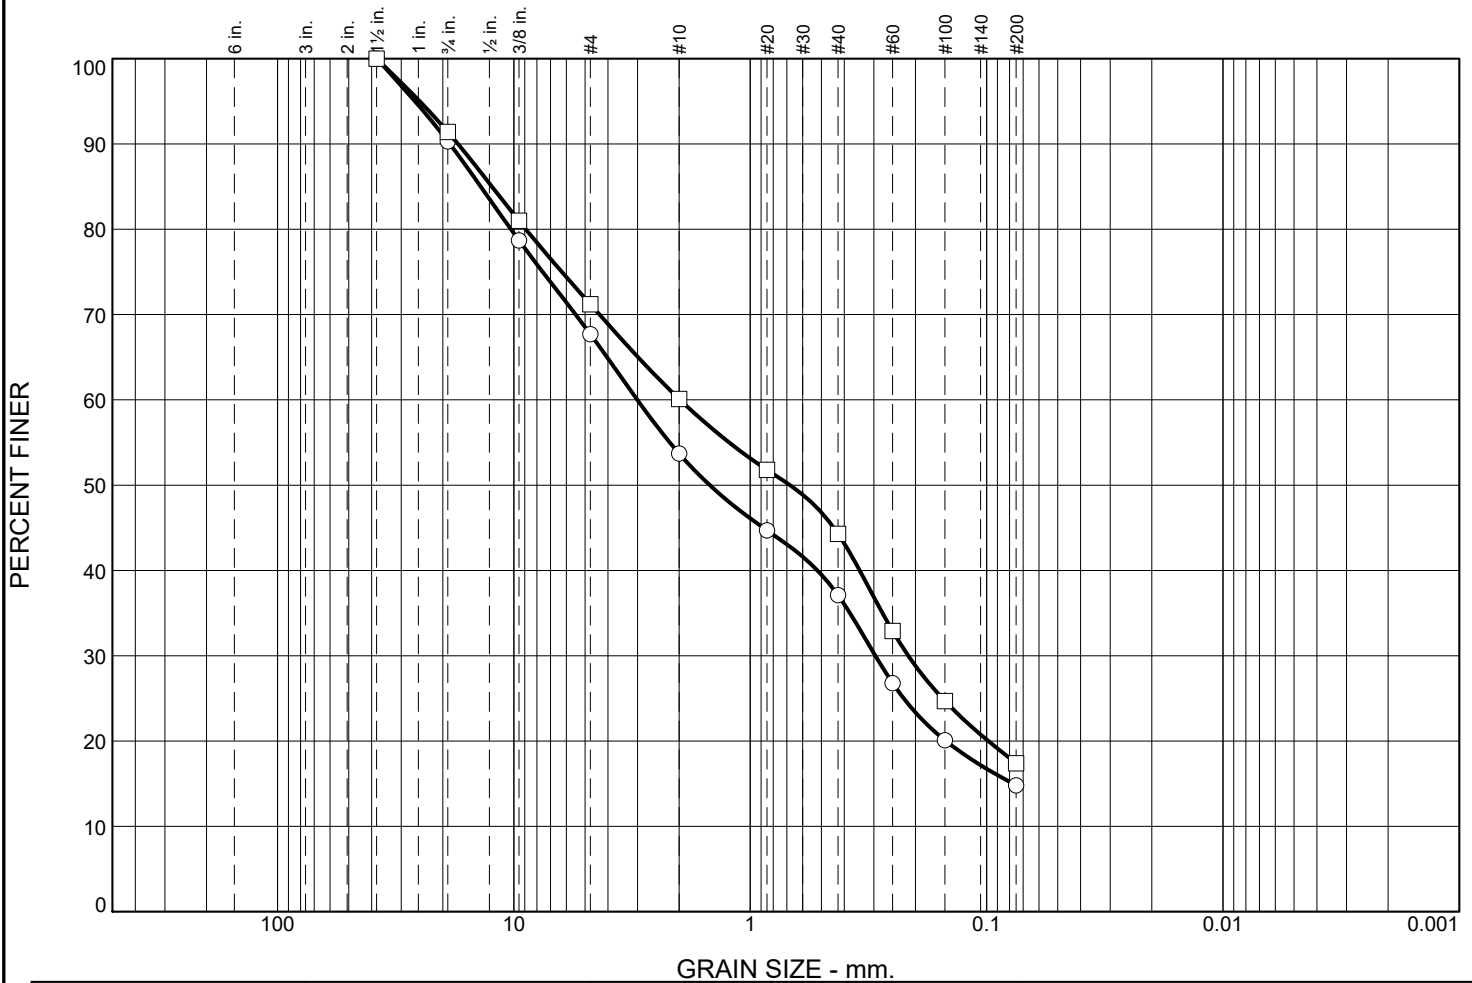
# Particle Size Distribution Report

% +3"	% Gravel		% Sand			% Fines	
		Coarse	Fine	Coarse	Medium	Fine	Silt	Clay
○	0.0	9.7	22.6	14.0	16.6	22.3	14.8	
□	0.0	8.6	20.2	11.1	15.8	26.9	17.4

LL	PL	D85	D60	D50	D30	D15	D10	Cc	Cu
○			13.8173	3.0041	1.4840	0.2954	0.0773			
□			12.3840	1.9827	0.6790	0.2145
