April 12, 2022  
Revised on April 18, 2022  
Project No. 22-111

**Subject: Geotechnical Report and Geologically Hazardous Areas Evaluation  
Proposed Addition  
7845 Southeast 62<sup>nd</sup> Street, Mercer Island, Washington**

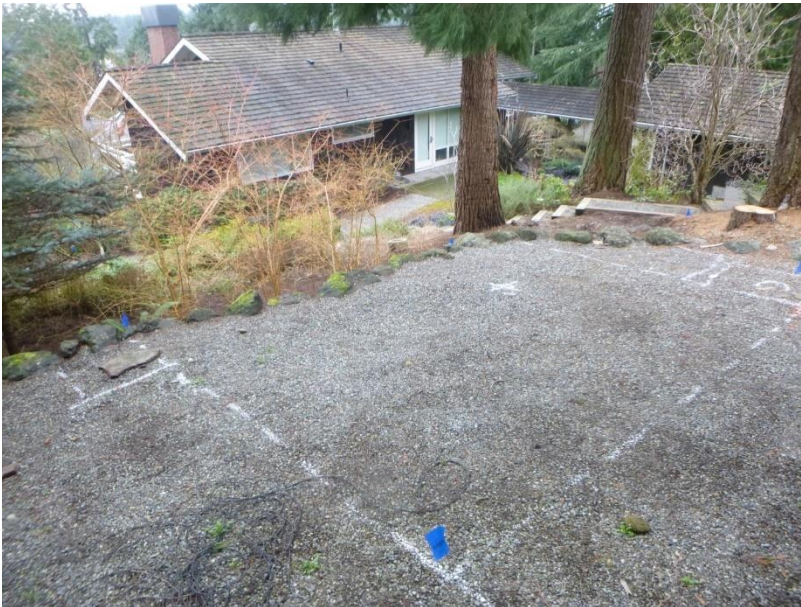
**Plate 1:** Rear view of the existing residence (back) and location of the proposed accessory structure (front). Looking northwest from the southeast property corner.

The project site is an approximately 14,577 square foot lot located at 7845 Southeast 62<sup>nd</sup> Street in Mercer Island, Washington, approximately as shown on Figure 1, Vicinity Map. The site is irregular in shape. It is bordered to the north by SE 62<sup>nd</sup> Street and to the other three sides by existing single-family residences. The site is currently occupied by a one-story single-family residence with a partial daylight basement and a detached garage. Based on review of the topographic survey and our site observations, the existing site grade generally slopes down from southeast to the north and west with a vertical relief of up to 28 feet and average an average gradient of 15 to 20 percent. Some grade separation is provided by several 1- to 2-foot-tall rockeries. The general conditions of the site at the time of our field exploration are shown on the Plates 1 and 2 on page 2.

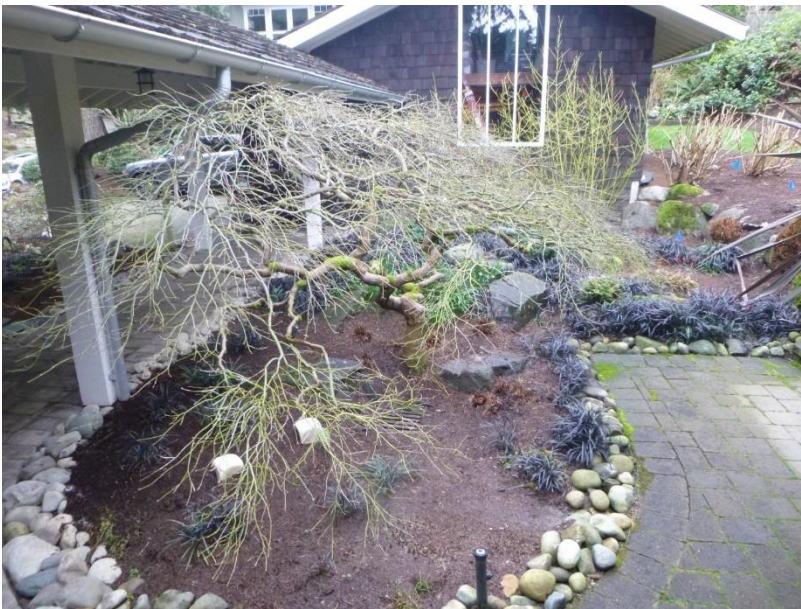
**Plate 2:** View of rockery (right) and existing detached garage (back), where the proposed addition will be located. Looking east from the existing residence.
