**Stormwater Drainage Report  
4533 90<sup>th</sup> Avenue SE  
Mercer Island, Washington  
KC Tax Parcel #019110-0190**

February 4, 2022

**Offe Engineers, PLLC  
Darrell Offe, P.E.  
13932 SE 159<sup>th</sup> Place  
Renton, Washington 98058  
425-260-3412  
[Darrell.Offe@comcast.net](mailto:Darrell.Offe@comcast.net)**

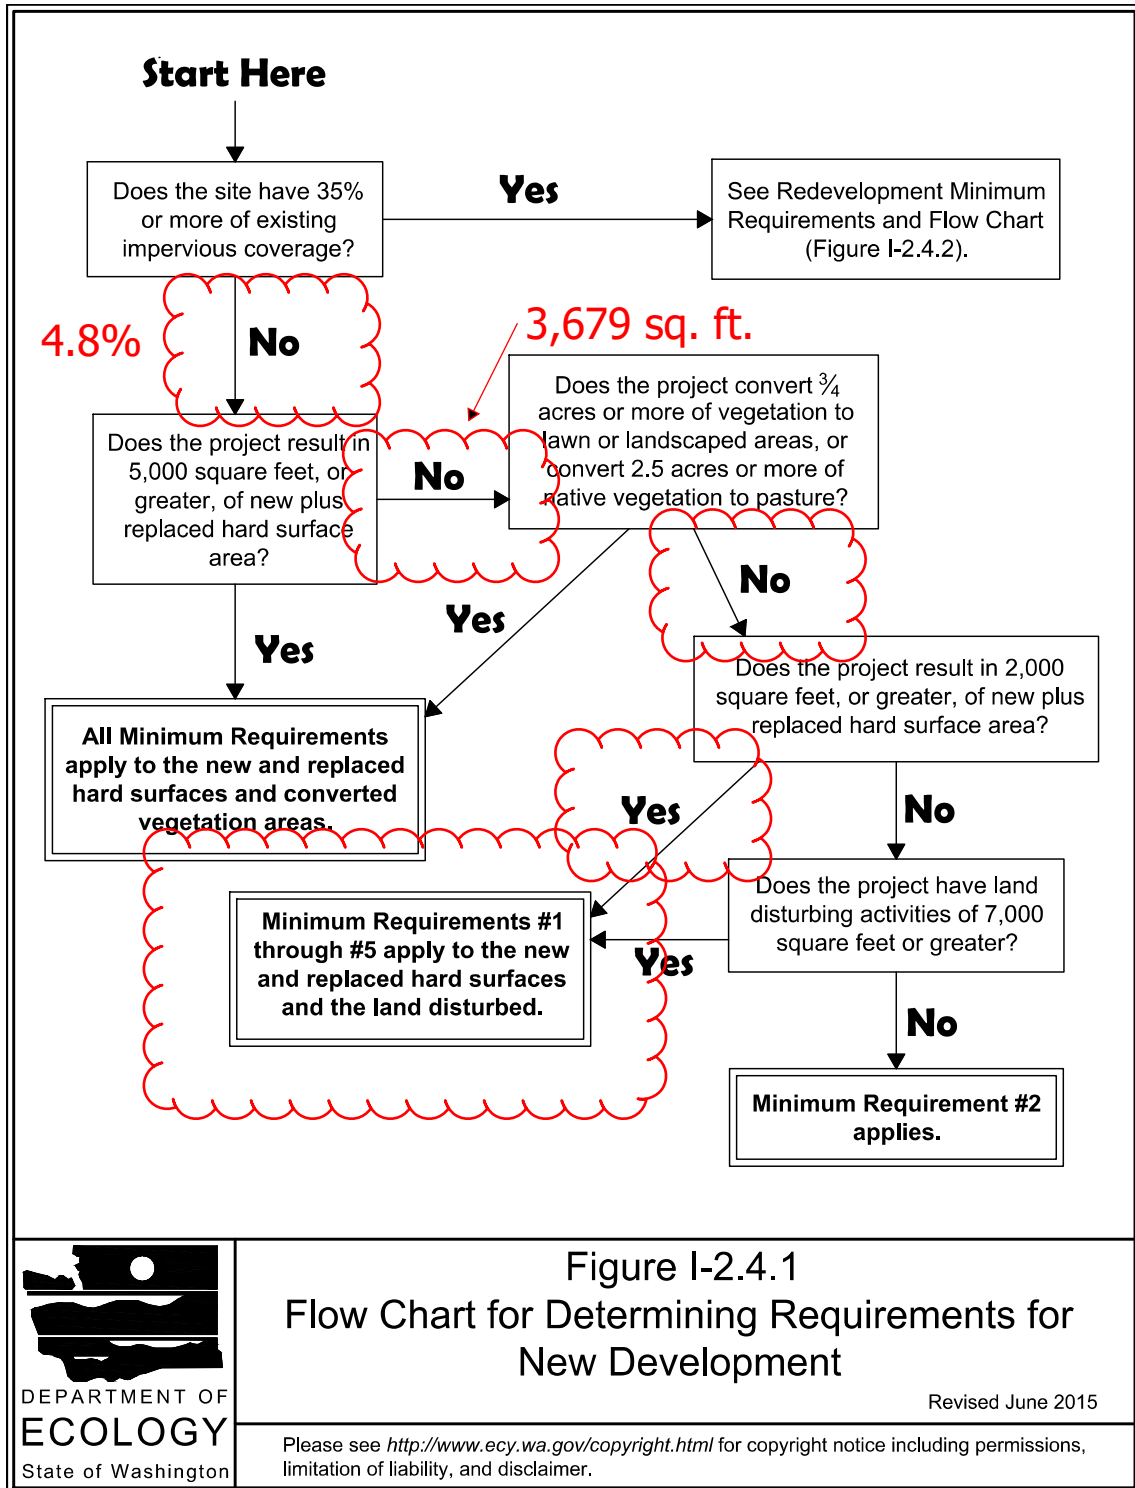
**Figure I-2.4.1 Flow Chart for Determining Requirements for New Development**

**Figure I-2.4.1**  
**Flow Chart for Determining Requirements for New Development**

The existing property has less than 35% (4.8%) impervious coverage and the total proposed project new plus replaced impervious surfaces will be less than 5,000 (3,679) square feet; using Figure I-2.4.1 – "Flow Chart for Determining Minimum Requirements for New Development" page 37, 2014 Stormwater Management Manual for Western Washington, Minimum Requirements #1 – #5 apply to this project.

Based upon the Flow Chart Figure I-2.4.1 and I-2.4.2 (Amended December 2014 SWMMWW, DOE Manual), the Minimum Requirements 1-5 apply to this project, see attached Flow Chart.
