STORM DRAINAGE REPORT

Headrick Residence

8822 SE 62nd Street

BRH Project: 2019094

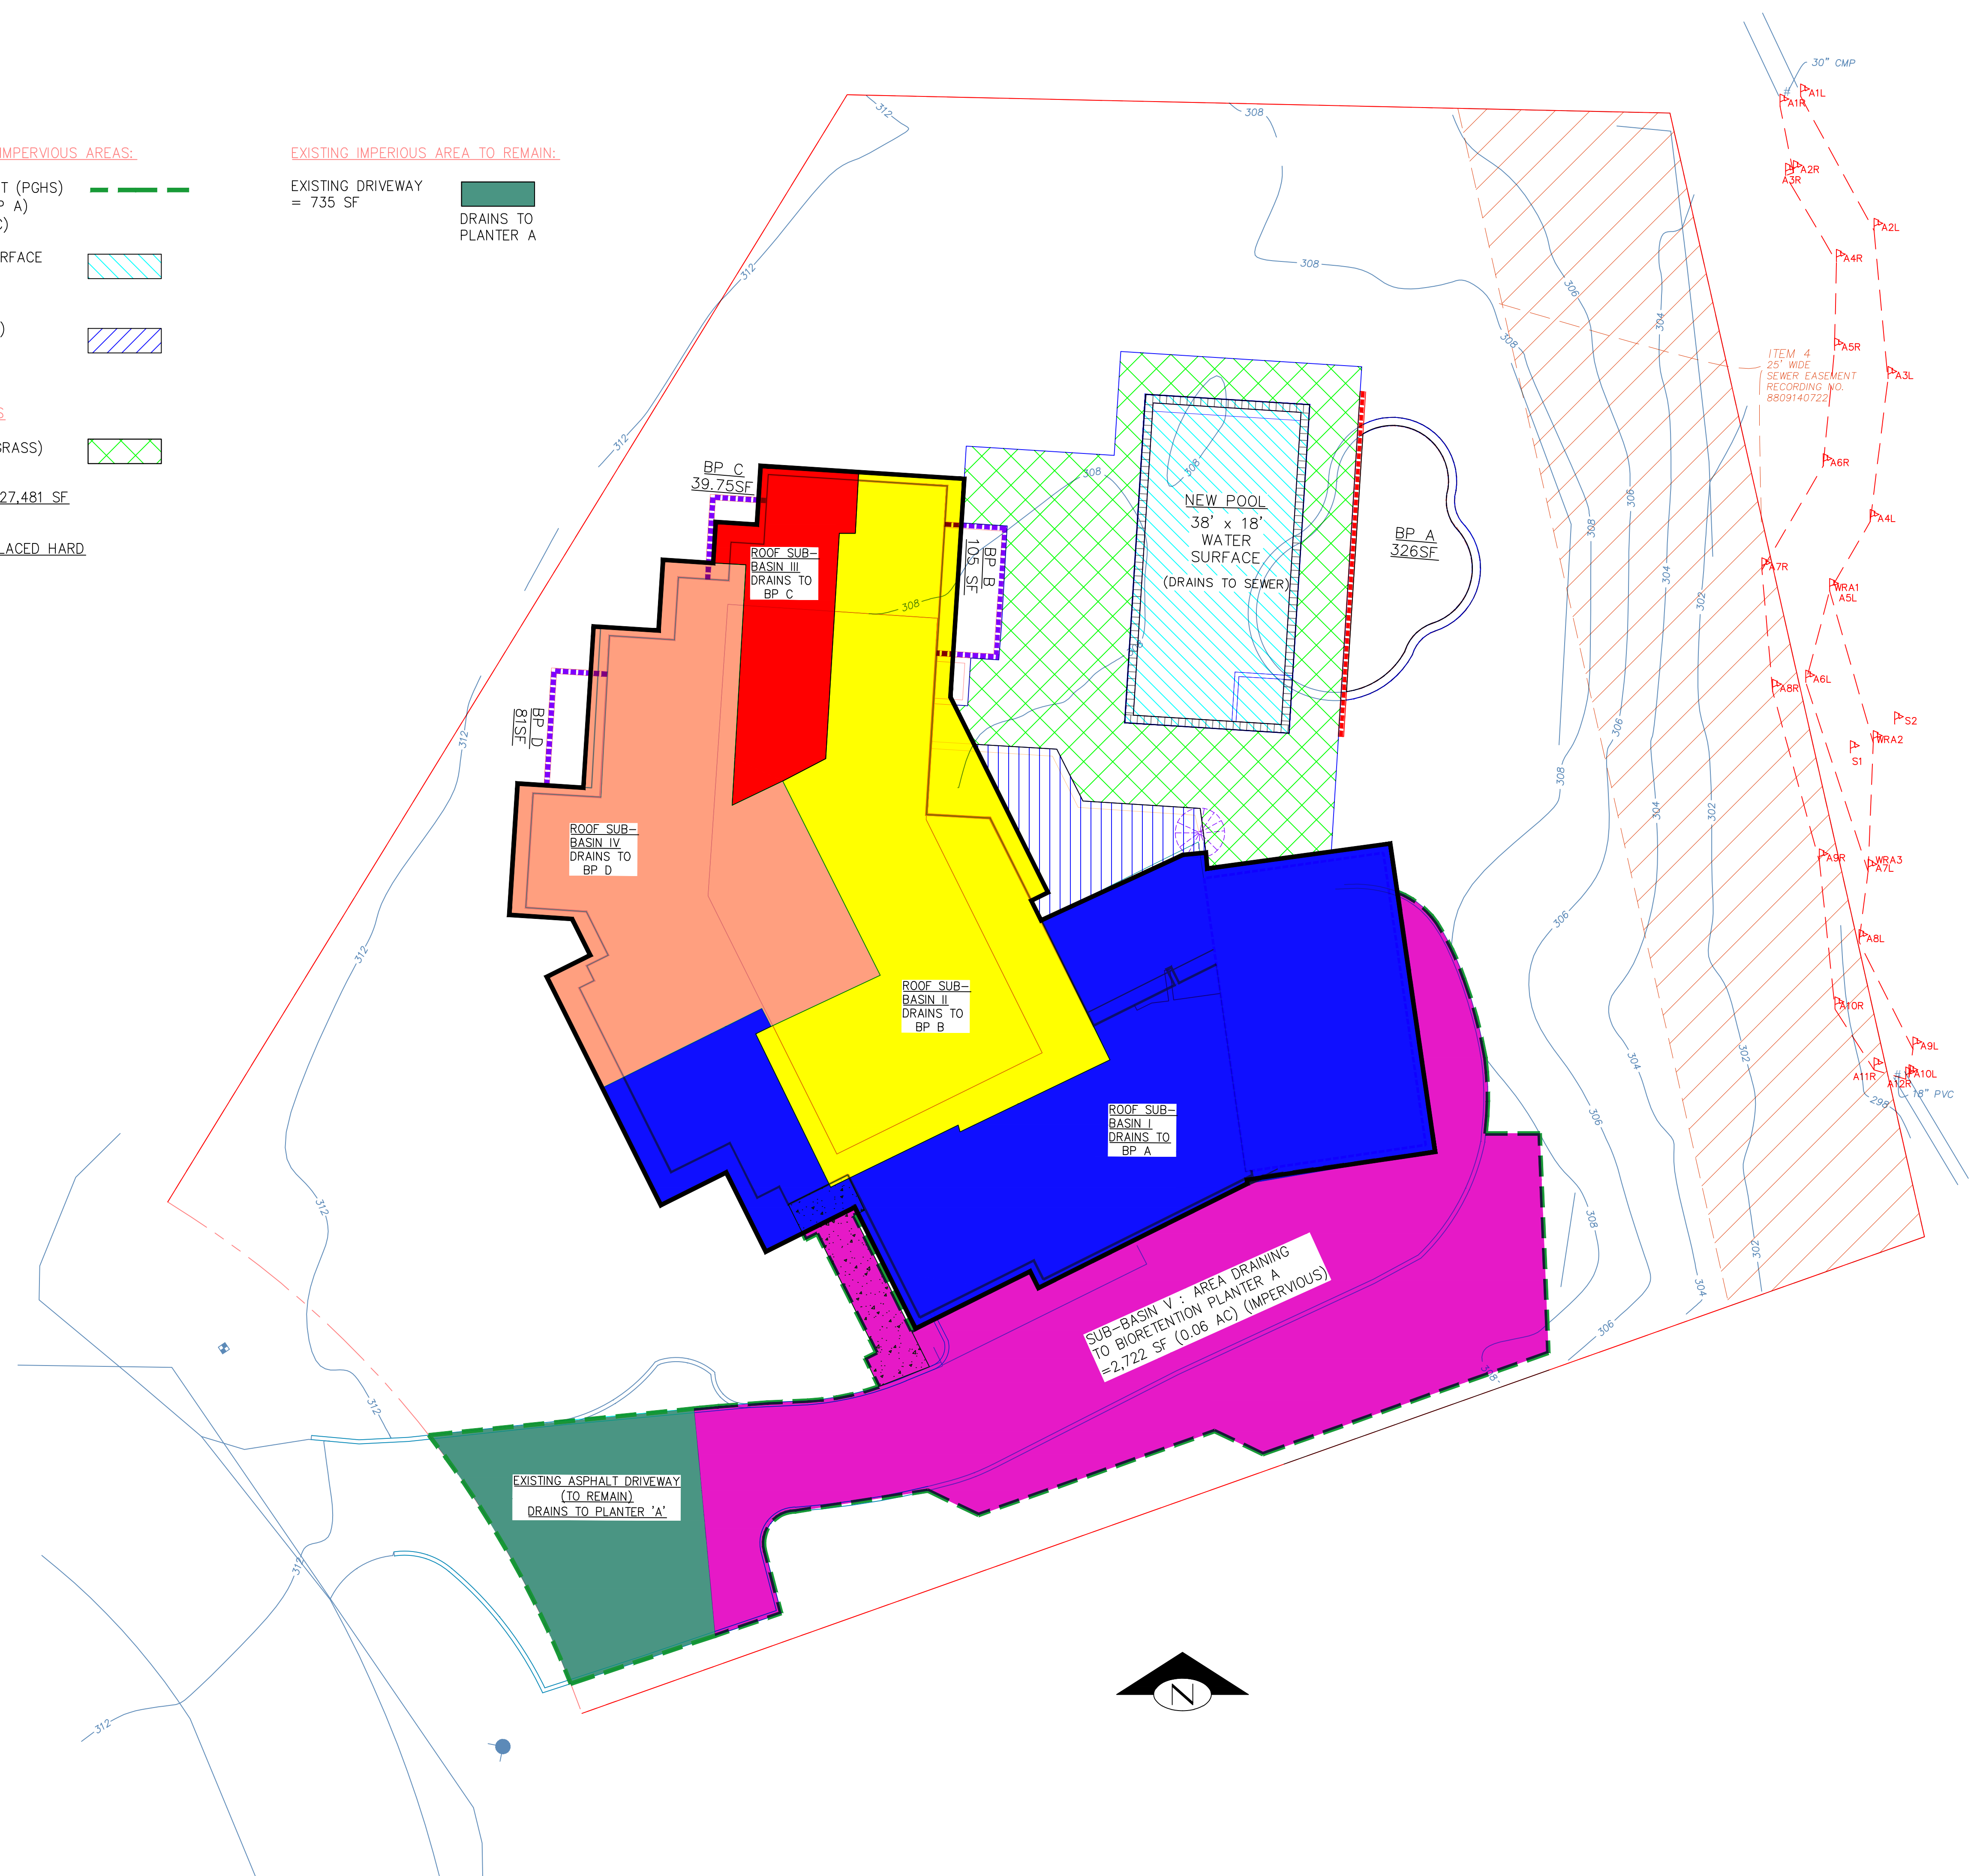
24" x 36" 5/23/2023 U:\C3D\2019\2019094\ENGINEERING\EXHIBITS\DRAINAGE BASIN MAPS\ON-SITE BASIN MAP-DWG

- ROOF AREAS:**
- - - - - BUILDING ROOF TO BIOPANTERS = 6,466 SF (0.15 AC)
 - SUB BASIN I (BP A) = 2,657SF
 - SUB BASIN II (BP B) = 1,829SF
 - SUB BASIN III (BP C) = 451SF
 - SUB BASIN IV (BP D) = 1,529SF
- BIORETENTION PLANTERS**
- (BP A) = 6,288 SF CONTRIBUTING AREA
 - (BP B) = 1,829 SF CONTRIBUTING AREA
 - (BP C) = 451 SF CONTRIBUTING AREA
 - (BP D) = 1,529 SF CONTRIBUTING AREA
- NEW AND REPLACED IMPERVIOUS AREAS:**
- IMPERVIOUS PAVEMENT (PGHS) (SUB BASIN V) - (BP A) = 3,457 SF (0.08 AC)
 - NEW POOL WATER SURFACE (DRAINS TO SEWER) = 684 SF (0.01 AC)
 - PATIO PAVERS (BP A) = 278 SF (0.004 AC)
 - NEW LANDSCAPING (GRASS) = 1,452 SF
- NEW PERVIOUS AREAS**
- TOTAL SITE AREA = 27,481 SF (0.63 AC)
- TOTAL NEW AND REPLACED HARD SURFACE = 10,781 SF (0.25 AC)
- EXISTING IMPERVIOUS AREA TO REMAIN:**
- EXISTING DRIVEWAY = 735 SF
 - DRAINS TO PLANTER A

Although the project creates more than 2,000 sf of new and replaced hard surfaces (10,781 sf), per the City of Mercer Island's stormwater management standards, Flow Control (MR-7) is not required for projects that any of the BMPs included on List #1 and List #2 are determined feasible for impervious and pervious surfaces. See **Section 2.0** for a description of the minimum requirements, **Section 4.2** for Low Impact Development Design and **Appendix A – Onsite Basin Map** for hard surface summary and sub-basins location.

Non-infiltrating bioretention planters were used where feasible to mitigate as much of the site as possible. There are three non-infiltrating bio-retention planters receiving all new and replaced hard surface of the total impervious surfaces. See **Appendix A** for onsite basin map and **Appendix B** for Onsite Plans.
