STORM DRAINAGE REPORT

Headrick Residence

8822 SE 62nd Street

BRH Project: 2019094

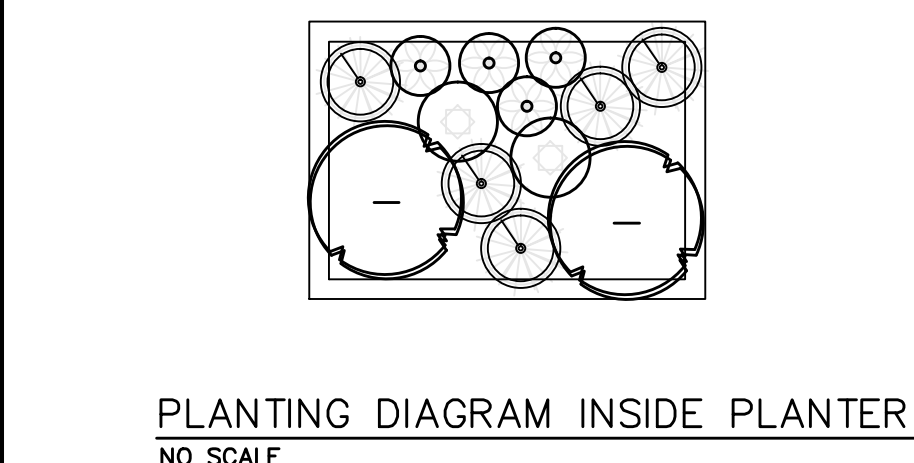
B SECTION B BIO RETENTION PLANTER

C SECTION C BIO RETENTION PLANTER
1"=5' H & 1"=5' V

D SECTION D BIO RETENTION PLANTER
1"=5' H & 1"=5' V

There will be a 4 in slotted underdrain PVC pipe per ASTM D1785 SCH 40. The slotted Underdrain is surrounded of underdrain aggregate material. See **Appendix B** for a **typical bioretention planter cross section**. The guidance for the aggregate underdrain filter and bedding layer is found in **Chapter V-7 – Infiltration and Bioretention Treatment Facilities** of “2019 Stormwater Management Manual for Western Washington”.
