STORM DRAINAGE REPORT

Headrick Residence

8822 SE 62nd Street

BRH Project: 2019094

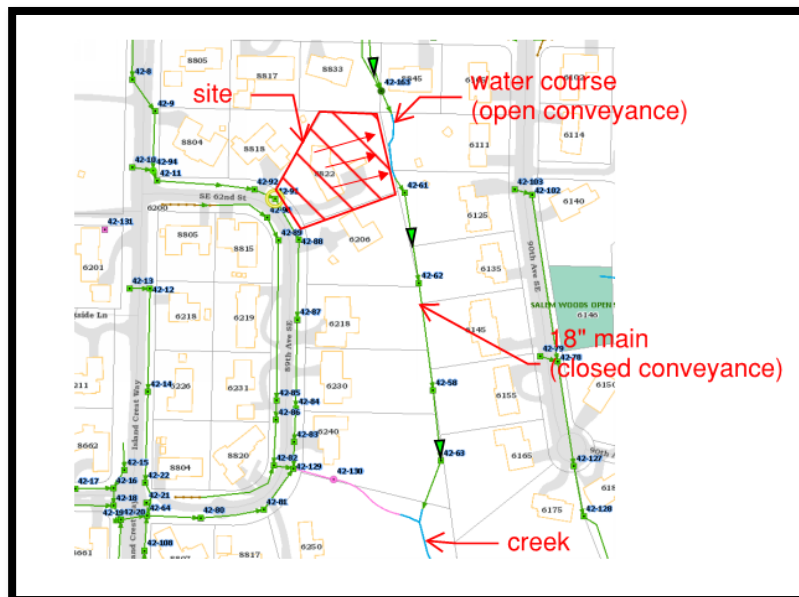
Figure 2 – Downstream flow path

Per records, the small water course carries the flow south for 115 ft where water enters an 18 inch storm main for 586 feet and discharges to a creek that carries the flows for 0.6 miles before discharging Lake Washington.

The proposed drainage will implement catch basins and roof leaders to drain runoffs to the proposed bioretention planters. The bioretention planters will be piped to the inlet of the 18 inch main and a new manhole will be placed at the entry of that inlet to convey flow from the site and the existing drainage.

A downstream analysis was conducted. See **Figure 2** below for the downstream flow path.
