Main Residence - 2

mist model 2-26-22.r3d

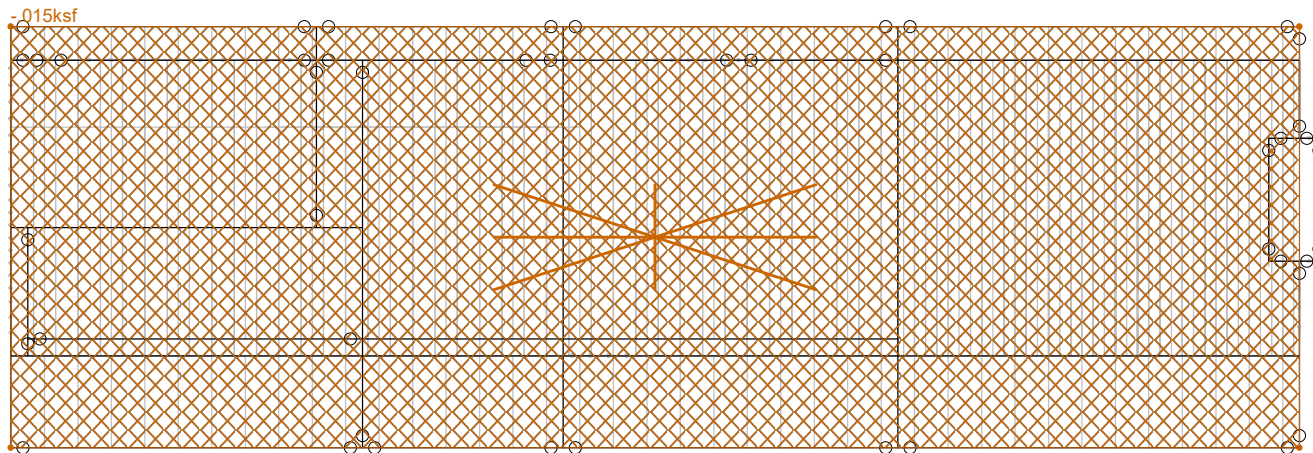
Loads: BLC 1, dead

Roof Dead Load

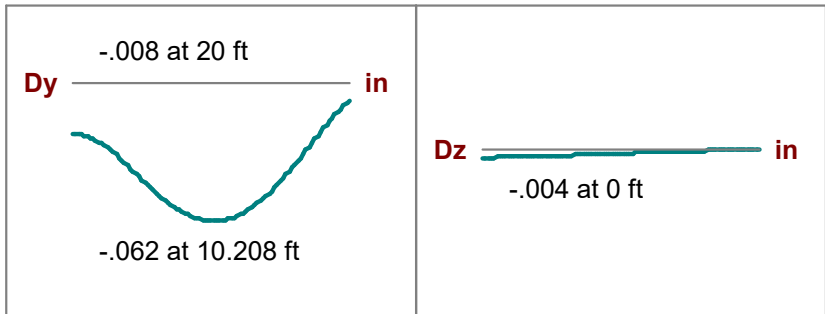
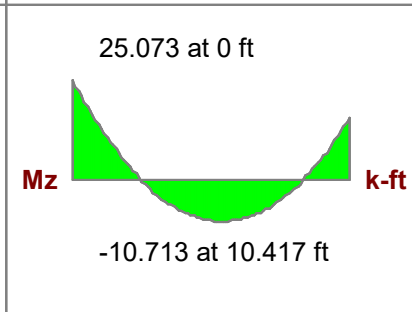
Beam: **M140**
 Shape: **W14X43**
 Material: **A992**
 Length: **20 ft**
 I Joint: **N173**
 J Joint: **N172**
LC 8: d+i
 Code Check: **0.149 (bending)**
 Report Based On 97 Sections

AISC 9th: ASD Code Check

Max Bending Check	0.149	Max Shear Check	0.076 (y)	Max Defl Ratio	L/5126
Location	0 ft	Location	0 ft	Location	10.625 ft
Equation	H1-2			Span	1

Compact

Fy	50 ksi	Cm	.248	z-z	.85
Fa	29.02 ksi	Lb	2 ft		2 ft
Ft	30 ksi	KL/r	12.671		4.118
Fby	37.5 ksi	Sway	No		No
Fbz	33 ksi	L Comp Flange	2 ft		
Fvy	20 ksi				
Fvz	20 ksi				
Cb	1.22
