GEOTECHNICAL ENGINEERING REPORT

PROPOSED SINGLE-FAMILY RESIDENTIAL ADDITIONS 8429 SE 33rd Place Mercer Island, Washington 98040

Project No. 2537.01
28 January 2022

Subject: Geotechnical Engineering Report
Proposed Single-family Residential Additions
8429 SE 33rd Place
Mercer Island, Washington 98040

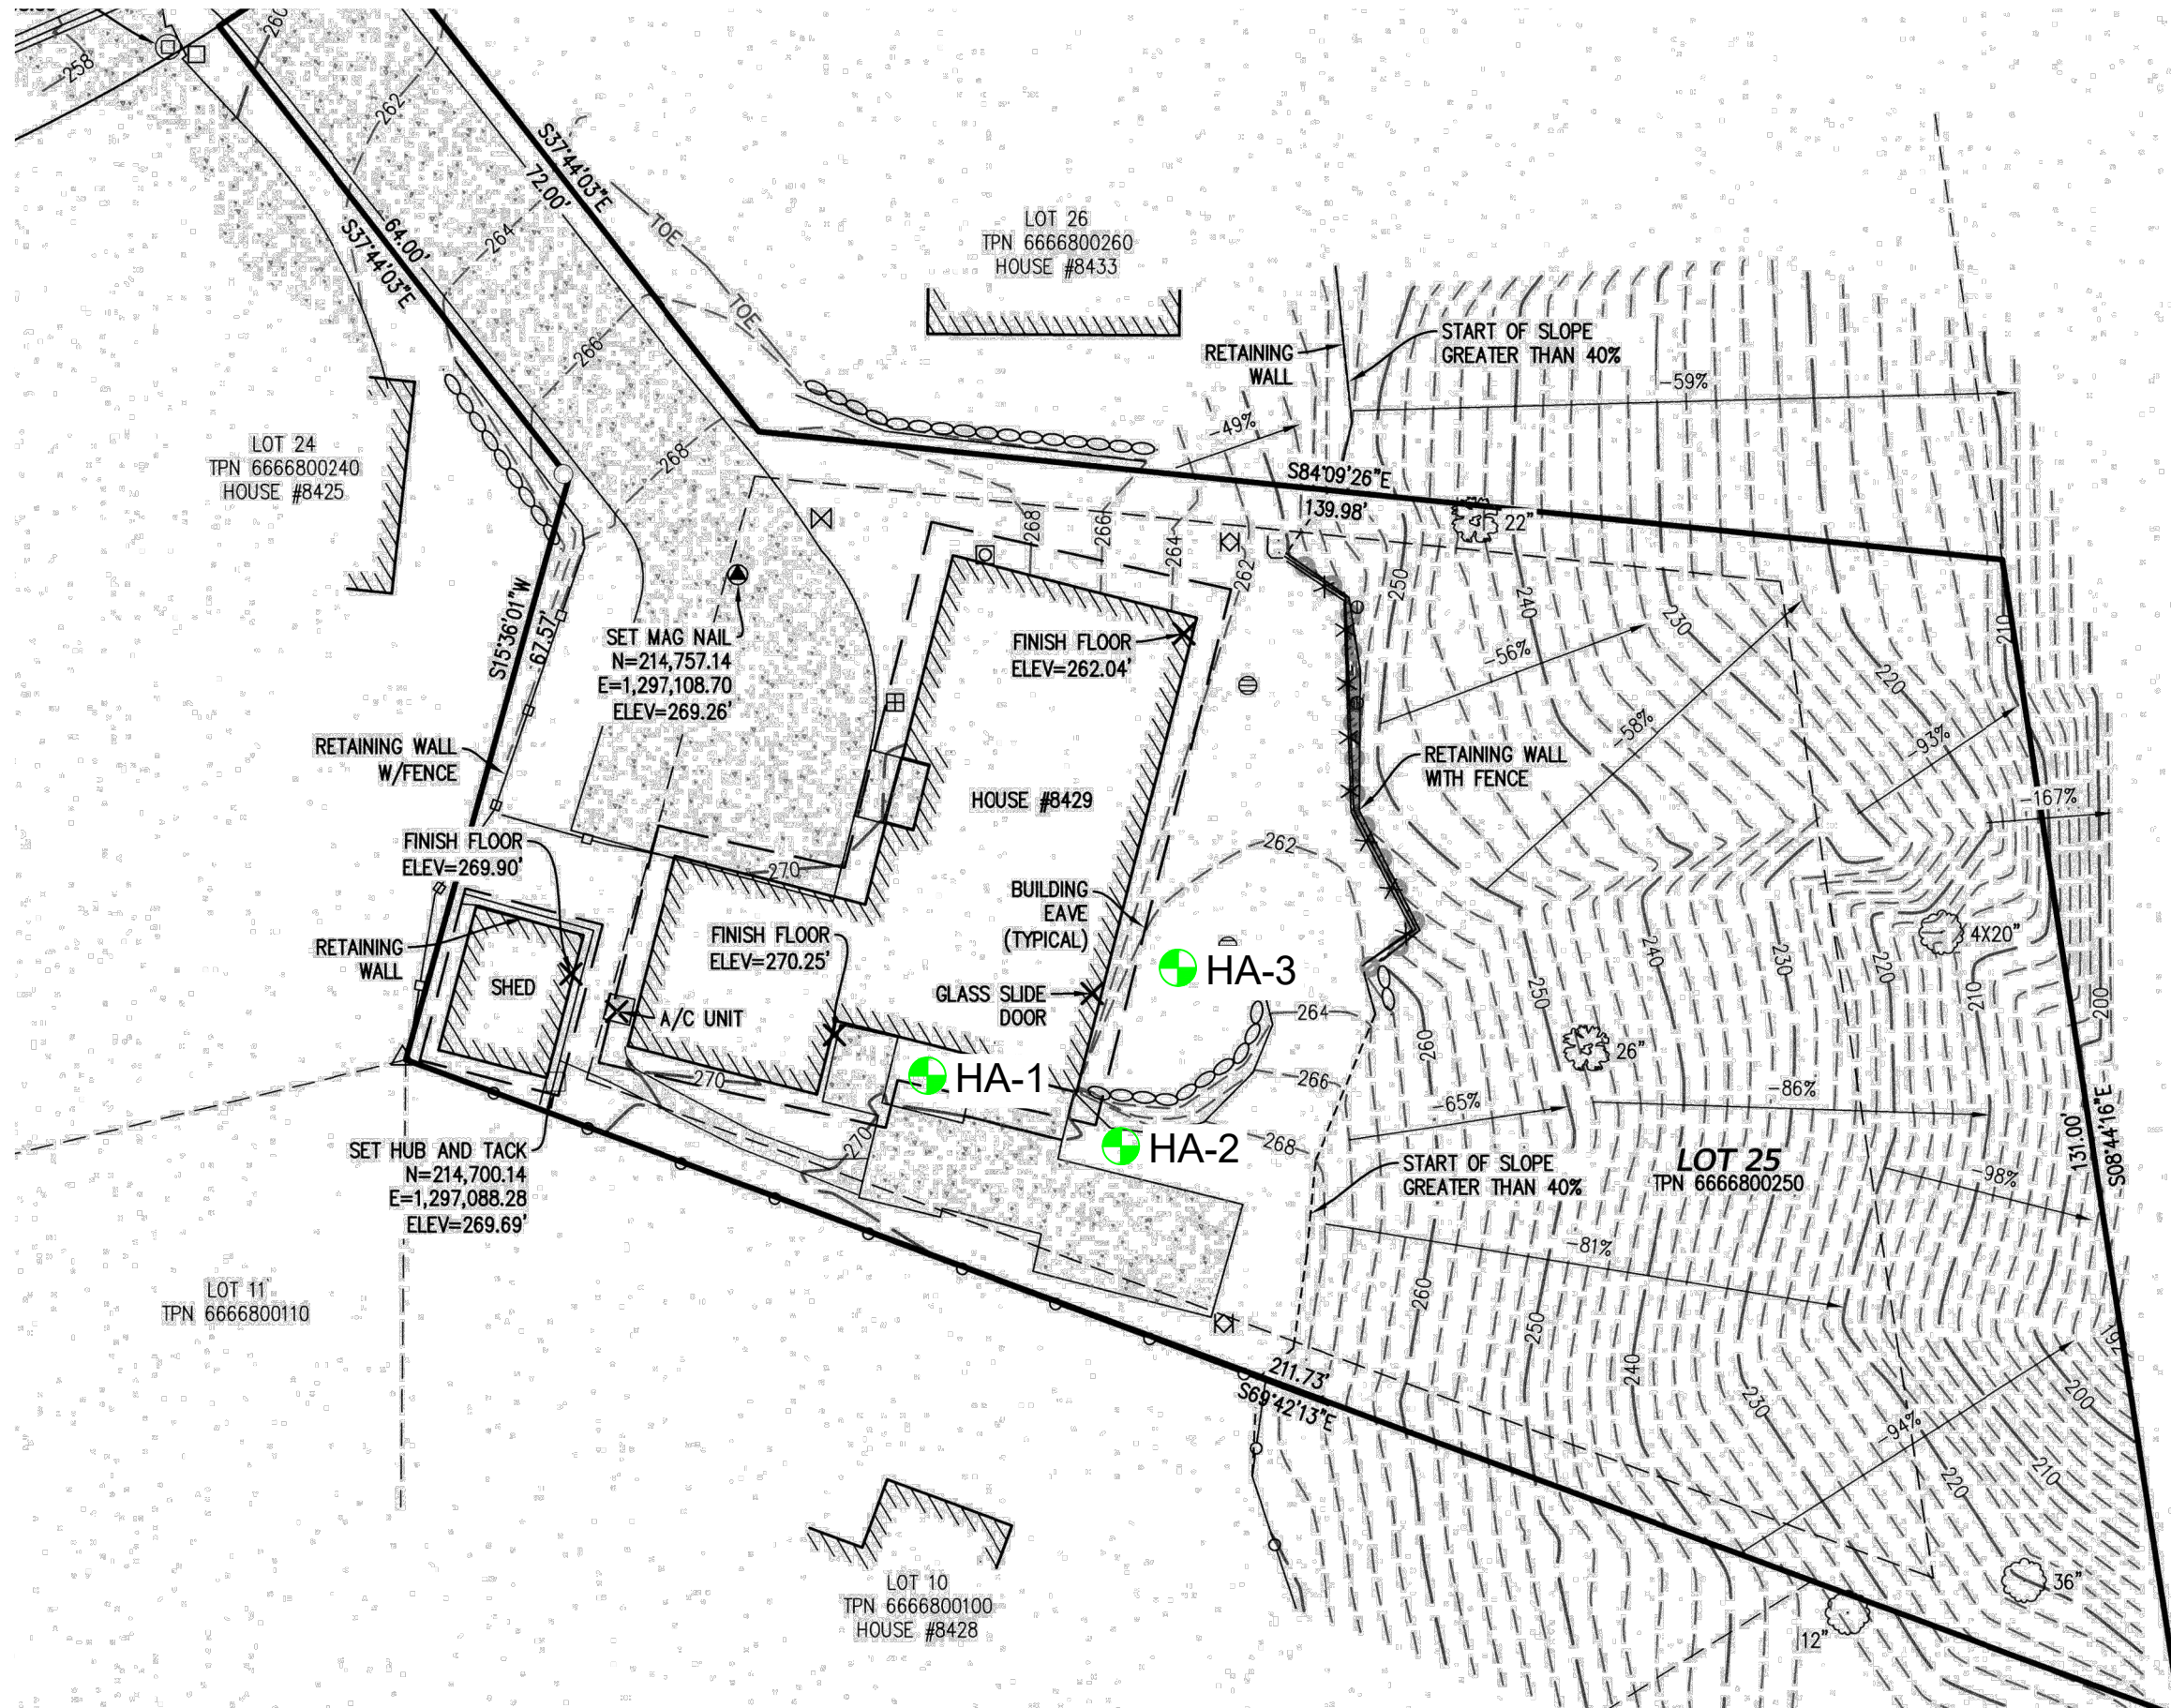
HA-1 ZGA BORING NUMBER AND APPROXIMATE LOCATION

Our subsurface evaluation consisted of excavating three hand auger borings (HA-1 through HA-3) on January 5, 2022. The approximate exploration locations are illustrated on Figure 1. Detailed descriptive logs presenting the subsurface conditions encountered and the procedures utilized in the subsurface

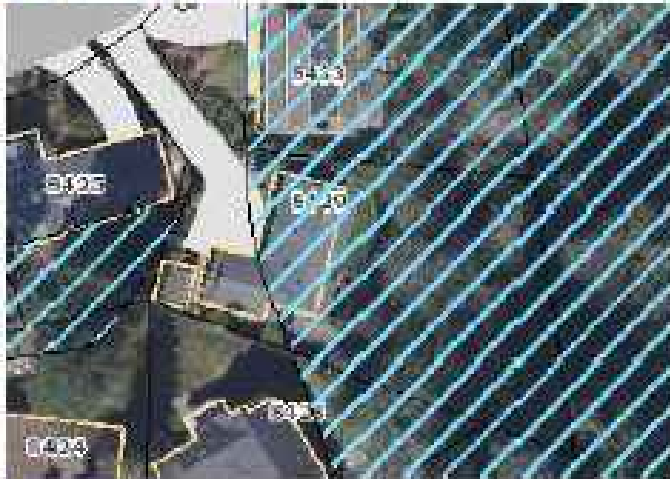
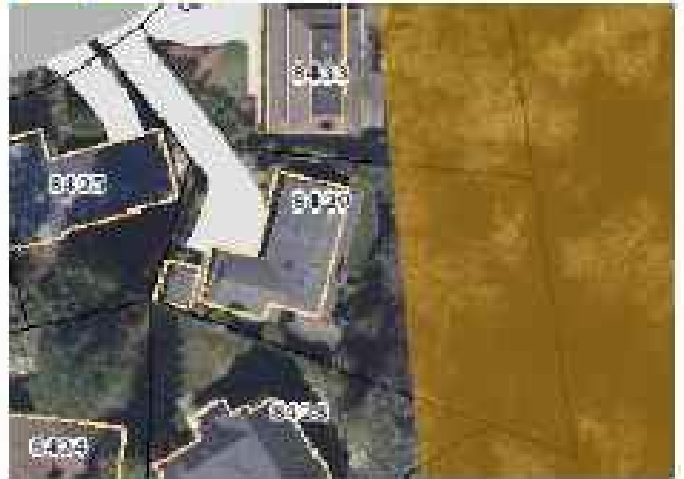
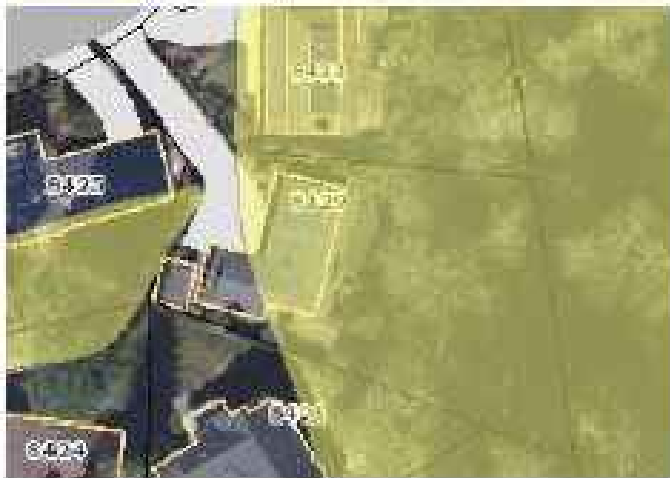
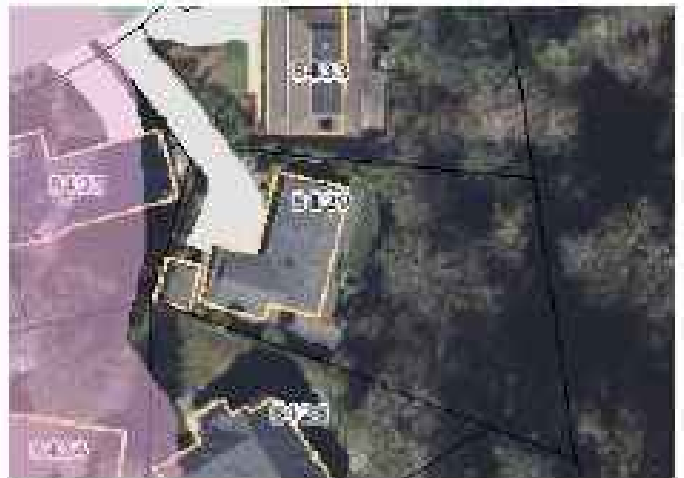
CRITICAL AREAS MAP

Potential Slide:

Steep Slope:

Erosion:

Seismic:

Chapter 19 of the Mercer Island City Code (MICC) regulates development activities in critical areas and their associated buffers. The property has been mapped by the City of Mercer Island as having potential landslide, steep slope, erosion, and seismic geologic hazard critical areas. The approximate extents of these regulated hazards on and near the property are shown on the Critical Areas Map, Figure 2. The City may allow alteration within a regulated geologic hazard area or buffer if the proposal effectively demonstrates that there is no impact on the regulated areas or that it adequately mitigates risks of the hazards.

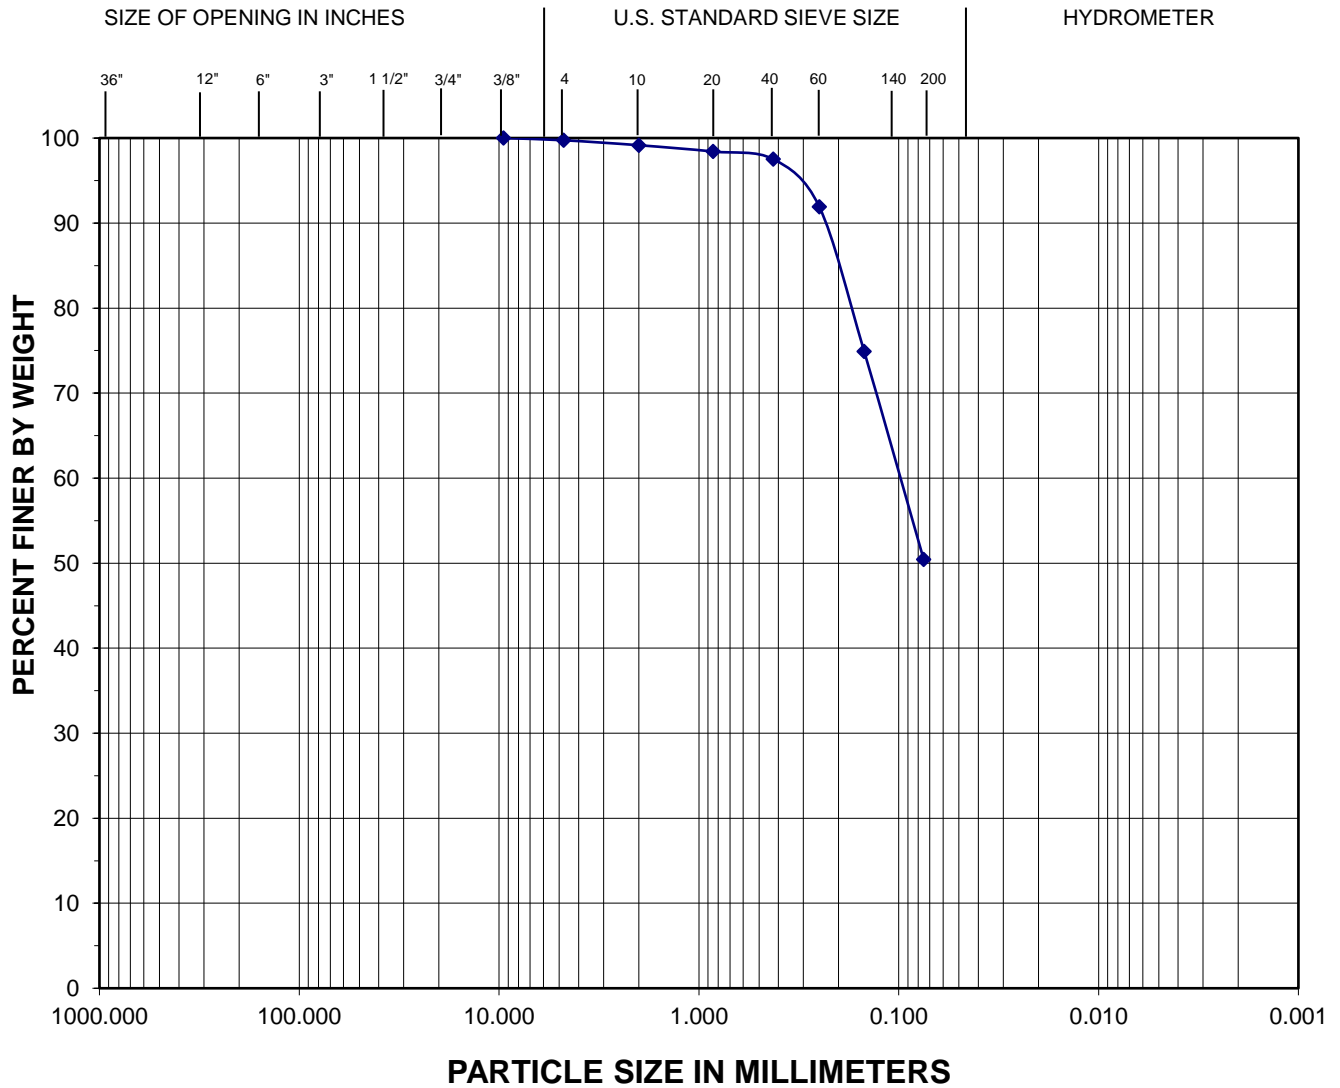
Test Results Summary

ASTM D6913

BOULDERS	COBBLES	Coarse	Fine	Coarse	Medium	Fine	Silt	Clay
		GRAVEL		SAND			FINE GRAINED

Comments: Trace to some organics in sample

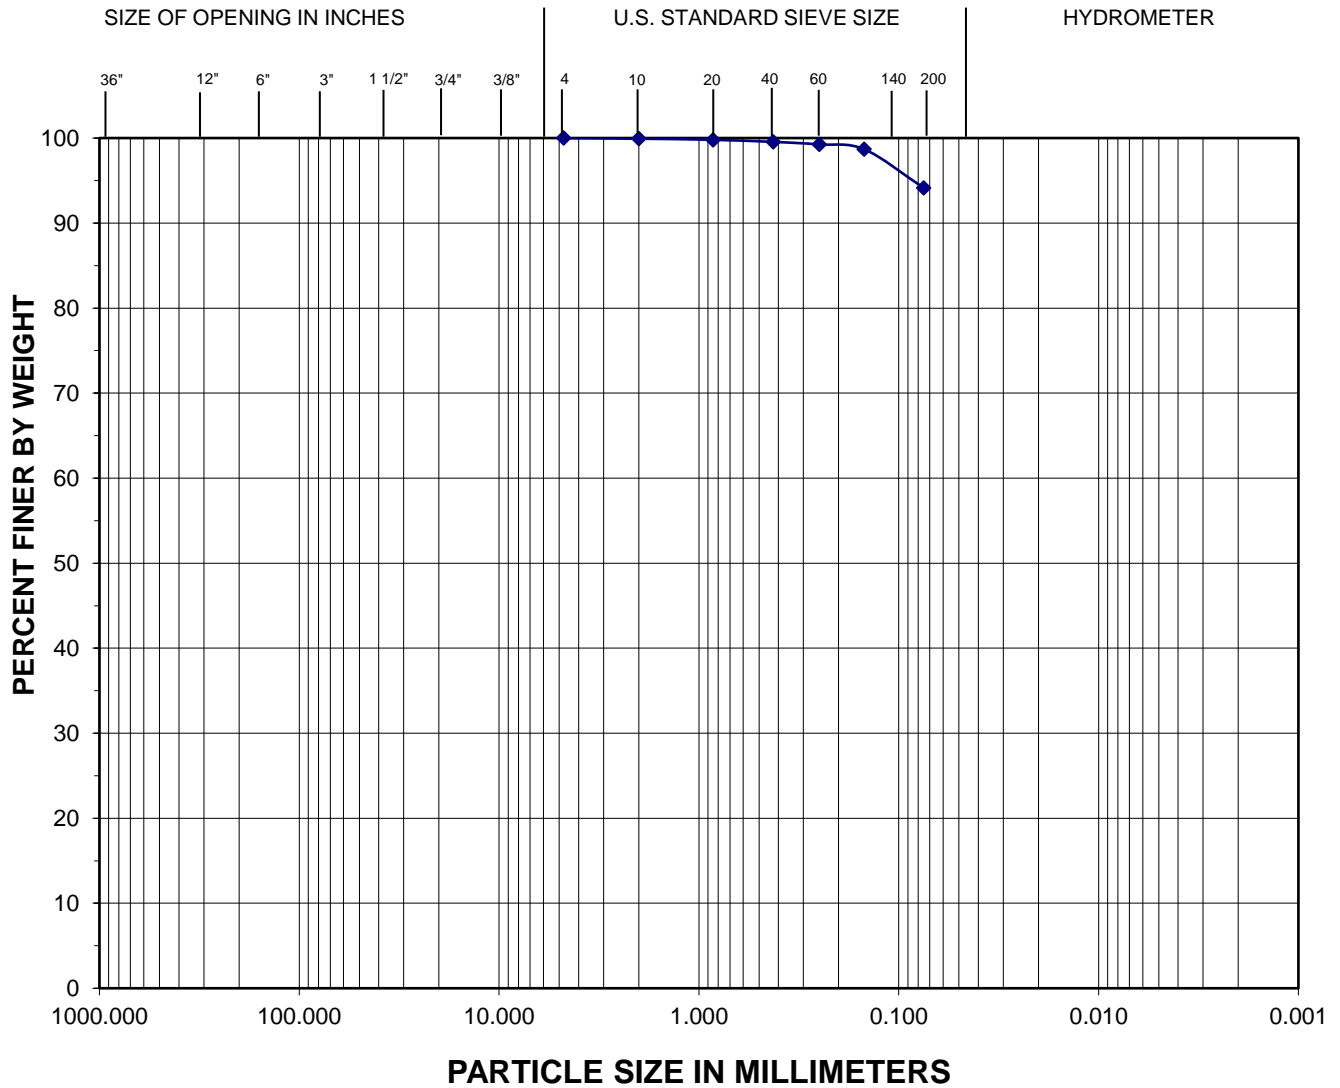
Test Results Summary

ASTM D6913

BOULDERS	COBBLES	Coarse	Fine	Coarse	Medium	Fine	Silt	Clay
		GRAVEL		SAND			FINE GRAINED
