## ARBORIST CORRECTIONS

**Project Name:** Mercer Island Treehouse

**Site Address:** 5637 East Mercer Way, Mercer Island, WA 98040  
King County Parcel # 1924059312

**Date:** August 12, 2022

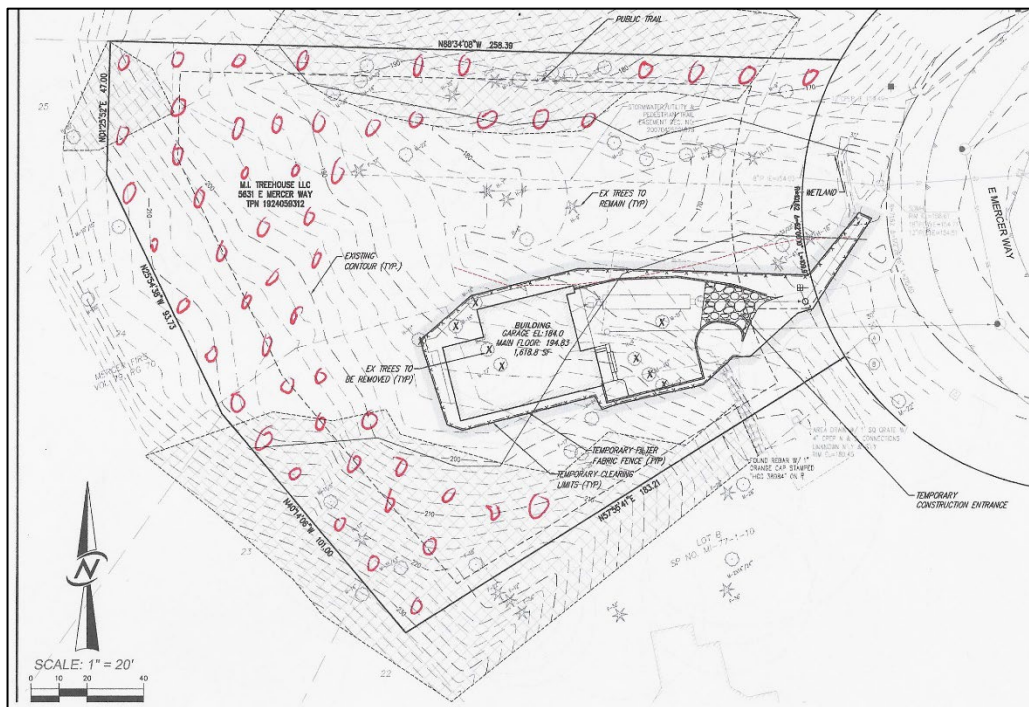
- Given the topography and the existing vegetation this replanting plan is generic and not specific in any way. The lot is 37,554 square feet. There is plenty of room for the tree installation at the minimum of 10-foot spacing.
- A professional landscape installation company shall be employed to properly install the 54 replacement trees.
  - The trees themselves as well as the installation shall conform to current industry standards.

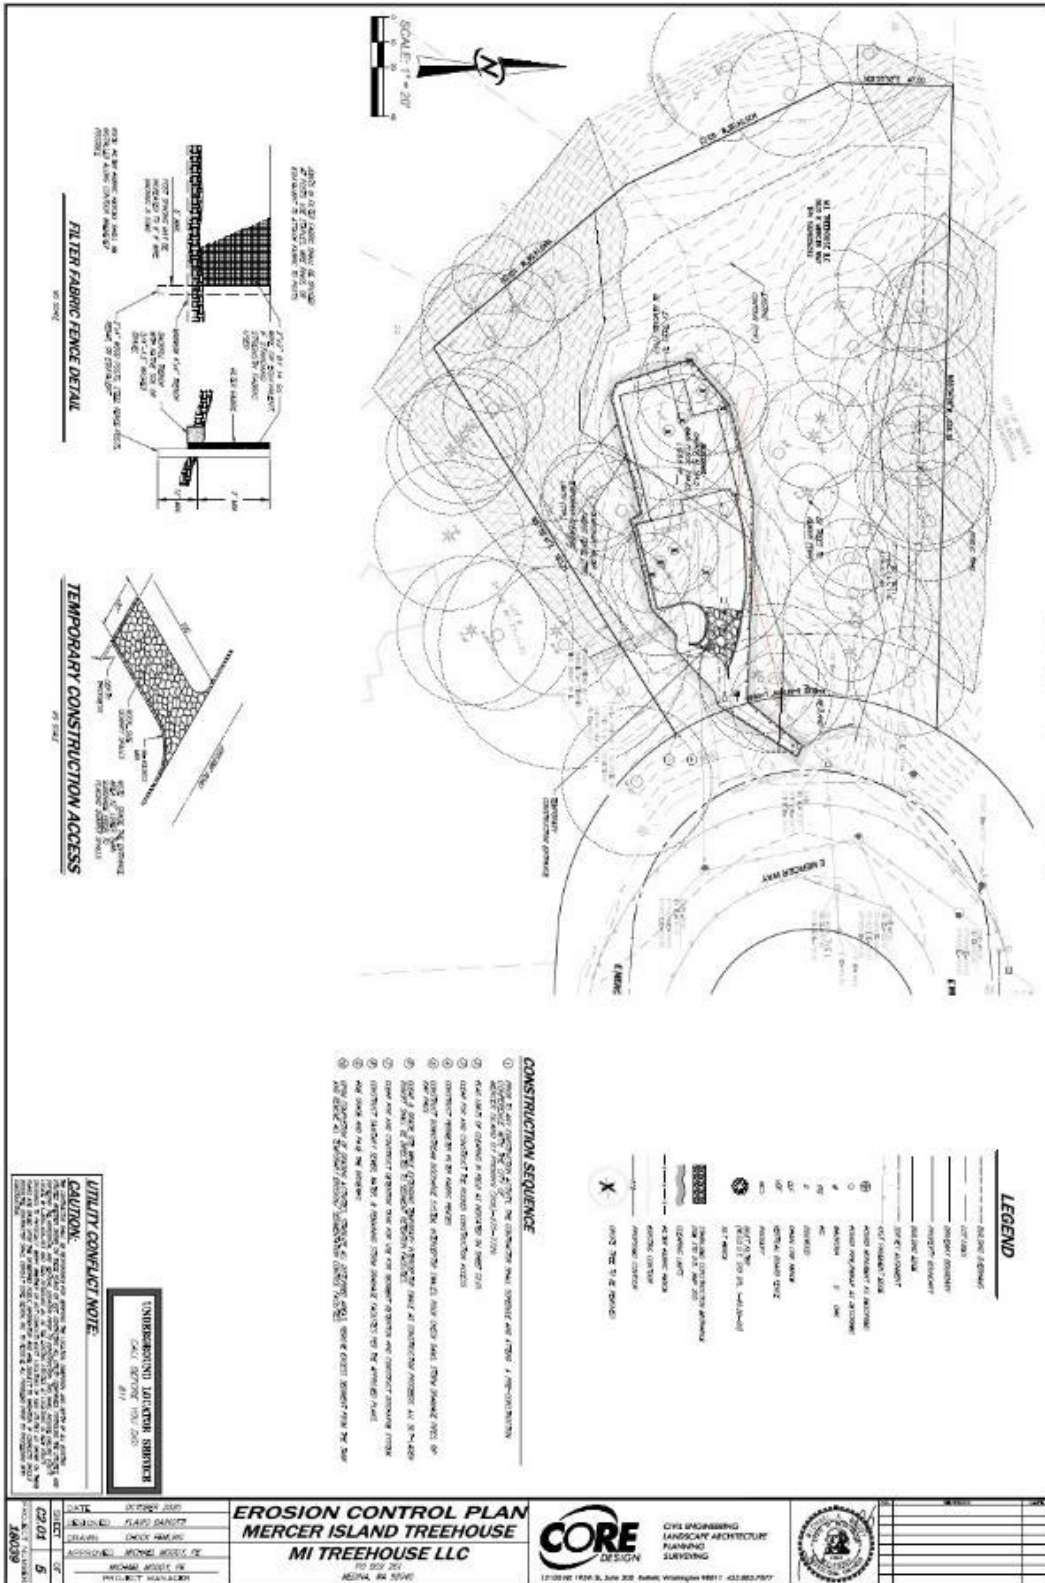
1. Tree Protection Fence:
  - a. Tree Protection Fences will need to be placed around the tree retained on the adjacent property.
    - i. *The Filter Fabric Fencing location is the same as the tree protection fencing.*
  - b. Tree Protection Fences are to be placed according to the drawing below.
  - c. Tree Protection Fences must be inspected and approved by the City prior to the beginning of any construction work activities.
  - d. The area inside of the fence is *The Tree Protection Zone*.
  - e. The area outside of the fence is *The Development Zone*.
    - i. Nothing must be parked or stored within the Tree Protection Fences—no equipment, vehicles, soil, debris, or construction supplies of any sorts.
  - f. Tree Protection Fence Signage:
    - i. The Tree Protection Fences need to be clearly marked with the following text:
