Subject: **Response to Geotechnical Peer Review Comments Regarding
2204-107-SUB1-PLANS**

Proposed Mercer Island Treehouse Residence
5637 East Mercer Way
Mercer Island, Washington

Subject: **Geotechnical Engineering Assessment of Landslide Hazard Mitigation**

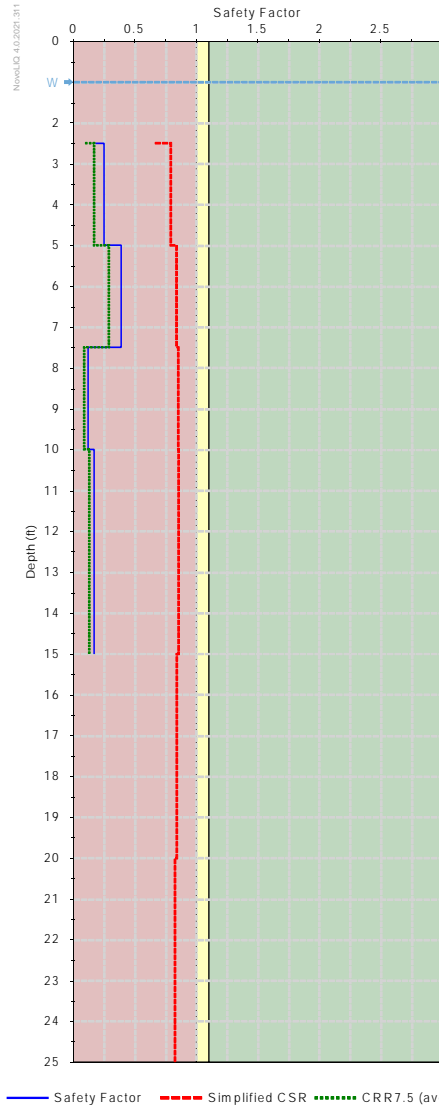
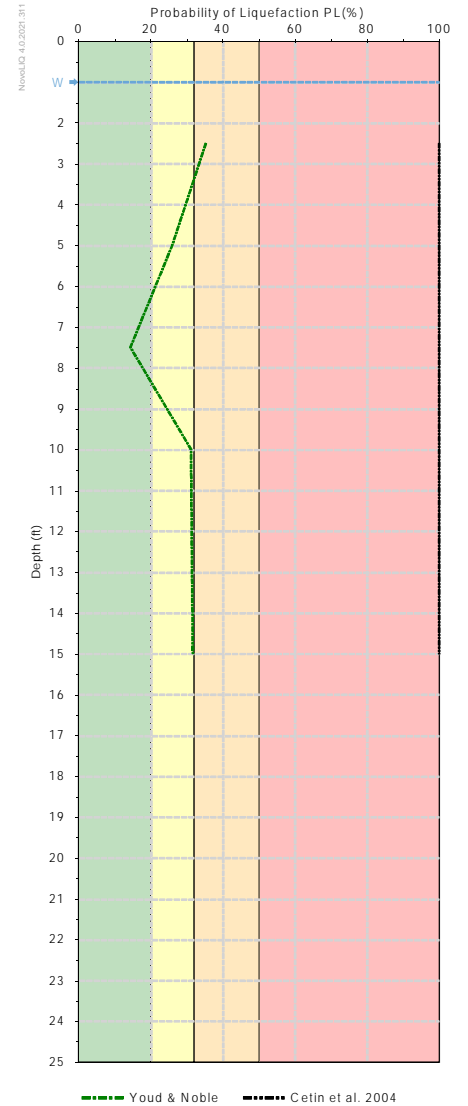
Soil Liquefaction Analysis Report

Borehole : B-2
 Total Depth : 27 ft
 Water Level : 1 ft
 Calculated By : MKM

— NCEER Workshop (1997)
 - - - Boulanger & Idriss (2014)
 — Safety Factor
 - - - Simplified CSR
 - - - CRR7.5 (ave)
 - - - Youd & Noble
 - - - Cetin et al. 2004
