Subject: **Response to Geotechnical Peer Review Comments Regarding  
2204-107-SUB1-PLANS**

Proposed Mercer Island Treehouse Residence  
5637 East Mercer Way  
Mercer Island, Washington

Subject: **Geotechnical Engineering Assessment of Landslide Hazard Mitigation**

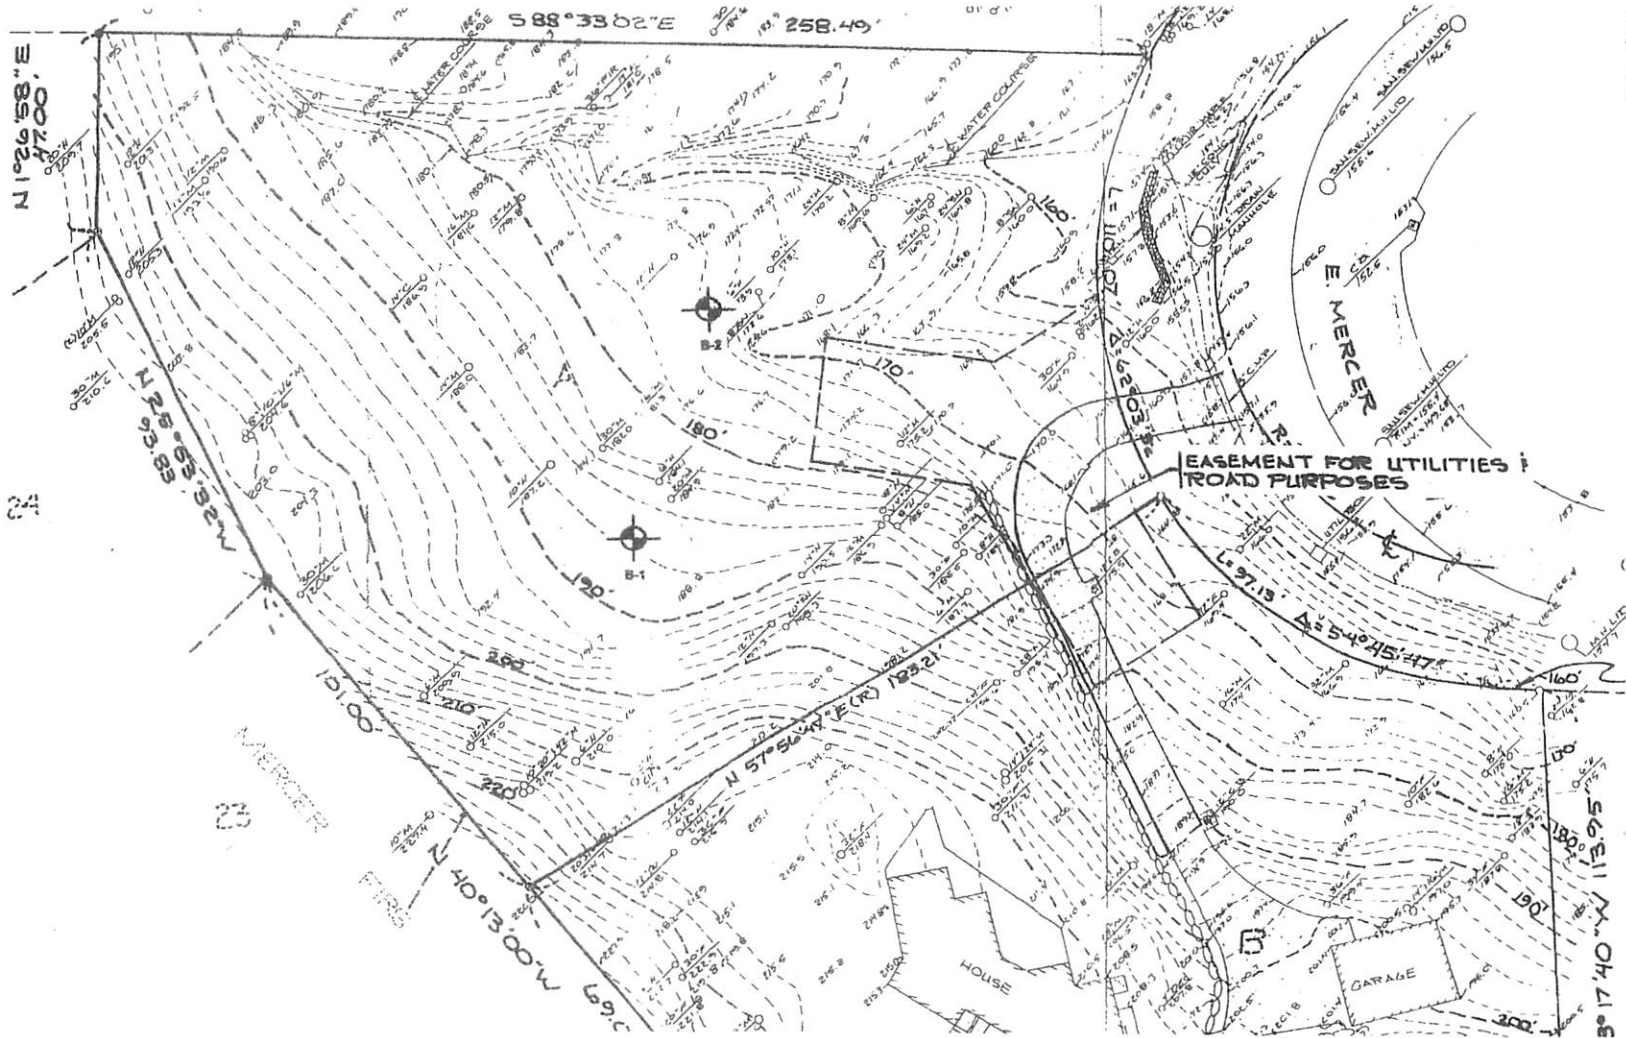
SCALE	1" = 30'	DRAWN BY	KJ	CHECKED BY	WC	DATE	3/10/2015	PROJECT NO.	G-3827	PLATE	2
-------	----------	----------	----	------------	----	------	-----------	-------------	--------	-------	---

The site consists of an irregular shaped lot that comprises about 38,700 square feet. The site generally slopes downward toward the north and northeast toward a ravine with an east-running stream on the north side of the site. Elevations on site range between approximately 158 feet at stream course in the northeast corner and approximately 226 feet at the south corner which is on a steeply rising slope (with inclinations up to approximately 75 percent). The existing conditions and topography on the site are illustrated in Plate 2 - Site Plan.

A GEO Group Northwest geologist supervised the drilling of two exploratory soil borings (B-1 and B-2) on August 10, 1999. The borings were completed by using a manually portable drilling rig and were located in the middle portion of the site, as indicated in Plate 2 - Site Plan. The

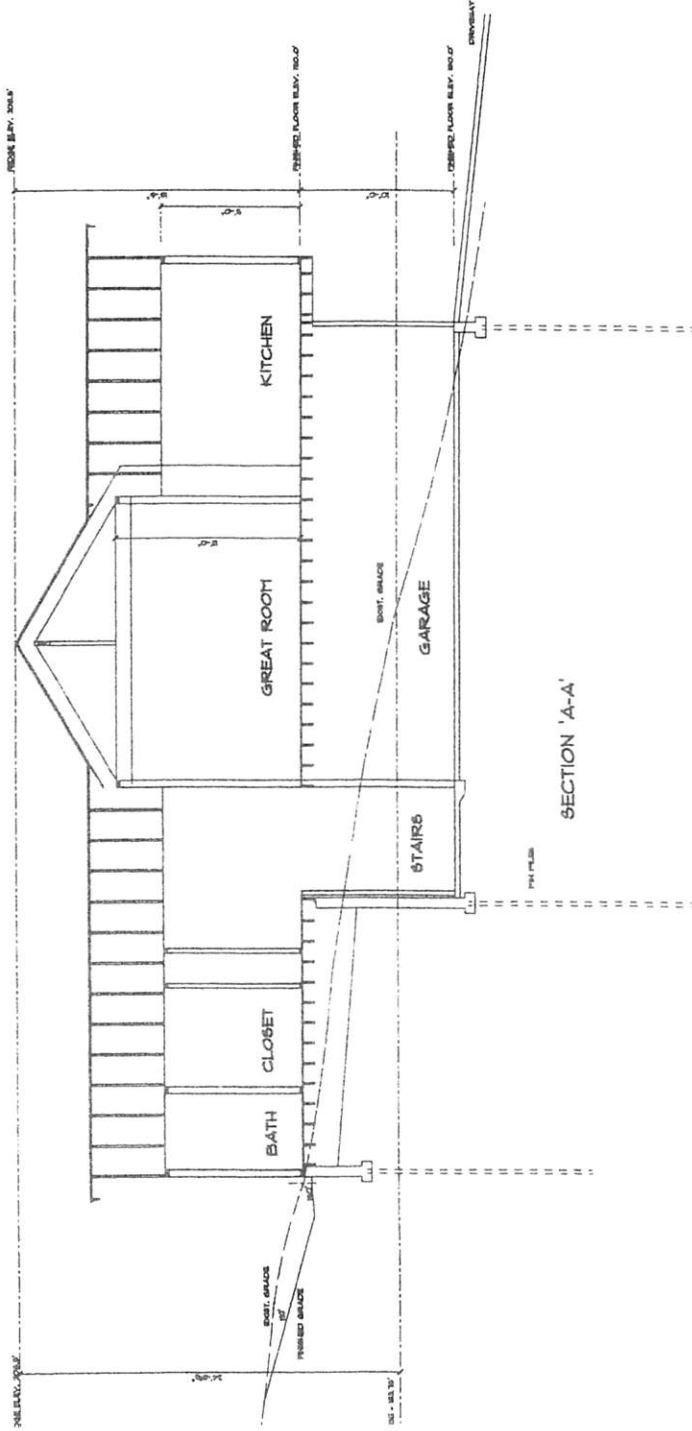
**PROPOSED RESIDENCE SECTION**

Source: Section A - A' by Healy-Jorgensen Architects, dated 10/1/14.

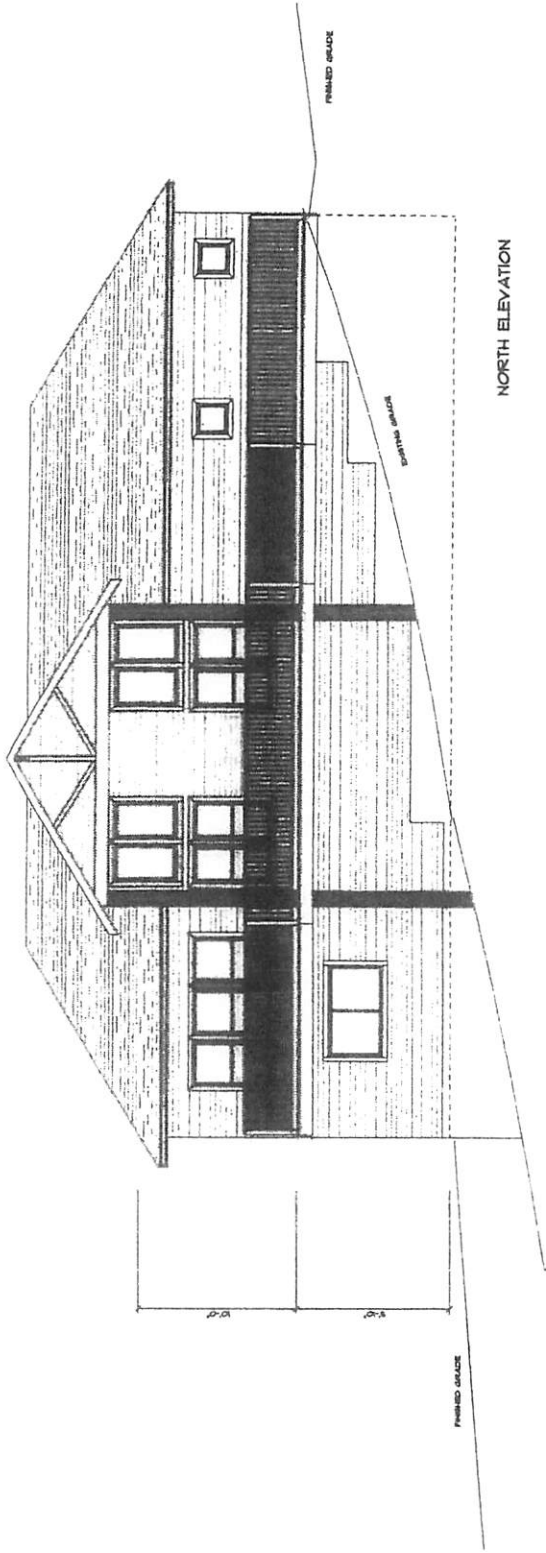
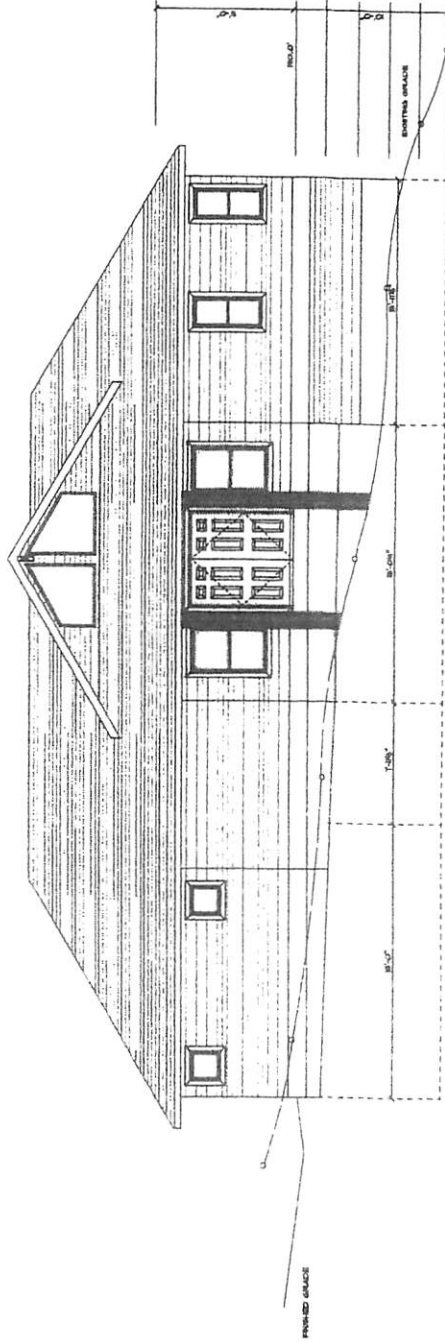
SCALE	1" = 8'	DRAWN BY	KJ	CHECKED BY	WC	DATE	3/10/2015	PROJECT NO.	G-3827	PLATE	5A
-------	---------	----------	----	------------	----	------	-----------	-------------	--------	-------	----

NORTH ELEVATION

SOUTH ELEVATION

Sources: North - South Elevations, by Healy-Jorgensen Architects, dated 10/1/14.

We understand the proposed residence is planned to be located on the relatively less steeply sloped middle part of the site, as illustrated in Plate 3 - Proposed Residence Plan. Slopes in this area have inclinations up to approximately 28 percent. The proposed floor elevation for the residence currently are 180 feet for the basement/garage and 190 feet for the main floor of the residence, as illustrated in Plate 4 - Proposed Residence Section. Elevation views of the proposed residence are presented in Plate 5A - North & South Elevations and Plate 5B - East & West Elevations.

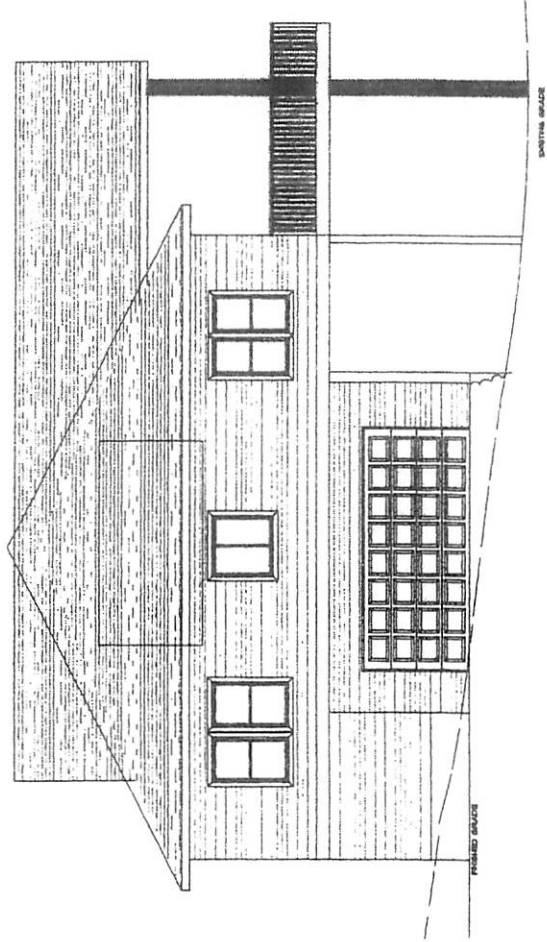
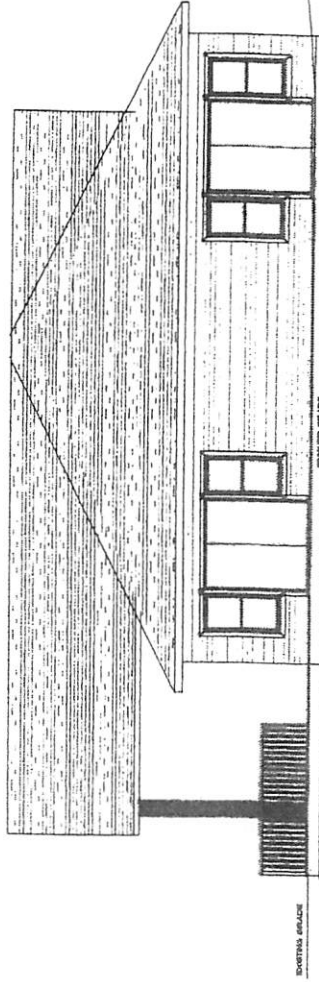
<b>Group Northwest, Inc.</b> Geotechnical Engineers, Geologists, & Environmental Scientists		<b>EAST &amp; WEST ELEVATIONS</b>									
		PROPOSED RESIDENCE 5637 E. MERCER WAY MERCER ISLAND, WASHINGTON									
SCALE	1" = 8'	DRAWN BY	KJ	CHECKED BY	WC	DATE	3/10/2015	PROJECT NO.	G-3827	PLATE	5B

EAST ELEVATION

WEST ELEVATION

Source: East - West Elevations, by Healy-Jorgensen Architects, dated 10/1/14.

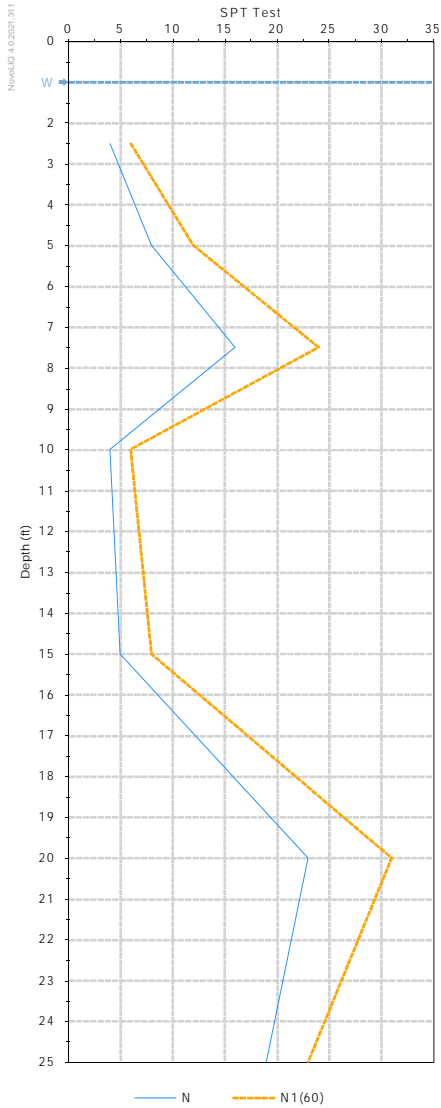
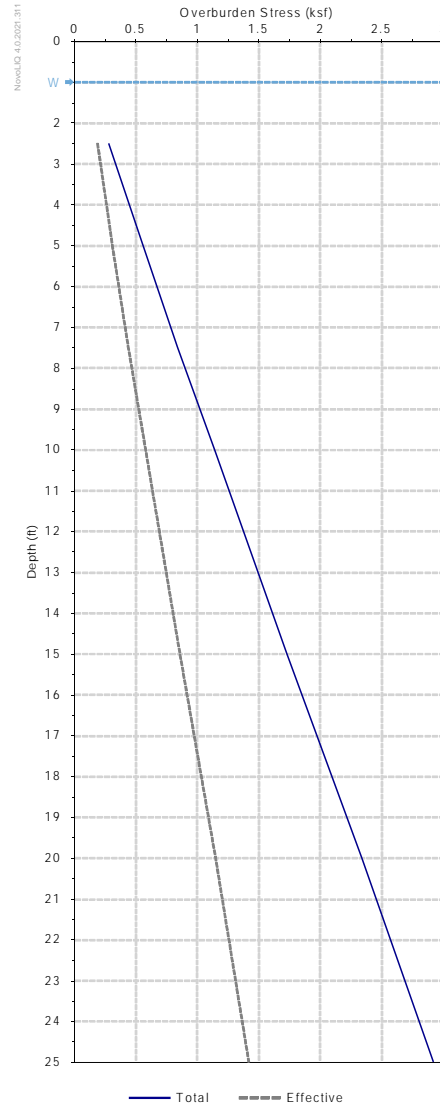
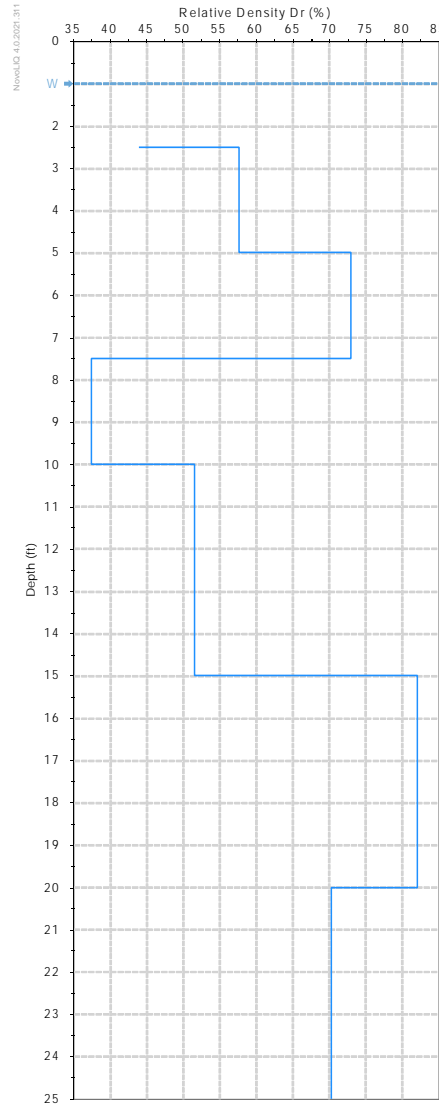
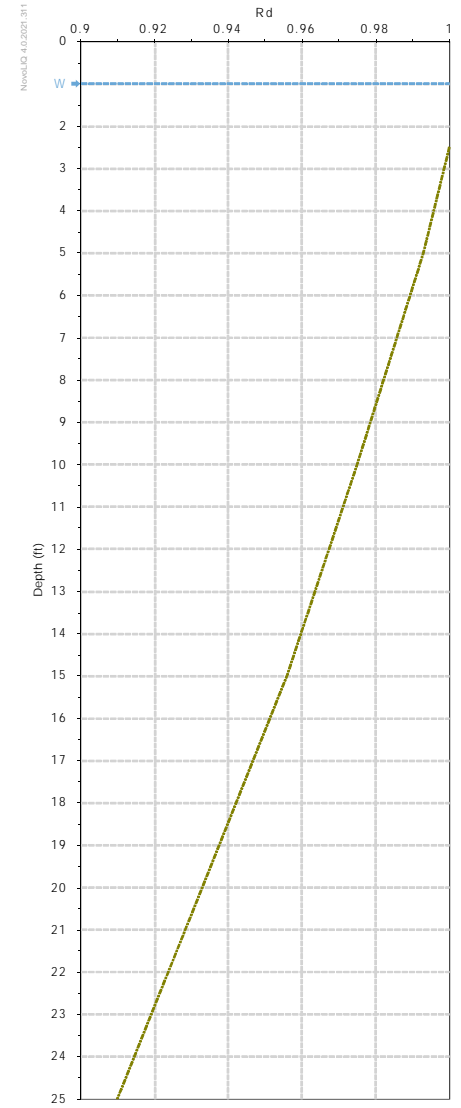
Borehole : B-2  
 Total Depth : 27 ft  
 Water Level : 1 ft  
 Calculated By : MKM

# Soil Liquefaction Analysis Report

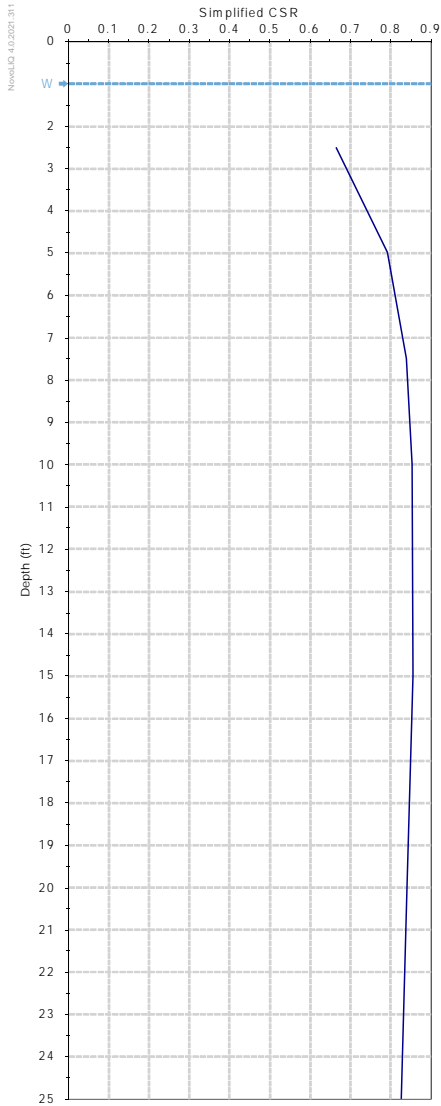
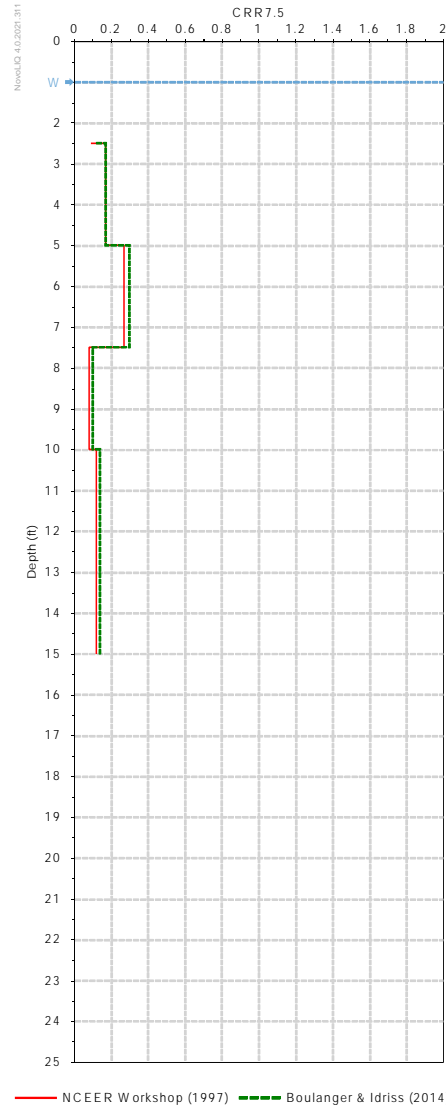
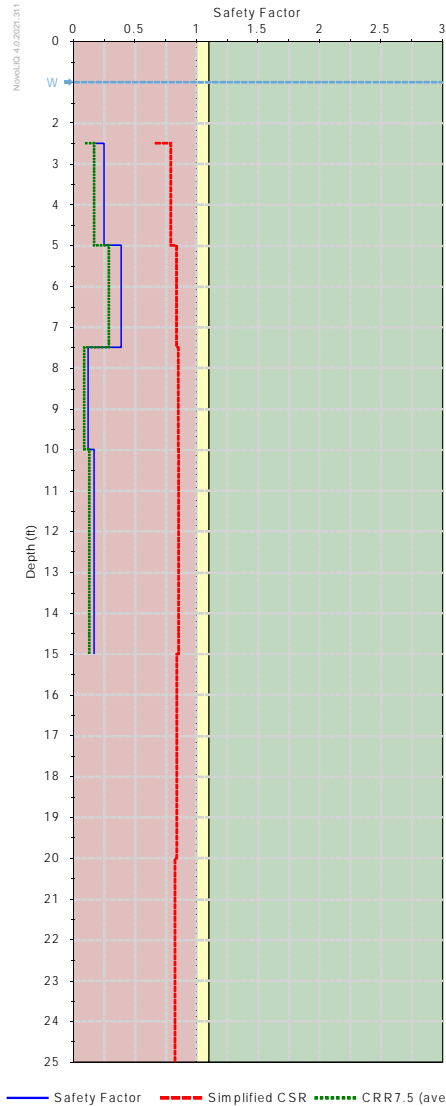
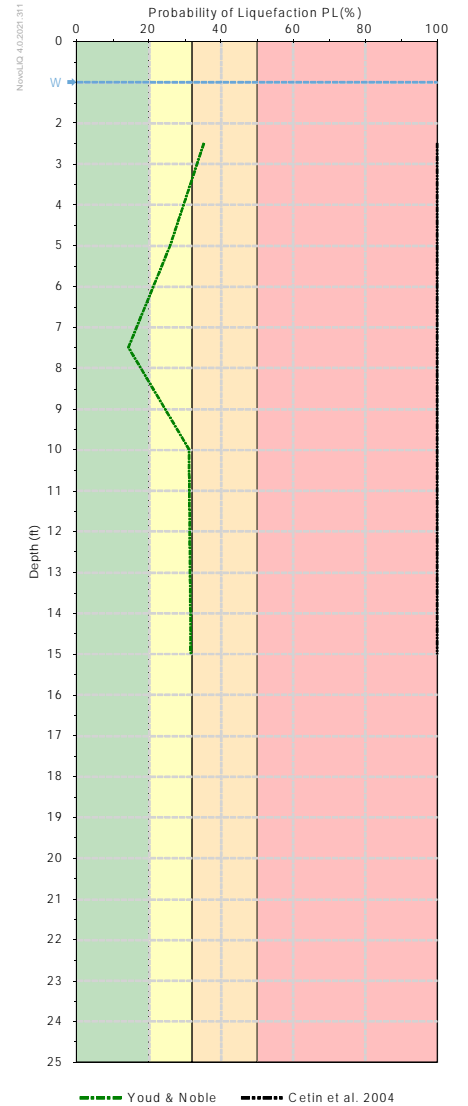
Borehole : B-2  
 Total Depth : 27 ft  
 Water Level : 1 ft  
 Calculated By : MKM

— NCEER Workshop (1997)   
 - - - Boulanger & Idriss (2014)   
 — Safety Factor   
 - - - Simplified CSR   
 - - - CRR7.5 (ave)   
 - - - Youd & Noble   
 - - - Cetin et al. 2004

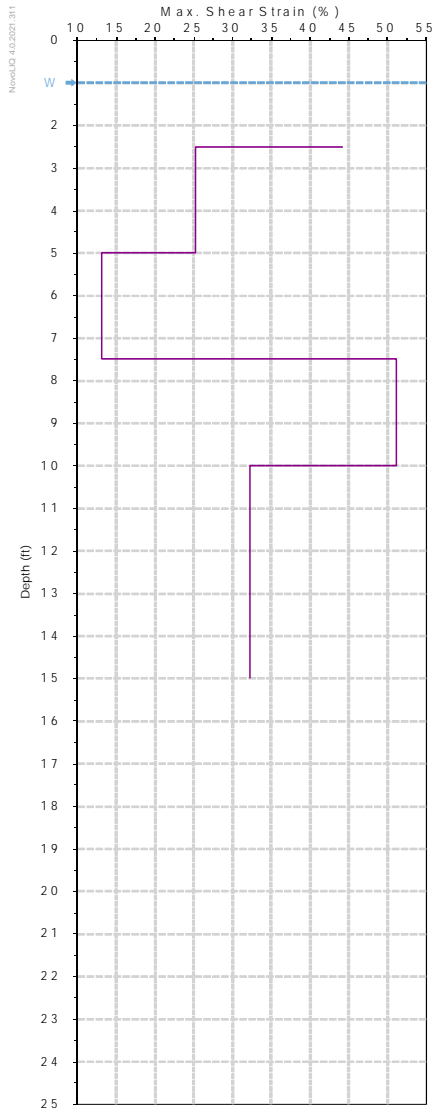
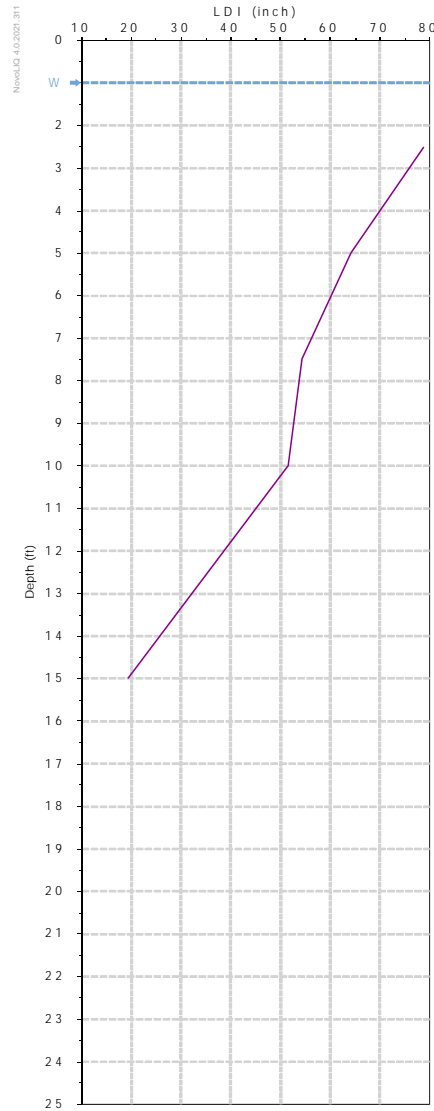
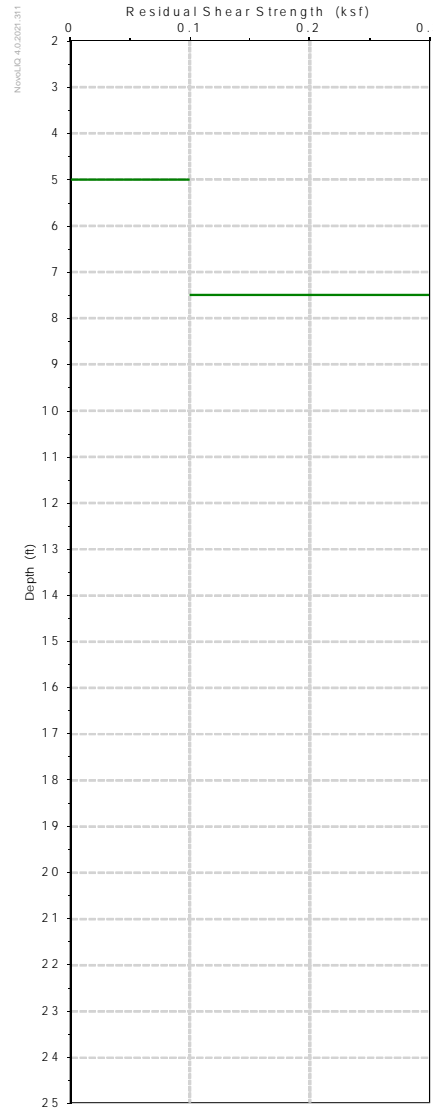
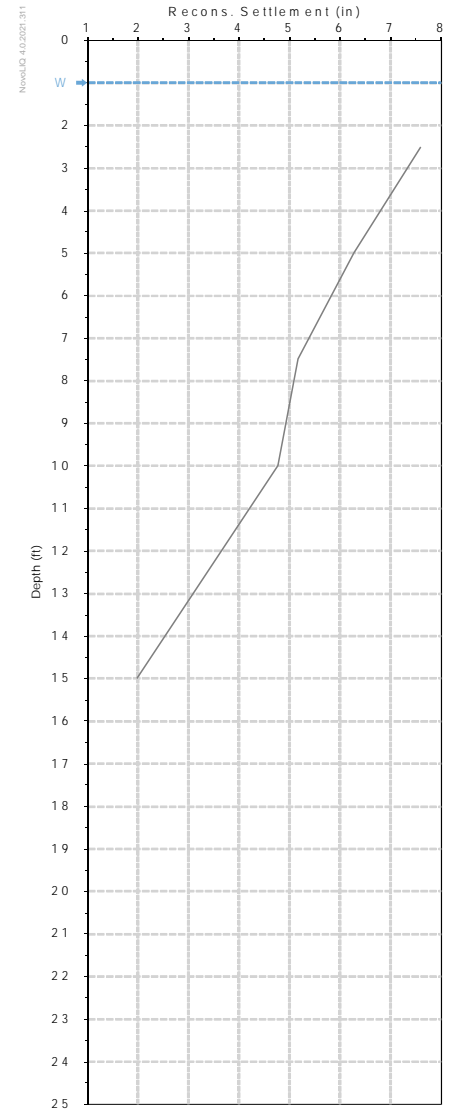
Borehole : B-2  
 Total Depth : 27 ft  
 Water Level : 1 ft  
 Calculated By : MKM

# Soil Liquefaction Analysis Report
