**Subject: Geotechnical Report
Leung Residence
9102 Southeast 78th Place, Mercer Island, Washington
Parcels: 919780-0070 and 19780-0060**

Attached please find our geotechnical report for the proposed garage addition and a detached auxiliary structure located at the above site in Mercer Island, Washington. This report documents the subsurface conditions at the site and presents our geotechnical engineering recommendations for the proposed development.

Geotechnical Report
Leung Residence: 9102 Southeast 78th Place, Mercer Island, WA
January 25, 2022

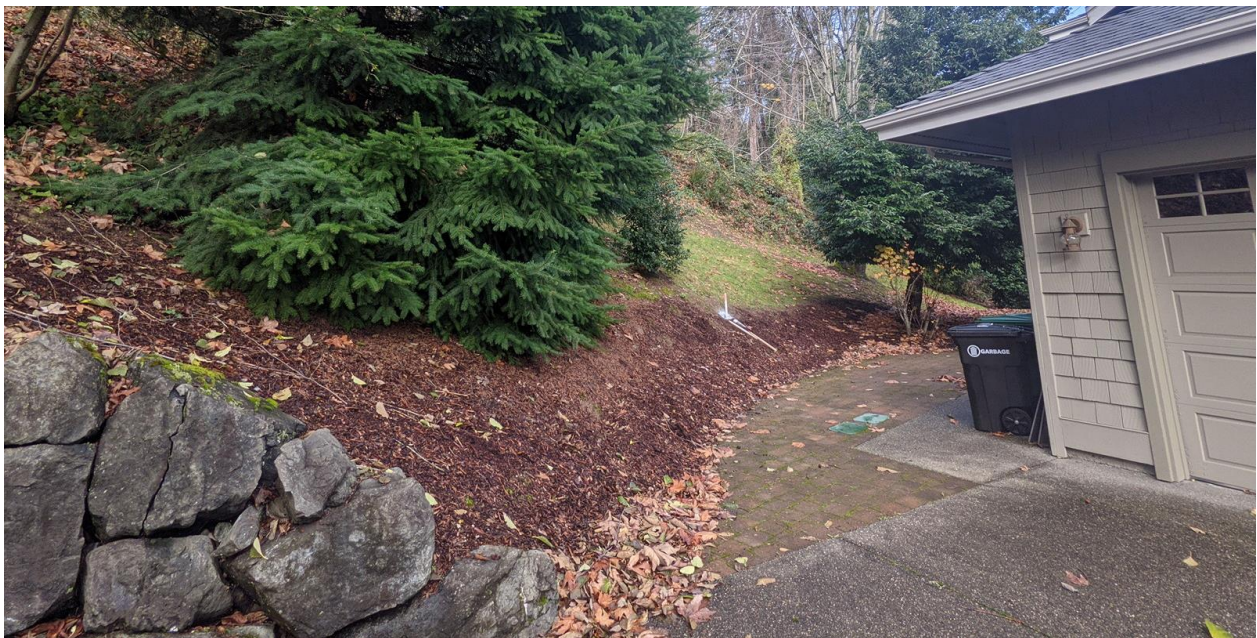
Plate 2. General conditions in the area of proposed garage addition, looking north.

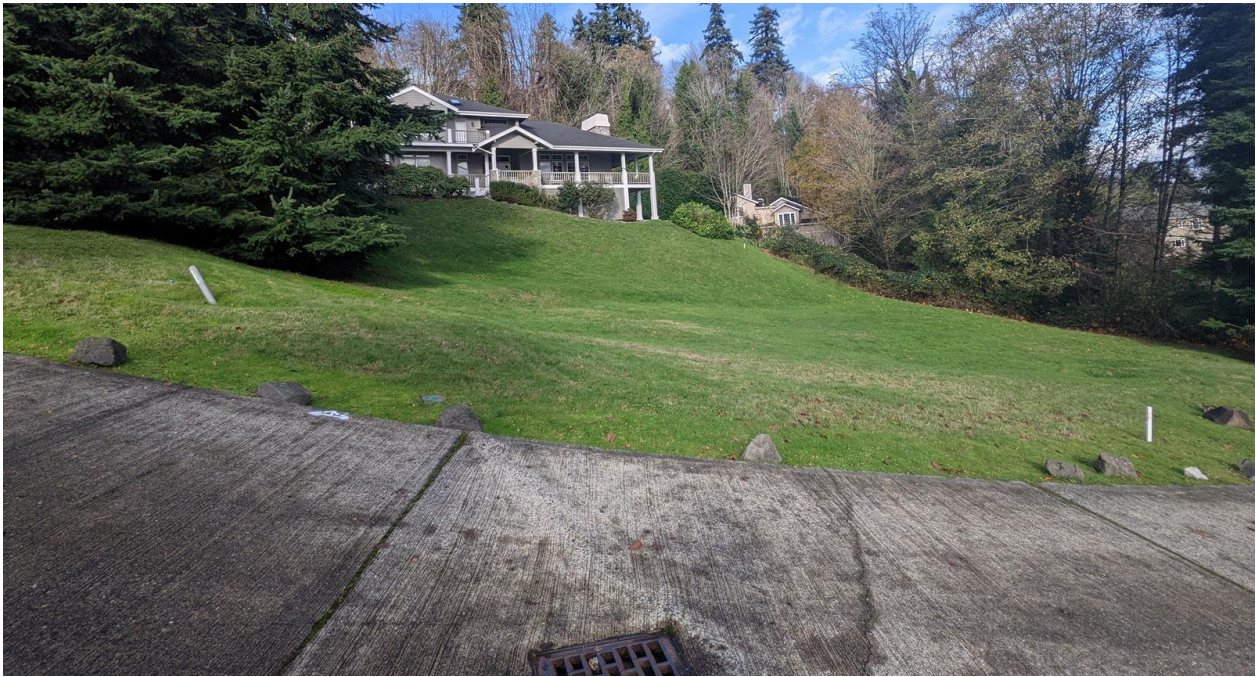
Plate 3. General conditions of the lower parcel (19780-0060), looking north.

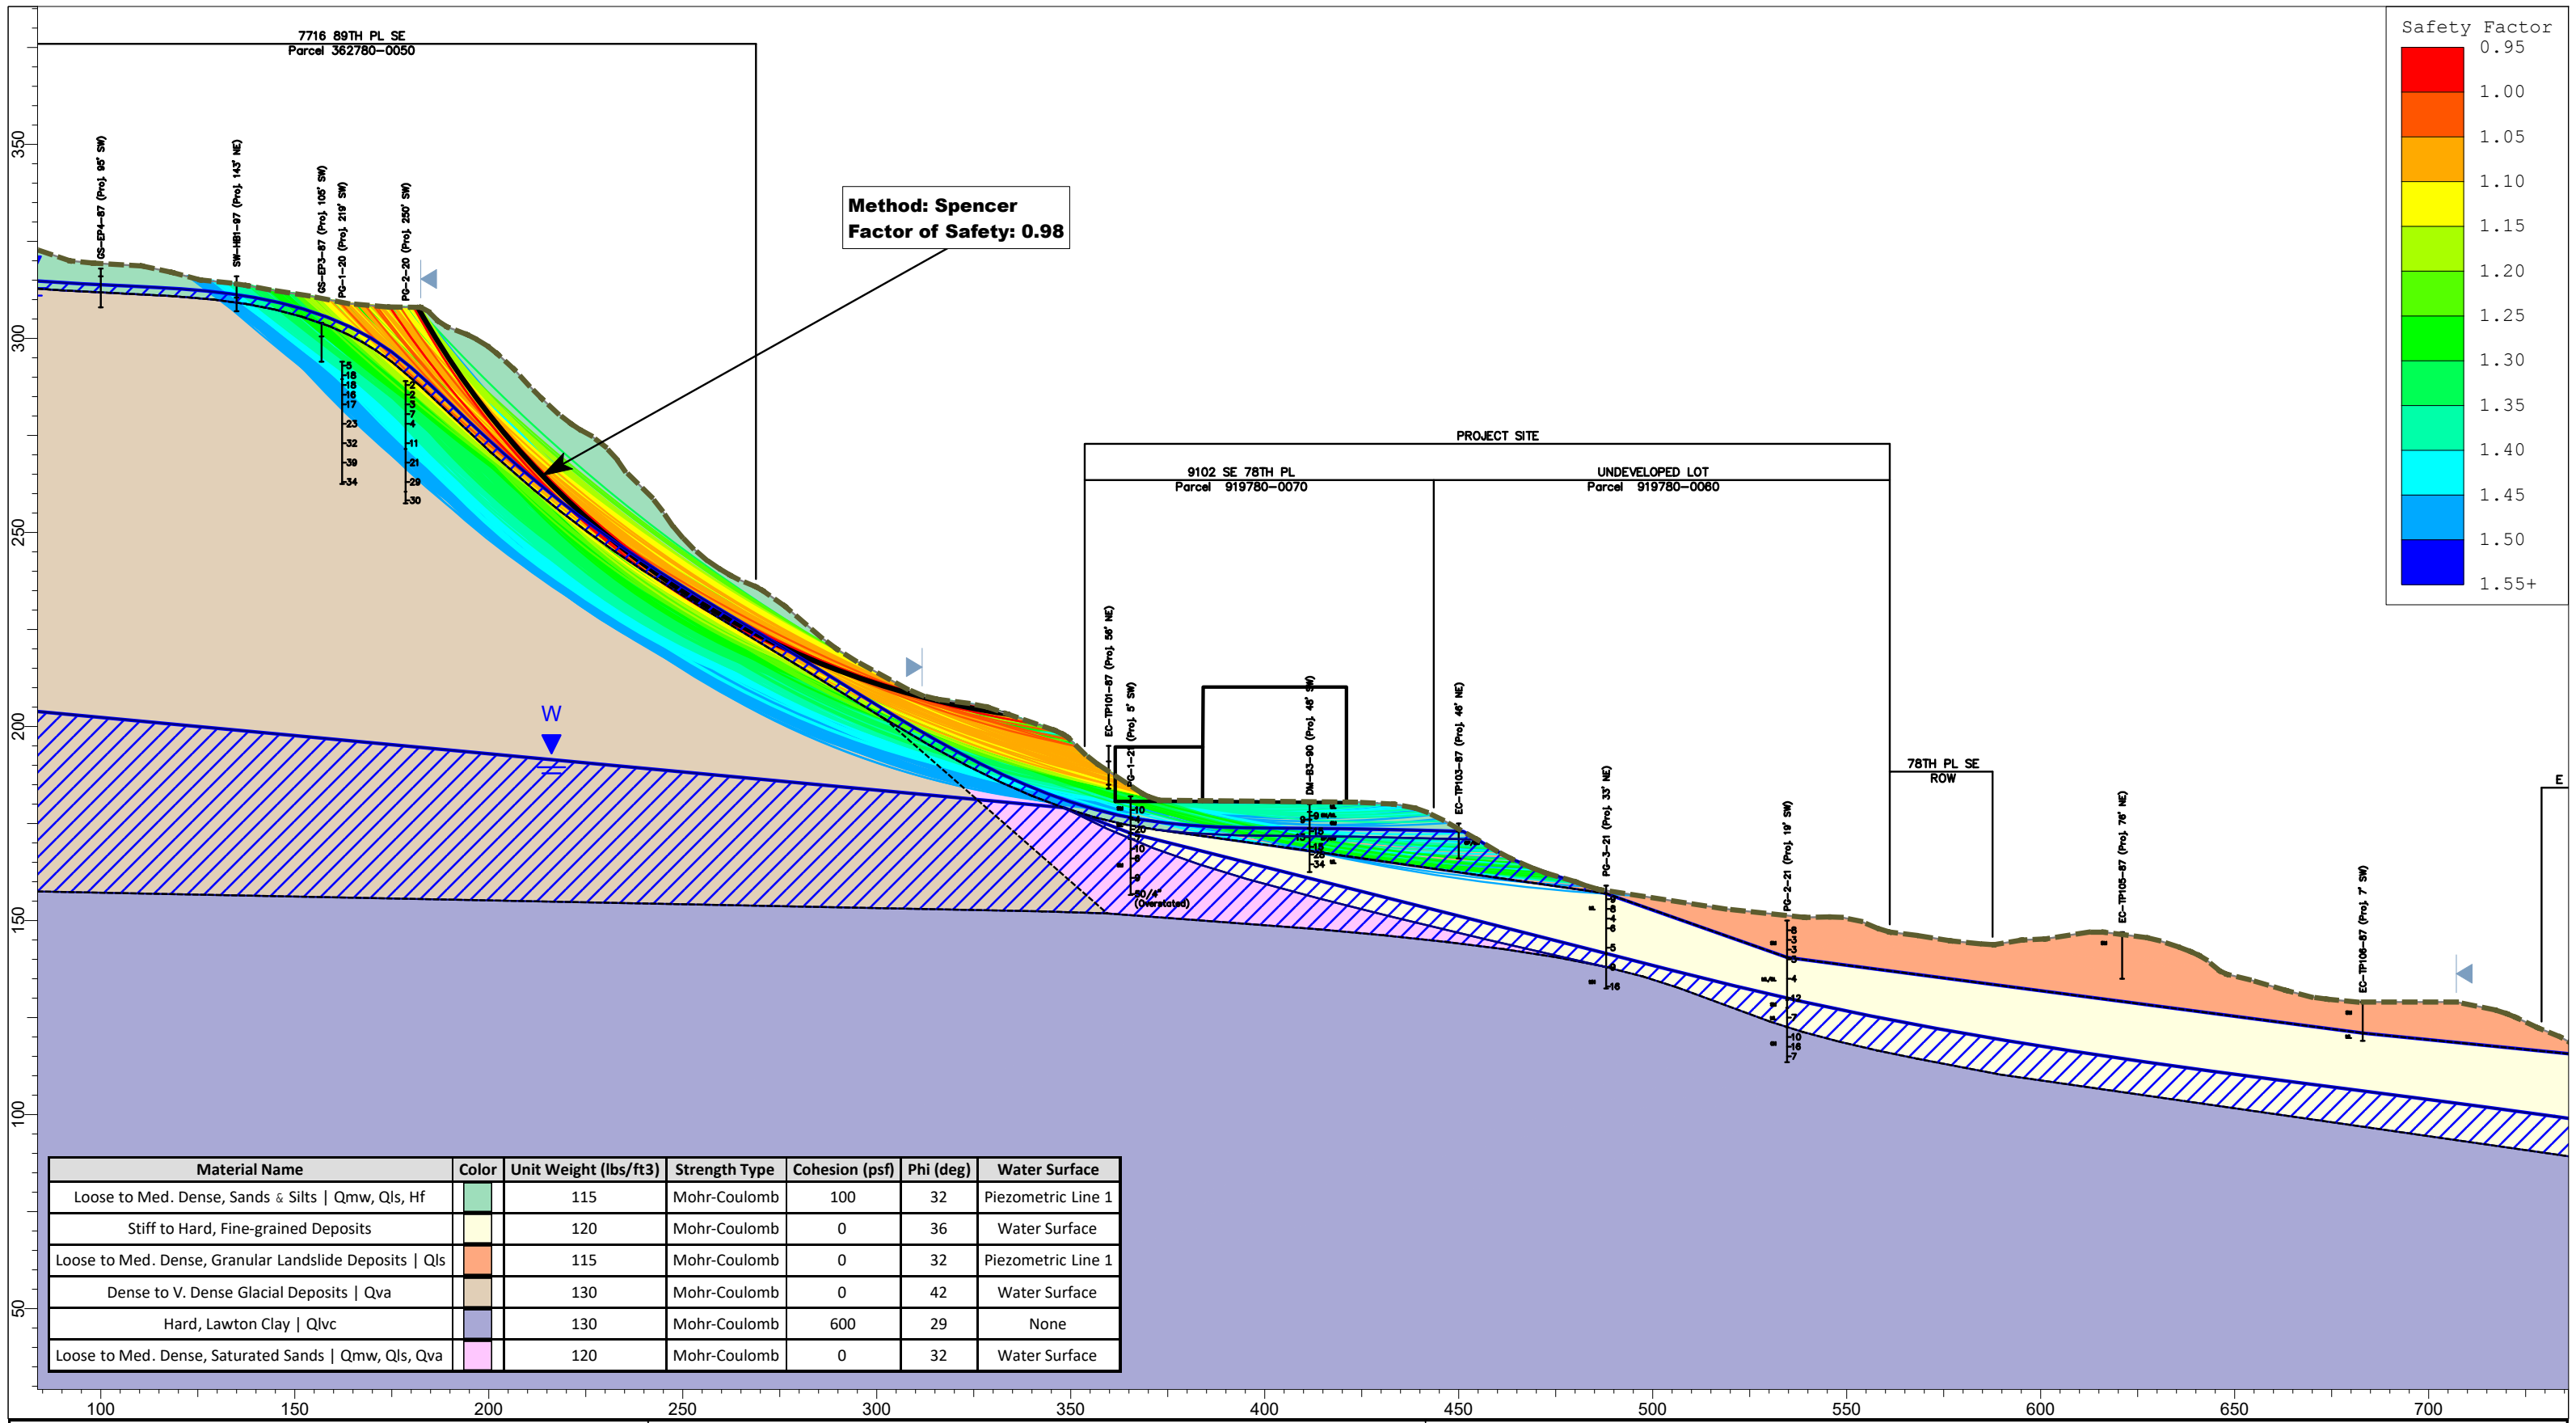
Scale:	Project No.	Figure No.
1:480	21-537	6

Static Stability Analysis
Section A | Existing Condition | F.S. < 1.5

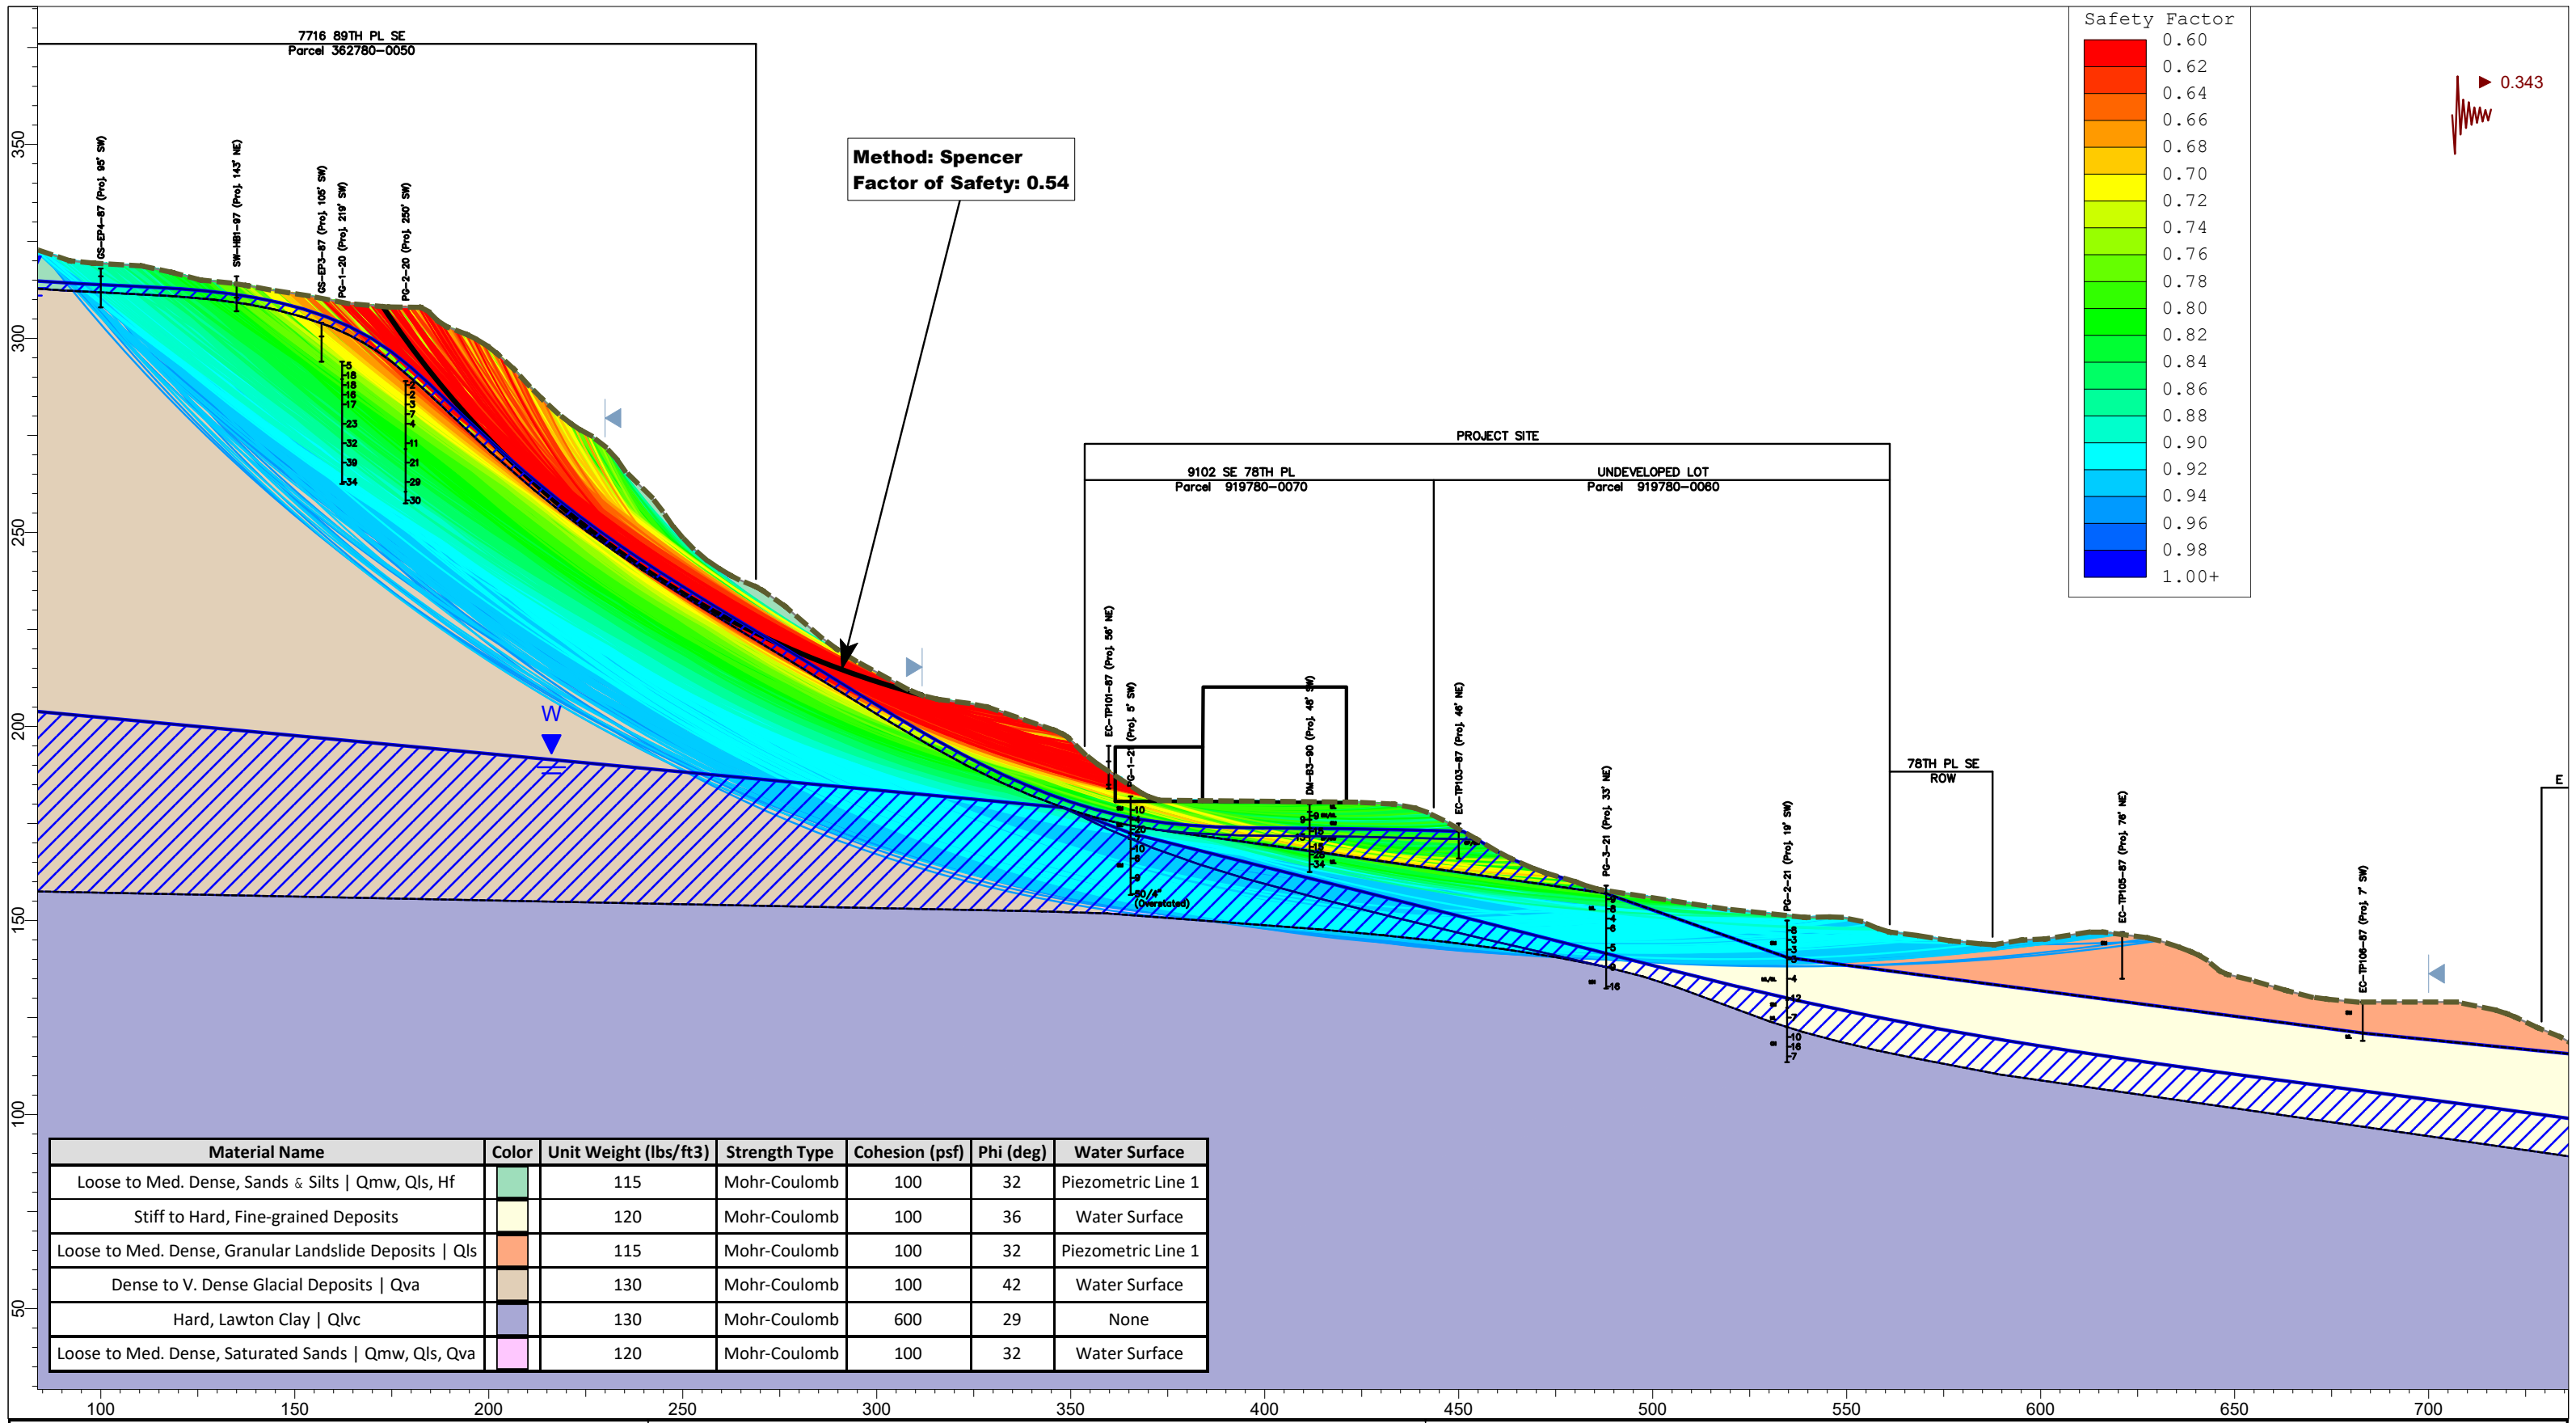
Scale:	Project No.	Figure No.
1:480	21-537	7

Pseudo-Static (Seismic) Stability Analysis
Section A | Existing Condition | F.S. < 1.0

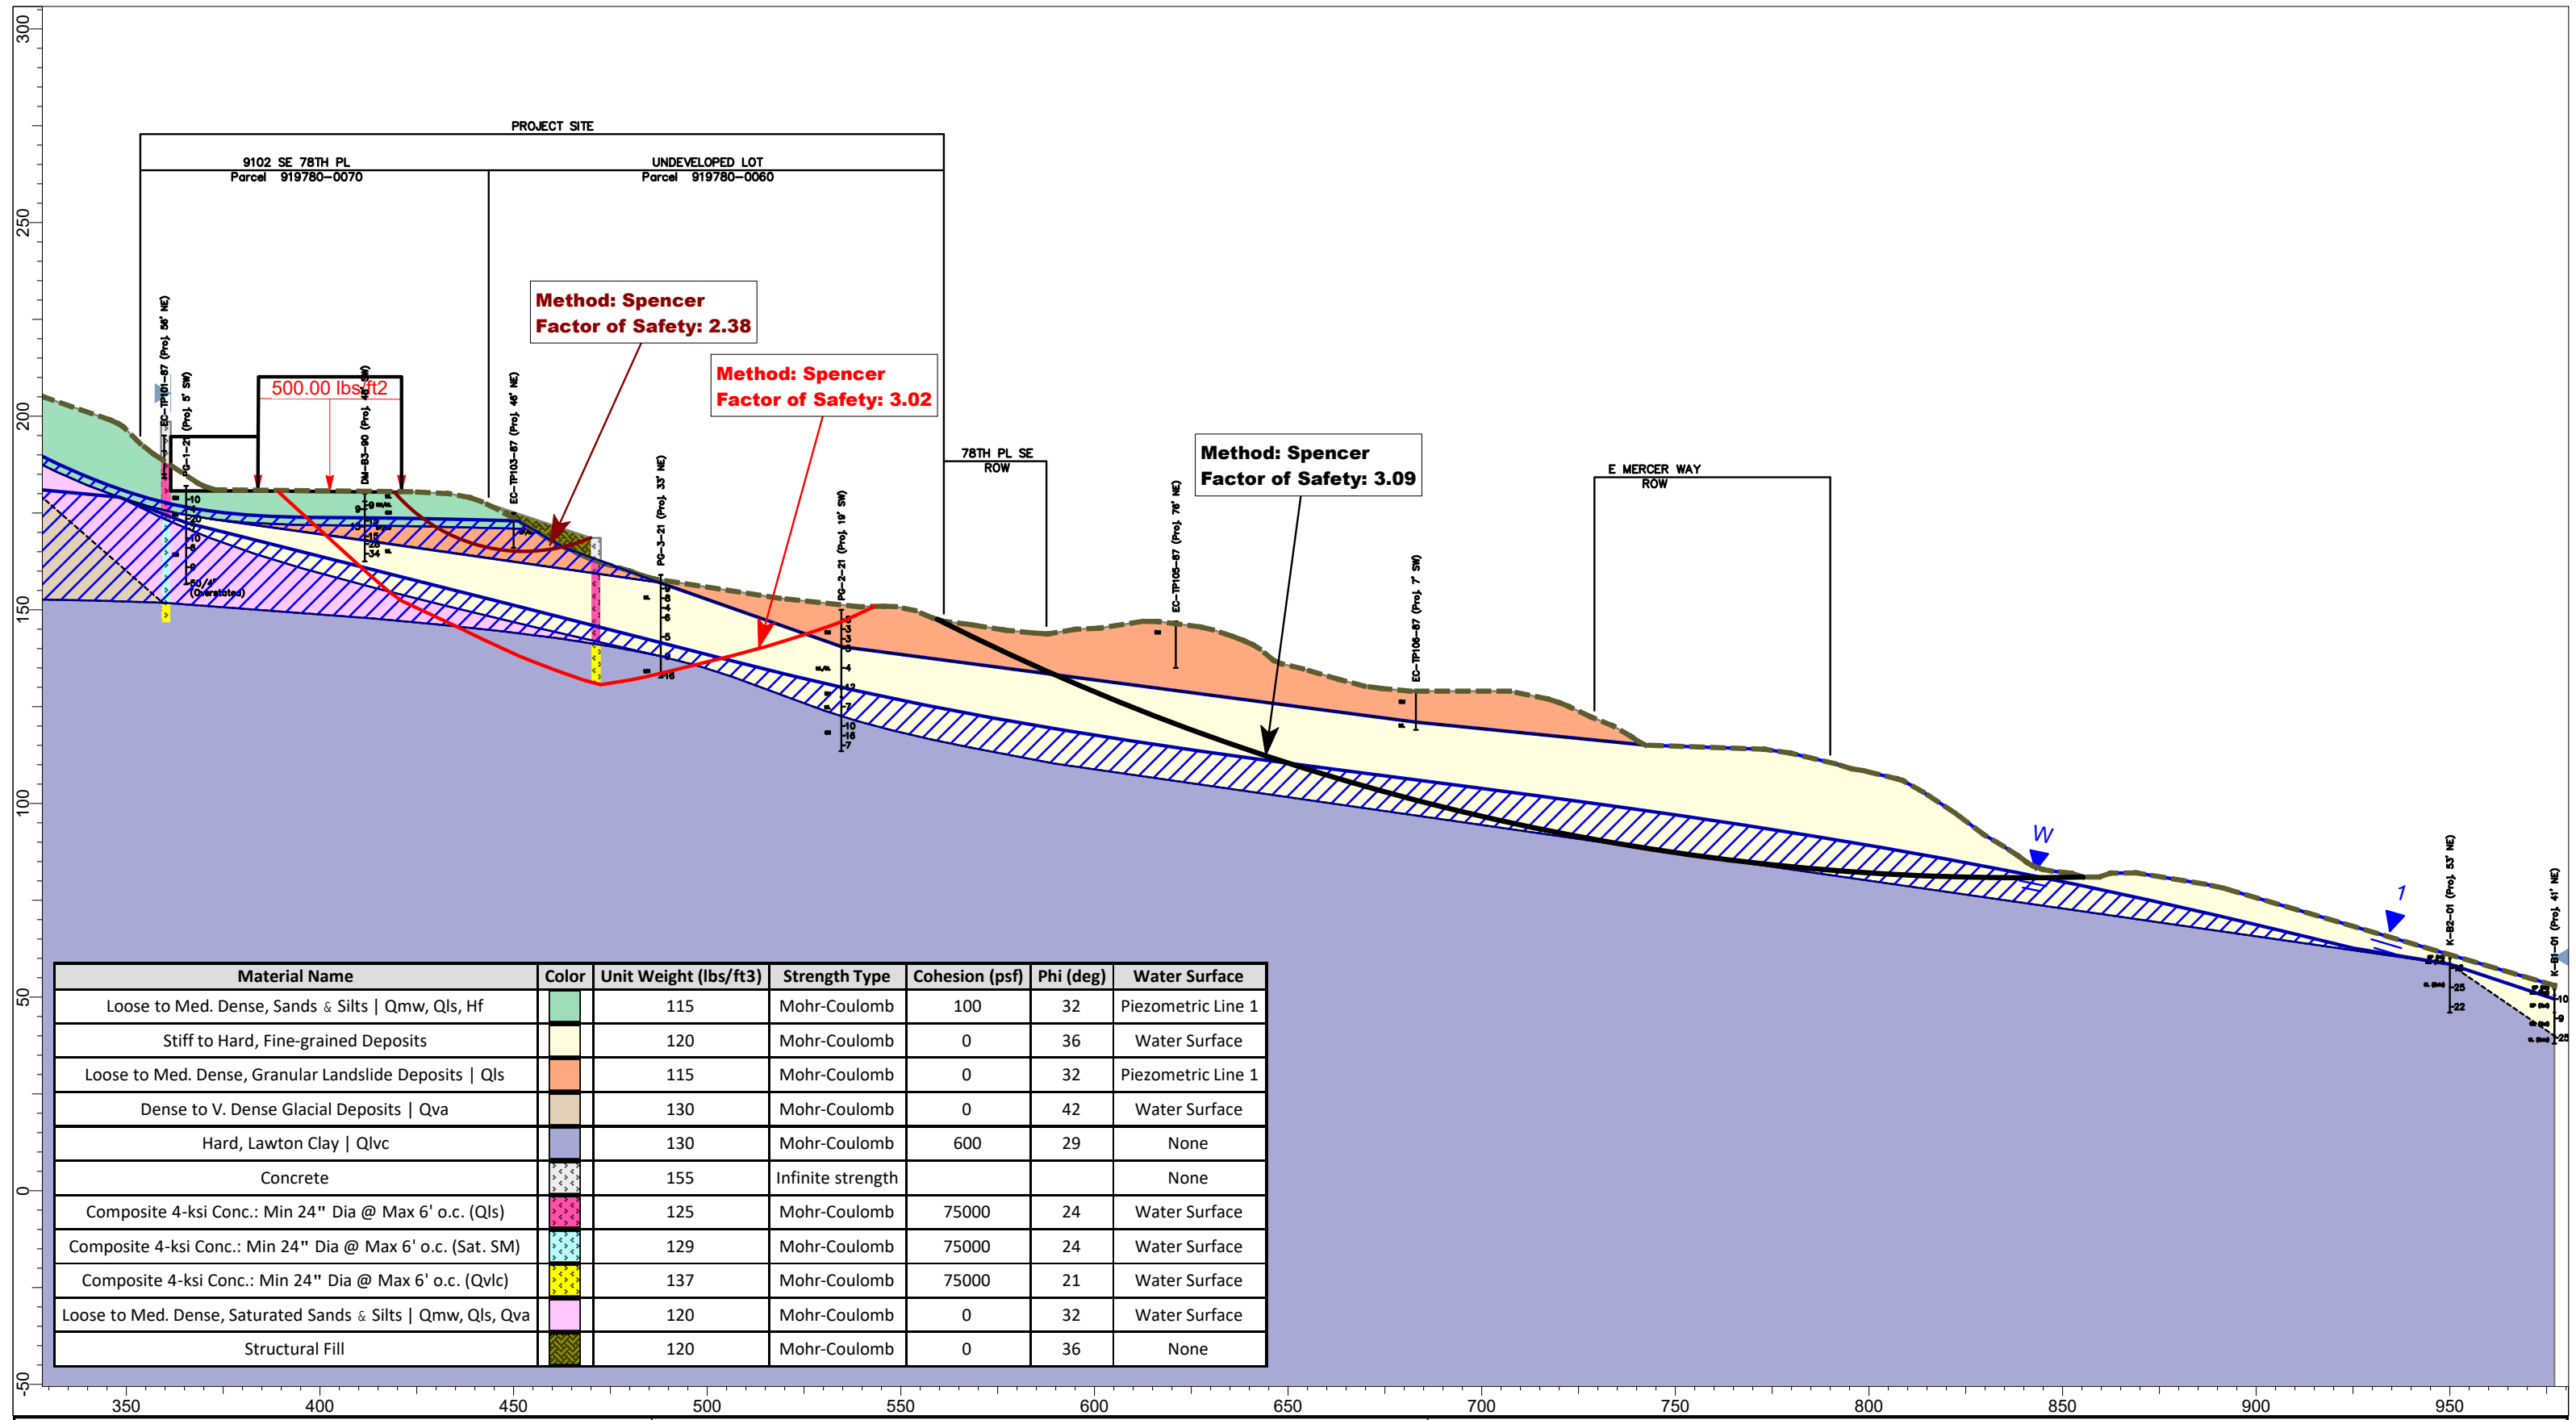
Scale:	Project No.	Figure No.
1:480	21-537	10

**Method: Spencer
Factor of Safety: 2.38**

**Method: Spencer
Factor of Safety: 3.02**
