Buttenweiser – Wiley Residence 6838 96th Avenue SE (Mercer Island)

Stormwater Site Plan May 16, 2022

Laurie J. Pfarr, P.E.
LPD Engineering, PLLC
1932 1st Ave, Suite 201
Seattle, WA 98101
(206) 725-1211

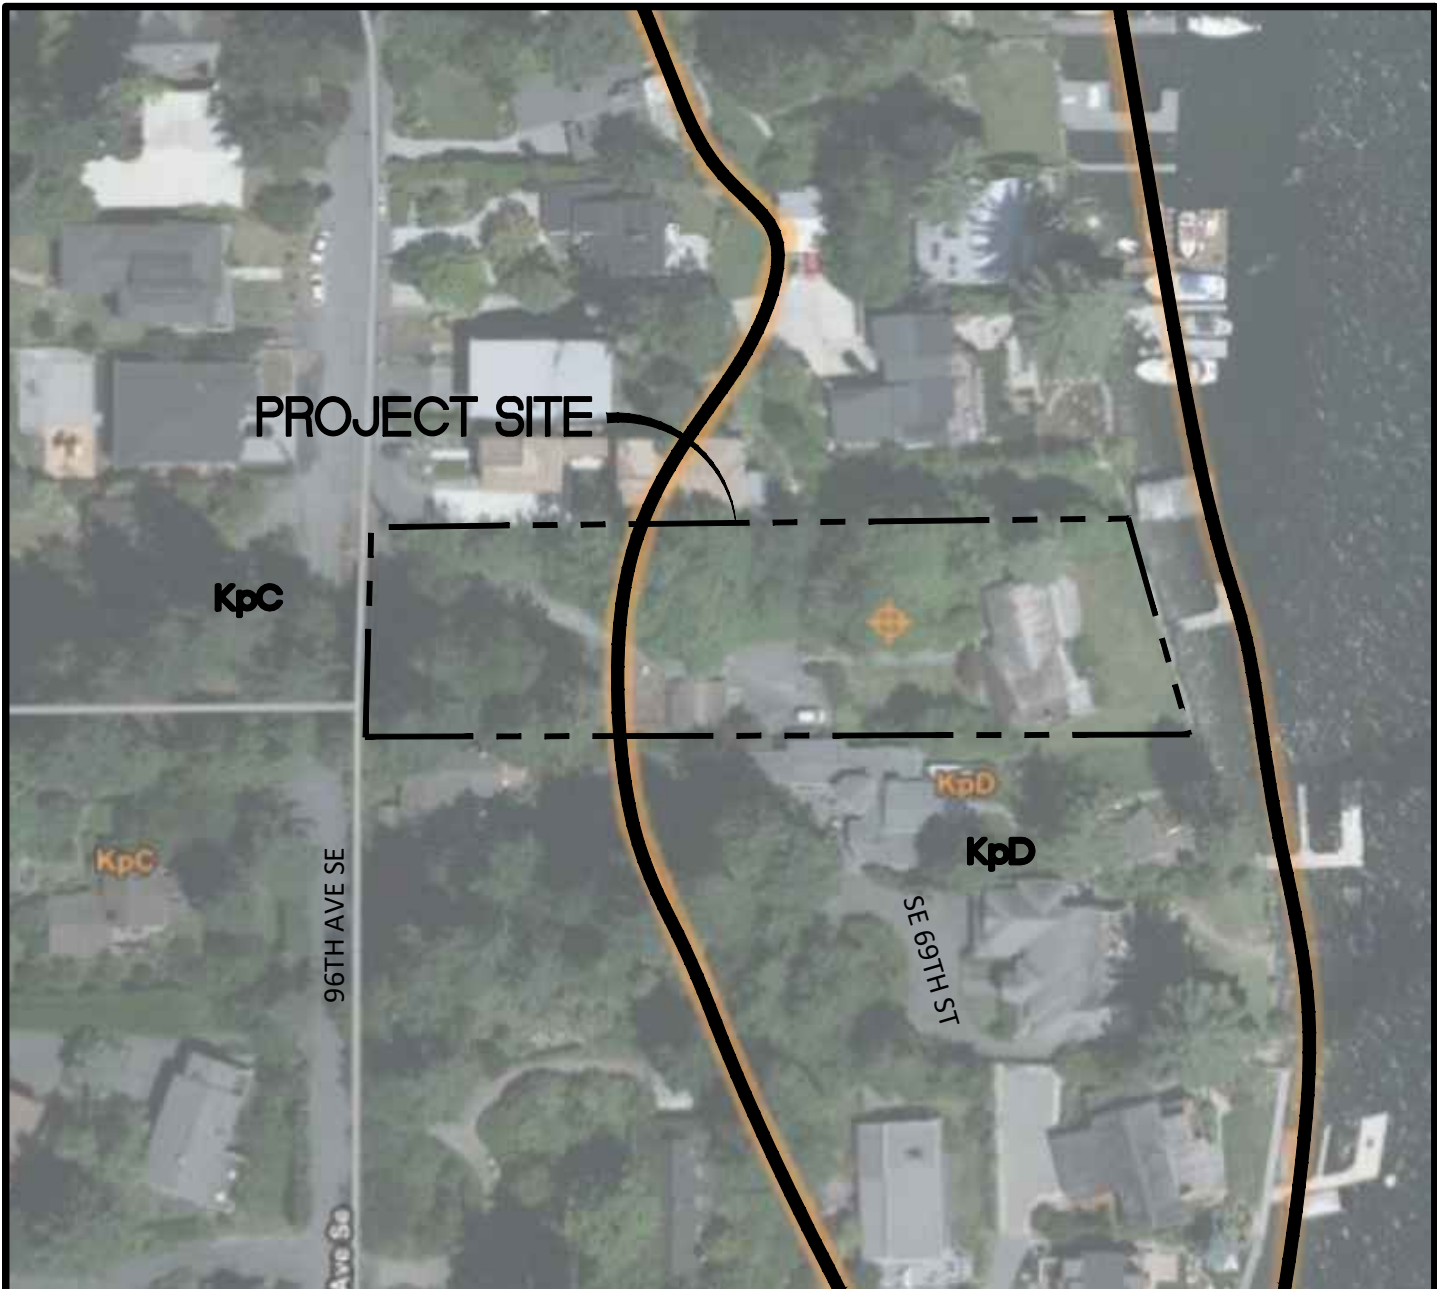
<p>1932 1st Ave, Suite 201, Seattle, WA 981041 p. 206.725.1211 f. 206.973.5344 www.lpdengineering.com</p>	<p>DESCRIPTION</p> <p style="text-align: center; font-size: 2em;">SOILS MAP</p>	<p>MAY 16, 2022</p> <p>FIGURE</p> <p style="font-size: 4em; text-align: center;">3</p>
---	--	---

KING COUNTY AREA, WASHINGTON (WA633)

MAP UNIT SYMBOL	MAP UNIT NAME
KpD	Kitsap silt loam, 15% to 30% slopes
KpC	Arents, Alderwood Material, 6% to 15% slopes
