# **Butenweiser – Wiley Residence 6838 96th Avenue SE (Mercer Island)**

## **Revised Stormwater Site Plan**

October 26, 2022

Laurie J. Pfarr, P.E.  
**LPD Engineering, PLLC**  
1932 1<sup>st</sup> Ave, Suite 201  
Seattle, WA 98101  
(206) 725-1211

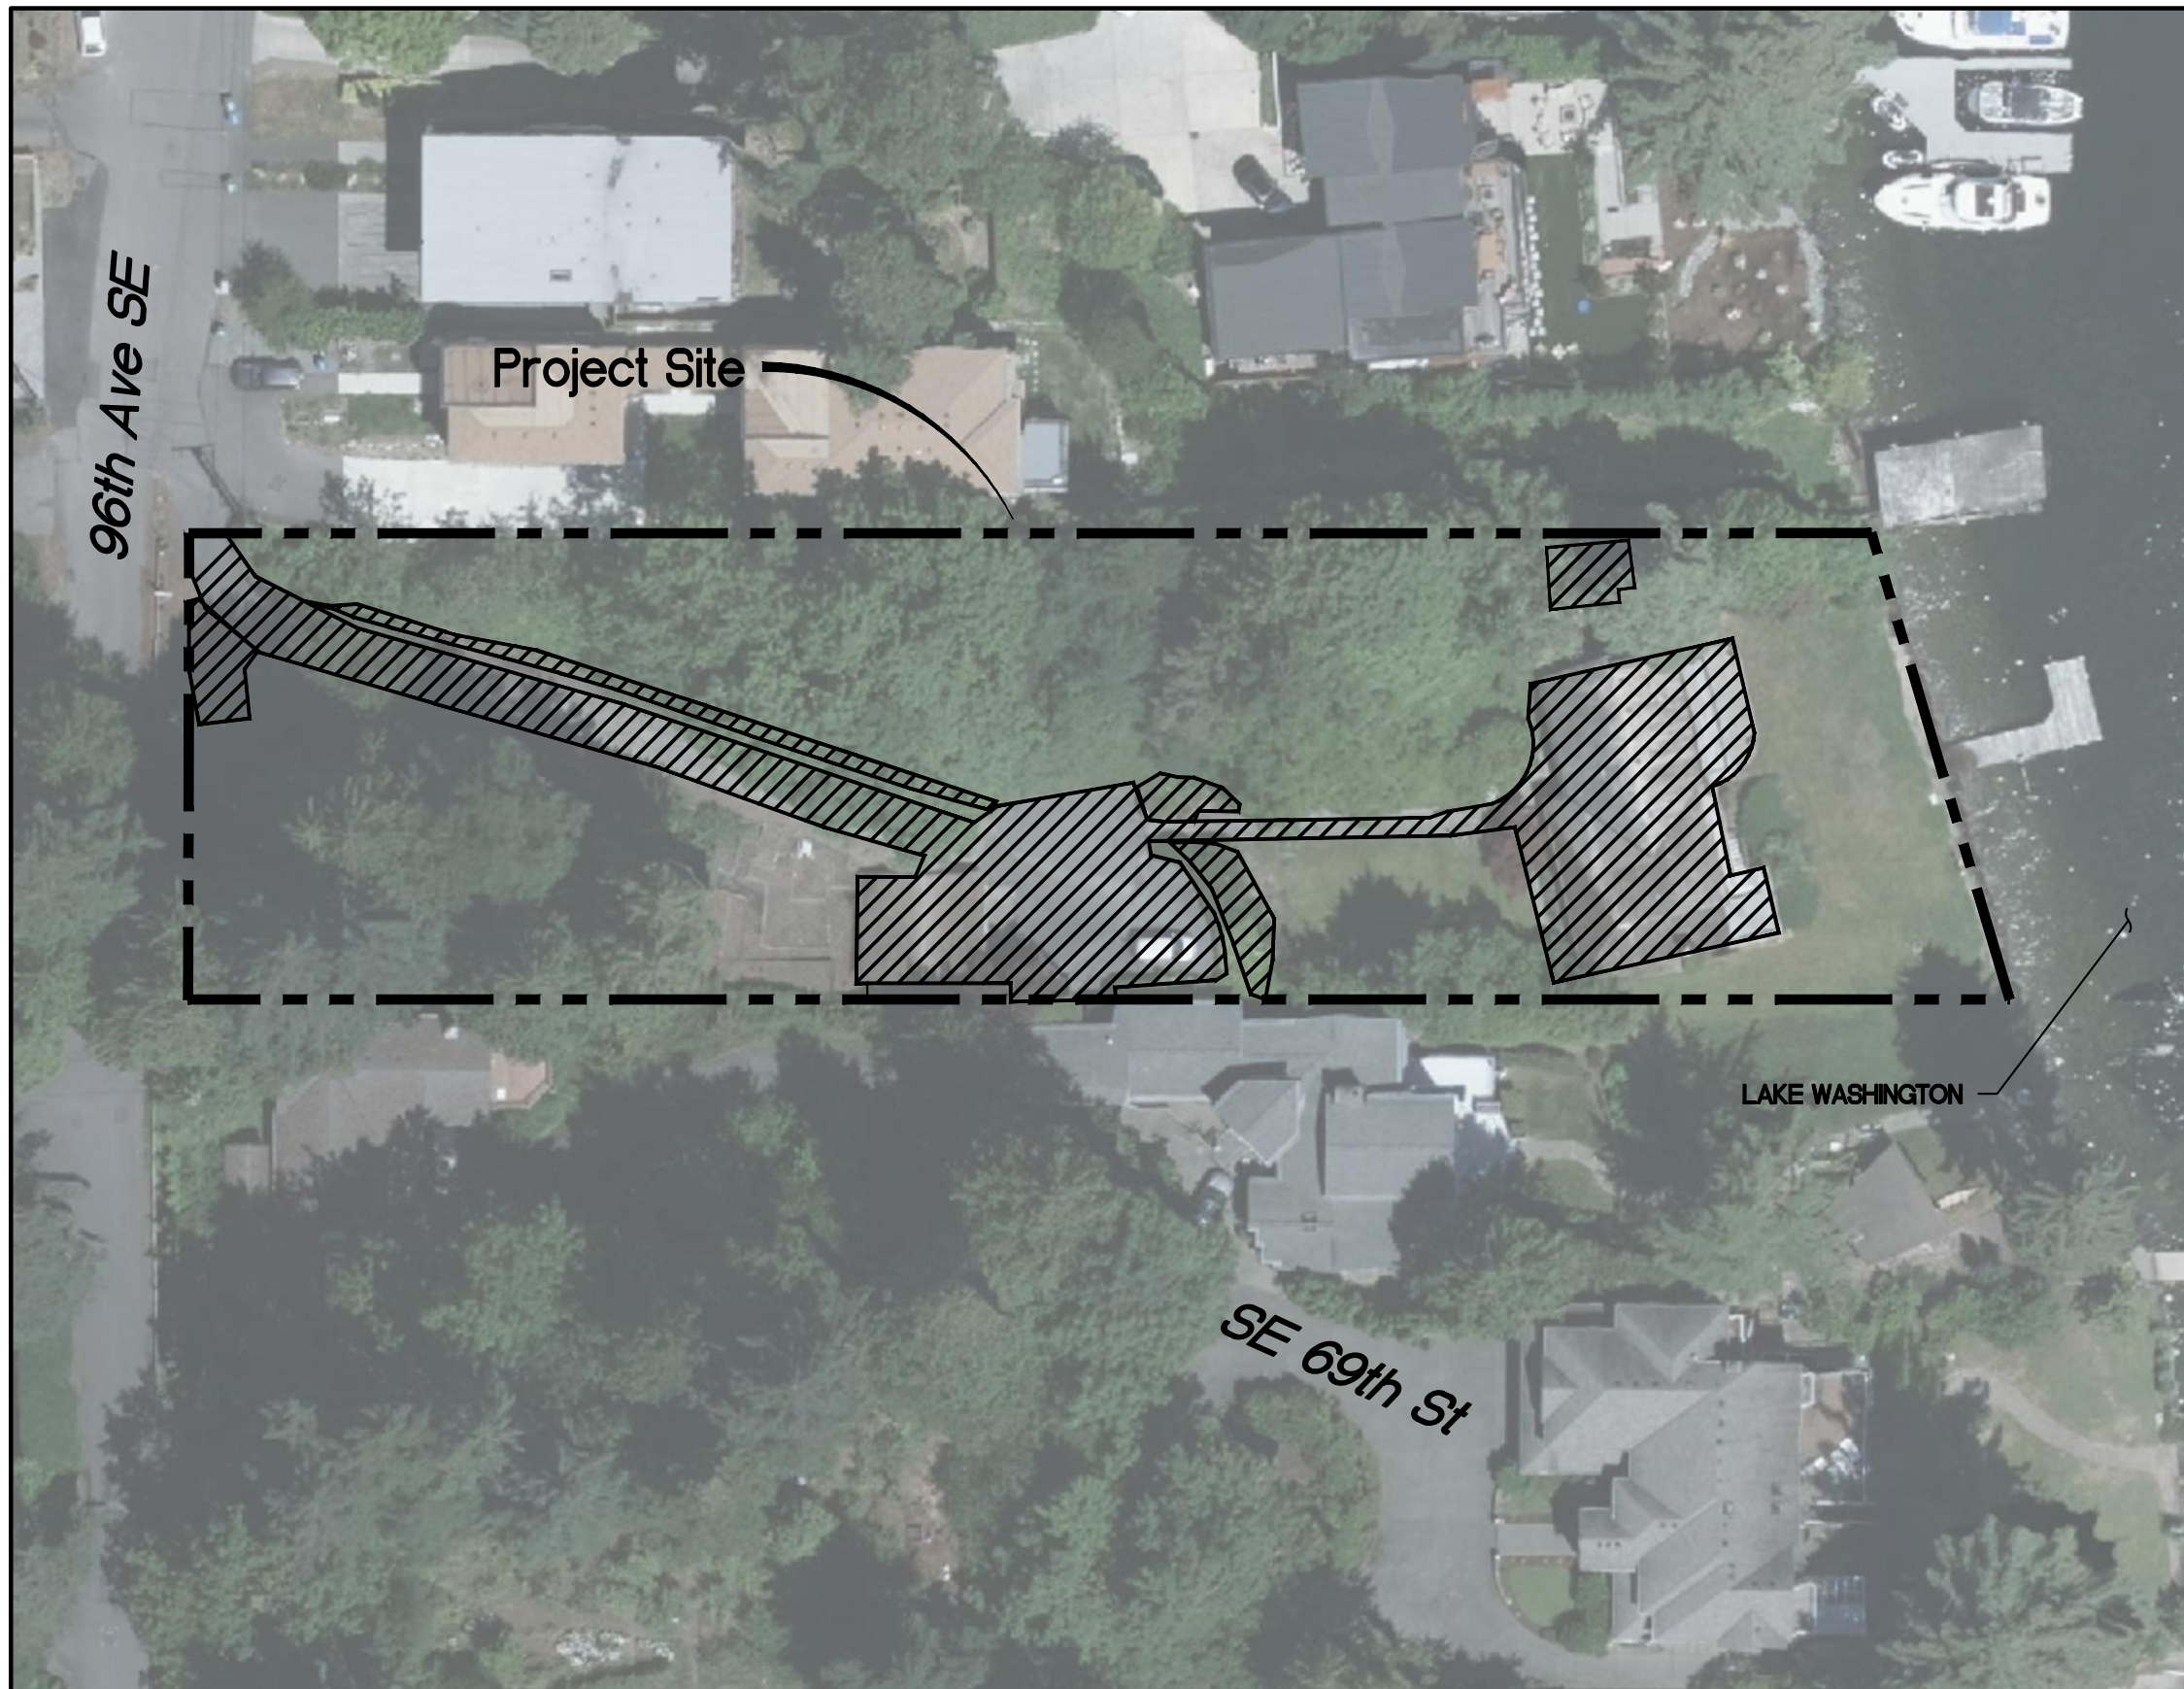
FIGURE  
**2**

EXISTING IMPERVIOUS AREA

DESCRIPTION  
 EXISTING IMPERVIOUS  
 COVERAGE  
 OCTOBER 26, 2022

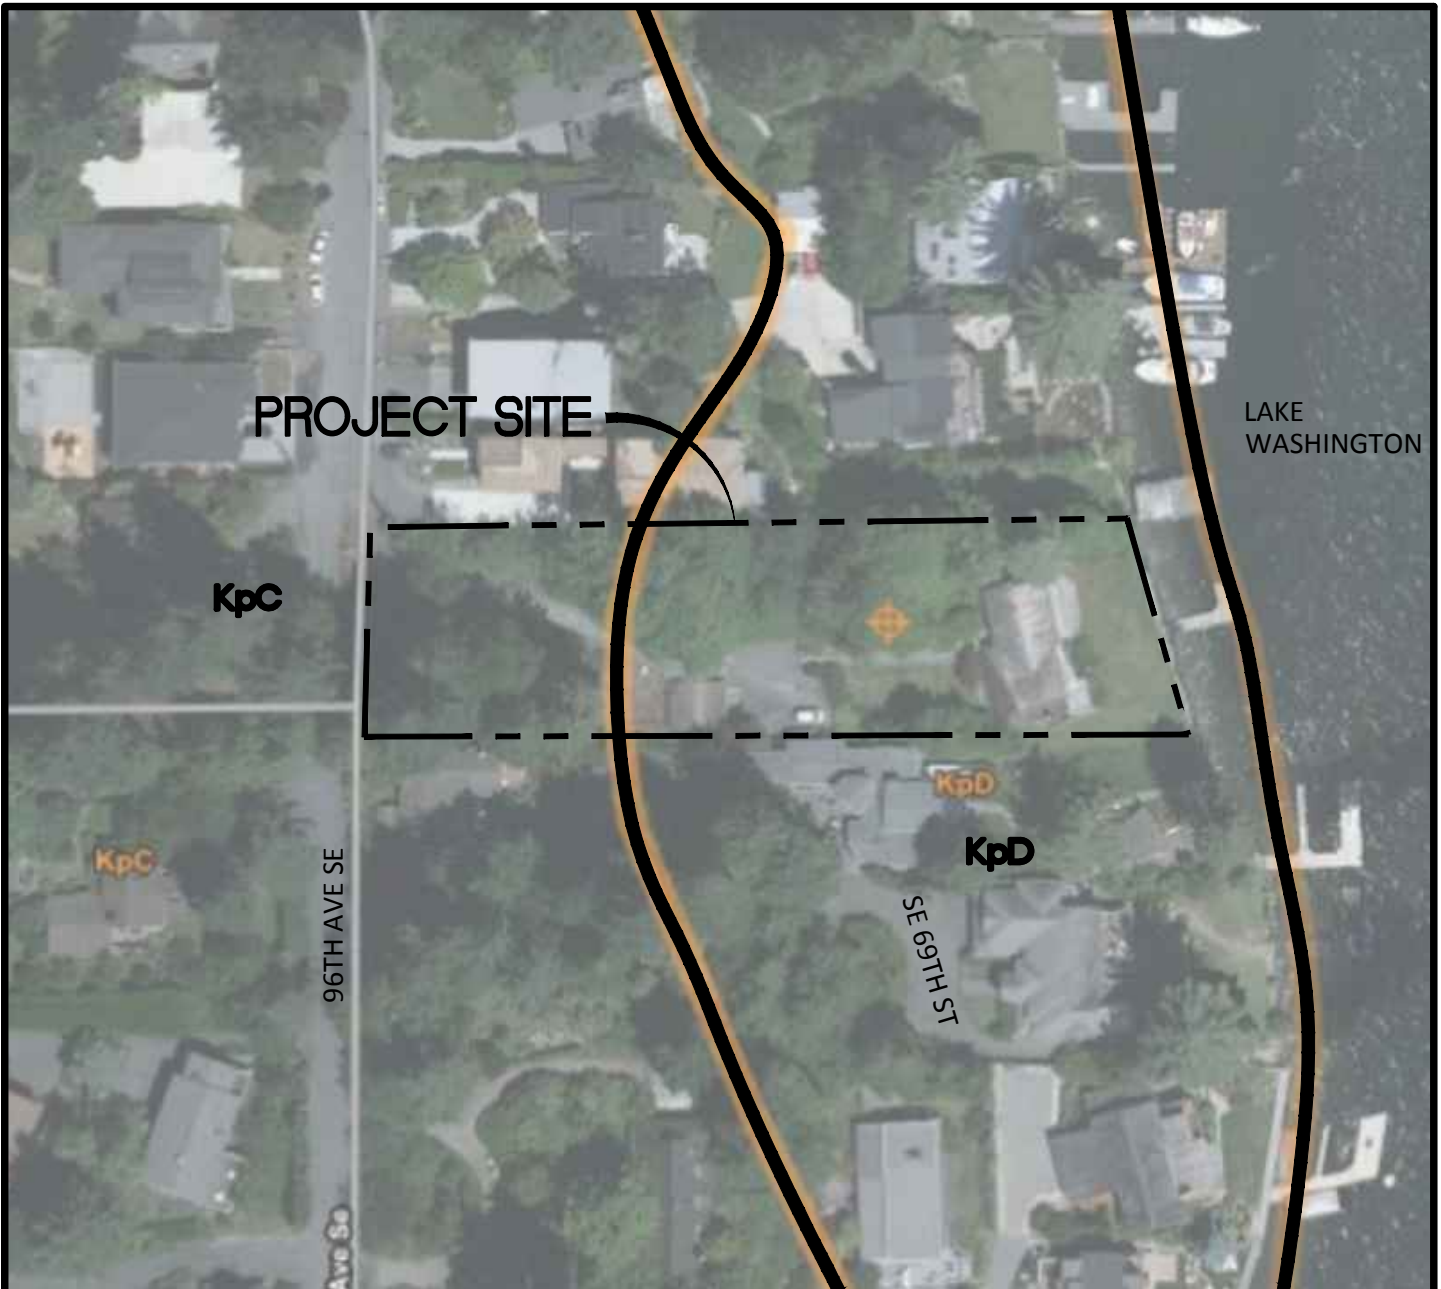
KING COUNTY AREA, WASHINGTON (WA633)

MAP UNIT SYMBOL	MAP UNIT NAME
KpD	Kitsap silt loam, 15% to 30% slopes
KpC	Arents, Alderwood Material, 6% to 15% slopes

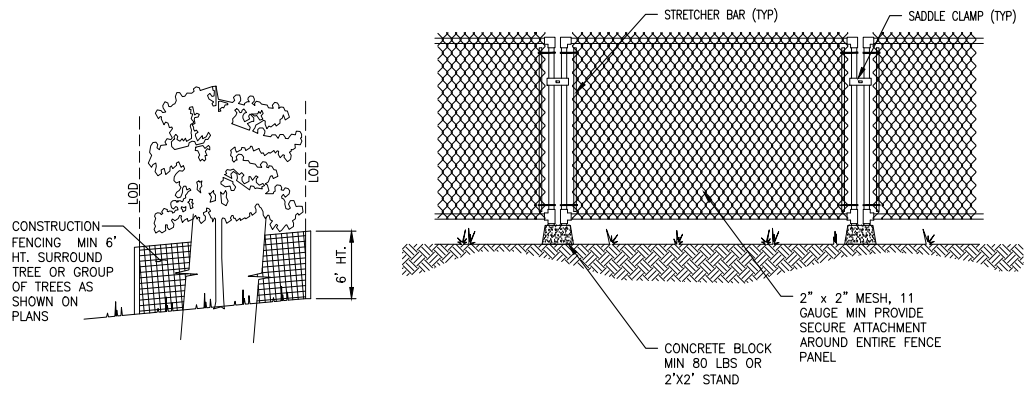
NTS TREE PROTECTION FENCING 2

1. A 6 FOOT HIGH TEMPORARY FENCE MUST BE PLACED PRIOR TO THE COMMENCEMENT OF CLEARING OR EARTHWORK. NOTIFY THE CLEARING AND GRADING INSPECTOR TO GET BOTH THE INSPECTION AND WRITTEN APPROVAL OF FLAGGED TREES AND TEMPORARY PROTECTION FENCING AROUND TREES TO BE SAVED PER THE APPROVED CLEARING AND GRADING PLAN.

3. ROOTS OF TREES TO BE SAVED WHICH ARE DAMAGED DURING CONSTRUCTION MUST BE TREATED IN THE FOLLOWING WAY: FOR DAMAGED ROOTS OVER 2" IN DIAMETER, MAKE A CLEAN, STRAIGHT CUT TO REMOVE THE DAMAGED PORTION OF THE ROOT. ALL EXPOSED ROOTS WILL BE TEMPORARILY COVERED WITH DAMP BURLAP OR WOOD SHAVINGS TO PREVENT DRYING AND COVERED WITH EARTH AS SOON AS POSSIBLE.

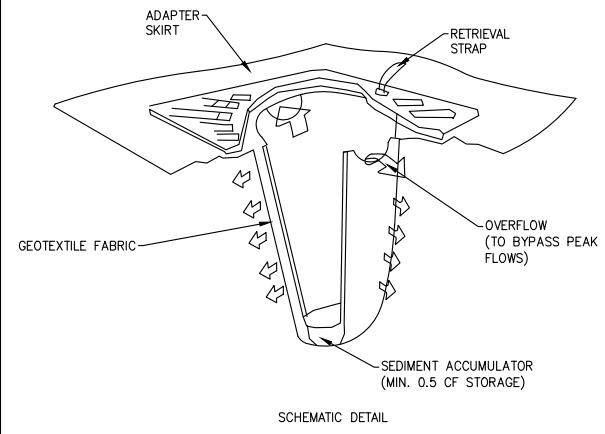
NTS CATCH BASIN PROTECTION 11

SCHEMATIC DETAIL  
 PROVIDE "STREAMGUARD SEDIMENT CATCH BASIN INSERT" OR APPROVED EQUAL.  
 MANUFACTURER'S NAME: BOWHEAD ENVIRONMENTAL & SAFETY  
 ADDRESS: P.O. BOX 375 PRESTON, WA 98050  
 TELEPHONE: FOR INFORMATION: (800) 909-3677  
 WWW.SHOPBOWHEAD.COM

3. CATCH BASIN FILTERS SHOULD BE PROVIDED FOR ALL STORM DRAIN CATCH BASIN/INLETS DOWNSLOPE AND WITHIN 500 FEET OF THE CONSTRUCTION AREA. CATCH BASIN FILTERS SHOULD BE DESIGNED BY THE MANUFACTURER FOR USE AT CONSTRUCTION SITES AND APPROVED BY THE CITY INSPECTOR. CATCH BASIN FILTERS SHOULD BE INSPECTED FREQUENTLY, ESPECIALLY AFTER STORM EVENTS. IF THE FILTER BECOMES CLOGGED, IT SHOULD BE CLEANED OR REPLACED.

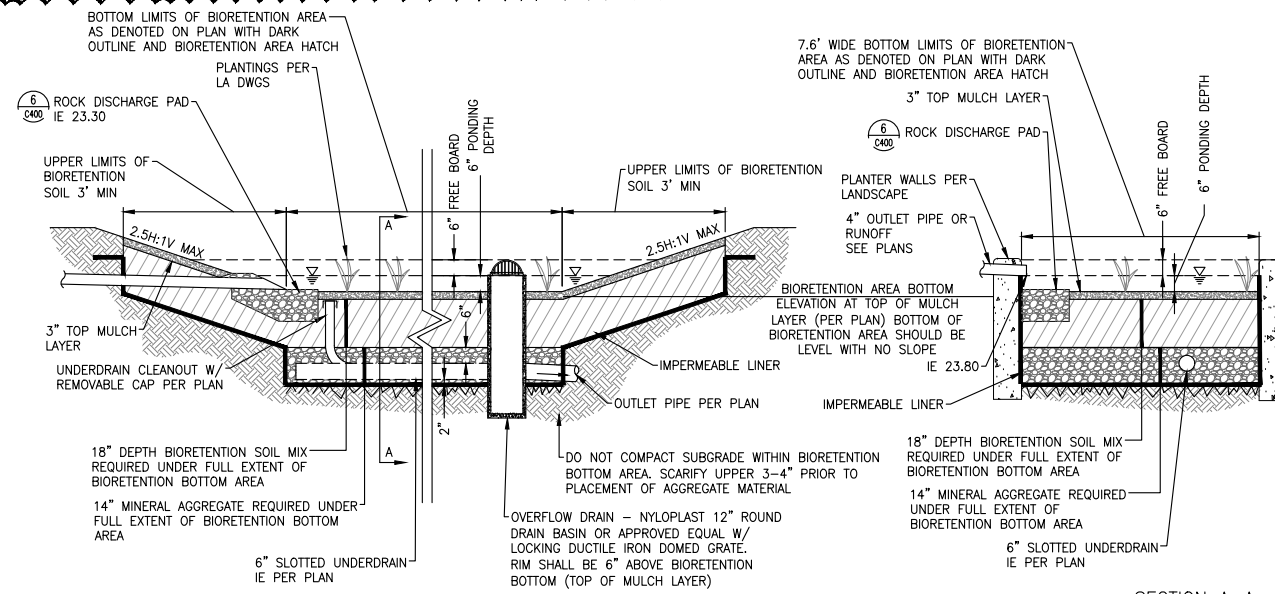
BIORETENTION AREA 3

11. PLANT VEGETATION ACCORDING TO PLANTING PLAN.
12. MULCH AND INSTALL EROSION PROTECTION AT SURFACE FLOW ENTRANCES WHERE NECESSARY UNTIL ENTIRE SITE IS STABILIZED. MULCH MUST BE WOOD CHIPS CONSISTING OF SHREDDED OR CHIPPED HARDWOOD. MULCH SHOULD NOT CONTAIN WEED SEEDS, GRASS CLIPPINGS, AND LARGE CHUNKS OF BARK.

13. CONTRACTOR IS RESPONSIBLE FOR KEEPING BIORETENTION SOIL SEDIMENT FREE AFTER INSTALLATION AND UPON COMPETITION OF CONSTRUCTION, AND ANY SEDIMENT CONTAMINATED BIORETENTION SOIL SHALL BE REMOVED AND REPLACED AT THE CONTRACTORS EXPENSE.

SECTION A-A

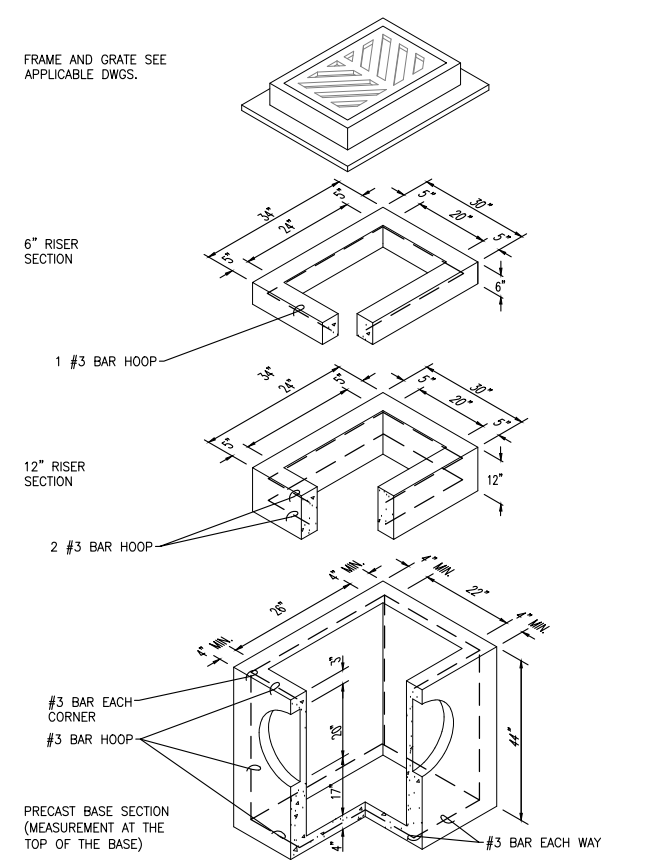
CATCH BASIN TYPE 1 8

- NOTES:
1. CATCH BASINS SHALL BE CONSTRUCTED IN ACCORDANCE WITH ASTM C478 (AASHTO M 199) & C890 UNLESS OTHERWISE SHOWN ON PLANS OR NOTED IN THE WSDOT/APWA STANDARD SPECIFICATIONS.

2. AS AN ACCEPTABLE ALTERNATIVE TO REBAR, WELDED WIRE FABRIC HAVING A MIN. AREA OF 0.12 SQUARE INCHES PER FOOT MAY BE USED. WELDED WIRE FABRIC SHALL COMPLY TO ASTM A497 (AASHTO M 221). WIRE FABRIC SHALL NOT BE PLACED IN KNOCKOUTS.

13. CATCH BASIN INSTALLATION SHALL BE PER CONTRACT DOCUMENTS AND DETAILS.

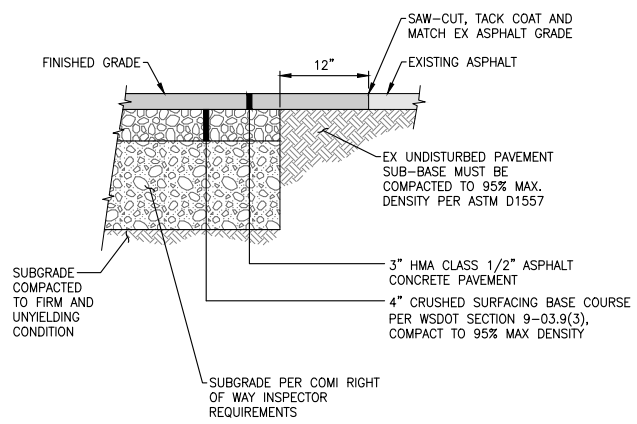
NTS  
 ASPHALT PAVEMENT 11

- NOTES:
1. IF EX PAVEMENT SECTION IS THICKER, MATCH EX SECTION. OTHERWISE CONSTRUCT SECTION SHOWN.
  2. SAW-CUT FULL DEPTH WHERE NEW PAVEMENT ABUTS EXISTING AND APPLY TACK COAT.
  3. PLACE ASPHALT IN ACCORDANCE WITH WSDOT APWA SECTION 5-04.
  4. PROOF ROLL AND REMOVE ANY SOFT SPOTS. REPLACE REMOVED MATERIAL WITH GRAVEL BORROW. CONTRACTOR SHALL TEST AND VERIFY SUBGRADE MEETS COMPACTION REQUIREMENTS PRIOR TO PAVING.

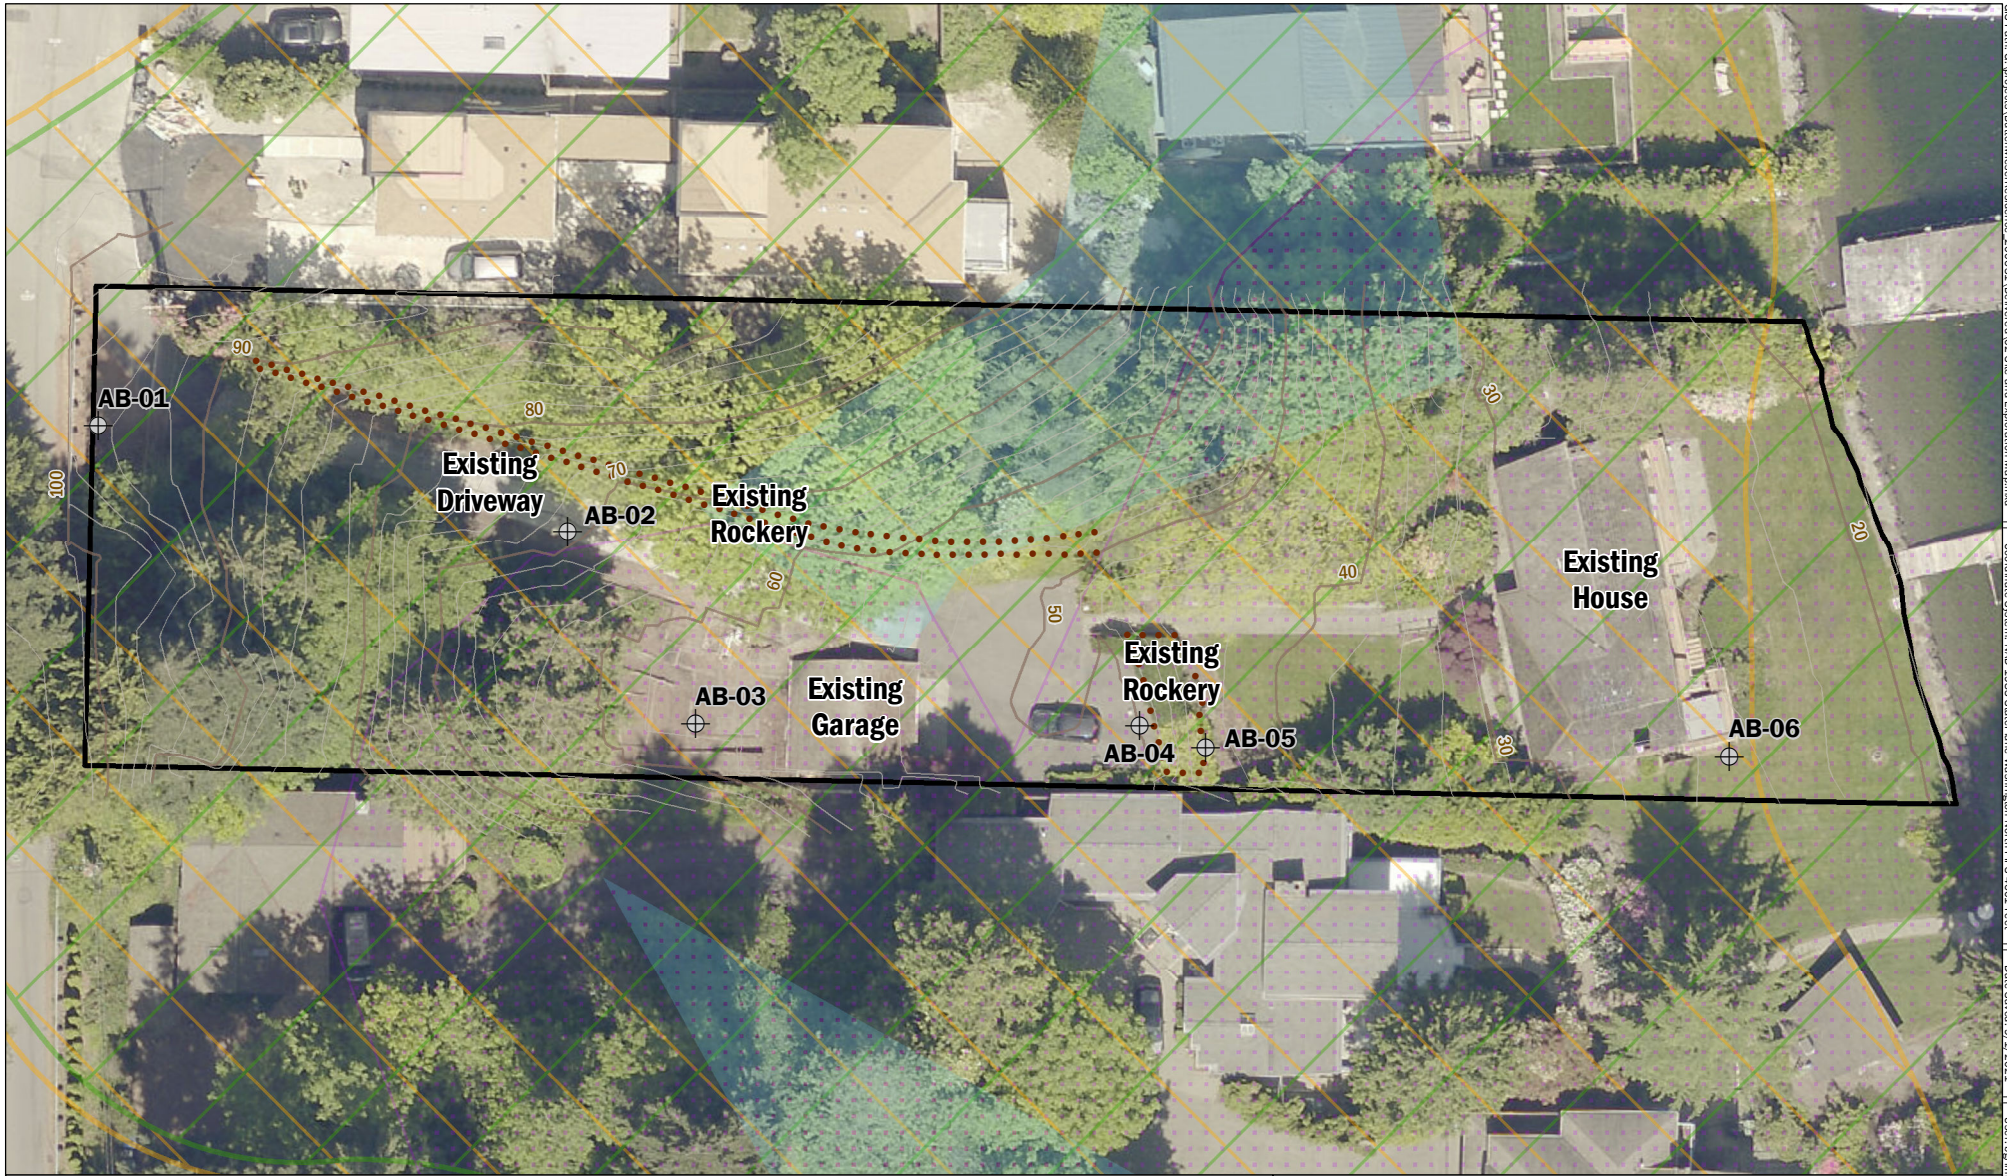
⊕ Explorations

Subsurface conditions at the Site were inferred from the completed field investigation, a review of applicable geologic literature, local geologic experience, and geotechnical laboratory testing. A more detailed description of the field exploration methods and

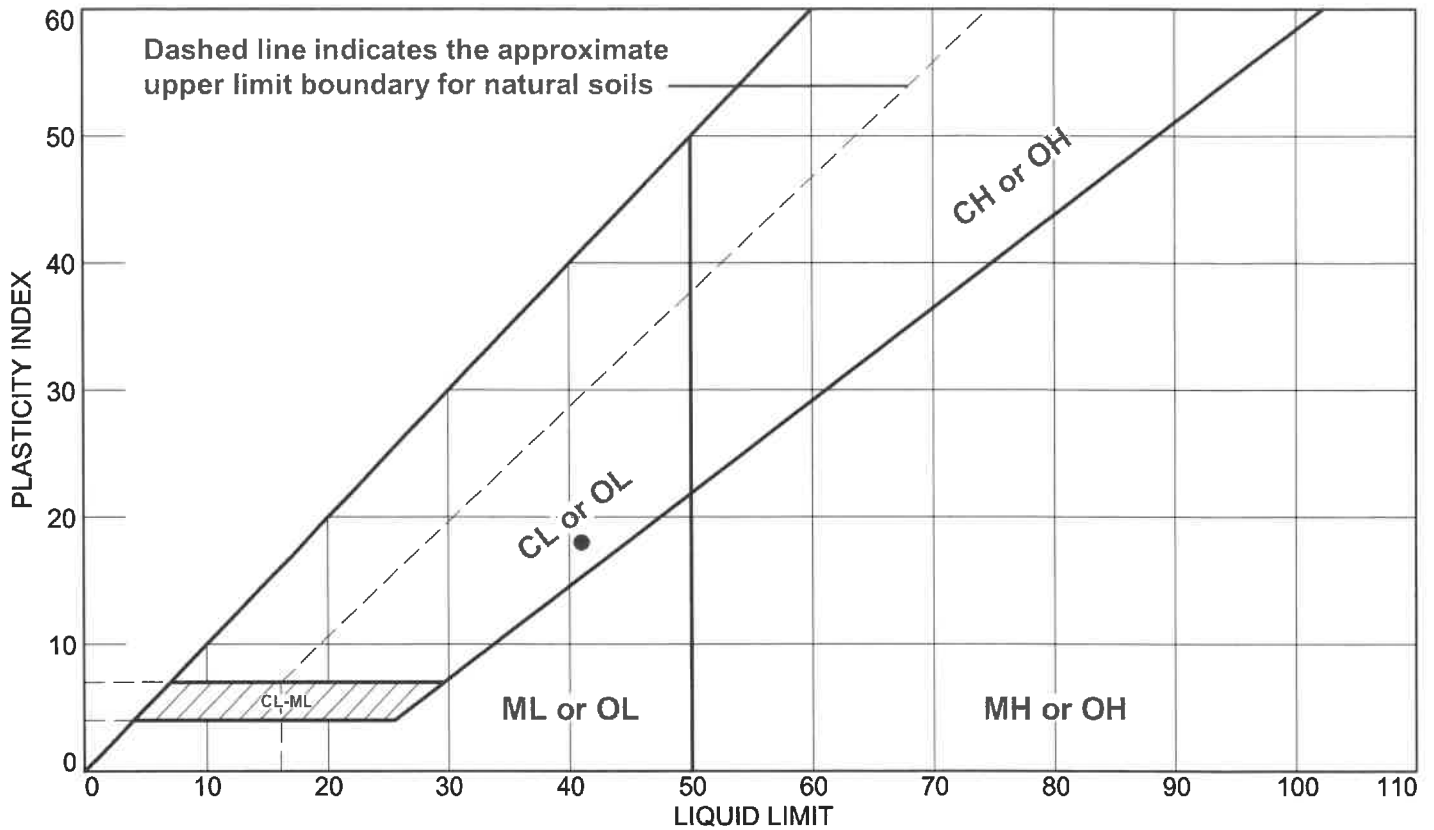
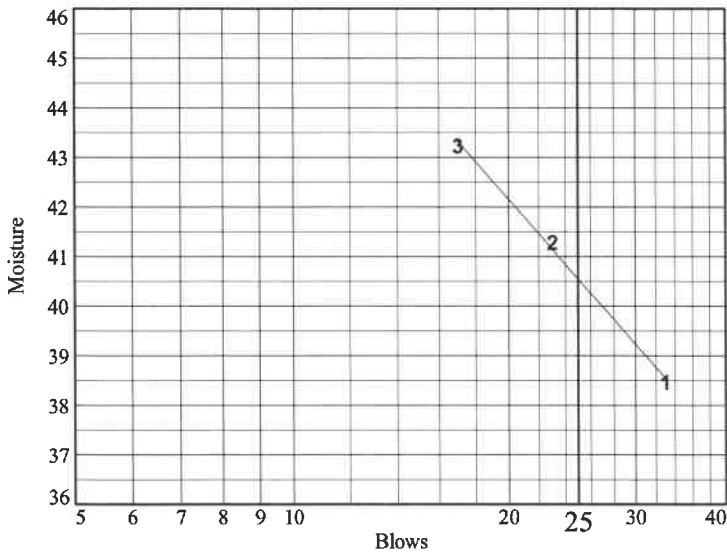
# LIQUID AND PLASTIC LIMITS TEST REPORT

SOURCE	SAMPLE NO.	DEPTH	NATURAL WATER CONTENT (%)	PLASTIC LIMIT (%)	LIQUID LIMIT (%)	PLASTICITY INDEX (%)	LIQUIDITY INDEX	USCS
●	AB-02 / S-3	8385-3	7.5	24.0	23	41	18	0.1	CL

**Liquid Limit=** 41  
**Plastic Limit=** 23  
**Plasticity Index=** 18  
**Natural Moisture=** 24.0  
**Liquidity Index=** 0.1

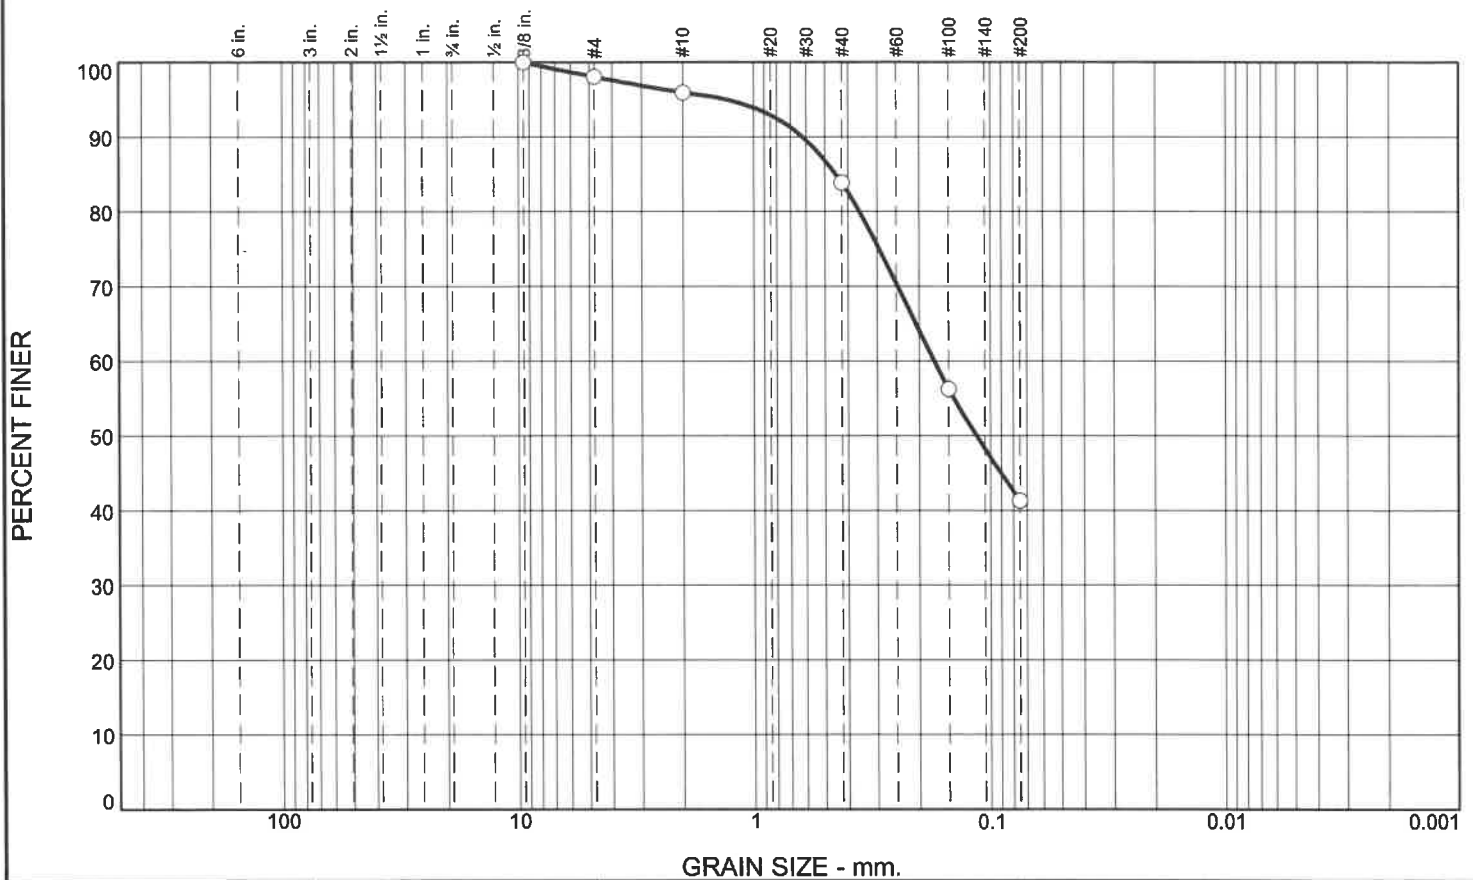
# Particle Size Distribution Report

% +3"	% Gravel		% Sand			% Fines	
	Coarse	Fine	Coarse	Medium	Fine	Silt	Clay
0.0	0.0	1.9	2.1	12.1	42.6	41.3

SIEVE SIZE	PERCENT FINER	SPEC.* PERCENT	PASS? (X=NO)
3/8"	100.0		
#4	98.1		
#10	96.0		
#40	83.9		
#100	56.2		
#200	41.3

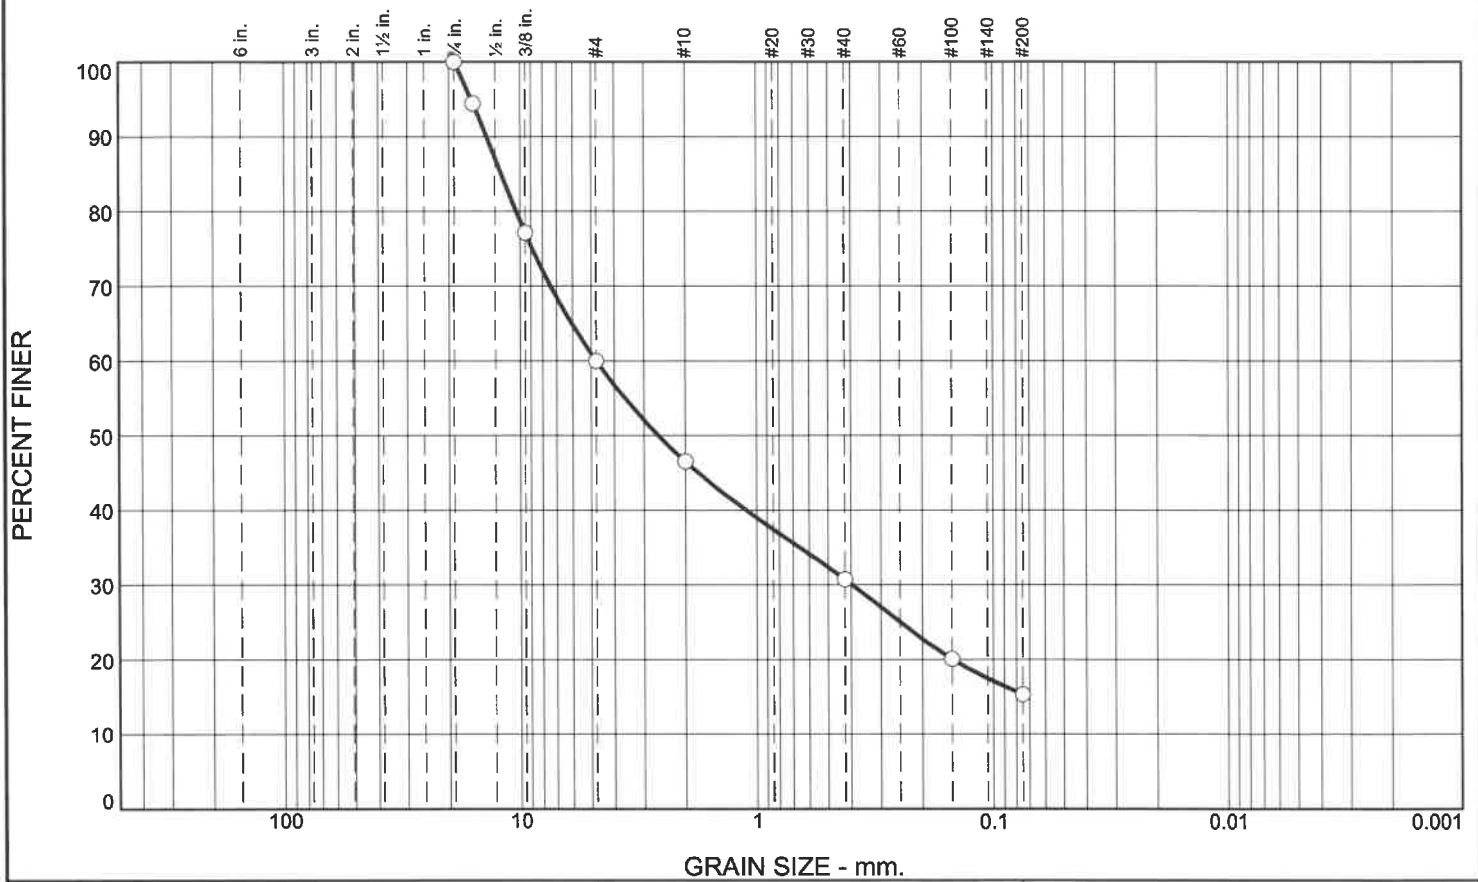
# Particle Size Distribution Report

% +3"	% Gravel		% Sand			% Fines	
	Coarse	Fine	Coarse	Medium	Fine	Silt	Clay
0.0	0.0	40.0	13.4	15.9	15.4	15.3

SIEVE SIZE	PERCENT FINER	SPEC.* PERCENT	PASS? (X=NO)
3/4"	100.0		
5/8"	94.5		
3/8"	77.2		
#4	60.0		
#10	46.6		
#40	30.7		
#100	20.1		
#200	15.3

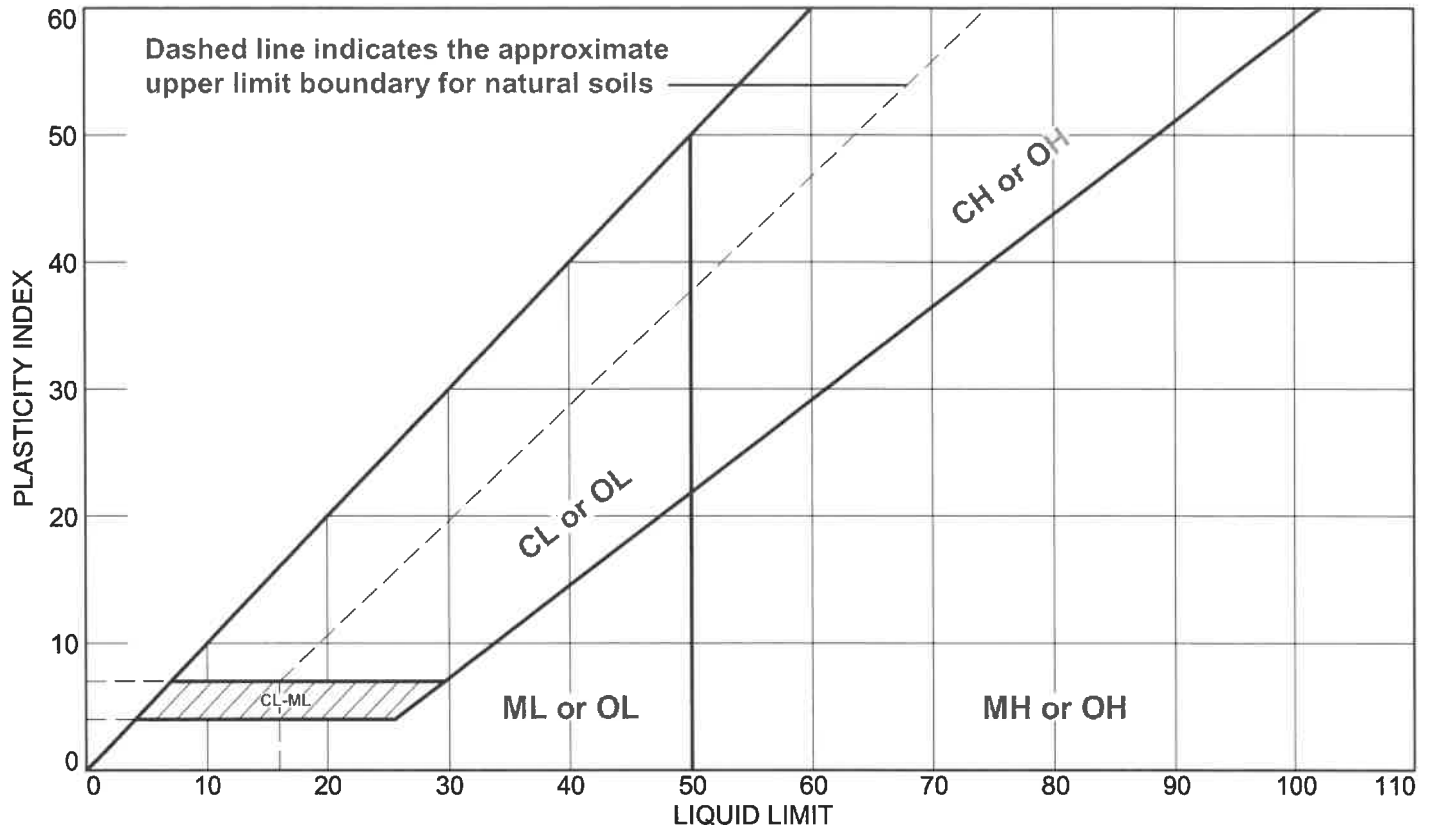
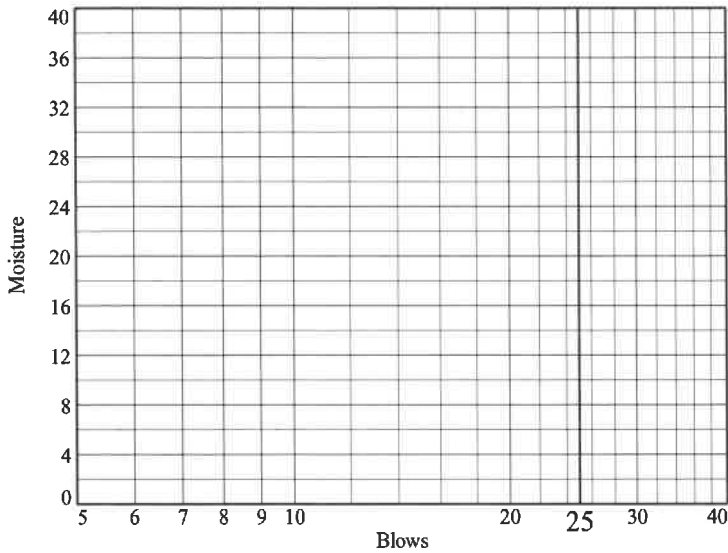
# LIQUID AND PLASTIC LIMITS TEST REPORT

SOURCE	SAMPLE NO.	DEPTH	NATURAL WATER CONTENT (%)	PLASTIC LIMIT (%)	LIQUID LIMIT (%)	PLASTICITY INDEX (%)	LIQUIDITY INDEX	USCS
●	AB-04 / S-1	8385-8	2.5	31.3	NP	NV	NP

Liquid Limit= NV  
 Plastic Limit= NP  
 Plasticity Index= NP  
 Natural Moisture= 31.3

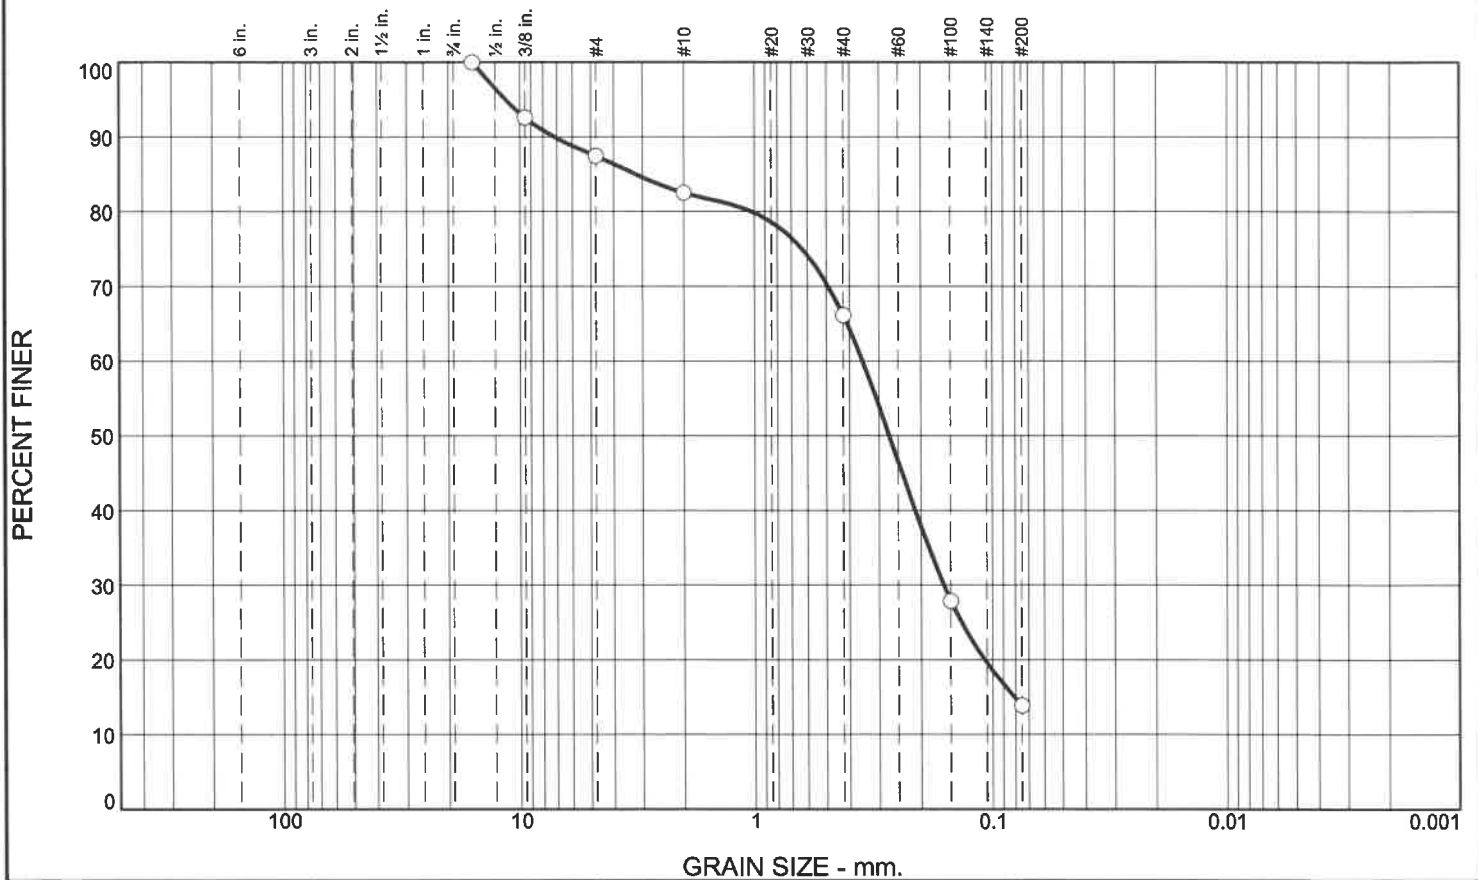
# Particle Size Distribution Report

% +3"	% Gravel		% Sand			% Fines	
	Coarse	Fine	Coarse	Medium	Fine	Silt	Clay
0.0	0.0	12.5	4.9	16.5	52.2	13.9

SIEVE SIZE	PERCENT FINER	SPEC.* PERCENT	PASS? (X=NO)
5/8"	100.0		
3/8"	92.6		
#4	87.5		
#10	82.6		
#40	66.1		
#100	27.9		
#200	13.9

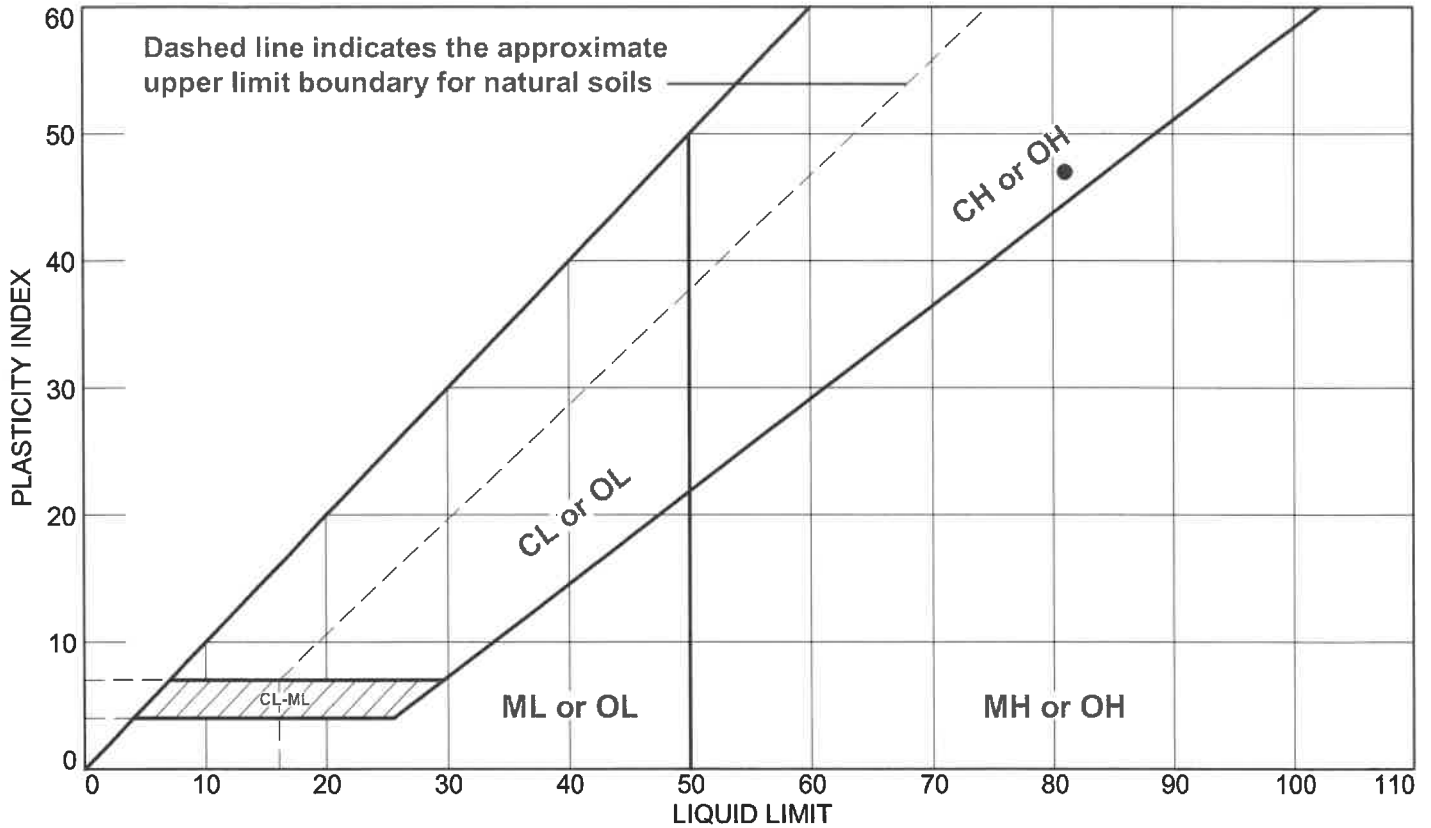
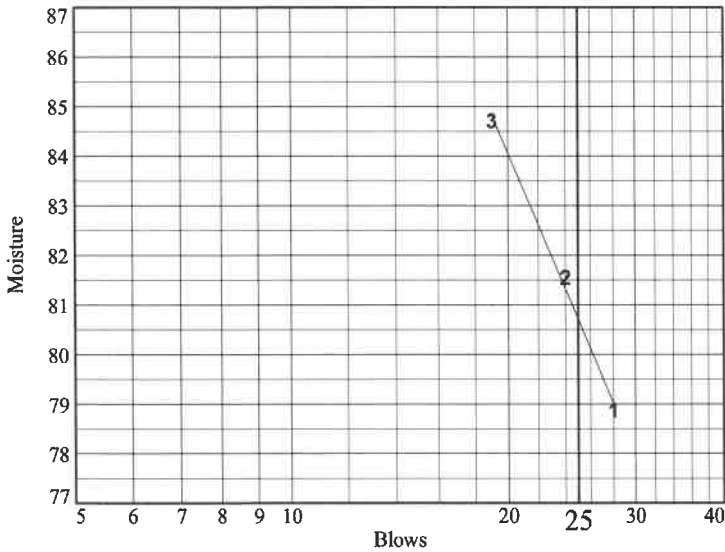
# LIQUID AND PLASTIC LIMITS TEST REPORT

SOURCE	SAMPLE NO.	DEPTH	NATURAL WATER CONTENT (%)	PLASTIC LIMIT (%)	LIQUID LIMIT (%)	PLASTICITY INDEX (%)	LIQUIDITY INDEX	USCS
●	AB-06 / S-5	8385-16	15	37.4	34	81	47	0.1	CH

**Liquid Limit=** 81  
**Plastic Limit=** 34  
**Plasticity Index=** 47  
**Natural Moisture=** 37.4  
**Liquidity Index=** 0.1

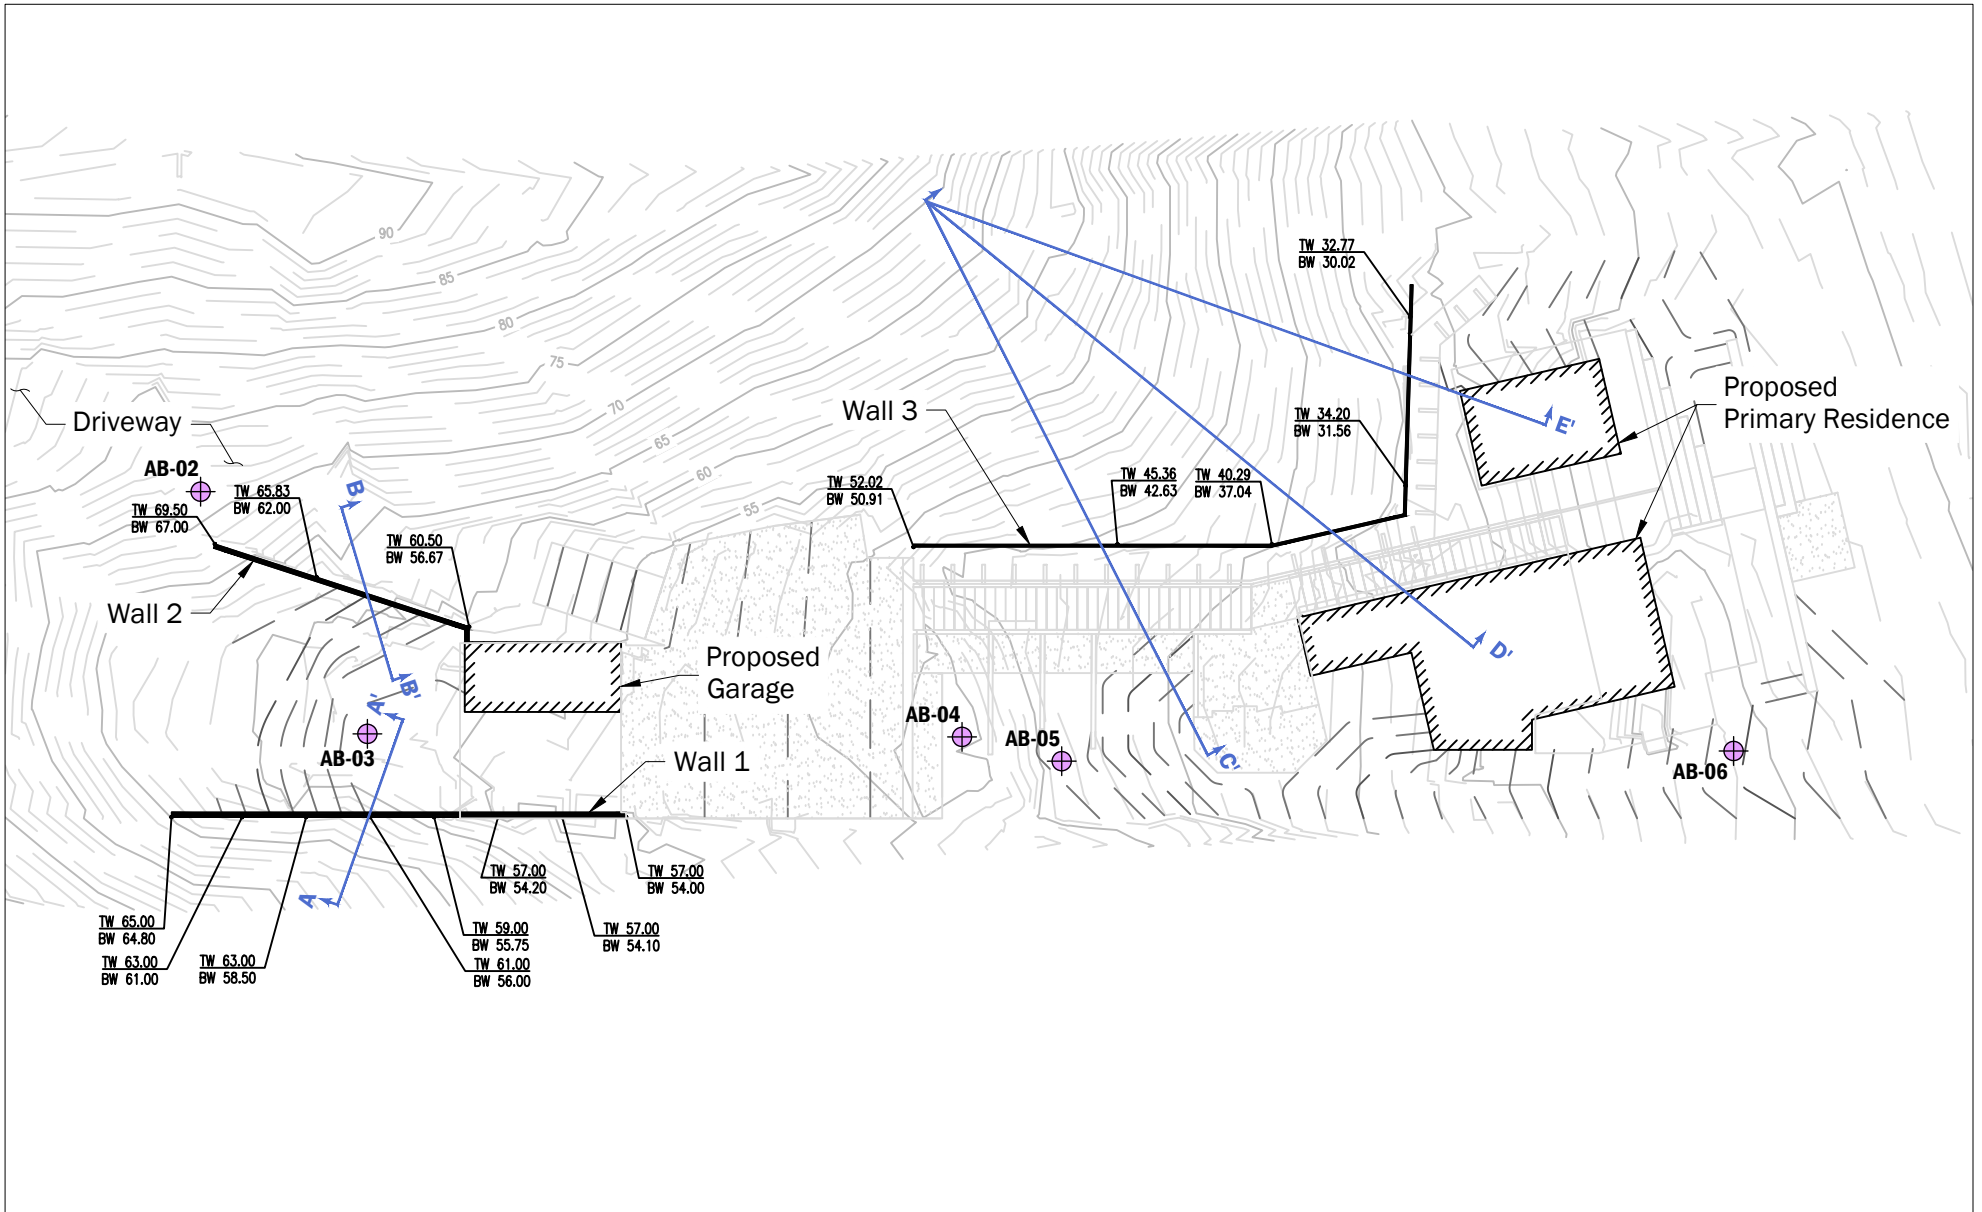
### **Wall Global Stability Analyses**

Material Name	Color	Unit Weight (lbs/ft <sup>3</sup> )	Strength Type	Cohesion (psf)	Phi (deg)	Water Surface
Fill/Colluvium		110	Mohr-Coulomb	0	30	Water Surface
Weathered Pre-Olympia Nonglacial		125	Mohr-Coulomb	0	35	Water Surface
Coarse-Grained Pre-Olympia Nonglacial		135	Mohr-Coulomb	0	40	Water Surface
Fine-Grained Pre-Olympia Nonglacial		130	Mohr-Coulomb	500	30	None
Concrete		150	Infinite strength			None
