# **Butenweiser – Wiley Residence 6838 96th Avenue SE (Mercer Island)**

## **Revised Stormwater Site Plan**

October 26, 2022

Laurie J. Pfarr, P.E.  
**LPD Engineering, PLLC**  
1932 1<sup>st</sup> Ave, Suite 201  
Seattle, WA 98101  
(206) 725-1211

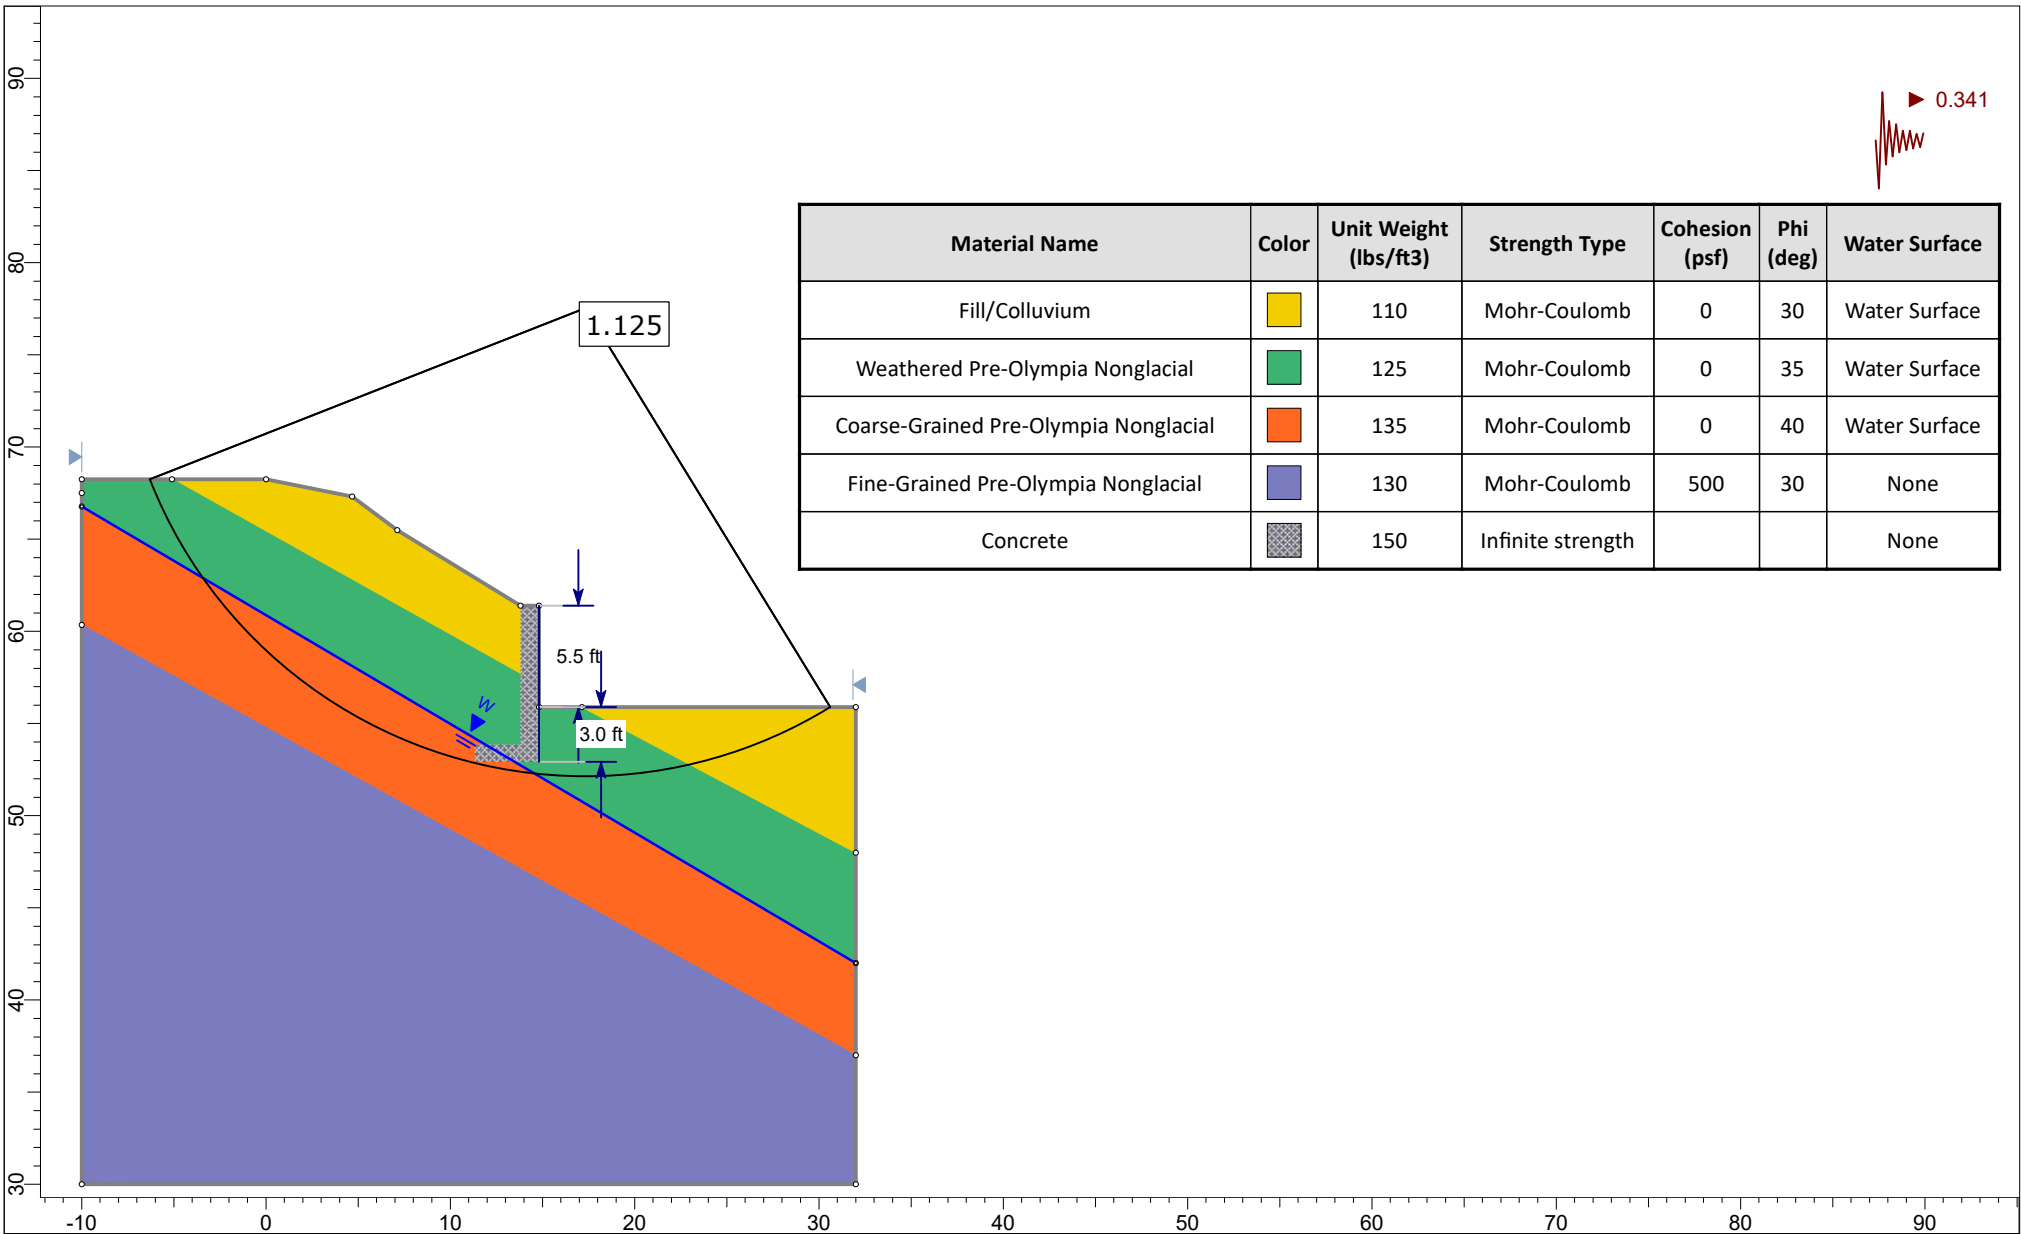
## Global Stability Analysis

- Search Grid
- Search Limits
- Modeled Groundwater Level
- Boring Location and Depth

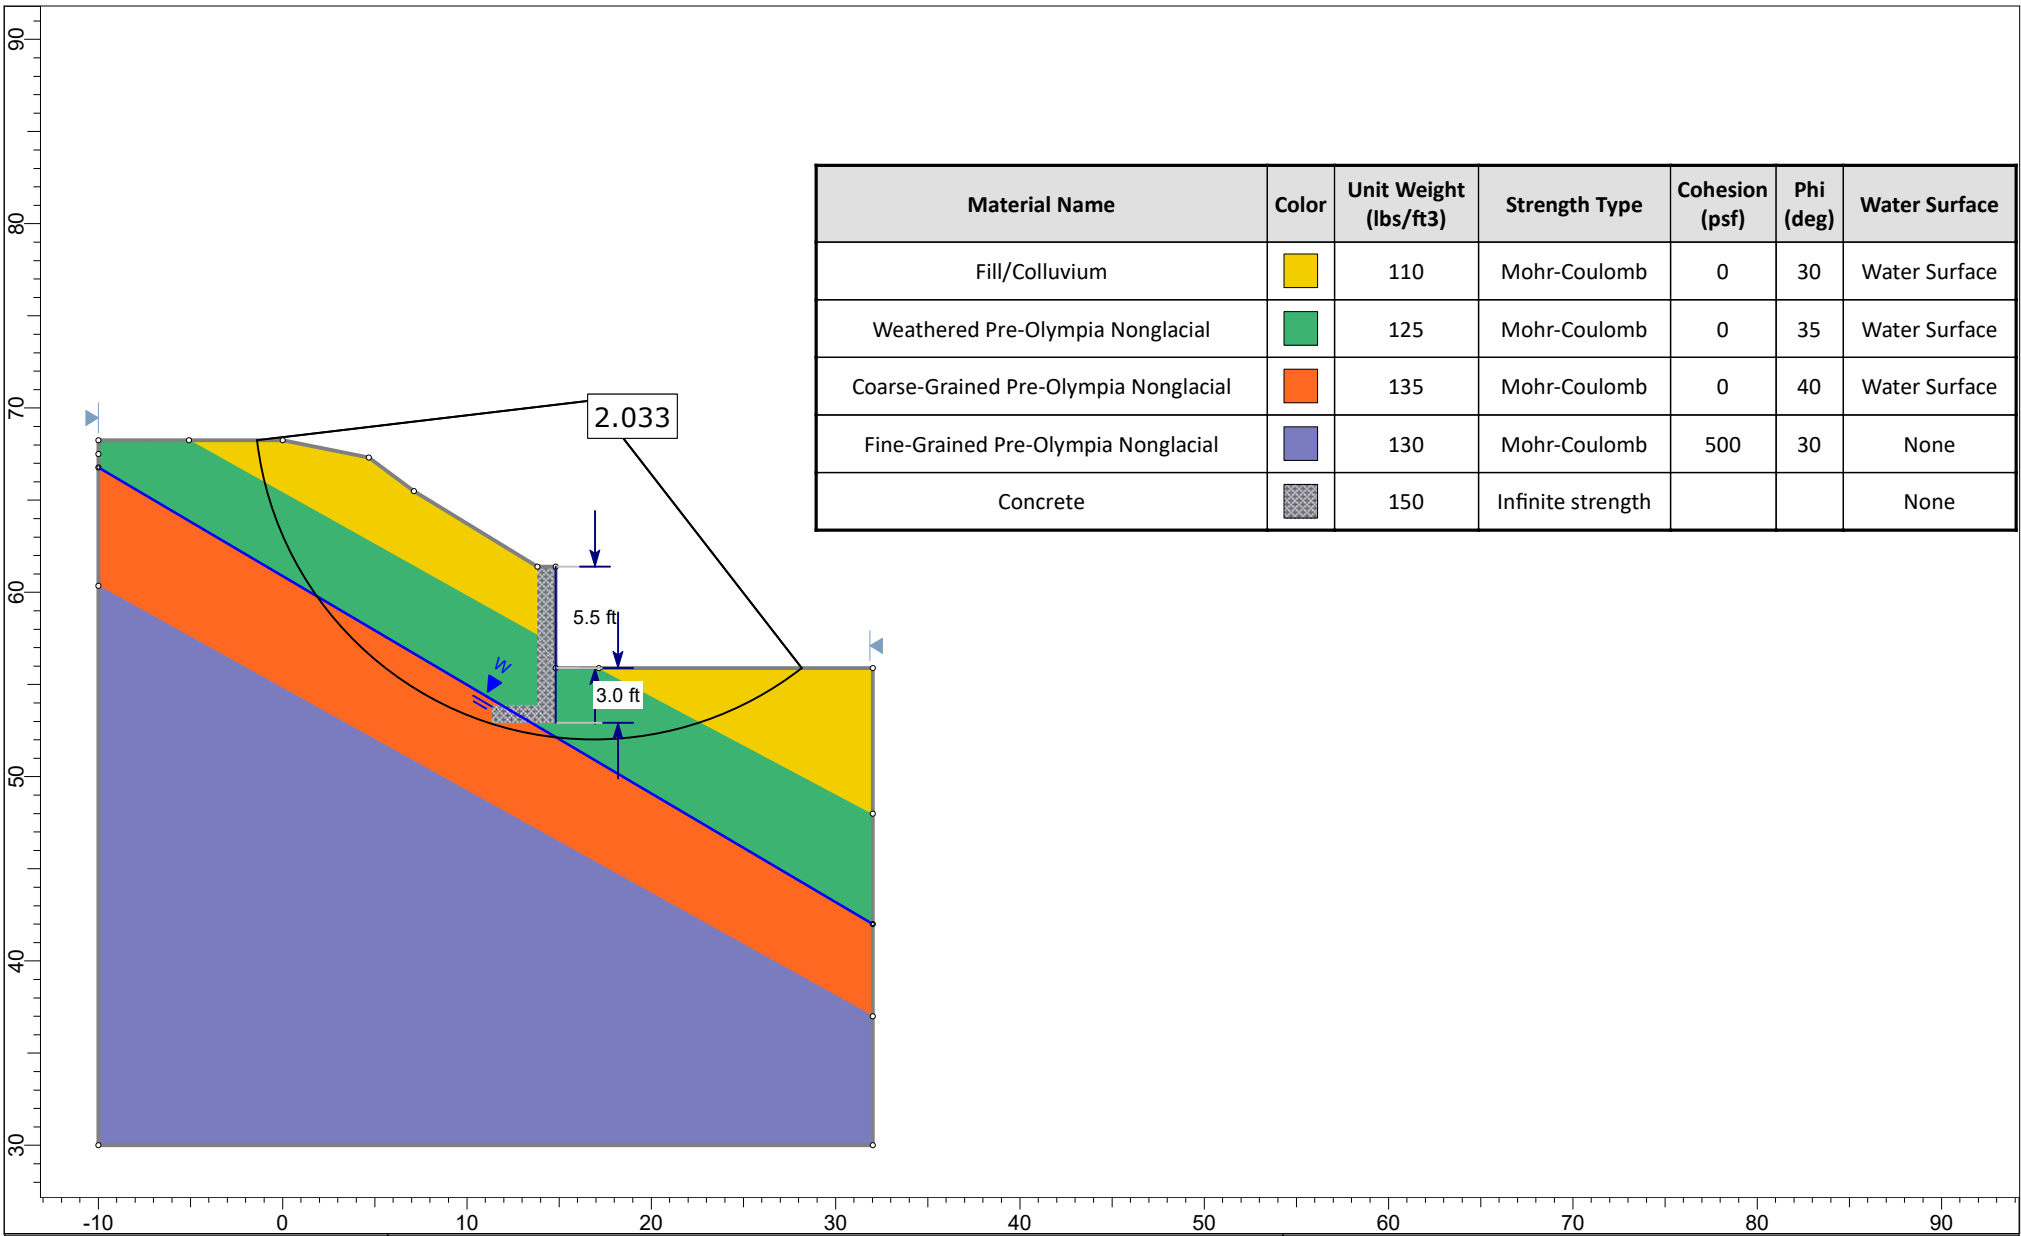
## Global Stability Analysis

Material Name	Color	Unit Weight (lbs/ft <sup>3</sup> )	Strength Type	Cohesion (psf)	Phi (deg)	Water Surface
Fill/Colluvium		110	Mohr-Coulomb	0	30	Water Surface
Weathered Pre-Olympia Nonglacial		125	Mohr-Coulomb	0	35	Water Surface
Coarse-Grained Pre-Olympia Nonglacial		135	Mohr-Coulomb	0	40	Water Surface
Fine-Grained Pre-Olympia Nonglacial		130	Mohr-Coulomb	500	30	None
Concrete		150	Infinite strength			None

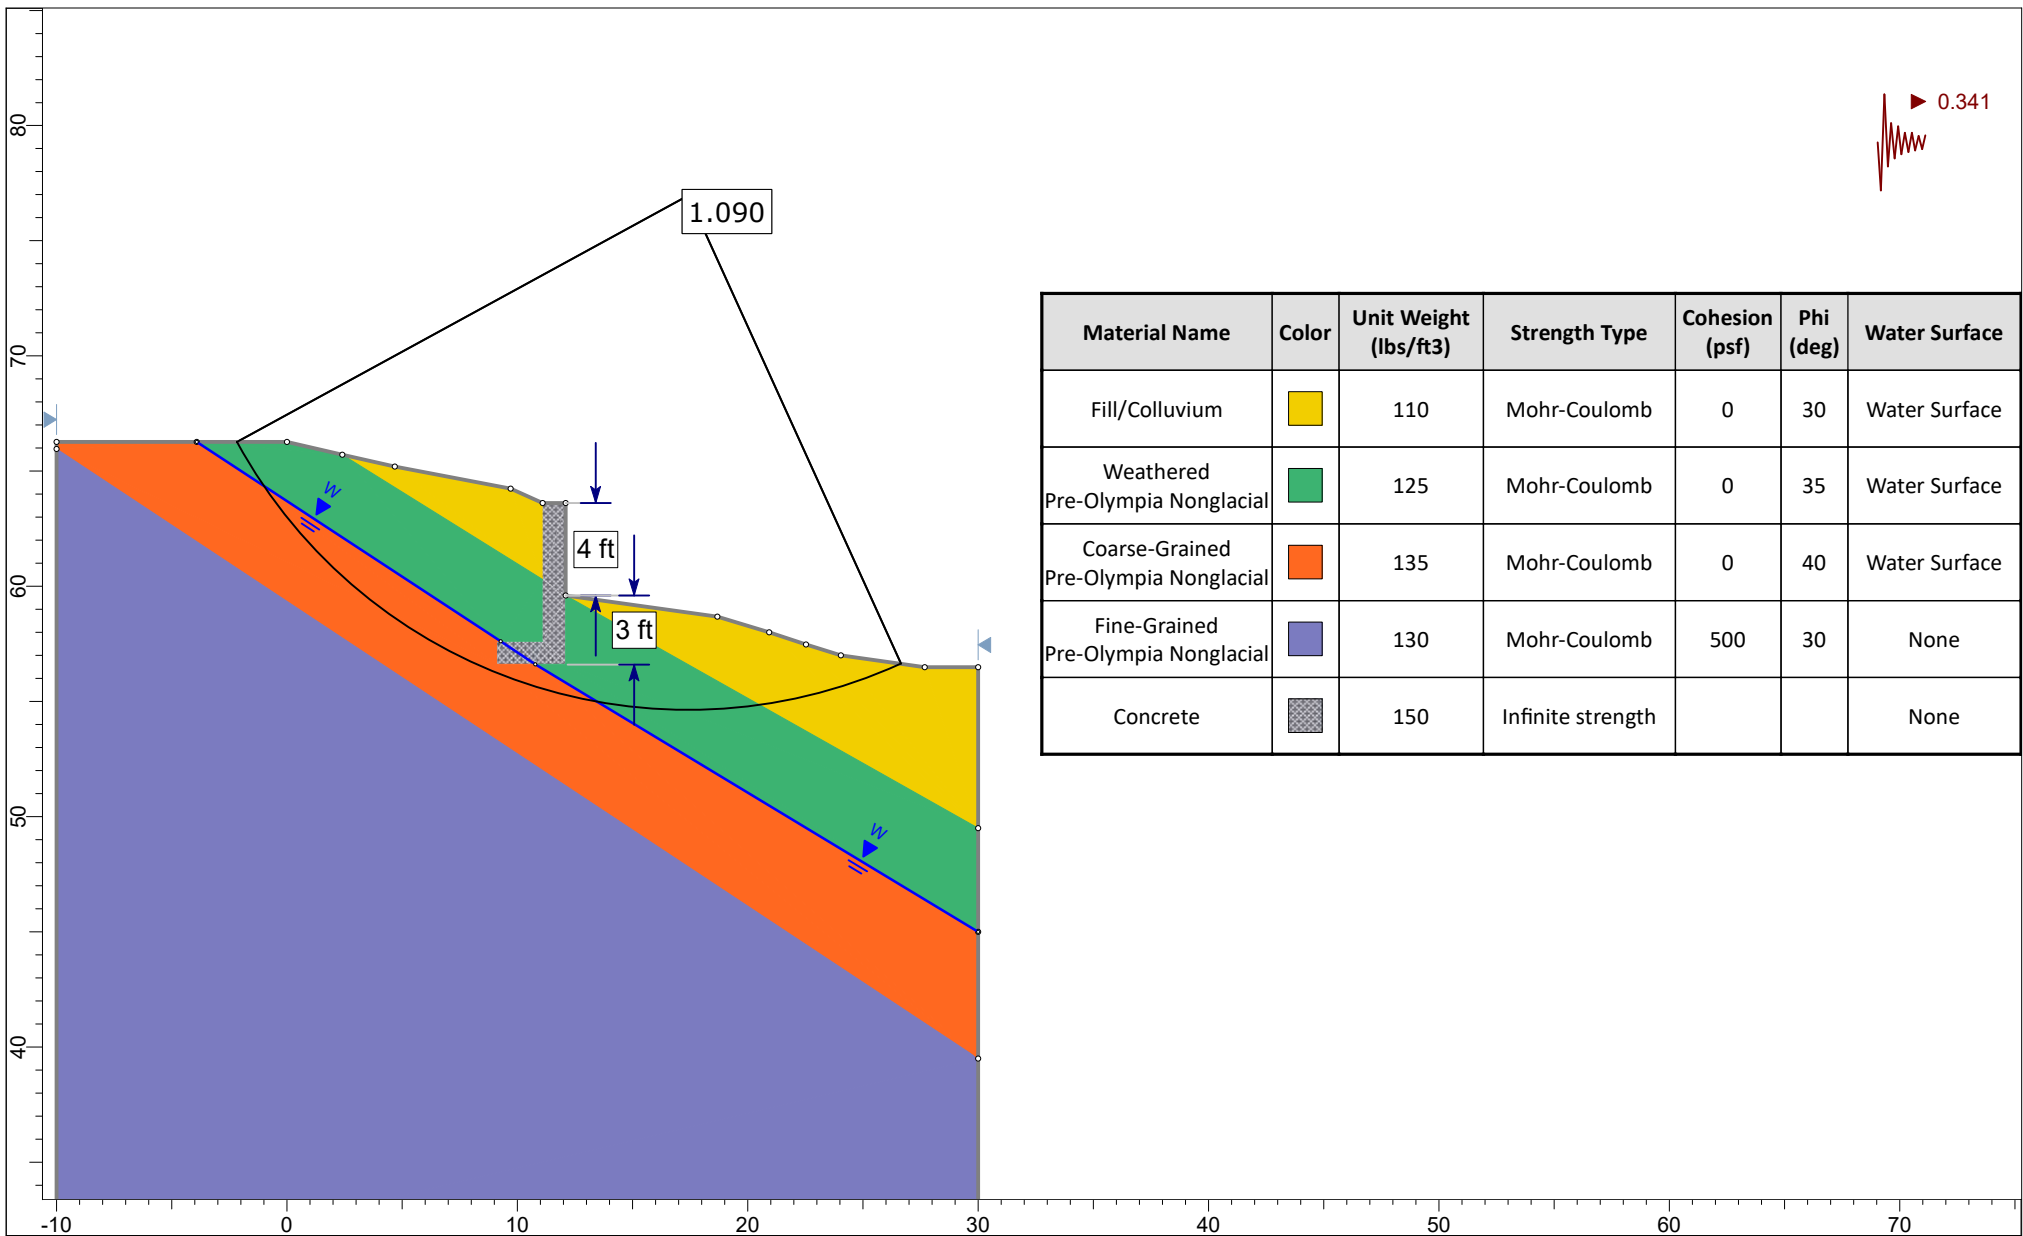
## Global Stability Analysis

Material Name	Color	Unit Weight (lbs/ft <sup>3</sup> )	Strength Type	Cohesion (psf)	Phi (deg)	Water Surface
Fill/Colluvium	Yellow	110	Mohr-Coulomb	0	30	Water Surface
Weathered Pre-Olympia Nonglacial	Green	125	Mohr-Coulomb	0	35	Water Surface
Coarse-Grained Pre-Olympia Nonglacial	Orange	135	Mohr-Coulomb	0	40	Water Surface
Fine-Grained Pre-Olympia Nonglacial	Purple	130	Mohr-Coulomb	500	30	None
Concrete	Grey pattern	150	Infinite strength			None

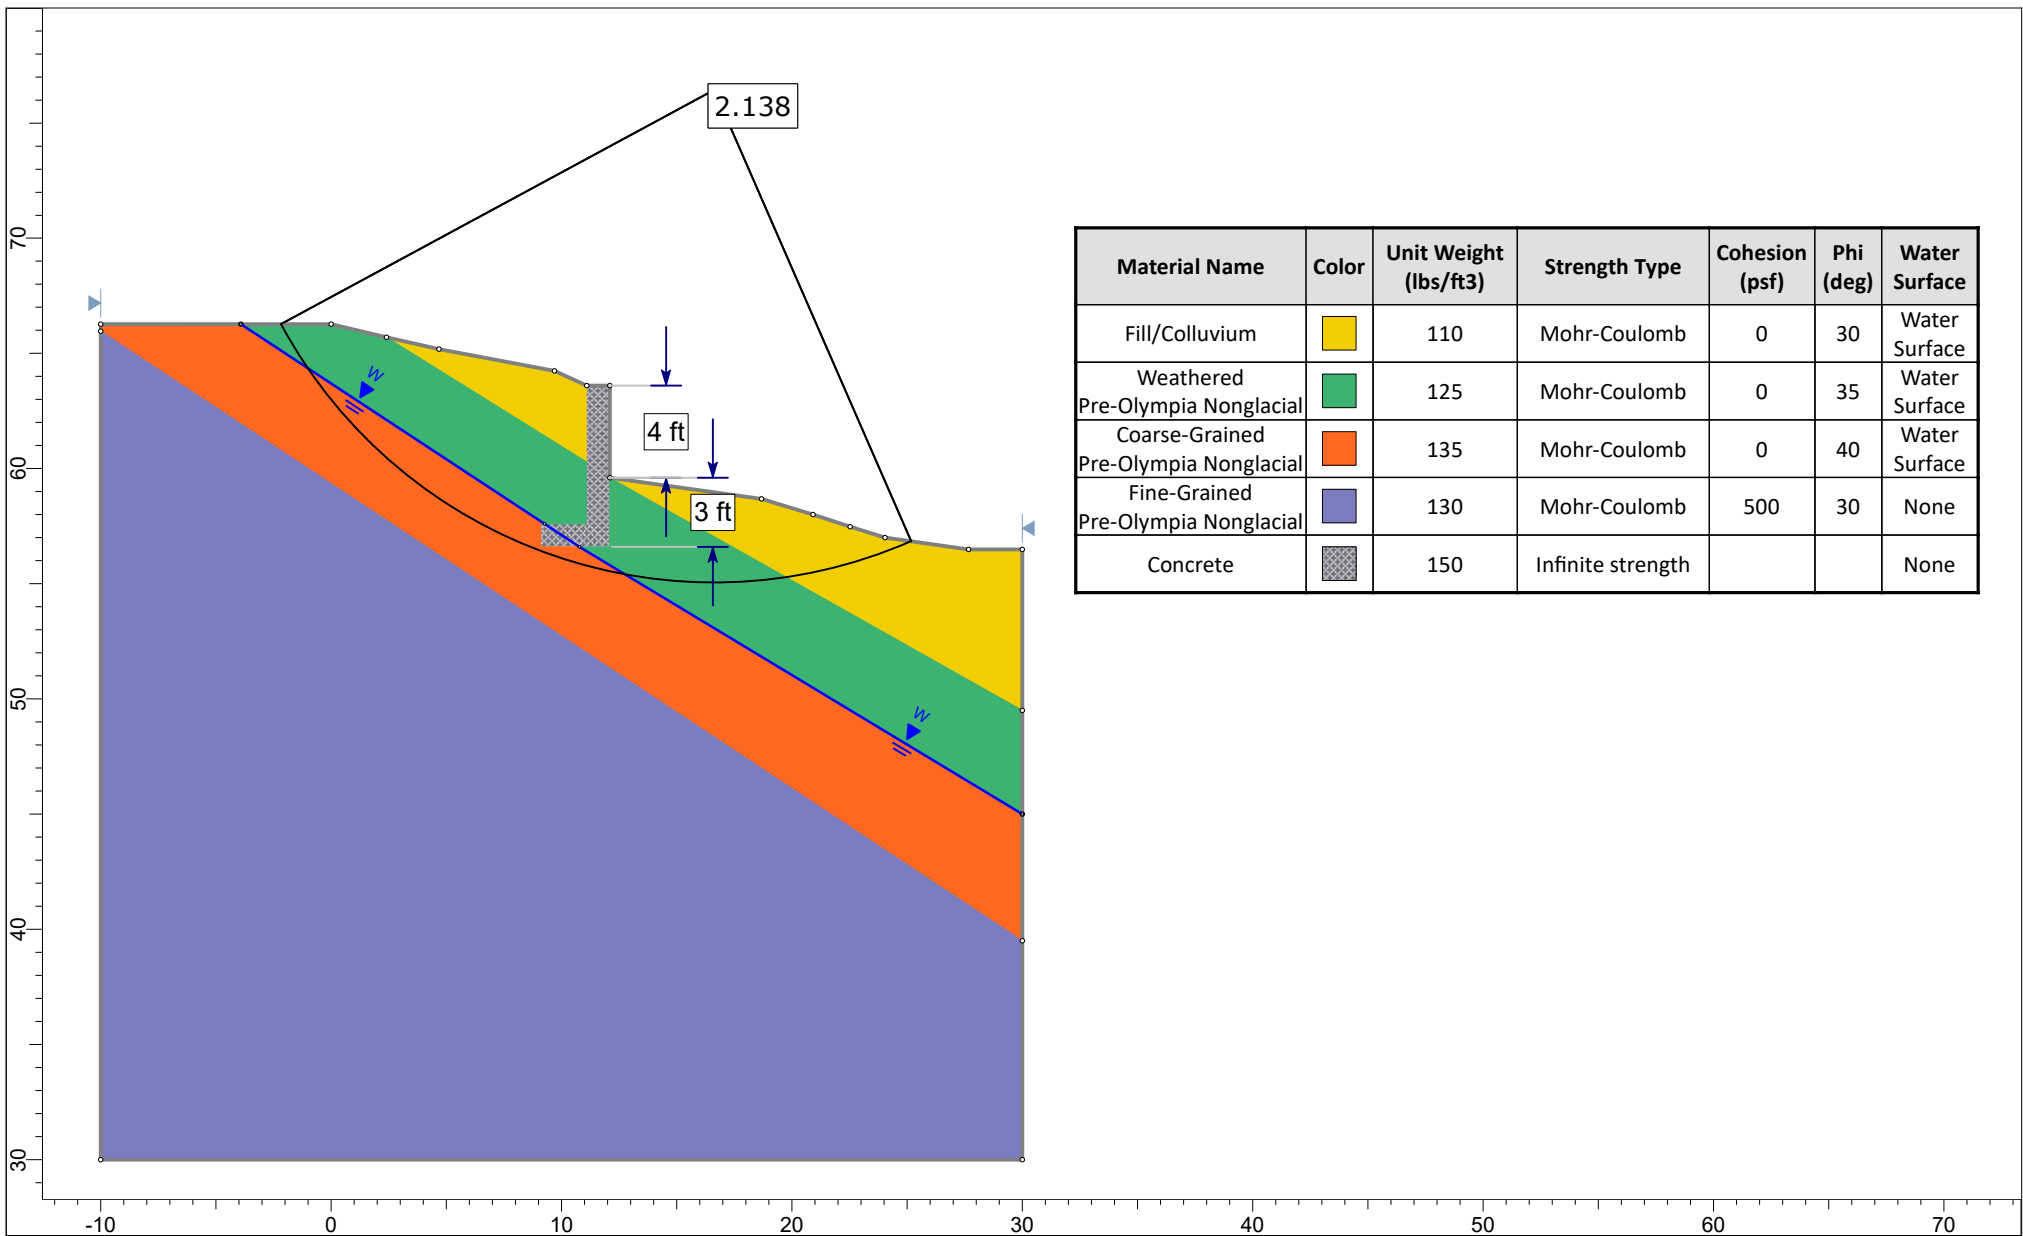
## Global Stability Analysis

Material Name	Color	Unit Weight (lbs/ft <sup>3</sup> )	Strength Type	Cohesion (psf)	Phi (deg)	Water Surface
Fill/Colluvium	Yellow	110	Mohr-Coulomb	0	30	Water Surface
Weathered Pre-Olympia Nonglacial Coarse-Grained	Green	125	Mohr-Coulomb	0	35	Water Surface
Pre-Olympia Nonglacial Fine-Grained	Purple	130	Mohr-Coulomb	500	30	None
Concrete	Hatched	150	Infinite strength			None

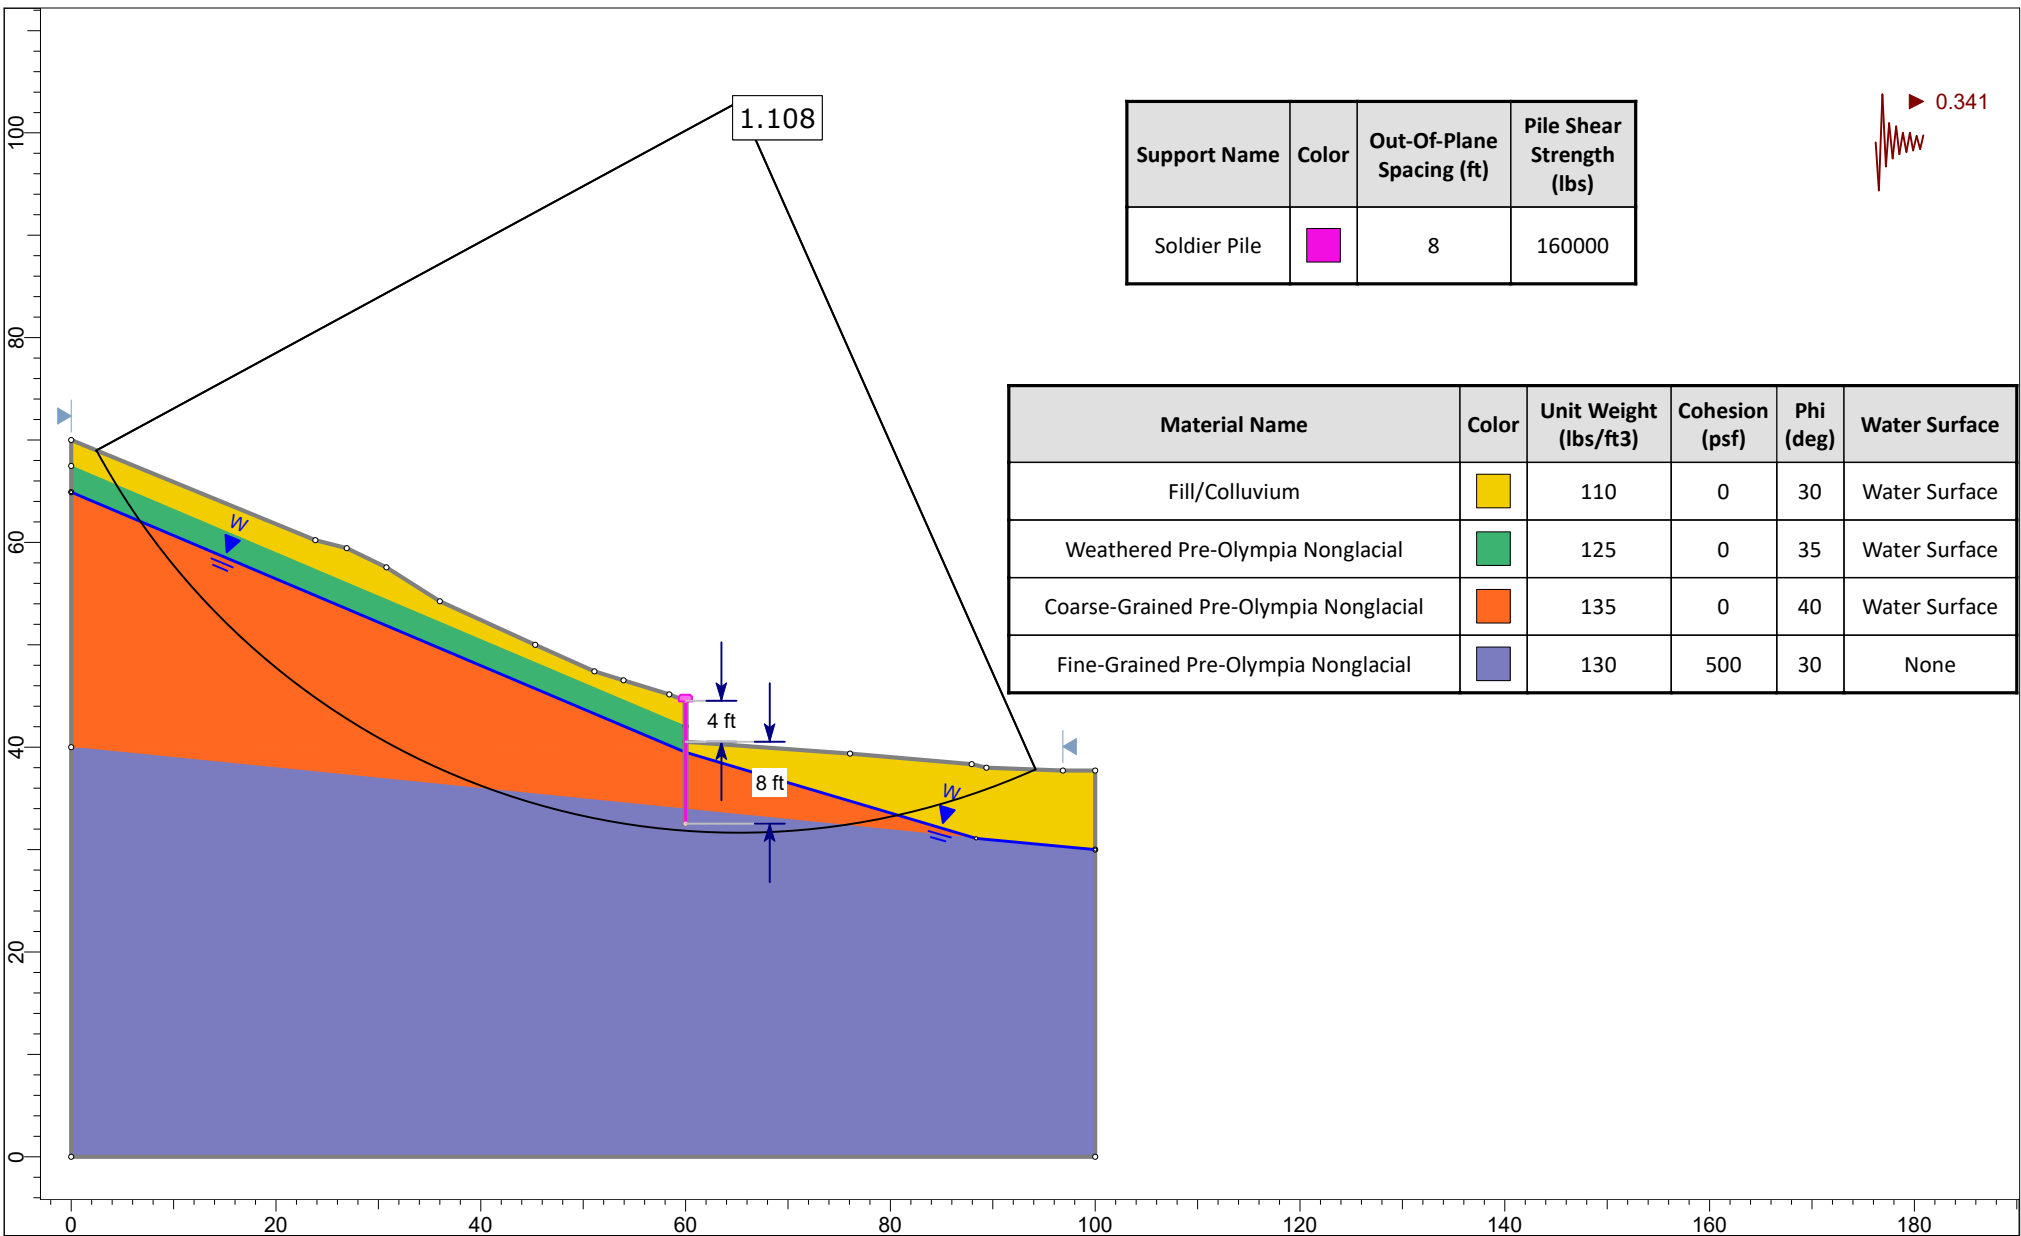
APPENDIX:  
**C-6**

Support Name	Color	Out-Of-Plane Spacing (ft)	Pile Shear Strength (lbs)
Soldier Pile	<span style="color: magenta;">■</span>	8	160000

Material Name	Color	Unit Weight (lbs/ft <sup>3</sup> )	Cohesion (psf)	Phi (deg)	Water Surface
Fill/Colluvium	<span style="color: yellow;">■</span>	110	0	30	Water Surface
Weathered Pre-Olympia Nonglacial	<span style="color: green;">■</span>	125	0	35	Water Surface
Coarse-Grained Pre-Olympia Nonglacial	<span style="color: orange;">■</span>	135	0	40	Water Surface
Fine-Grained Pre-Olympia Nonglacial	<span style="color: blue;">■</span>	130	500	30	None

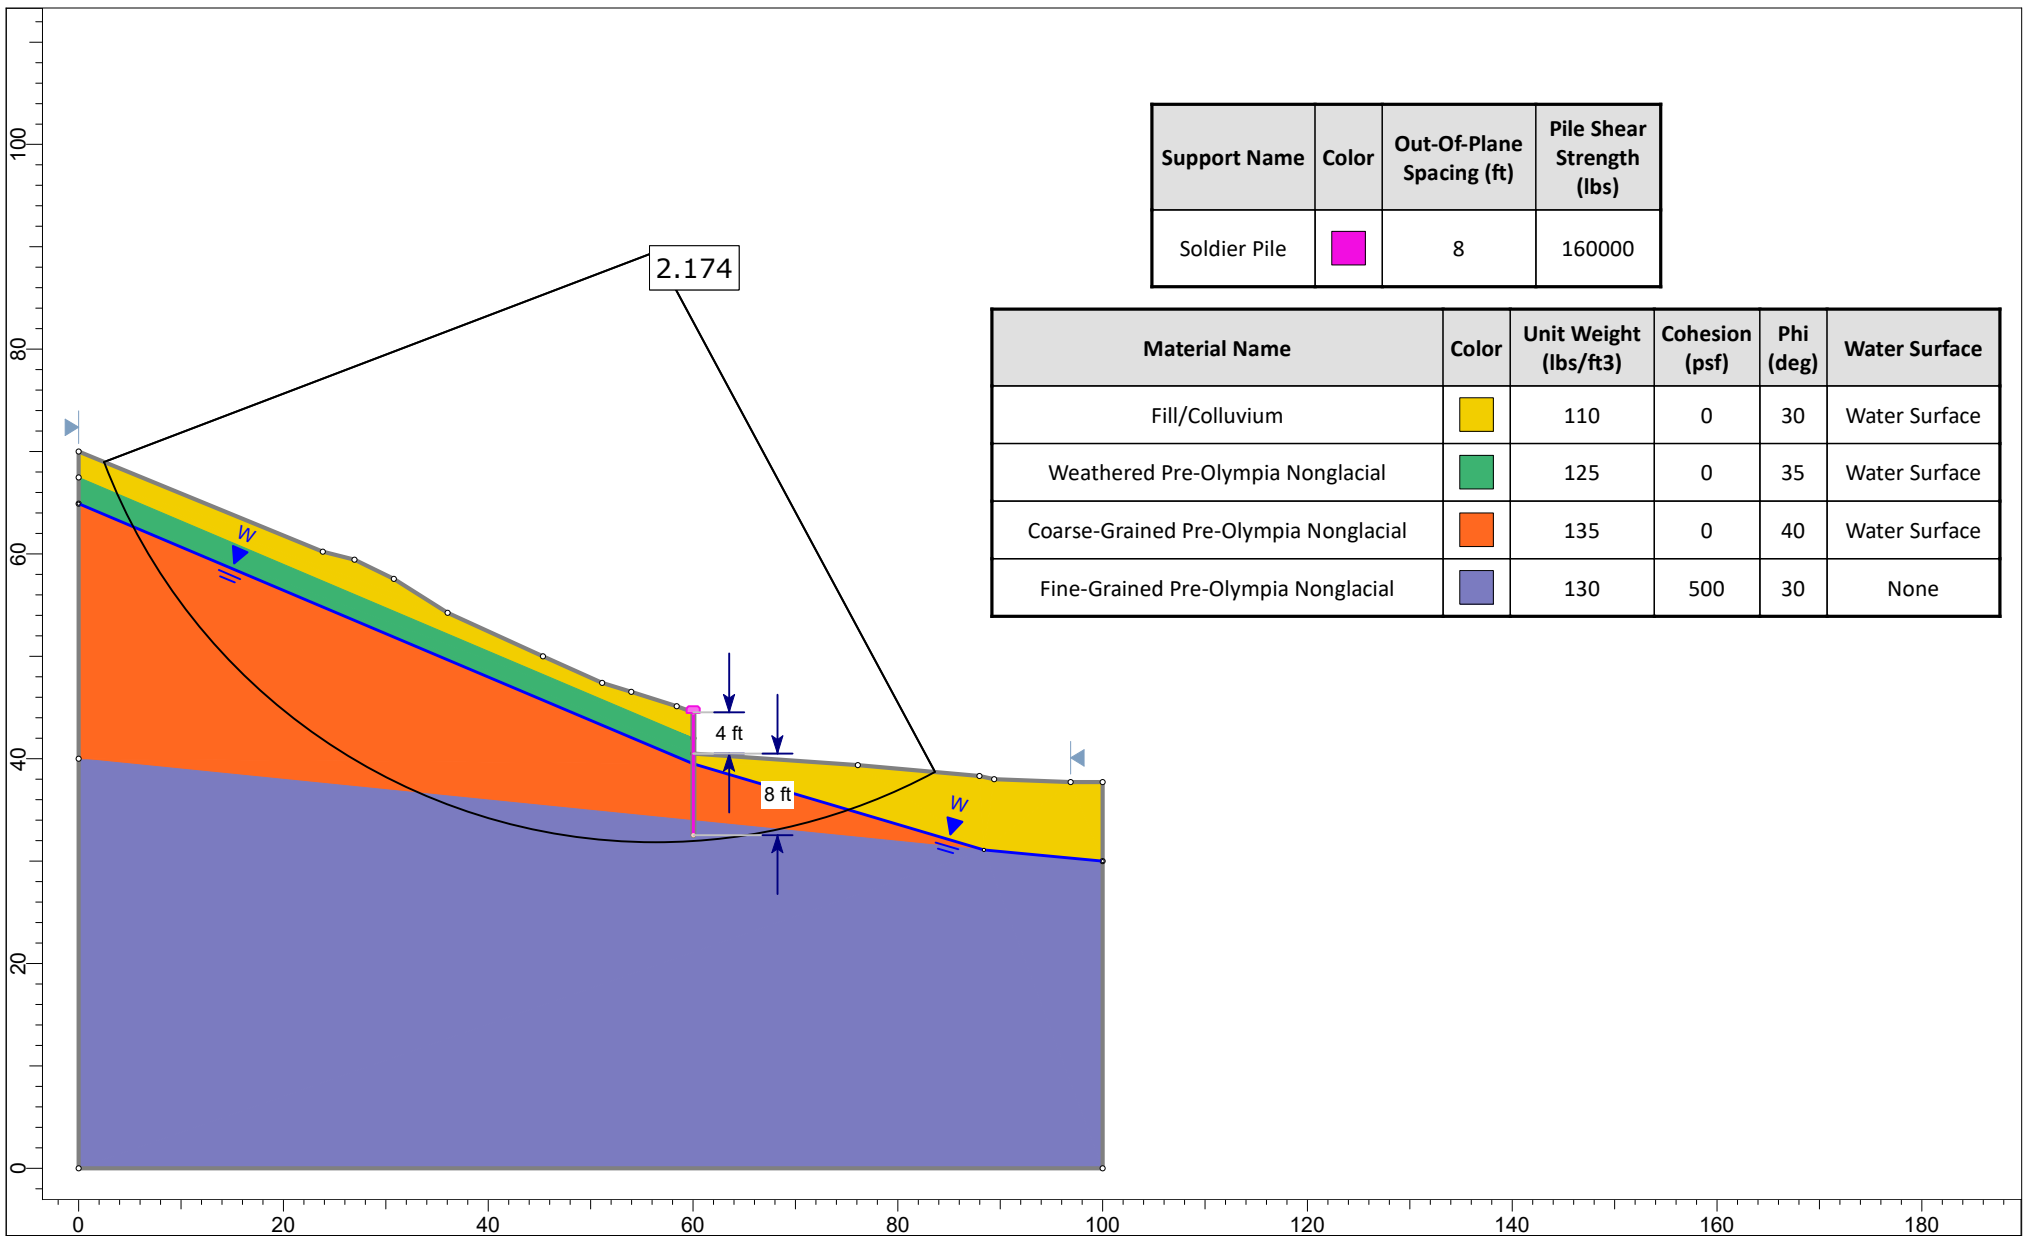
**Section C-C'  
Static**

Support Name	Color	Out-Of-Plane Spacing (ft)	Pile Shear Strength (lbs)
Soldier Pile	<span style="color: magenta;">■</span>	8	160000

Material Name	Color	Unit Weight (lbs/ft <sup>3</sup> )	Cohesion (psf)	Phi (deg)	Water Surface
Fill/Colluvium	<span style="color: yellow;">■</span>	110	0	30	Water Surface
Weathered Pre-Olympia Nonglacial	<span style="color: green;">■</span>	125	0	35	Water Surface
Coarse-Grained Pre-Olympia Nonglacial	<span style="color: orange;">■</span>	135	0	40	Water Surface
Fine-Grained Pre-Olympia Nonglacial	<span style="color: blue;">■</span>	130	500	30	None

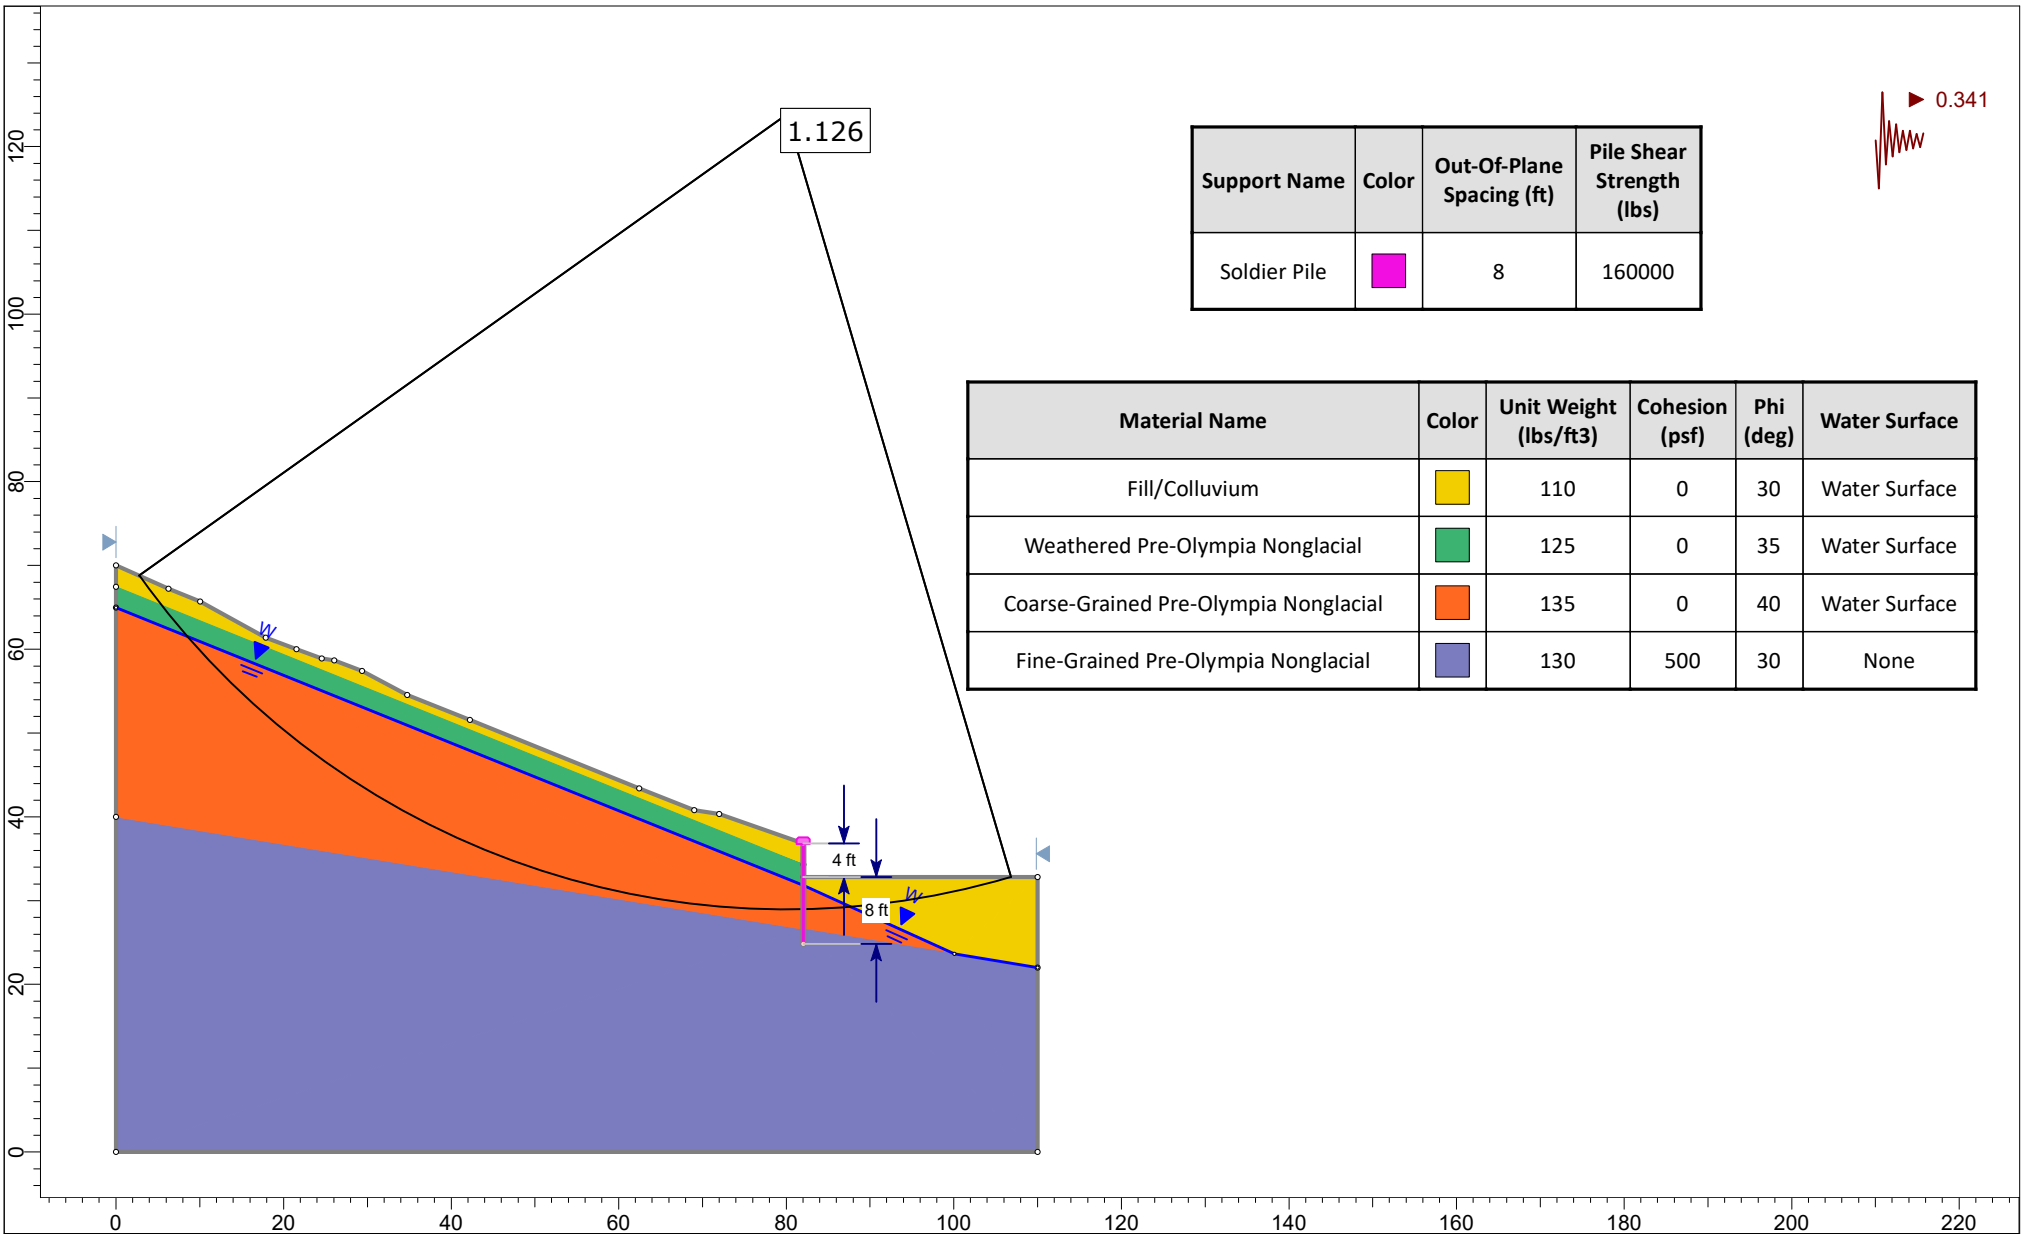
## Global Stability Analysis

Support Name	Color	Out-Of-Plane Spacing (ft)	Pile Shear Strength (lbs)
Soldier Pile	<span style="color: magenta;">■</span>	8	160000

Material Name	Color	Unit Weight (lbs/ft <sup>3</sup> )	Cohesion (psf)	Phi (deg)	Water Surface
Fill/Colluvium	<span style="color: yellow;">■</span>	110	0	30	Water Surface
Weathered Pre-Olympia Nonglacial	<span style="color: green;">■</span>	125	0	35	Water Surface
Coarse-Grained Pre-Olympia Nonglacial	<span style="color: orange;">■</span>	135	0	40	Water Surface
Fine-Grained Pre-Olympia Nonglacial	<span style="color: purple;">■</span>	130	500	30	None

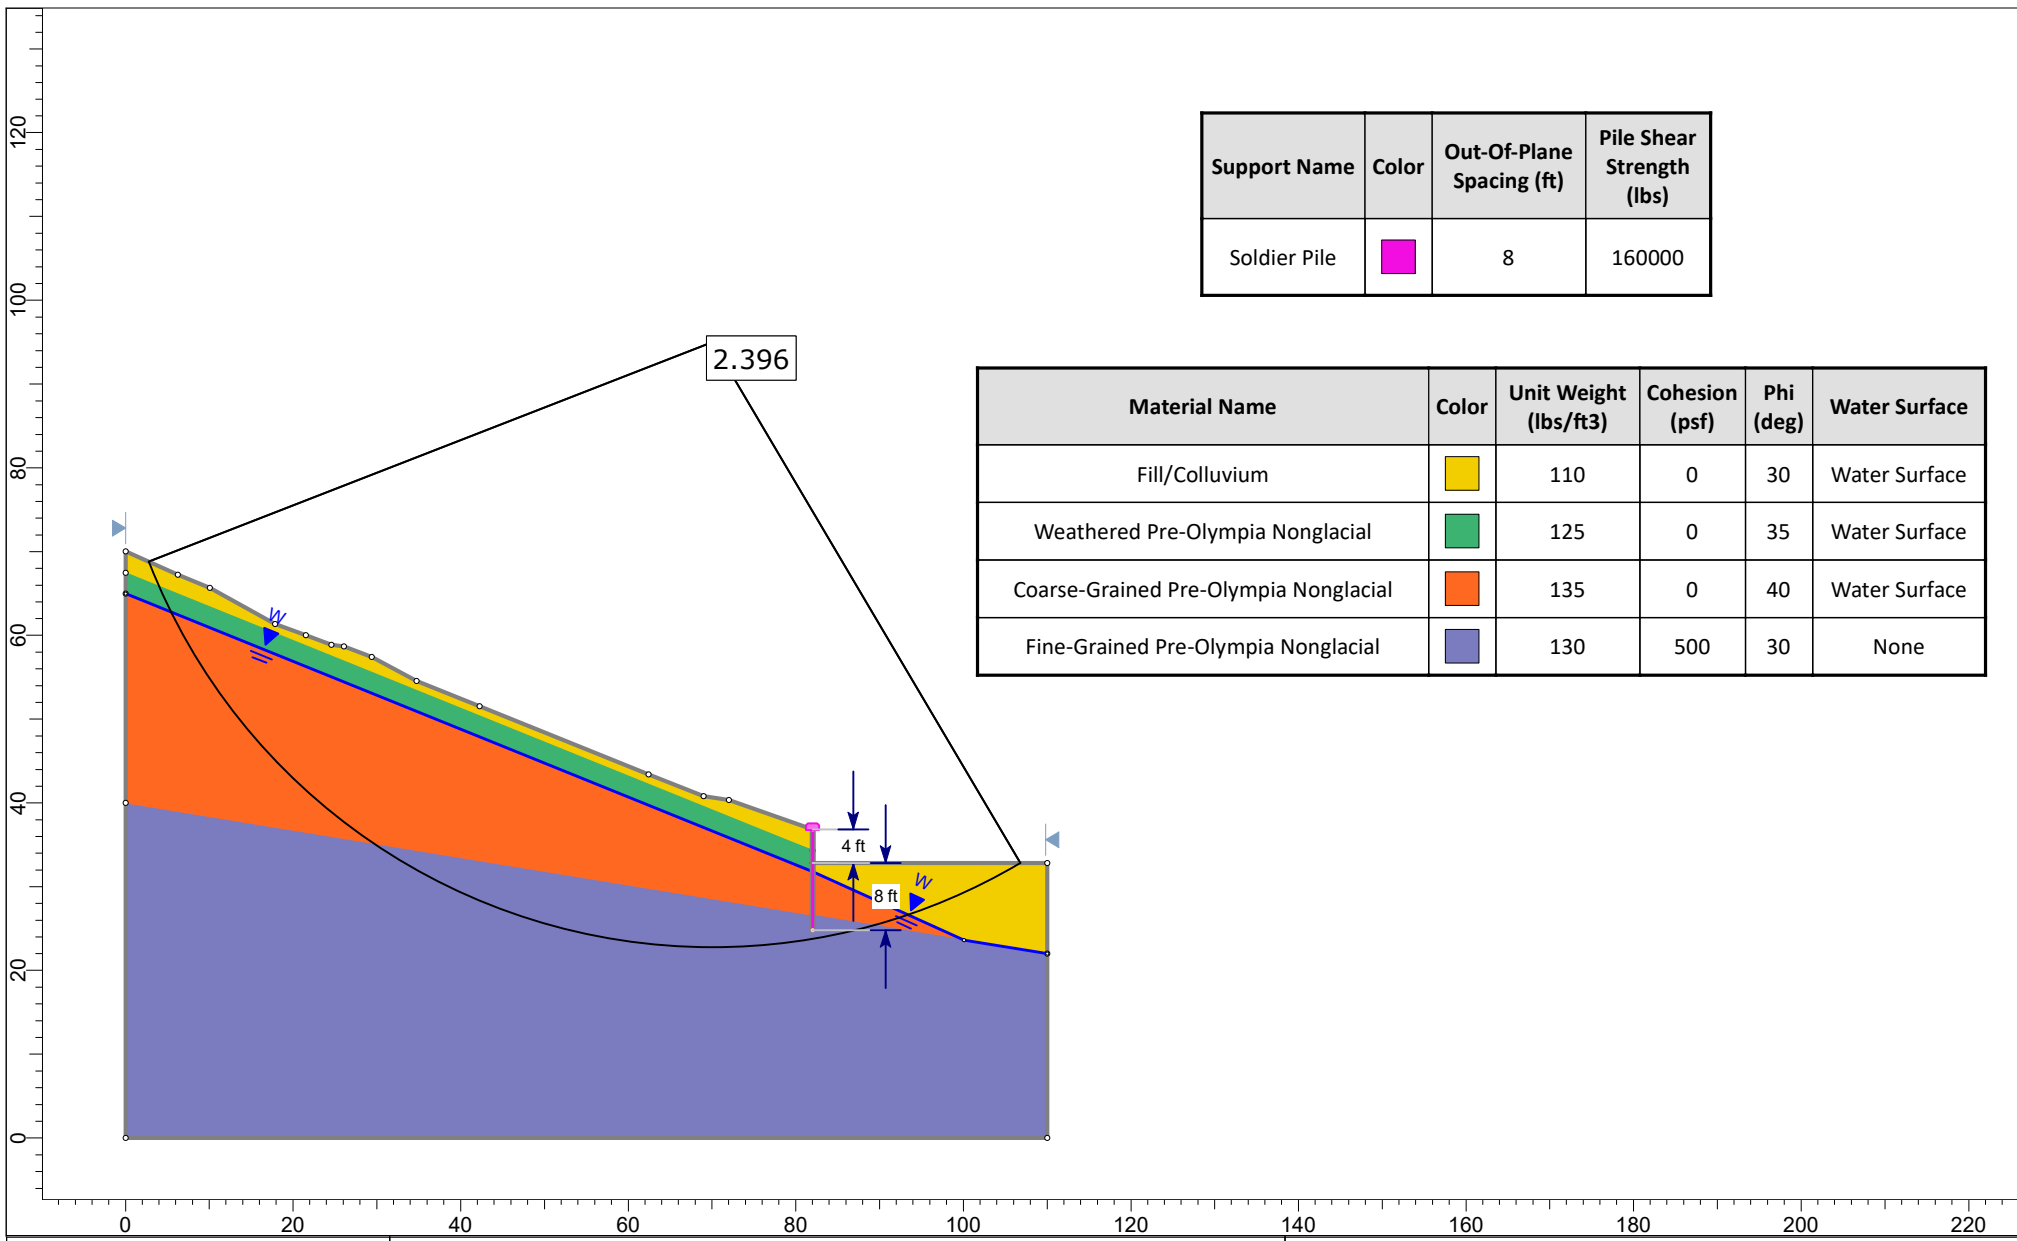
### Global Stability Analysis

Support Name	Color	Out-Of-Plane Spacing (ft)	Pile Shear Strength (lbs)
Soldier Pile	<span style="color: magenta;">■</span>	8	160000

Material Name	Color	Unit Weight (lbs/ft <sup>3</sup> )	Cohesion (psf)	Phi (deg)	Water Surface
Fill/Colluvium	<span style="color: yellow;">■</span>	110	0	30	Water Surface
Weathered Pre-Olympia Nonglacial	<span style="color: green;">■</span>	125	0	35	Water Surface
Coarse-Grained Pre-Olympia Nonglacial	<span style="color: orange;">■</span>	135	0	40	Water Surface
Fine-Grained Pre-Olympia Nonglacial	<span style="color: purple;">■</span>	130	500	30	None
