# **Butenweiser – Wiley Residence 6838 96th Avenue SE (Mercer Island)**

## **Revised Stormwater Site Plan**

October 26, 2022

Laurie J. Pfarr, P.E.  
**LPD Engineering, PLLC**  
1932 1<sup>st</sup> Ave, Suite 201  
Seattle, WA 98101  
(206) 725-1211

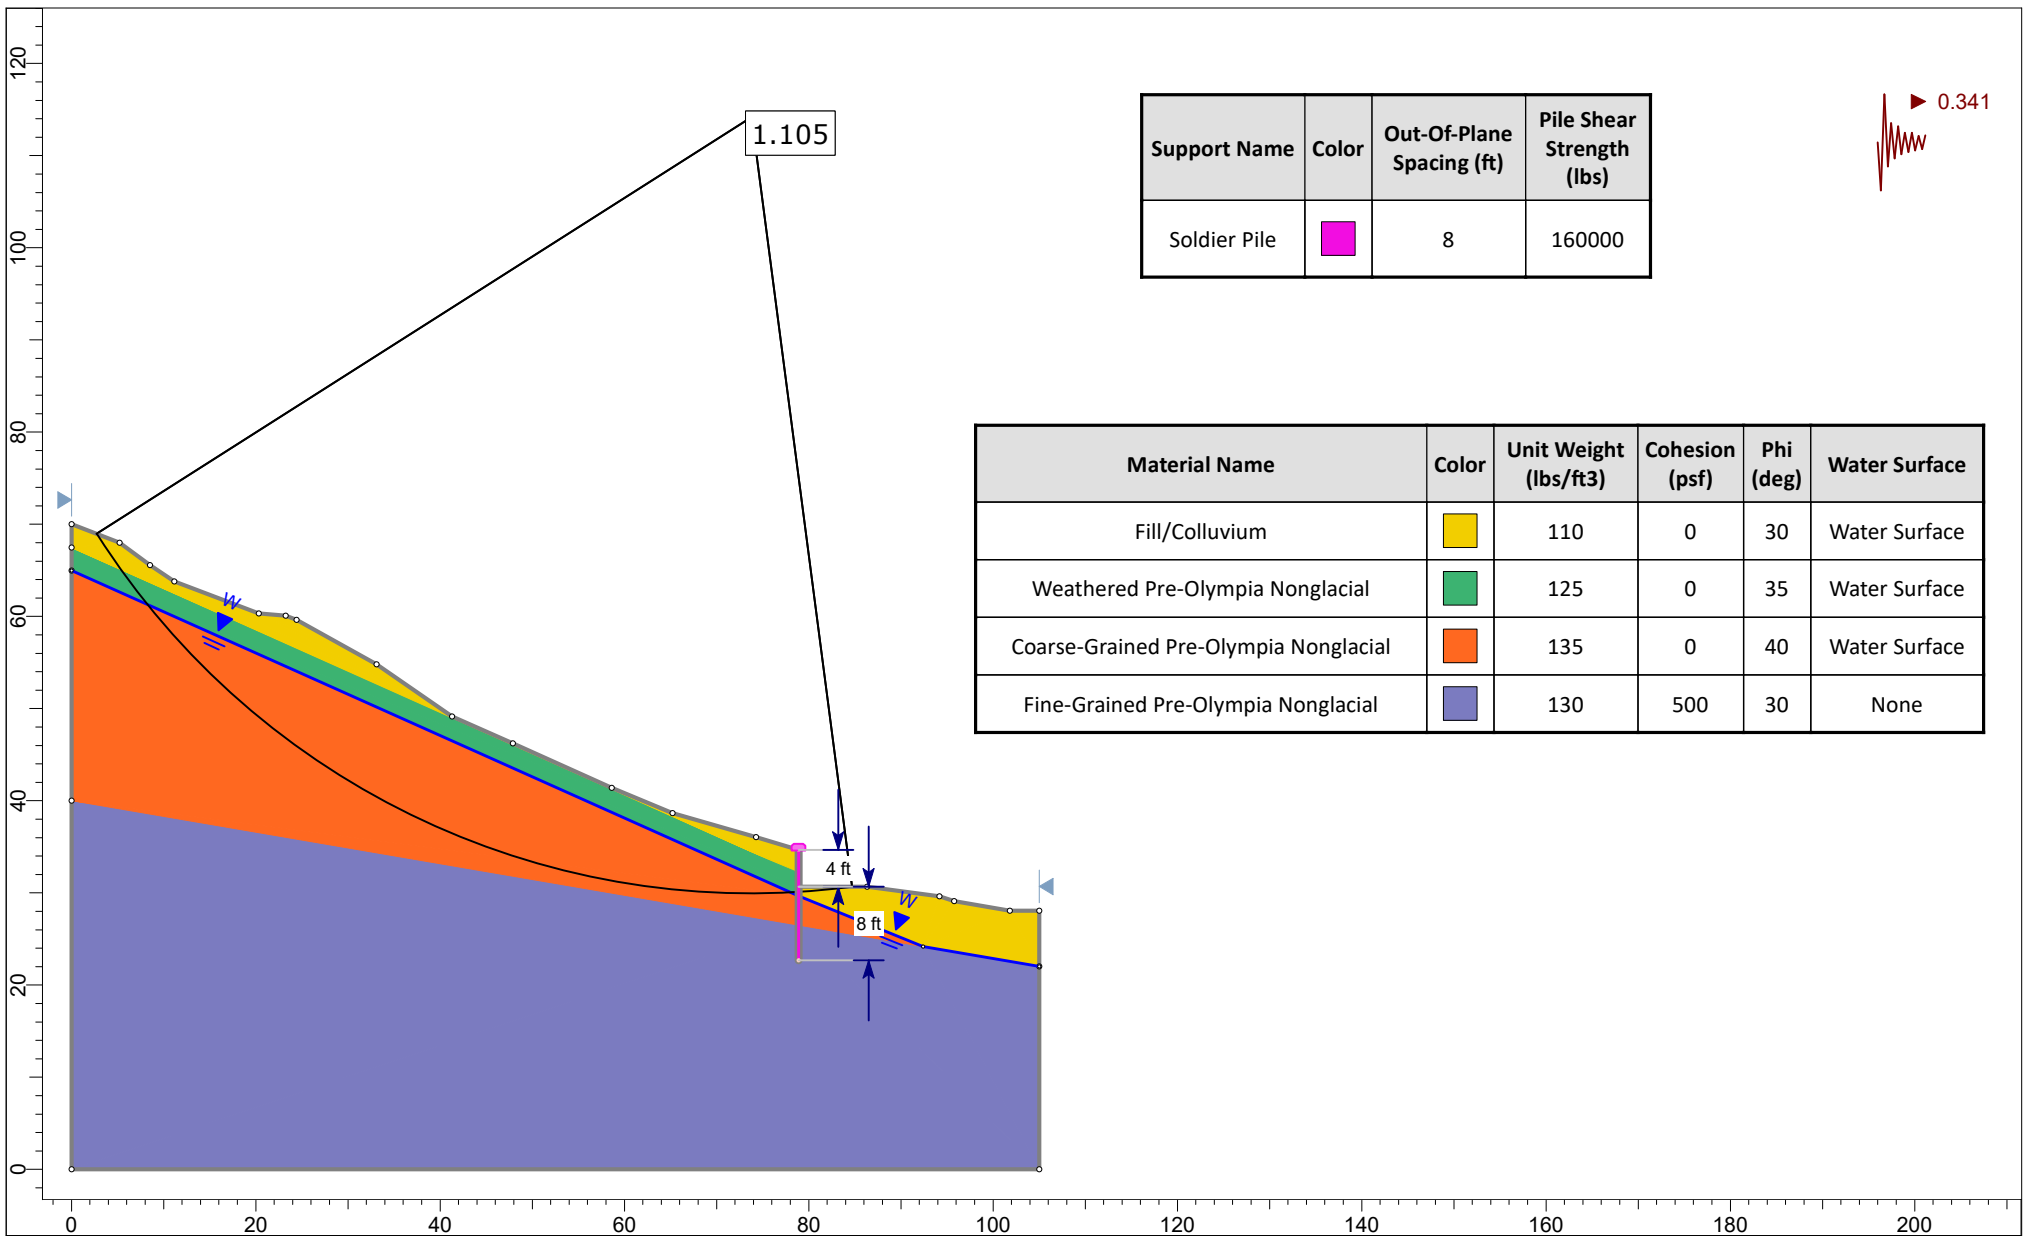
APPENDIX:  
**C-10**

Support Name	Color	Out-Of-Plane Spacing (ft)	Pile Shear Strength (lbs)
Soldier Pile	<span style="color: magenta;">■</span>	8	160000

Material Name	Color	Unit Weight (lbs/ft <sup>3</sup> )	Cohesion (psf)	Phi (deg)	Water Surface
Fill/Colluvium	<span style="color: yellow;">■</span>	110	0	30	Water Surface
Weathered Pre-Olympia Nonglacial	<span style="color: green;">■</span>	125	0	35	Water Surface
Coarse-Grained Pre-Olympia Nonglacial	<span style="color: orange;">■</span>	135	0	40	Water Surface
Fine-Grained Pre-Olympia Nonglacial	<span style="color: blue;">■</span>	130	500	30	None

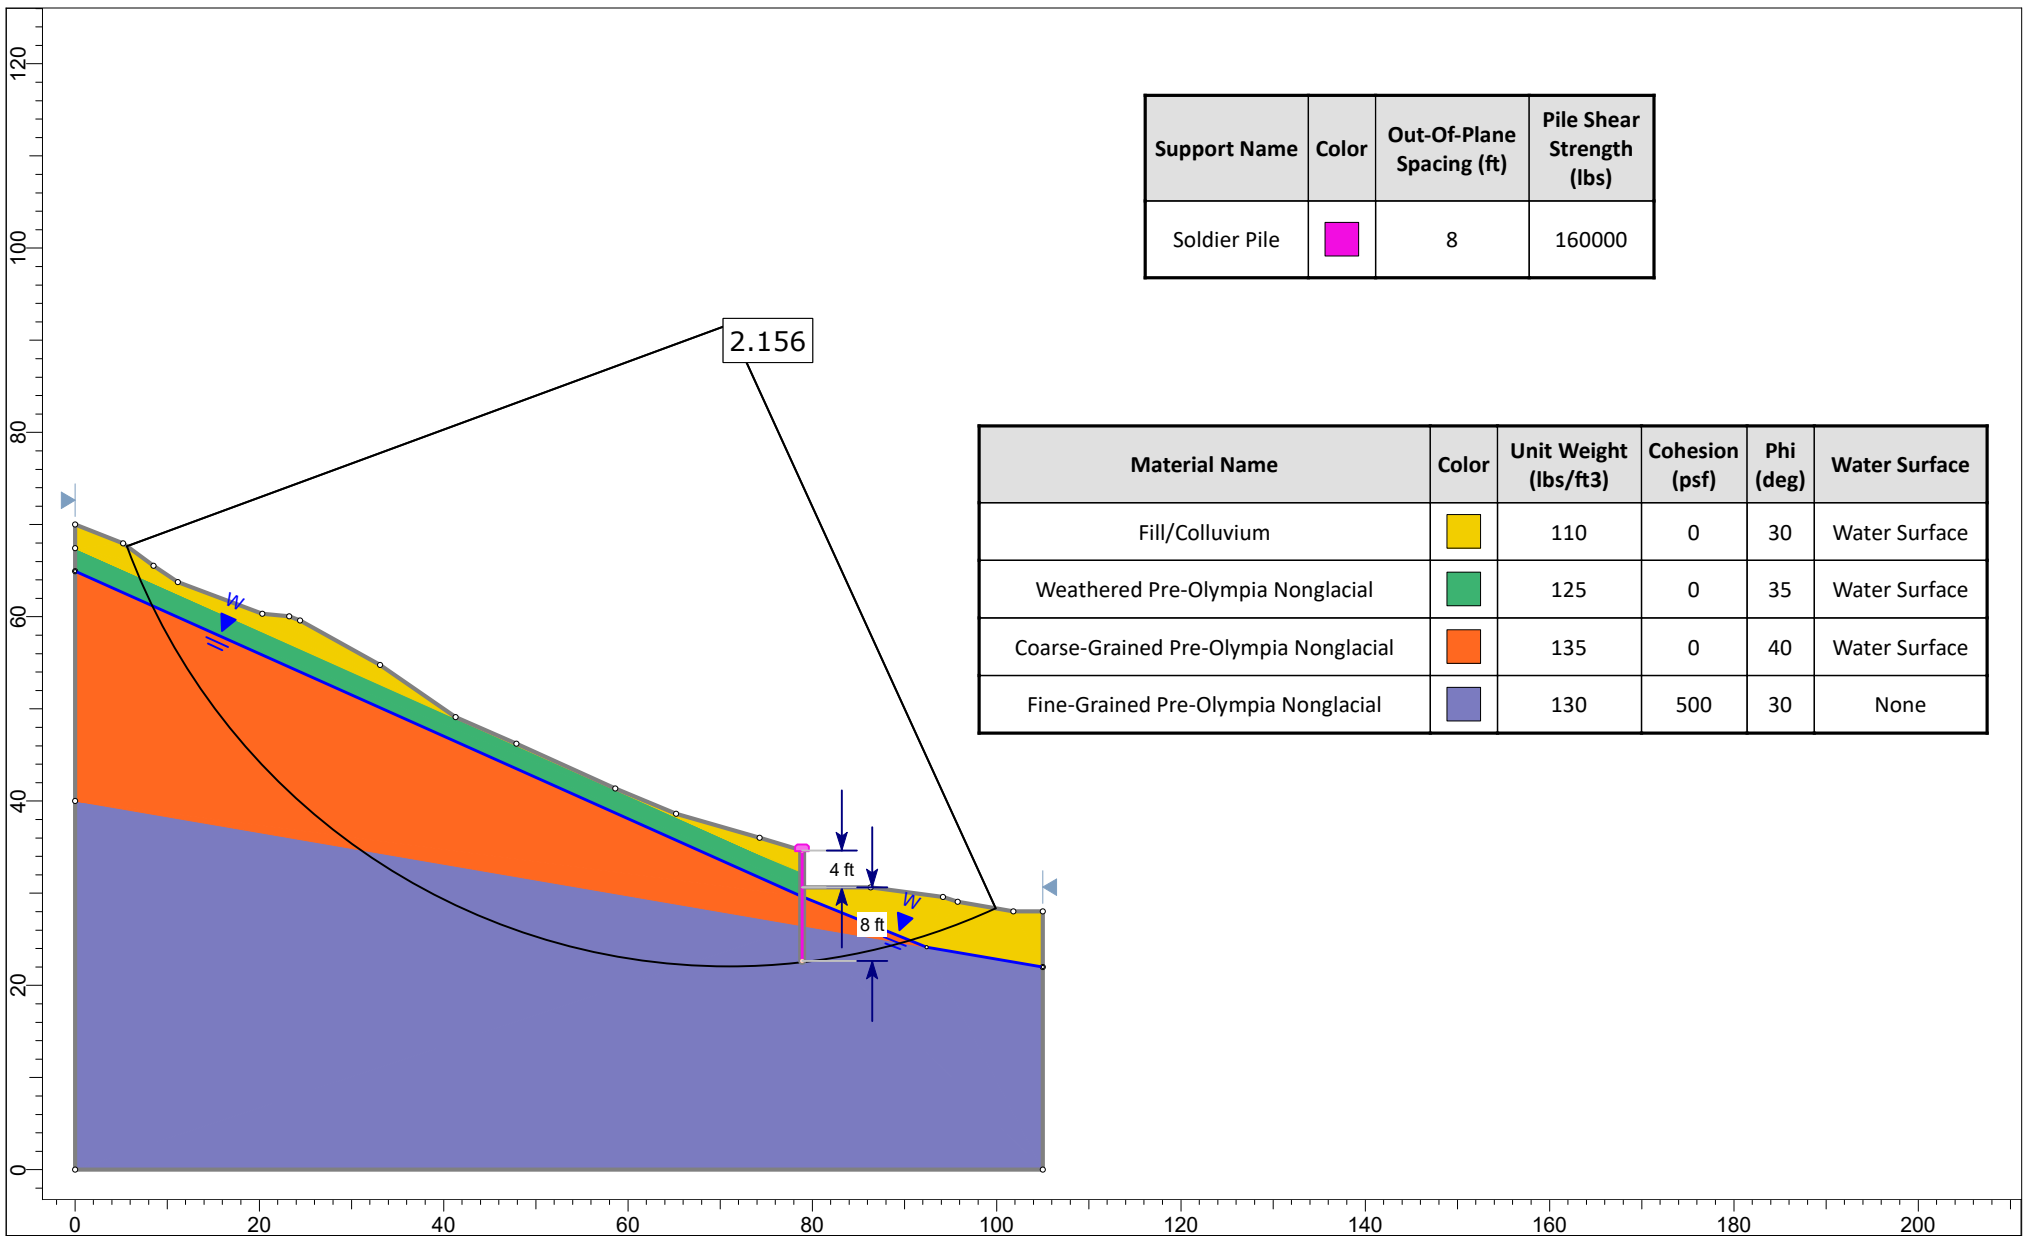
Support Name	Color	Out-Of-Plane Spacing (ft)	Pile Shear Strength (lbs)
Soldier Pile	<span style="color: magenta;">■</span>	8	160000

Material Name	Color	Unit Weight (lbs/ft <sup>3</sup> )	Cohesion (psf)	Phi (deg)	Water Surface
Fill/Colluvium	<span style="color: yellow;">■</span>	110	0	30	Water Surface
Weathered Pre-Olympia Nonglacial	<span style="color: green;">■</span>	125	0	35	Water Surface
Coarse-Grained Pre-Olympia Nonglacial	<span style="color: orange;">■</span>	135	0	40	Water Surface
Fine-Grained Pre-Olympia Nonglacial	<span style="color: purple;">■</span>	130	500	30	None
