April 16, 2019
File No. 19-062.100

**Subject: Geotechnical Engineering Study
Proposed Development
6423 East Mercer Way
Mercer Island, WA**

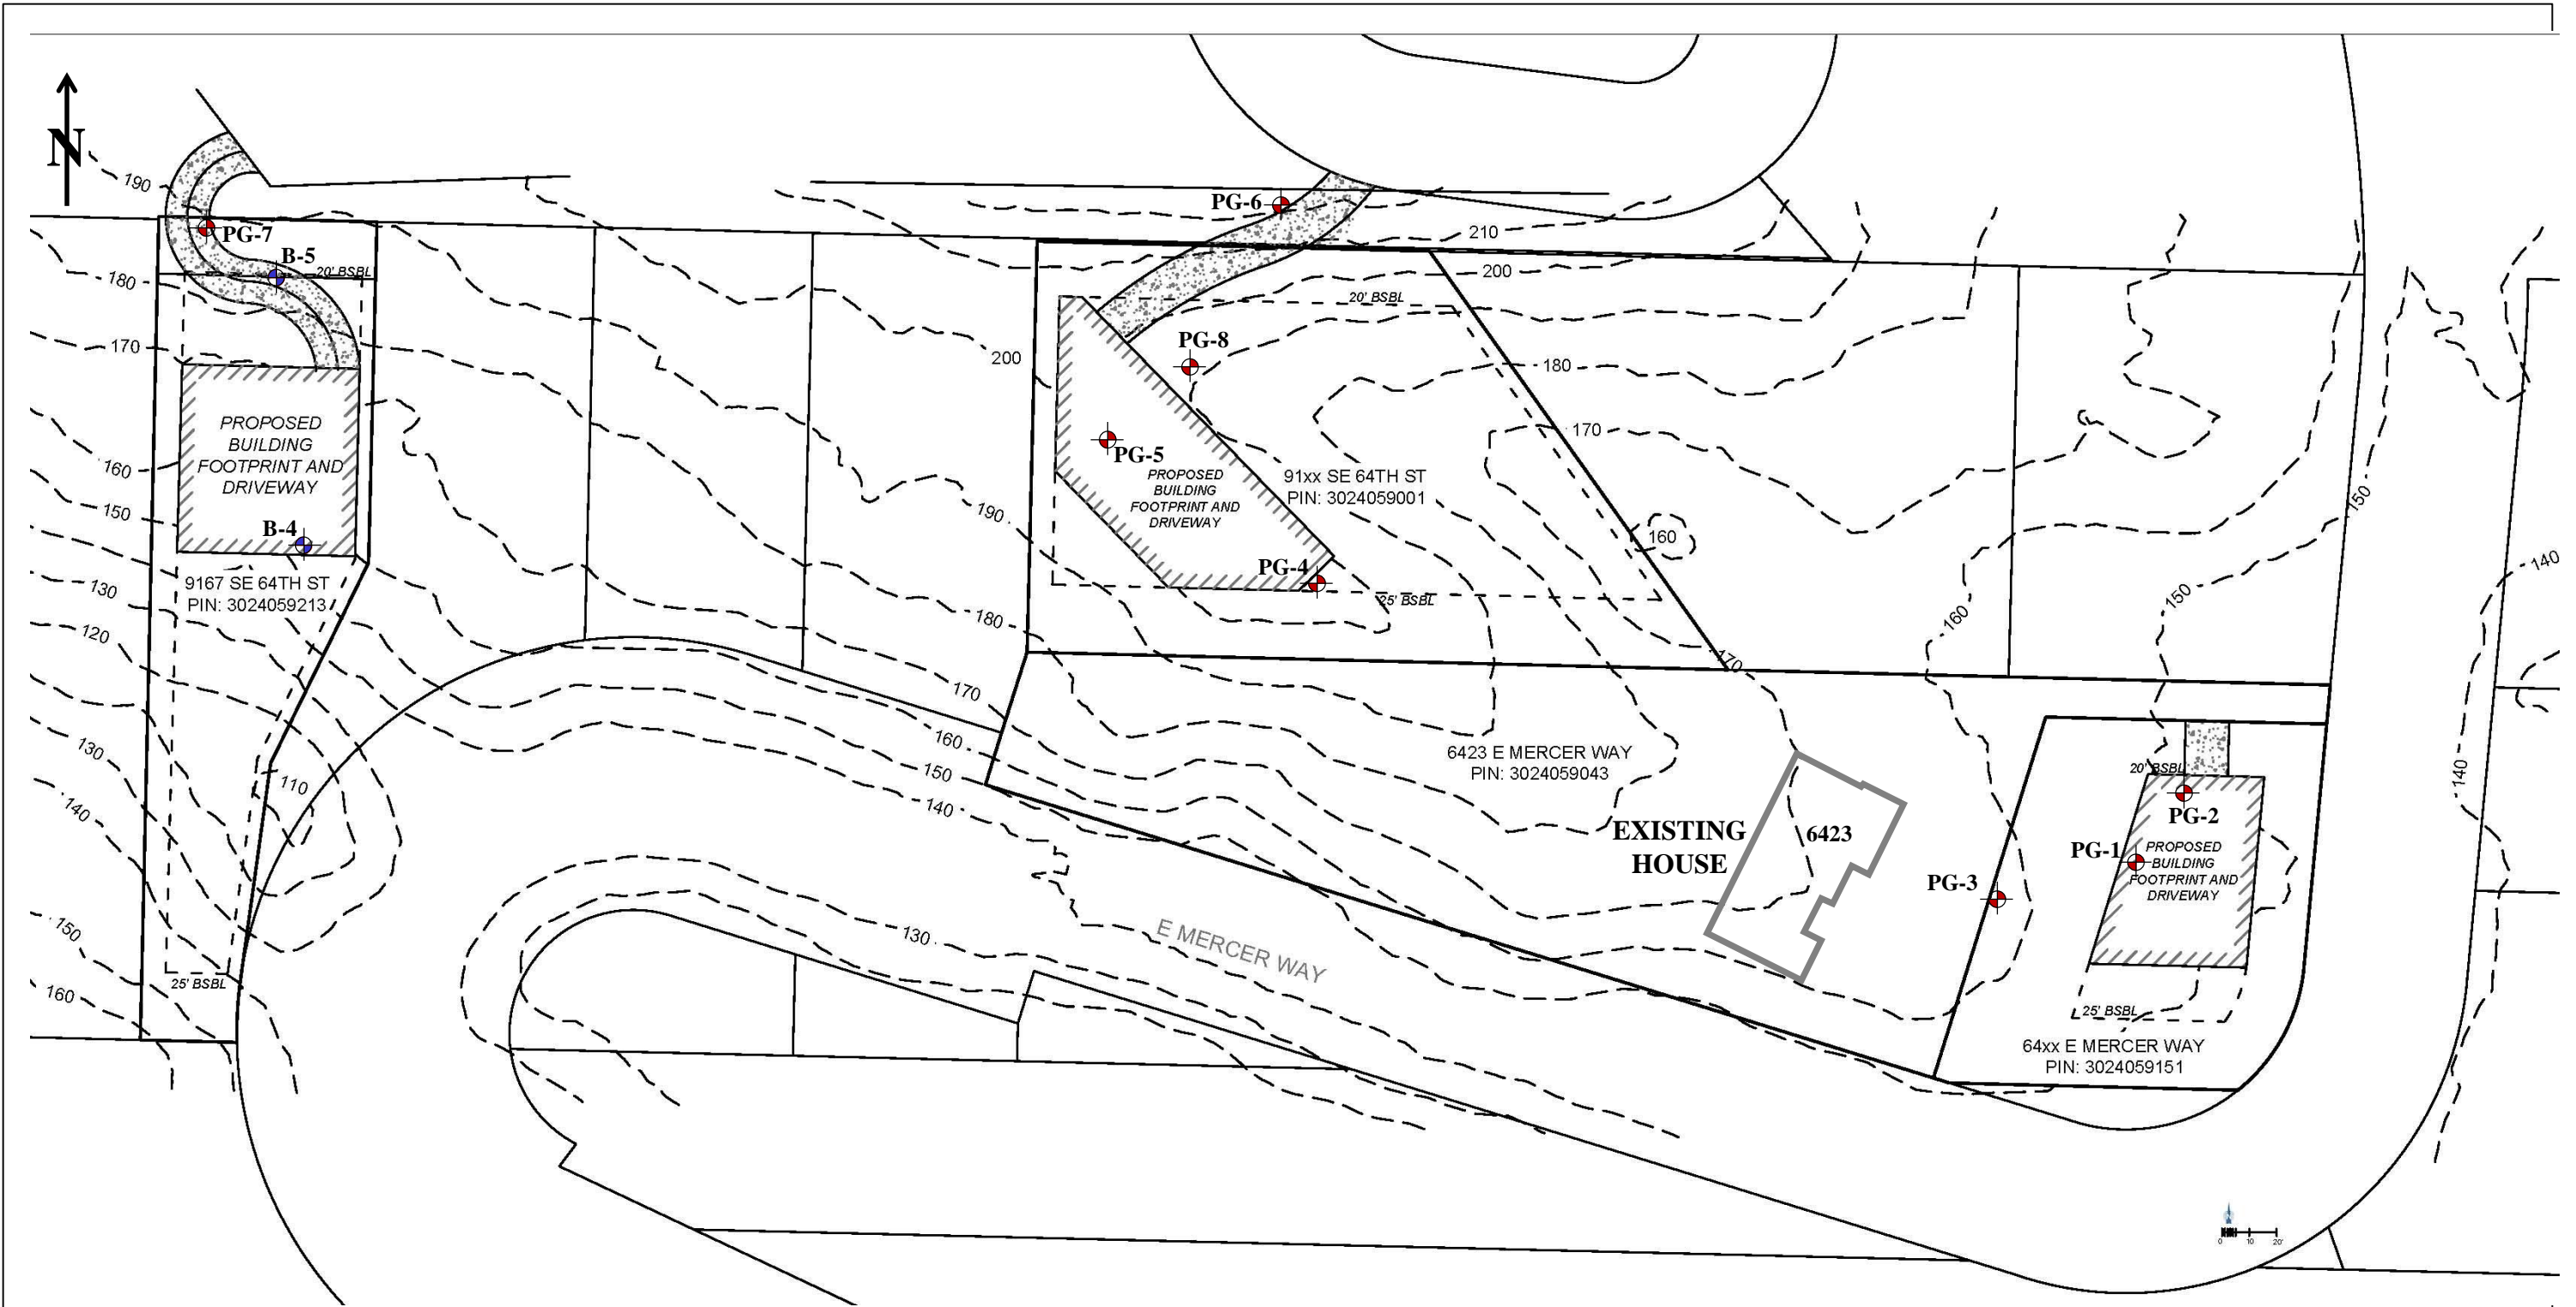
Proposed Development 6423 E Mercer Way Mercer Island, WA	PROJECT OVERVIEW AND BORING LOCATIONS	
		Project No. 19-062	Figure No. 2

Figure 2: Project Overview and Boring Locations

The easternmost, 15,812 sq. ft. parcel (302405-9151) is located above the 90-degree bend in E. Mercer Way (see Figures 2 and 3a). Moderately steep slopes surround the property to the south and west, forming a semi-open bowl with about 30 feet of total relief. The surface within the bowl is relatively level, and the near 90-degree angle between the south and west slopes suggest the site has been excavated. Preliminary plans call for developing the bowl portion of the property (see Figure 2).

Parcel 302405-9001 (see Figures 2 and 3b) is located north of the property at 6423 E. Mercer Way, between the reference property and SE 64th Street. The site slopes generally steeply to the east and south, and the southwestern portion of the property is traversed by a moderately sloping, east facing ridge. A prominent drainage swale occupies the northeastern part of the site. A steep slope, up to 1H:1V, divides SE 64th Street from the main level of the property. Preliminary plans call for the development of the ridge crest and upper swale portion of the property (see Fig. 2).

The parcel (#302405-9213) located at 9167 SE 64th Street is also irregularly shaped, undeveloped, and 18,635 sq. feet in size (see Figures 2 and 3c). The property slopes moderately to steeply to the south, with nearly 60 feet of relief down to East Mercer Way. There is a moderately sloping bench area at about elevation 170 feet, which is about 20 feet below SE 64th Street. Preliminary plans call for the development of the area above the bench (see Figure 2).

Preliminary concept for driveway access to the parcel 30214059001 indicates a plan to construct a driveway from SE64th Street, as shown on Figure 2. This would require traversing a slope that is up to 1H:1V in places, especially at the top, and the slope is designated a steep slope hazard by the City of Mercer Island. In our opinion, the proposed driveway would require a soldier pile wall for support, would have a gradient of some 25 percent, and have poor sight distances with

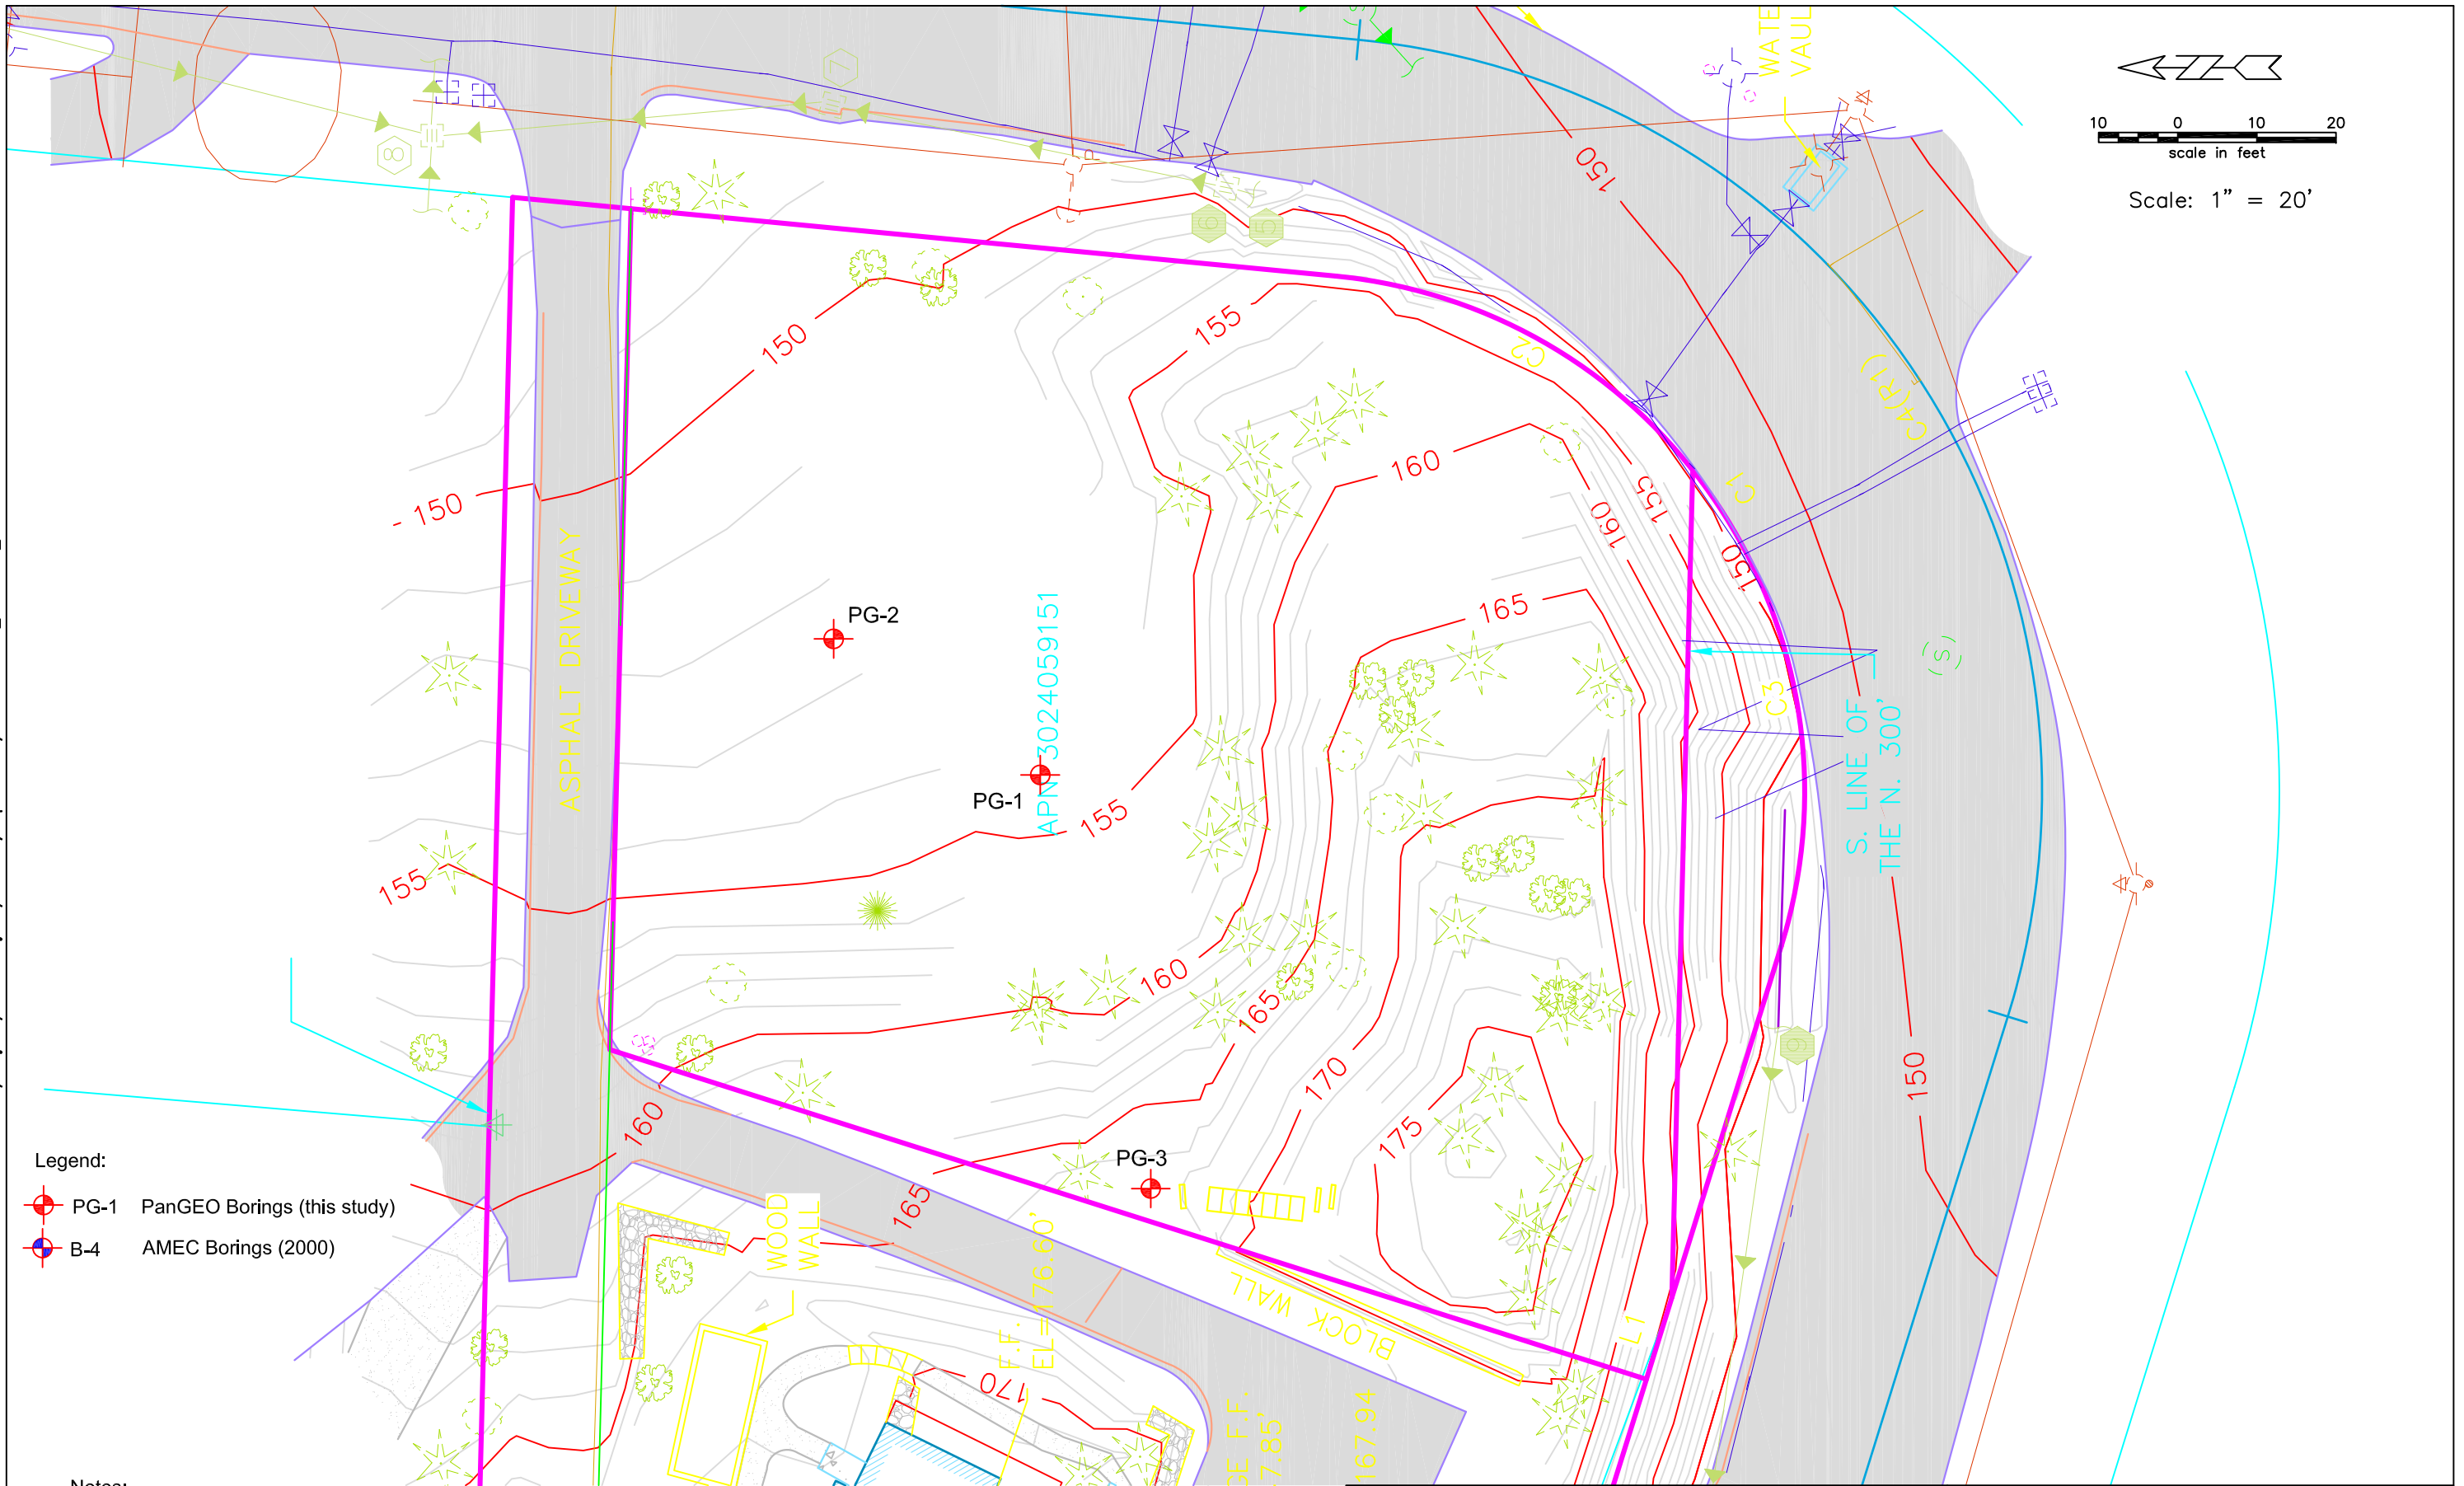
FIGURE NO. 3a

Figure 3a: Site and Exploration Plan, Lot 302405-9151

- Legend:**
- PG-1 PanGEO Borings (this study)
 - B-4 AMEC Borings (2000)

- Notes:**
1. Base map provided by Plan to Permit, May, 2019. Elevations are based on the NAVD88 datum.
 2. Boring logs for PanGEO borings PG-1 through PG-8 are located in Appendix A. Locations for these borings are approximate and based on the relative locations of known site features.
 3. Boring logs for historic investigations are located in Appendix B.

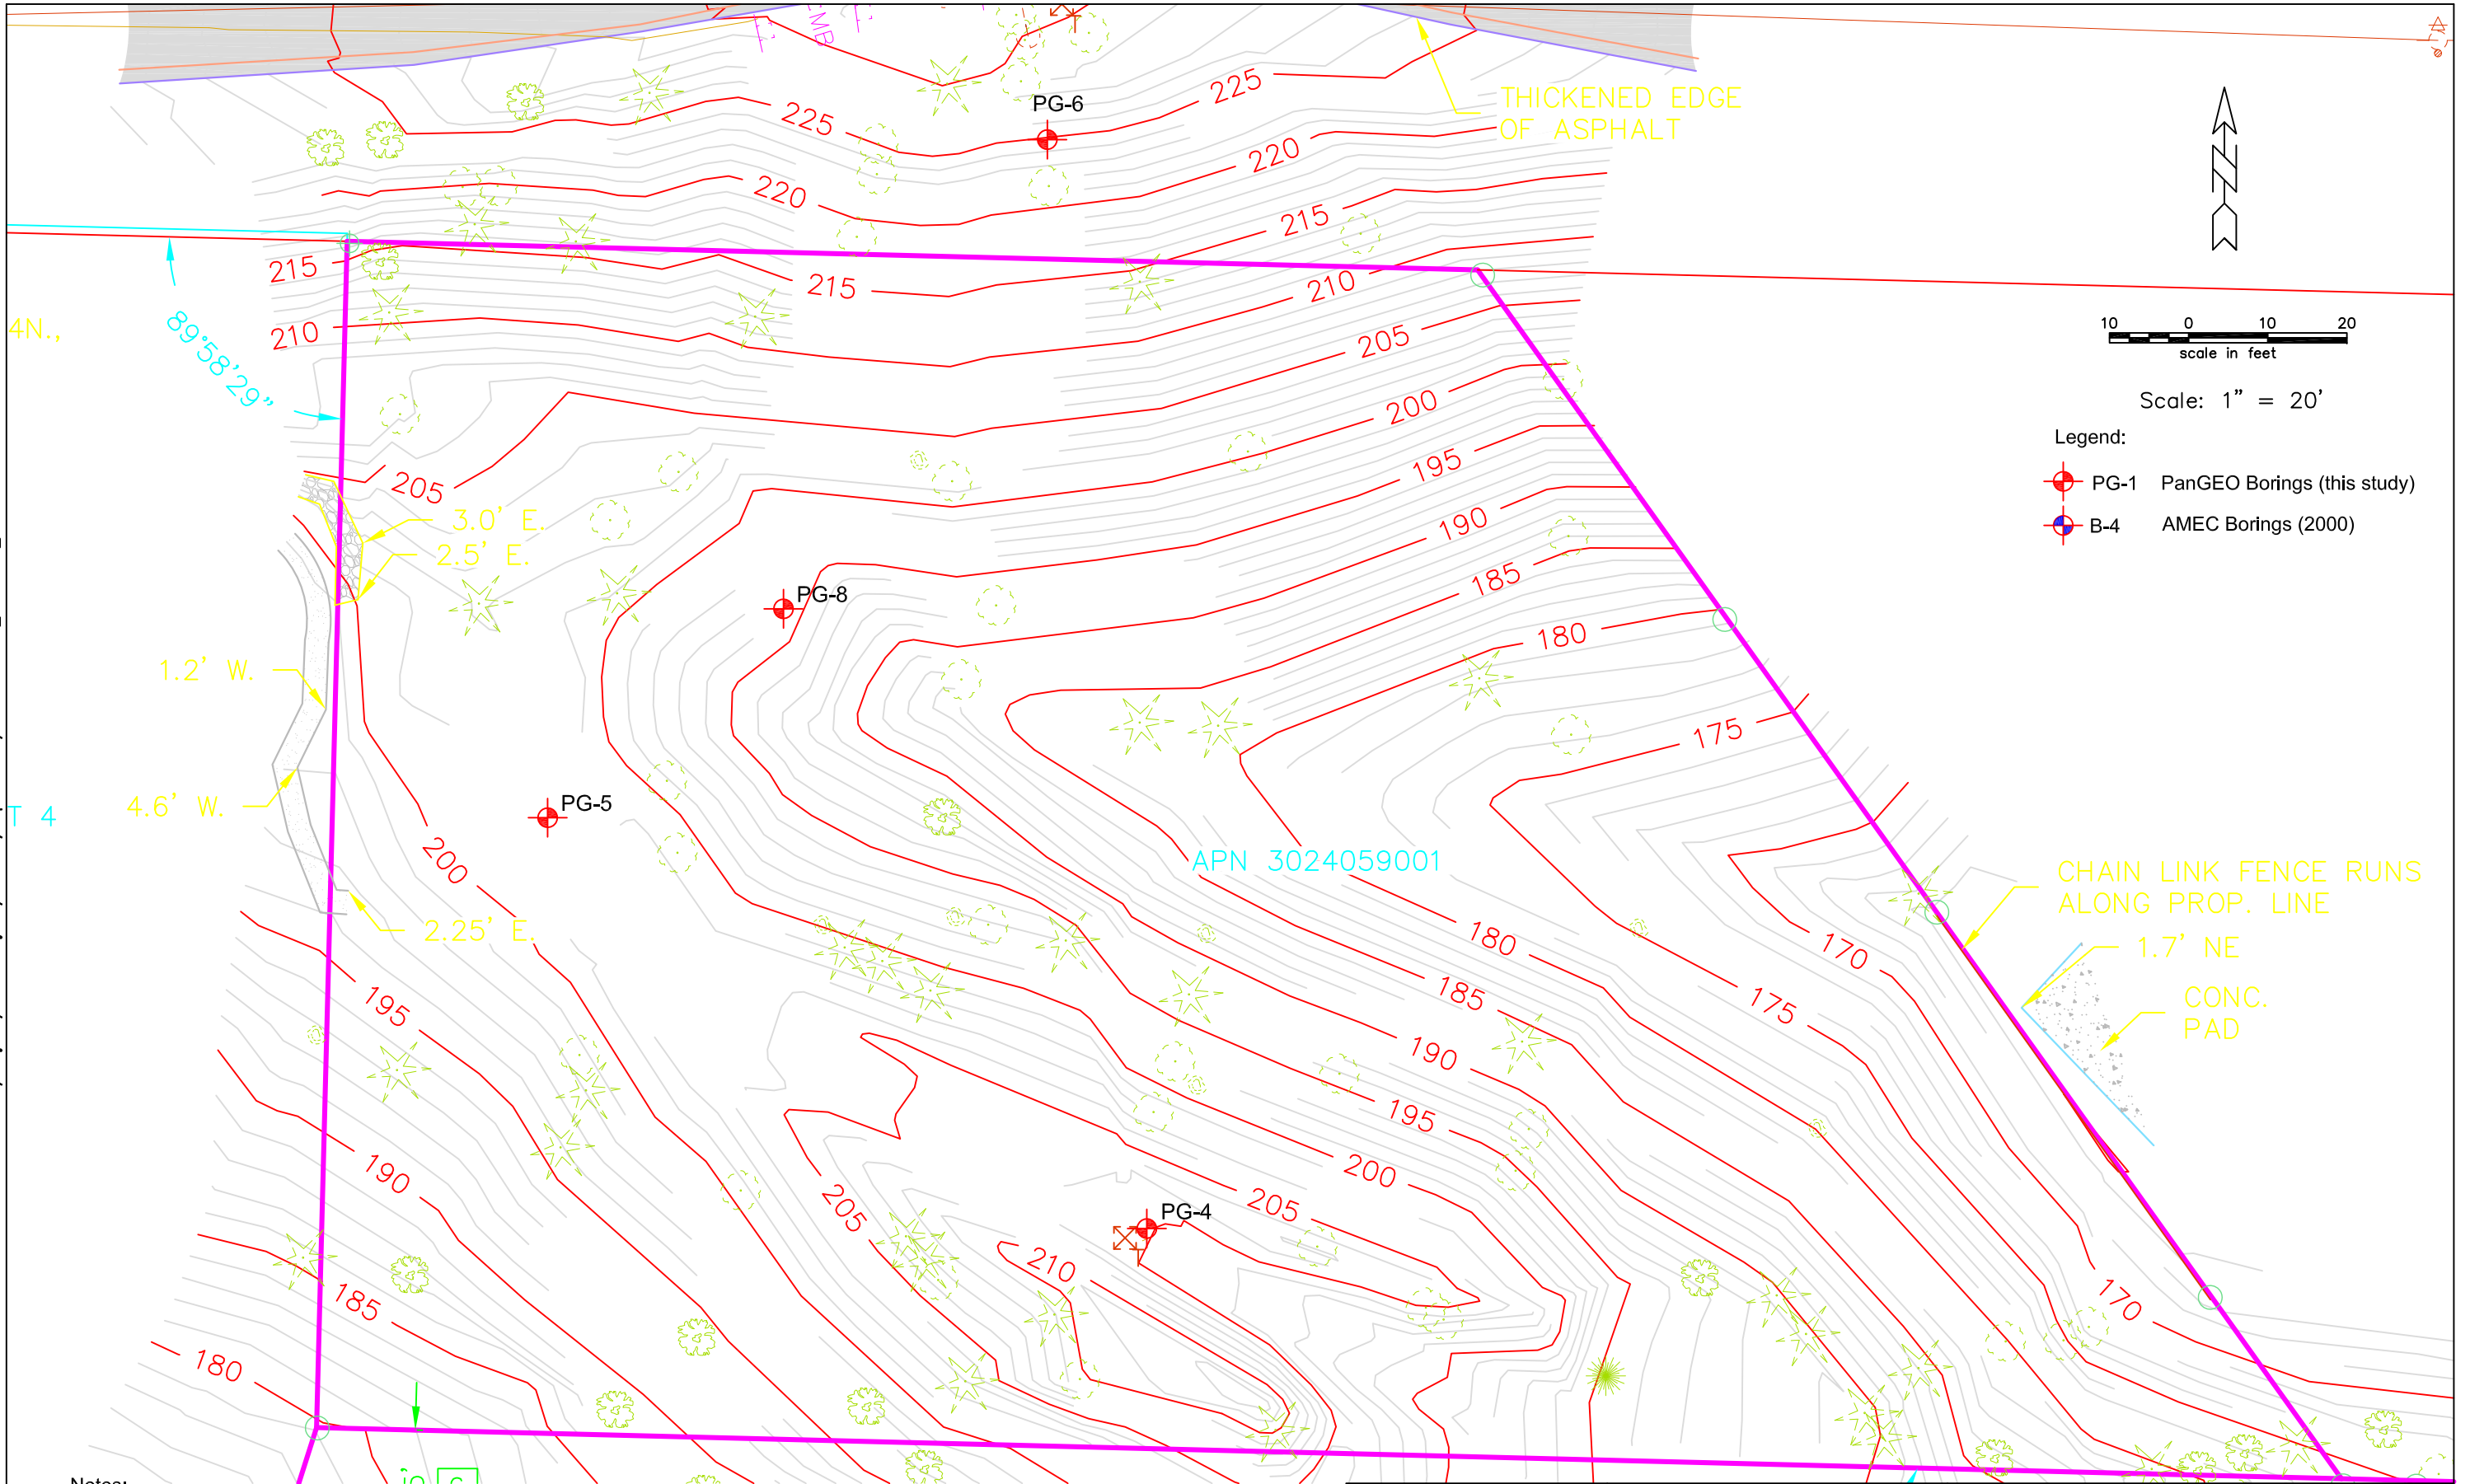
FIGURE NO. 3b

Figure 3b: Site and Exploration Plan, Lot 302405-9001

1. Base map provided by Plan to Permit, May, 2019. Elevations are based on the NAVD88 datum.
2. Boring logs for PanGEO borings PG-1 through PG-8 are located in Appendix A. Locations for these borings are approximate and based on the relative locations of known site features.
3. Boring logs for historic investigations are located in Appendix B.

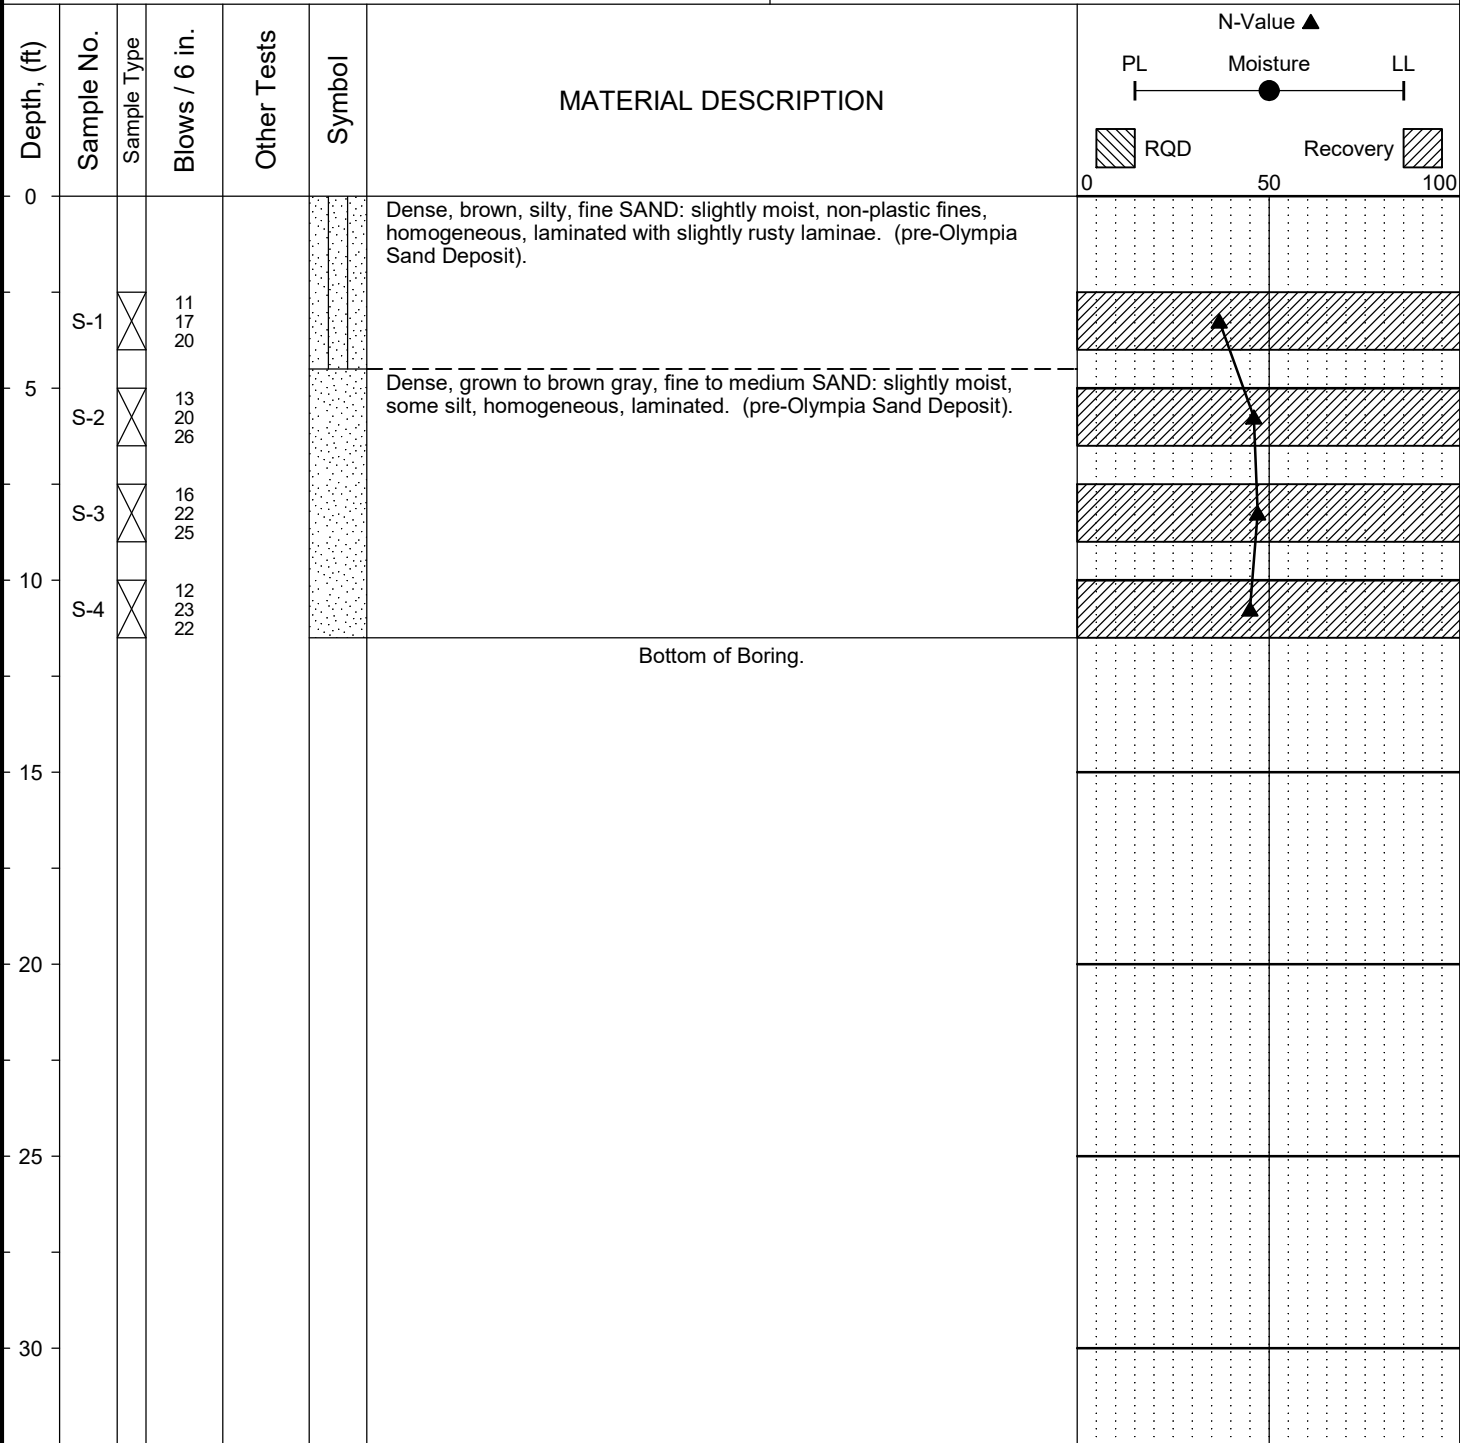
Project: Proposed Lot Development Job Number: 19-062 Location: 6423 East Mercer Way, Mercer Island, WA Coordinates: Northing: , Easting:	Surface Elevation: Top of Casing Elev.: Drilling Method: HSA Sampling Method: SPT
---	--

Completion Depth: 11.5ft Date Borehole Started: 3/7/19 Date Borehole Completed: 3/7/19 Logged By: S. Evans Drilling Company: Boretac, Inc	Remarks: No groundwater encountered during drilling.
---	--

The stratification lines represent approximate boundaries. The transition may be gradual.

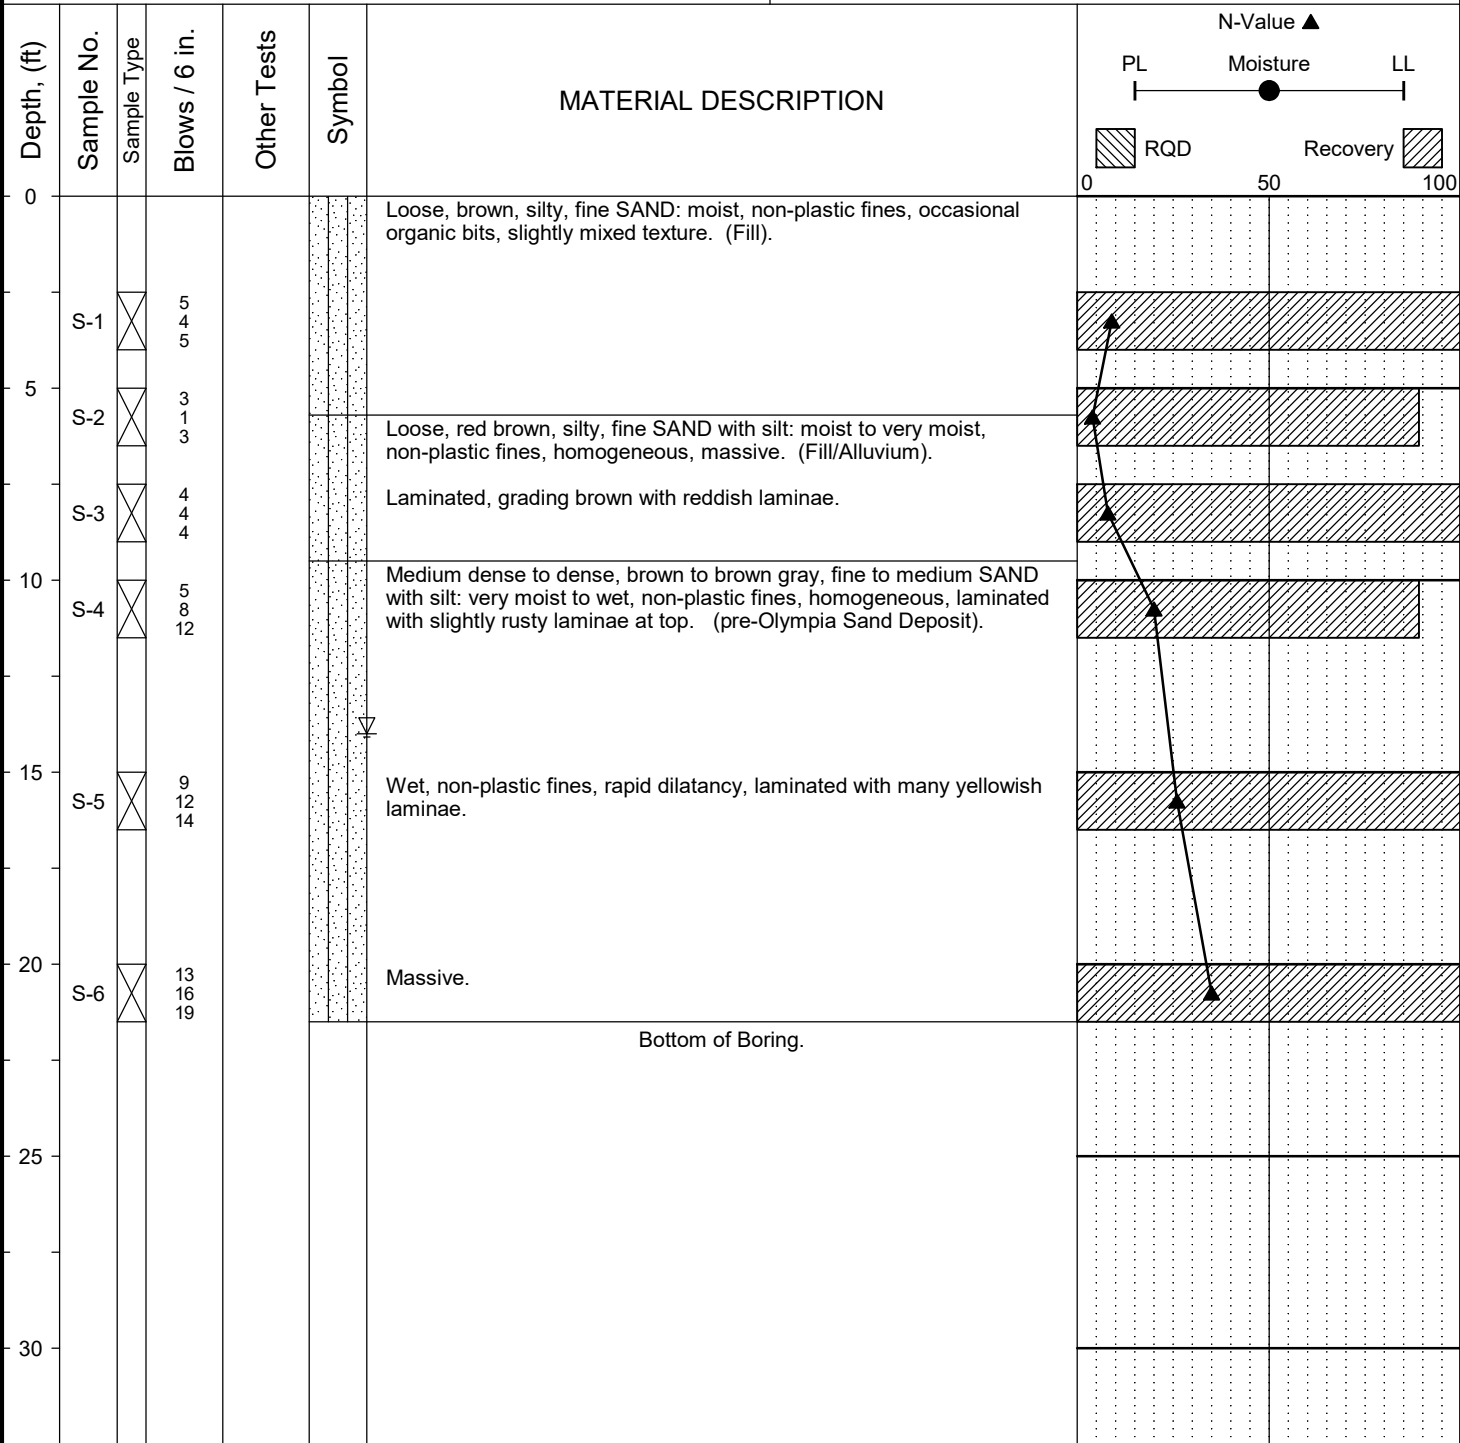
Project: Proposed Lot Development Job Number: 19-062 Location: 6423 East Mercer Way, Mercer Island, WA Coordinates: Northing: , Easting:	Surface Elevation: Top of Casing Elev.: Drilling Method: HSA Sampling Method: SPT
---	--

Completion Depth: 21.5ft Date Borehole Started: 3/7/19 Date Borehole Completed: 3/7/19 Logged By: S. Evans Drilling Company: Boretac, Inc	Remarks: Groundwater level estimated based on wetness of soil sample and water on the sampling rods.
---	--

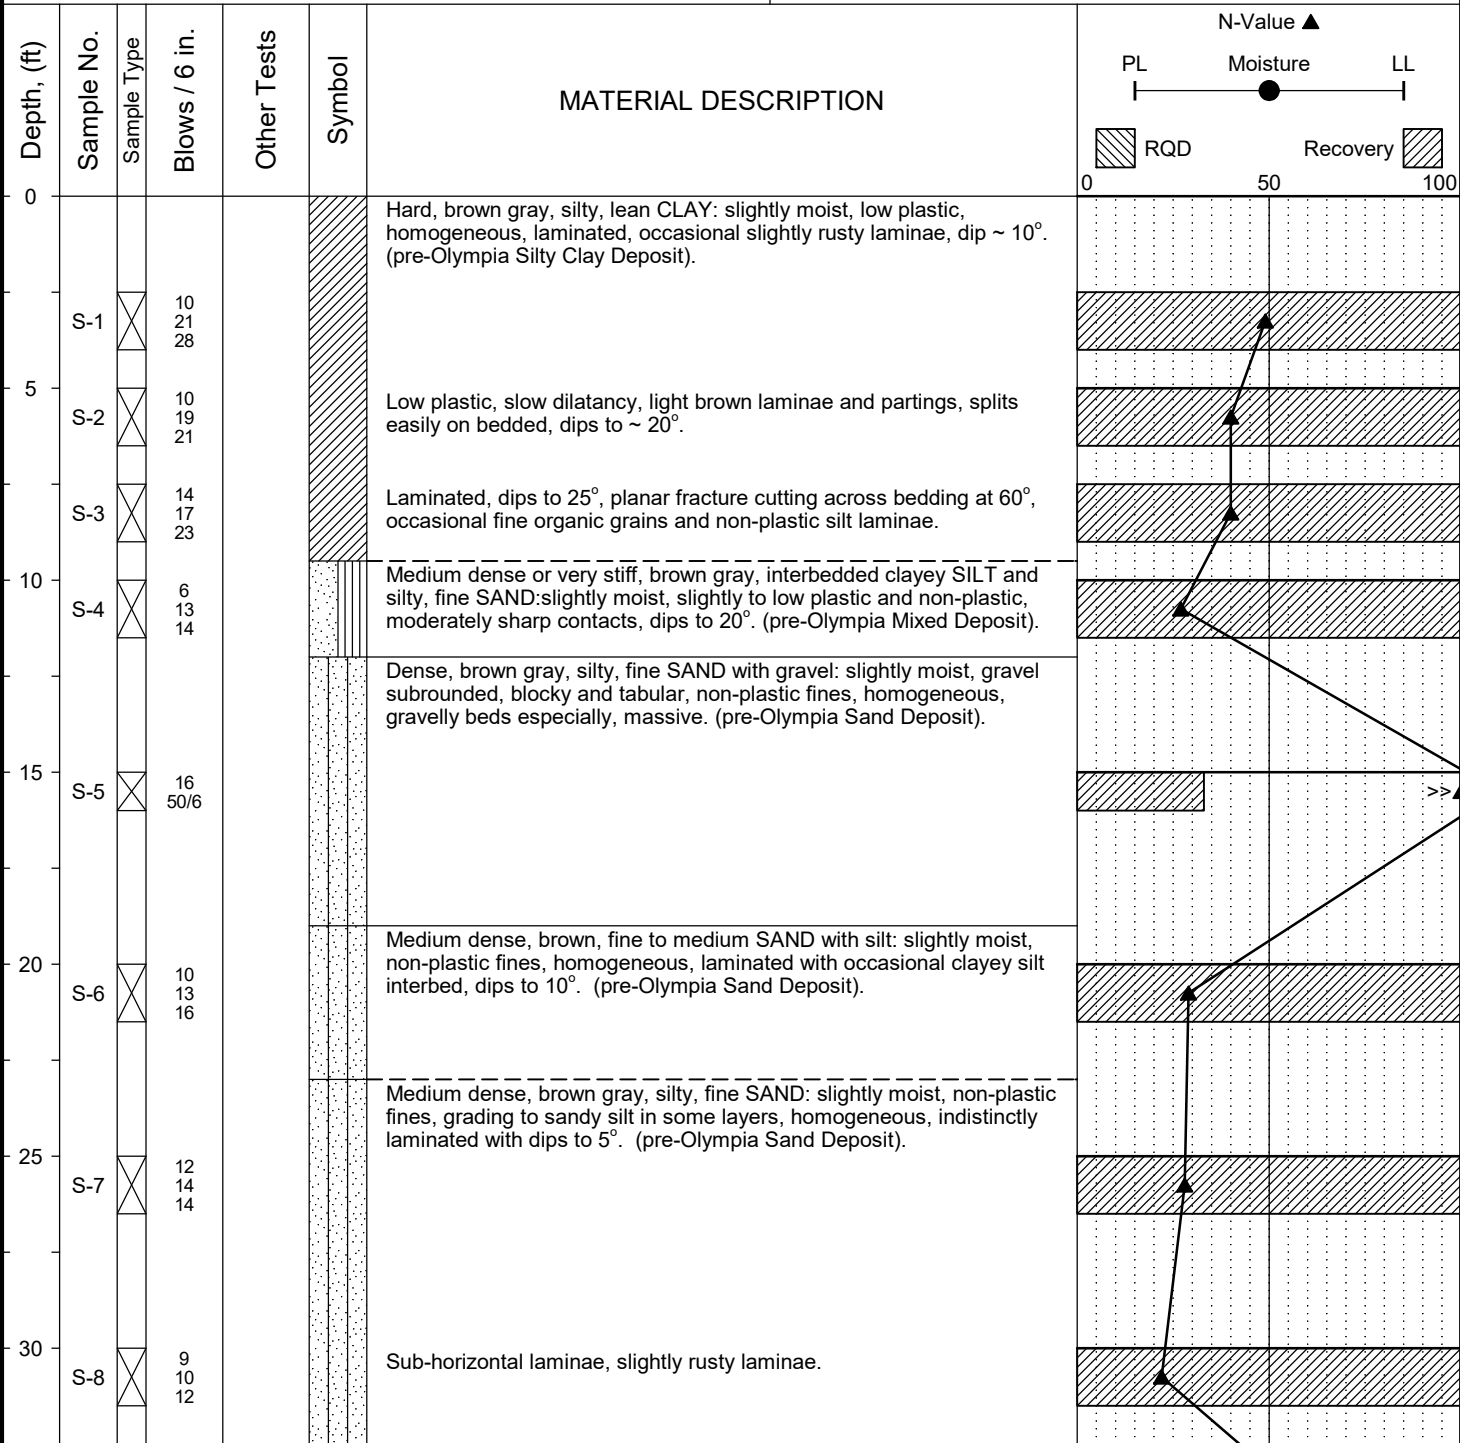
Project: Proposed Lot Development Job Number: 19-062 Location: 6423 East Mercer Way, Mercer Island, WA Coordinates: Northing: , Easting:	Surface Elevation: Top of Casing Elev.: Drilling Method: HSA Sampling Method: SPT
---	--

Completion Depth: 41.5ft Date Borehole Started: 3/7/19 Date Borehole Completed: 3/7/19 Logged By: S. Evans Drilling Company: Boretac, Inc	Remarks: No groundwater encountered during drilling.
---	--

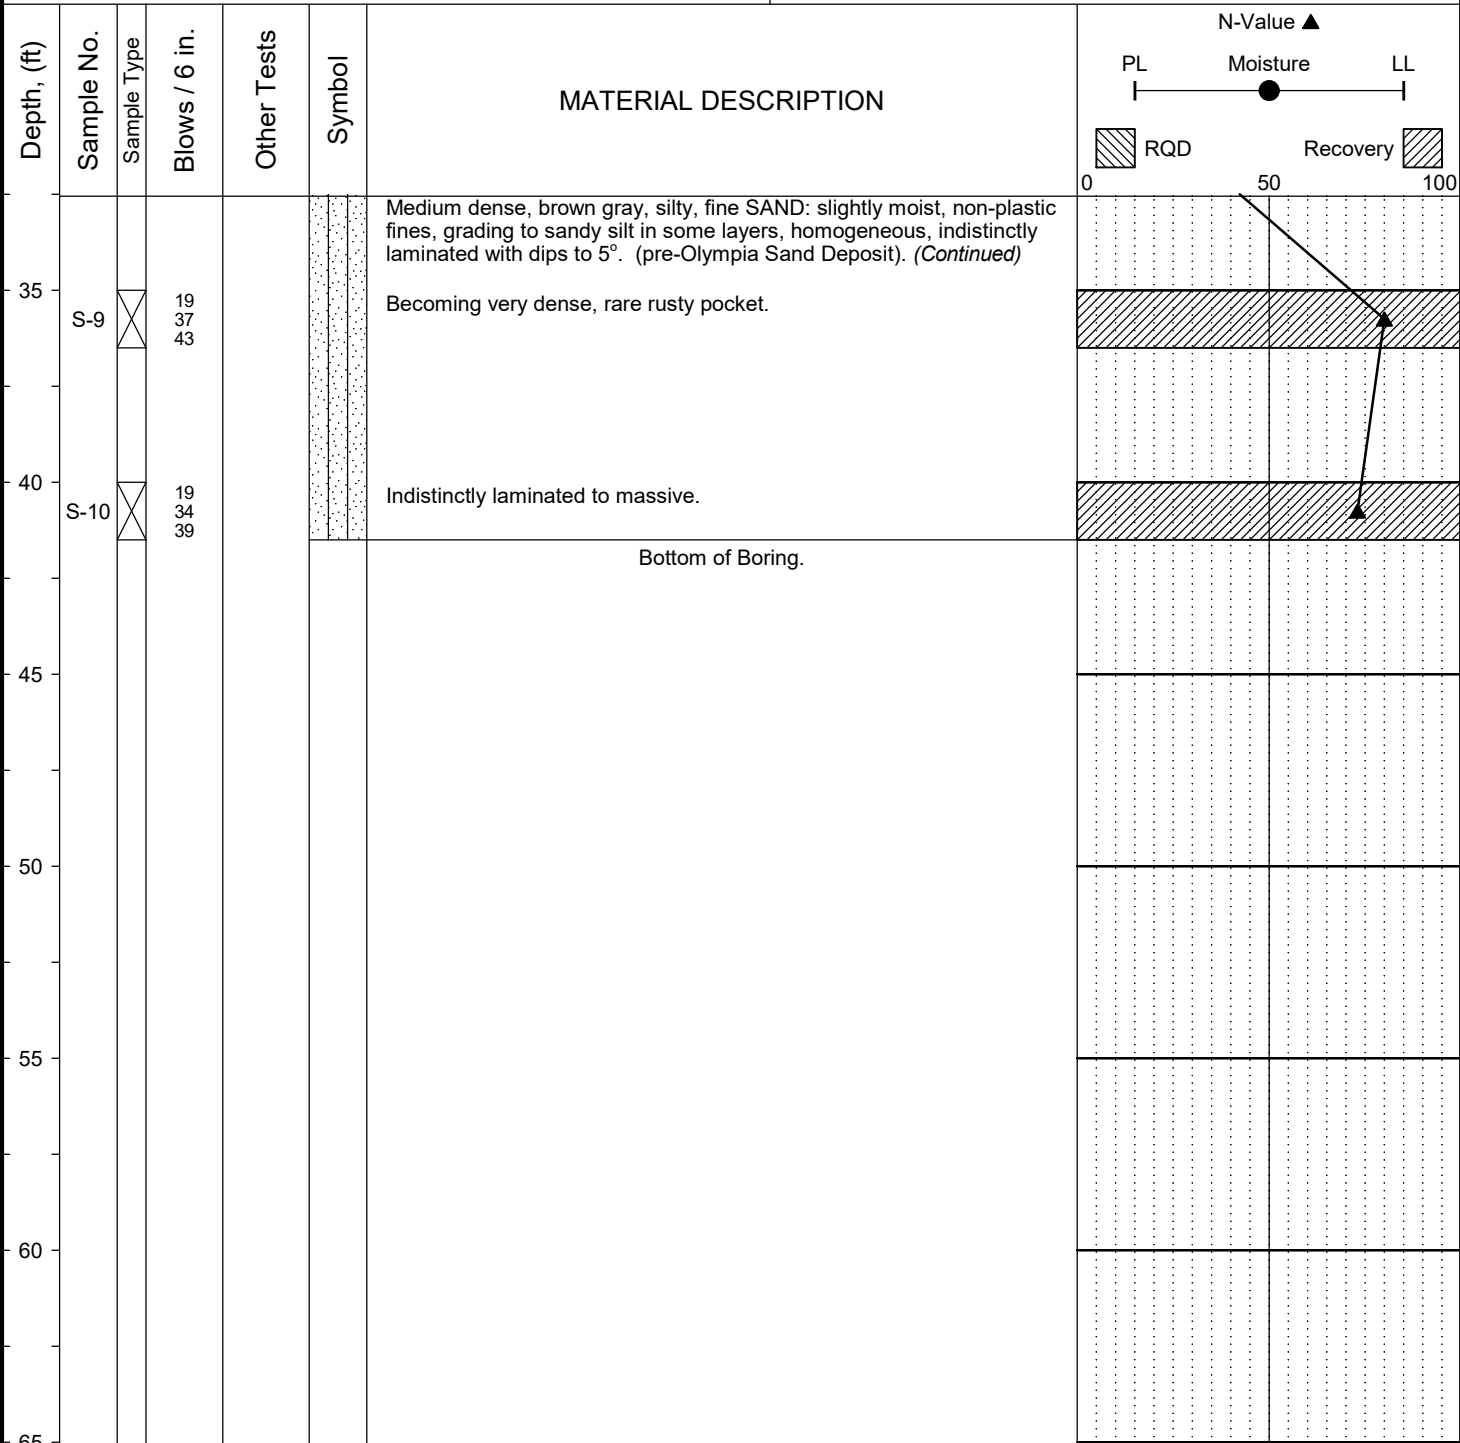
Project: Proposed Lot Development Job Number: 19-062 Location: 6423 East Mercer Way, Mercer Island, WA Coordinates: Northing: , Easting:	Surface Elevation: Top of Casing Elev.: Drilling Method: HSA Sampling Method: SPT
---	--

Completion Depth: 41.5ft Date Borehole Started: 3/7/19 Date Borehole Completed: 3/7/19 Logged By: S. Evans Drilling Company: Boretac, Inc	Remarks: No groundwater encountered during drilling.
---	--

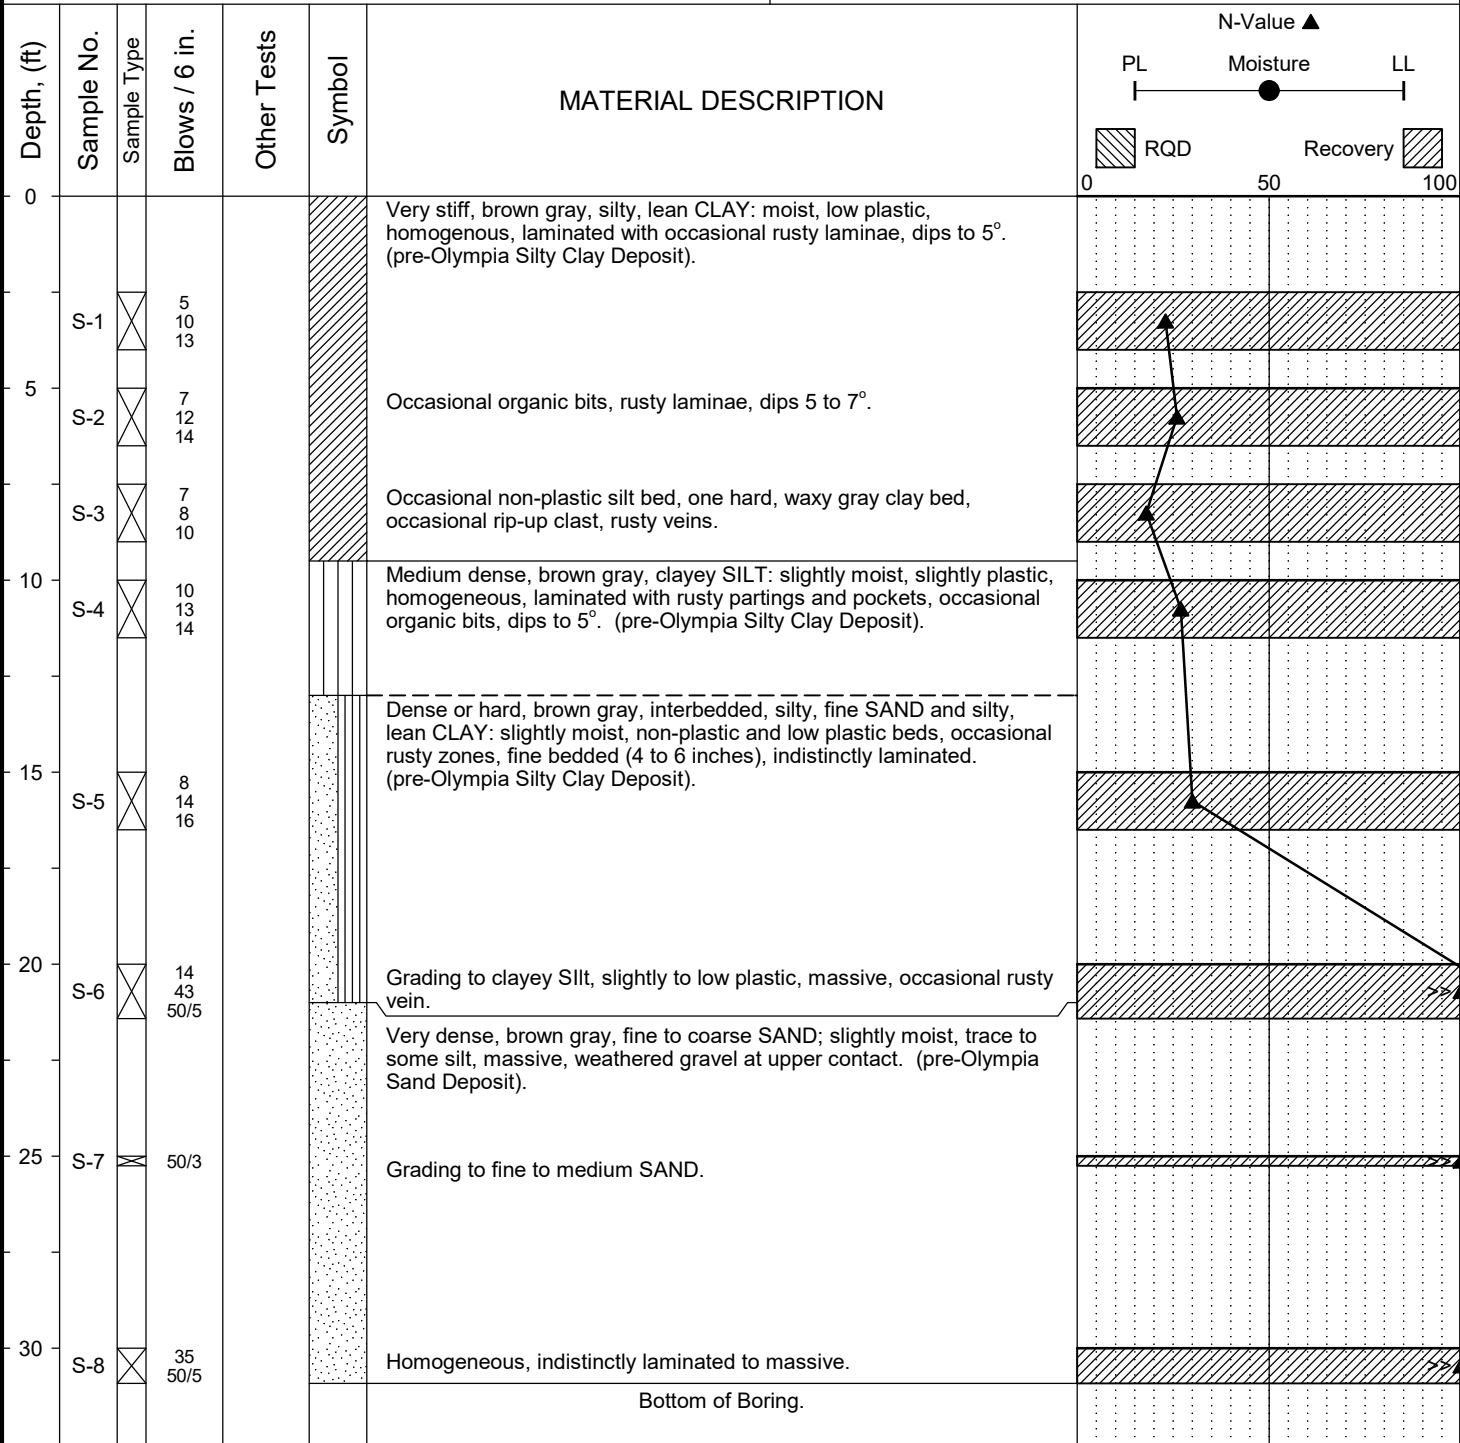
Project: Proposed Lot Development Job Number: 19-062 Location: 6423 East Mercer Way, Mercer Island, WA Coordinates: Northing: , Easting:	Surface Elevation: Top of Casing Elev.: Drilling Method: HSA Sampling Method: SPT
---	--

Completion Depth: 30.9ft Date Borehole Started: 3/7/19 Date Borehole Completed: 3/7/19 Logged By: S. Evans Drilling Company: Boretac, Inc	Remarks: No groundwater encountered during drilling.
---	--
