April 16, 2019
File No. 19-062.100

**Subject: Geotechnical Engineering Study
Proposed Development
6423 East Mercer Way
Mercer Island, WA**

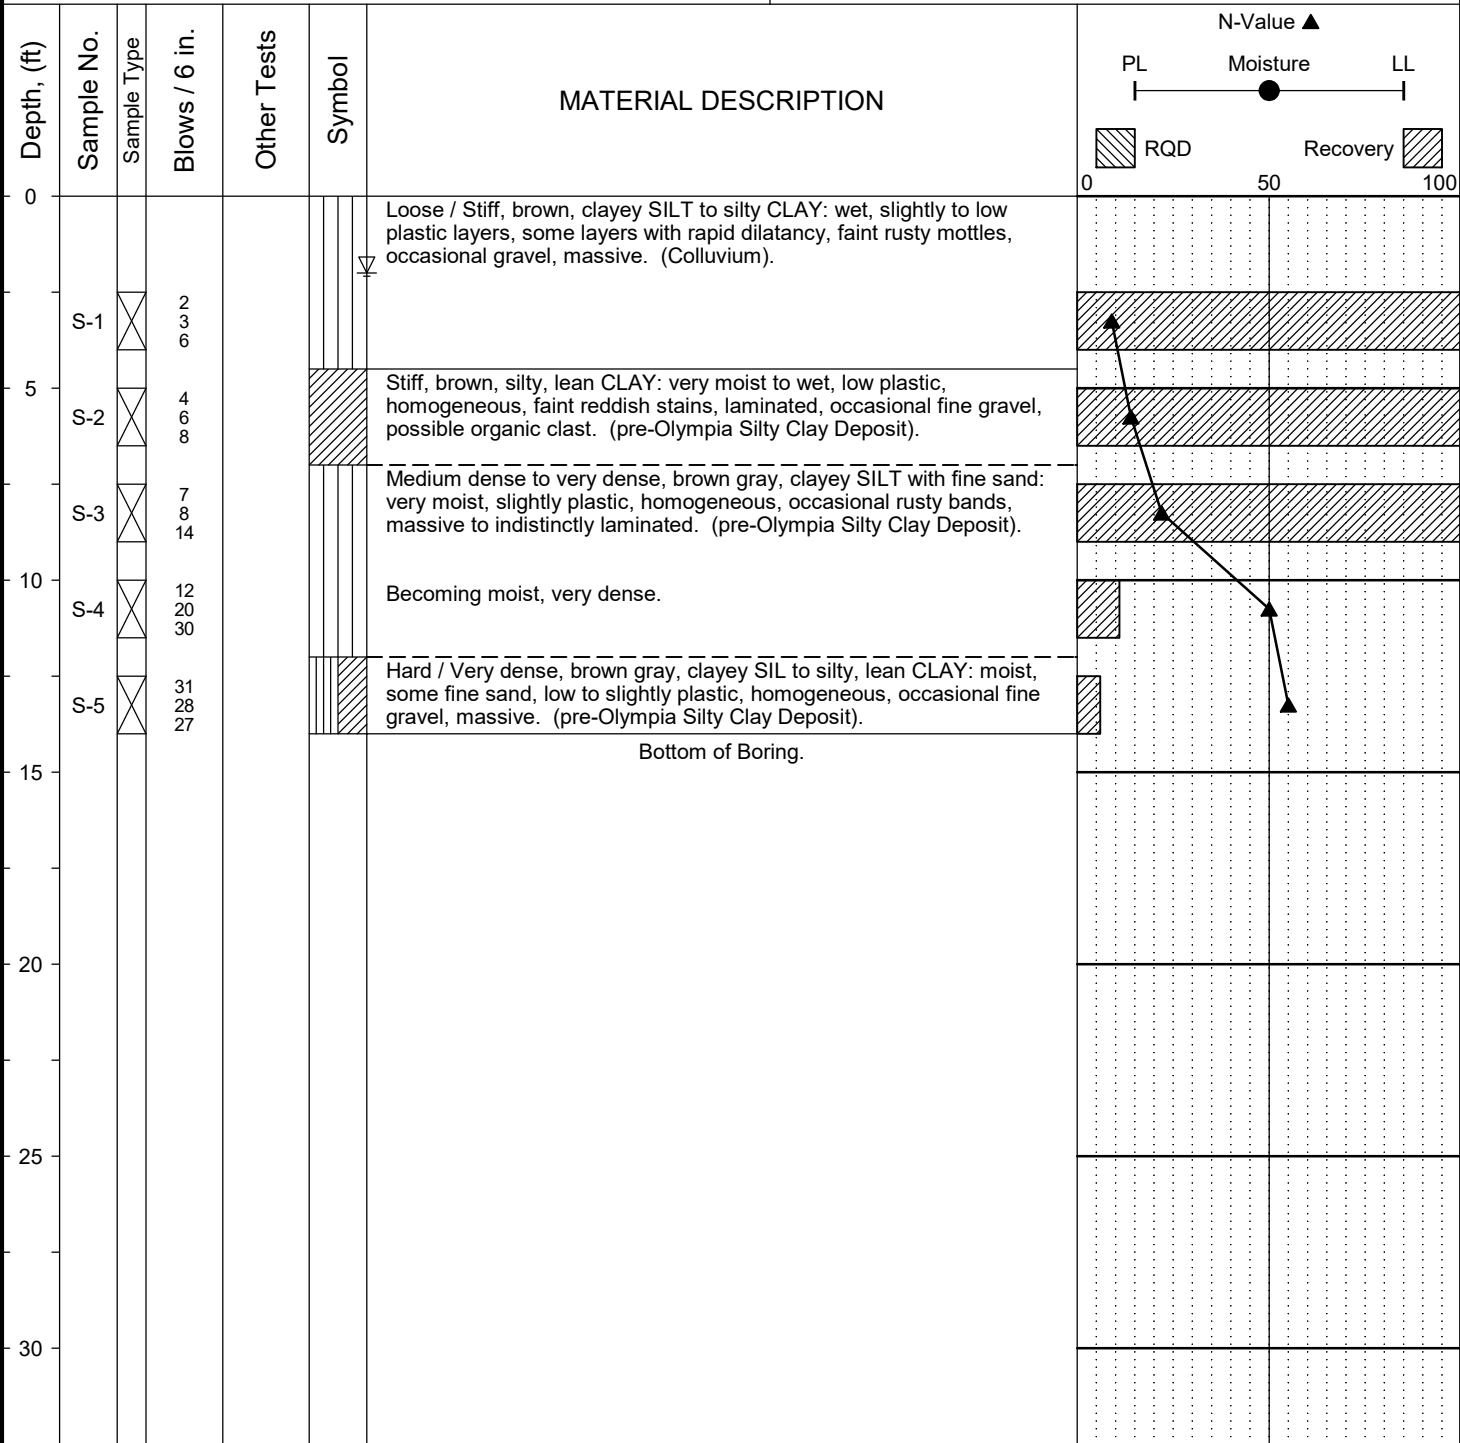
Project: Proposed Lot Development Job Number: 19-062 Location: 6423 East Mercer Way, Mercer Island, WA Coordinates: Northing: , Easting:	Surface Elevation: Top of Casing Elev.: Drilling Method: HSA Sampling Method: SPT
---	--

Completion Depth: 14.0ft Date Borehole Started: 3/21/19 Date Borehole Completed: 3/21/19 Logged By: S. Evans Drilling Company: Boretac, Inc	Remarks: Groundwater level estimated based on wetness of soil sample and water on the sampling rods.
---	--
