**Re: Comment Letter for Proposed Redevelopment of 6950 SE Maker Street
Permit No. 2207-019**

On behalf of our client, Dan Grove, we submit these comments on the permit application for the proposed demolition and rebuild of the home located at 6950 SE Maker Street (the “Strand Property”) pending under Permit No. 2207-019 (the “Permit”). Mr. Grove owns the house immediately adjacent to the east of the Strand Property and is acutely familiar with the issues discussed in this letter. Mr. Grove respectfully requests notice and a copy of the permit decision once made by the City.

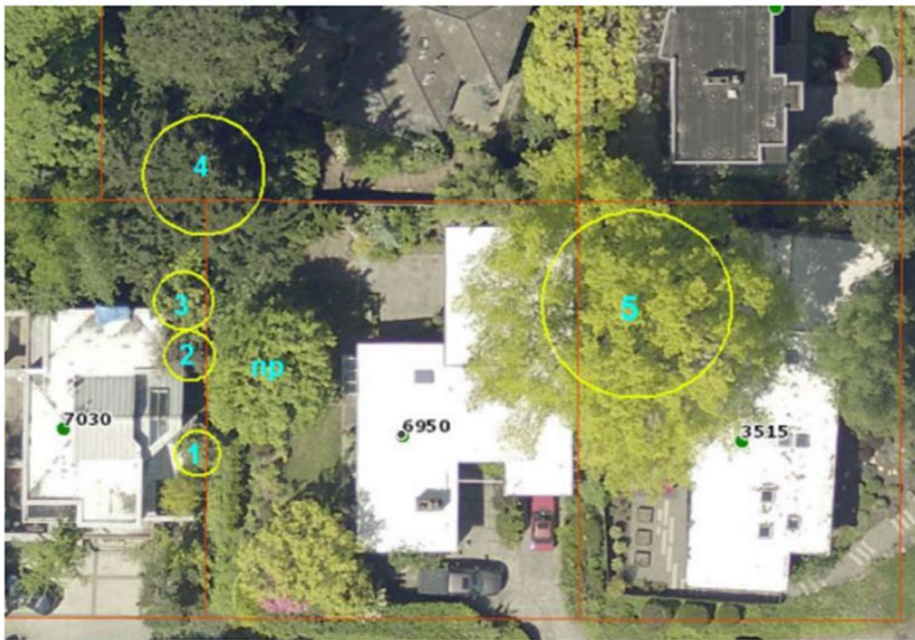
The following excerpt from the Assessment shows the Red Oak Tree on Mr. Grove’s property as Tree #5:

The Assessment states: “[The] Red oak (*Quercus rubra*) easily 40” DSH, 50’ tall in the highest reaches, spreads as much as 45’ north and south, around 35’ east, but was cut back quite hard on the west and extends no more than 18’ to that side (Figure 6). The base of the tree is 25’ south of the northeast corner and 10’ on center east of the east line. It sits on top of a large stone retaining wall that is near 5’ tall and fully on the neighbor’s lot (Figure 7).”¹⁹ The Assessment further states that “[i]f grade changes due to landscaping are proposed later in the project they should be analyzed for potential impact prior to implementation.”²⁰

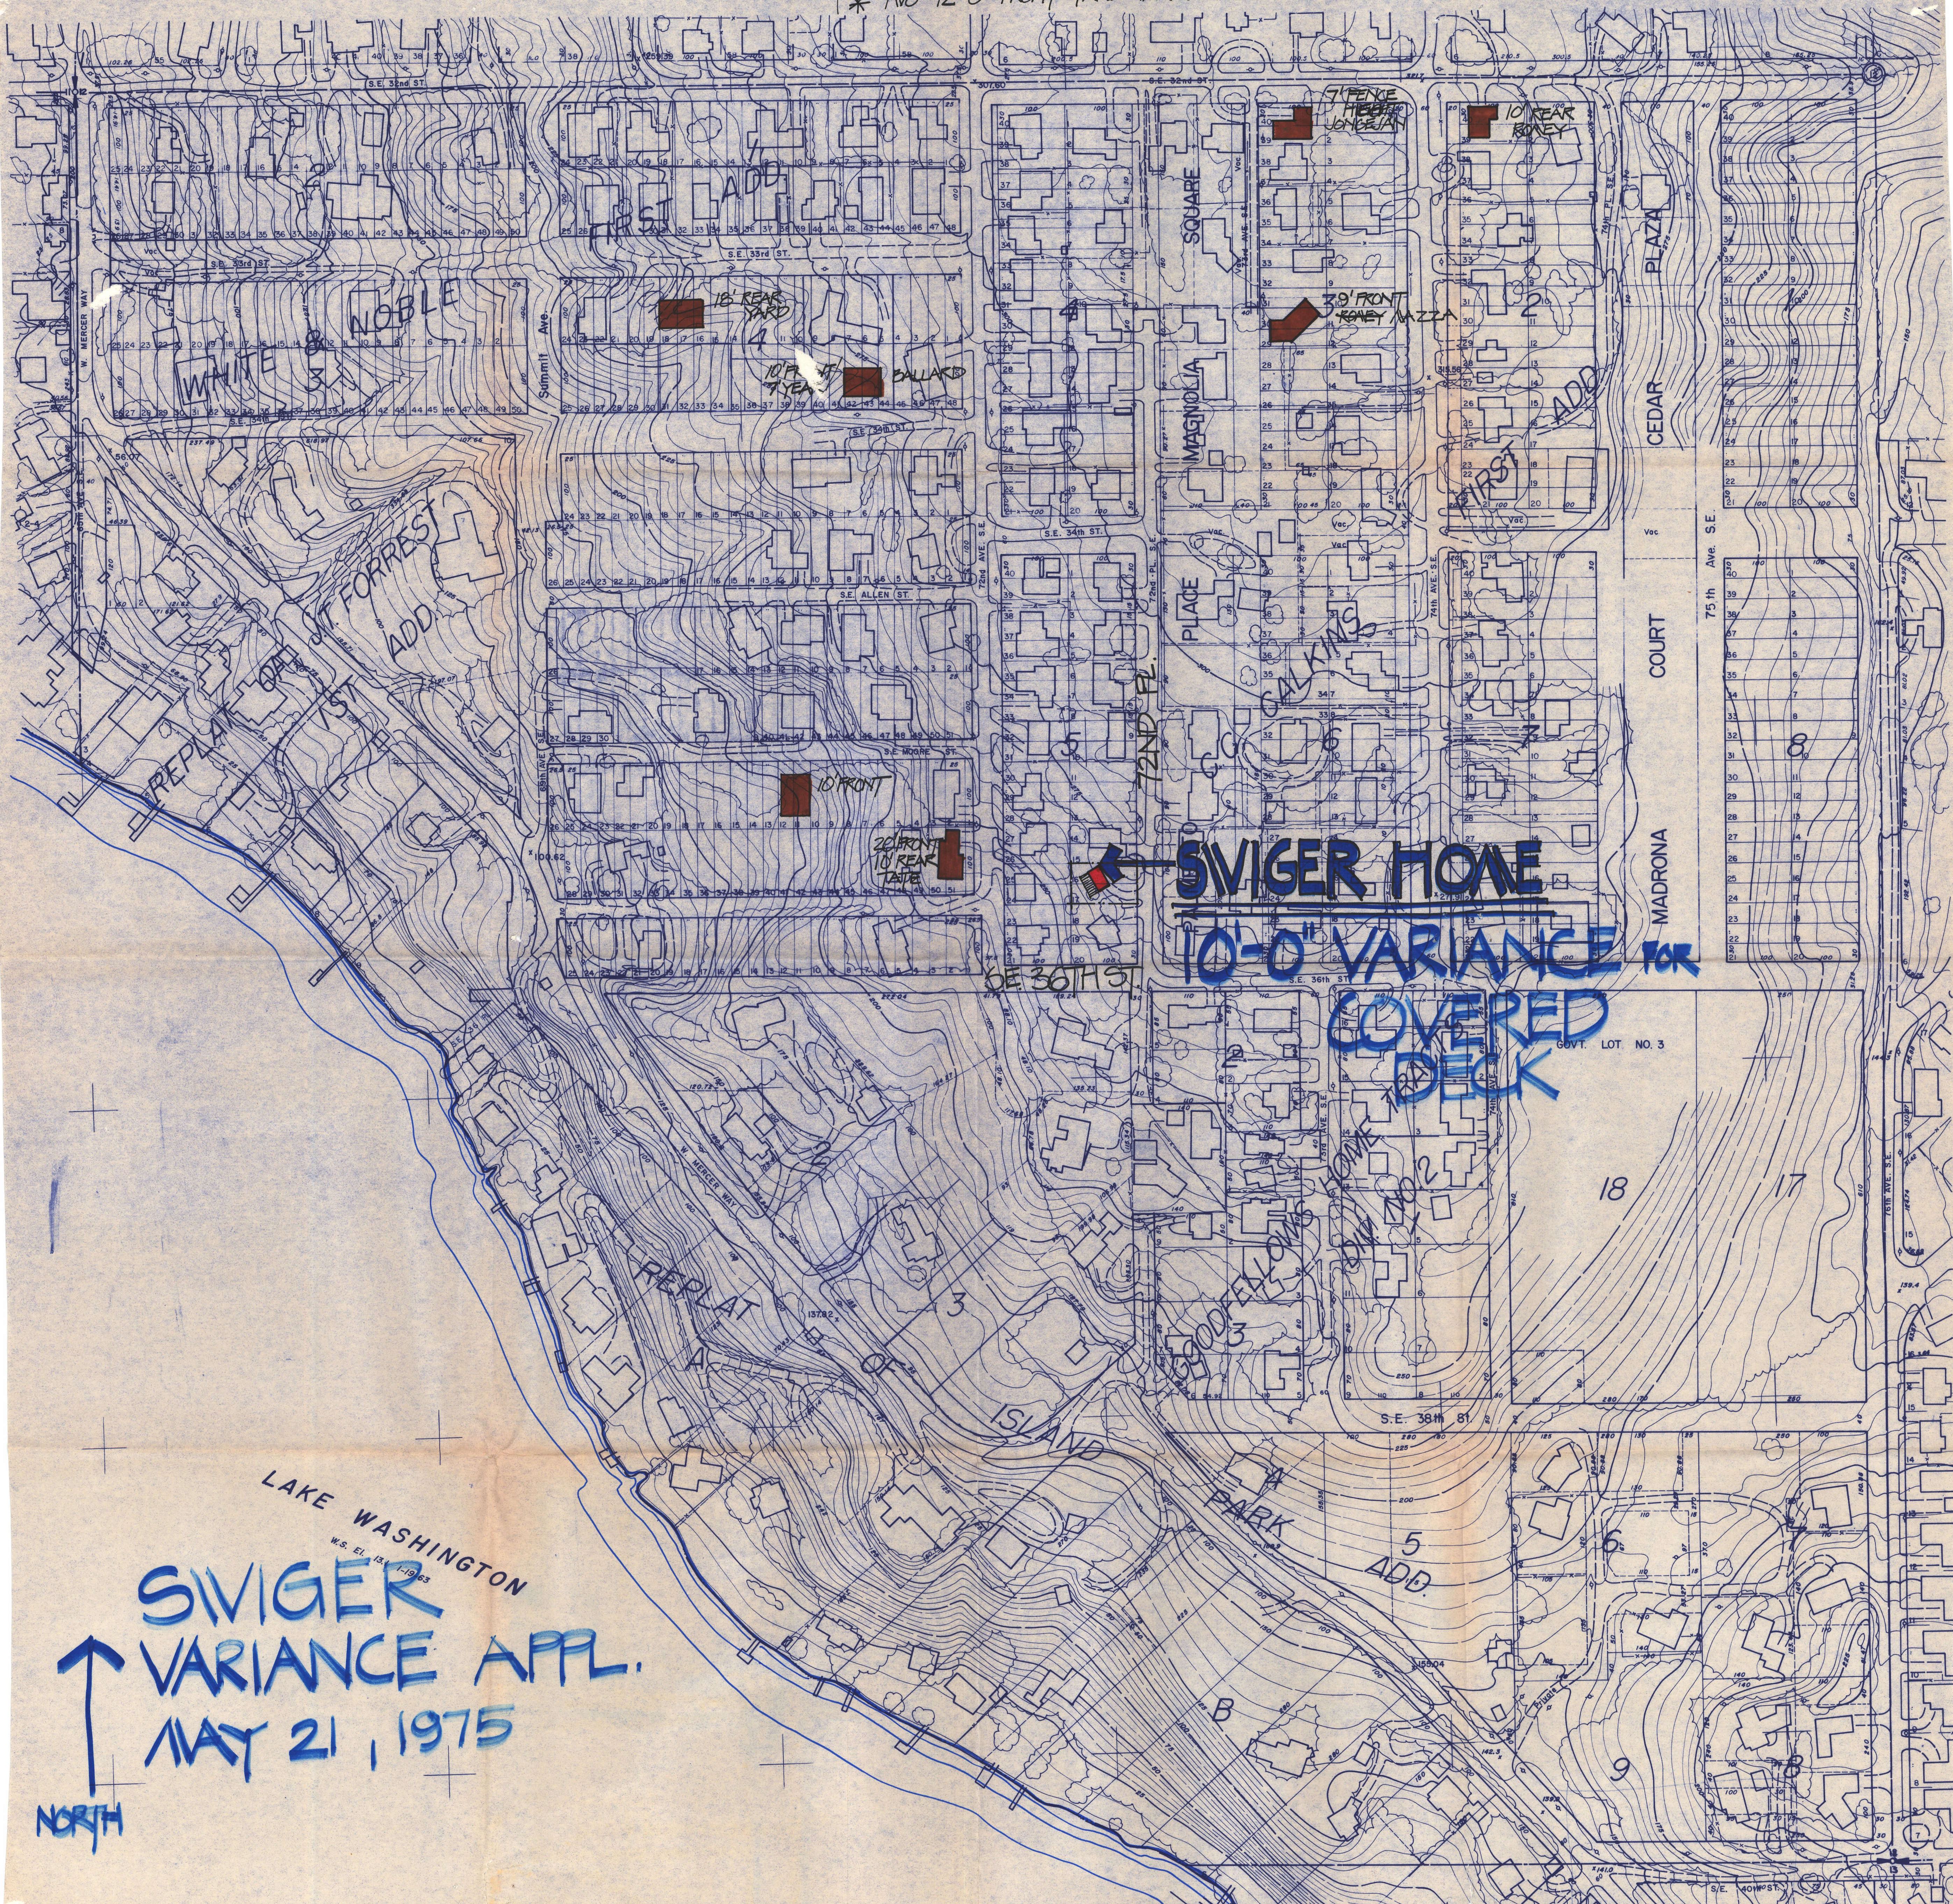
EXHIBIT D

* TWO 12'-0" FRONT YARD VARIANCES

LAKE WASHINGTON
W.S. EL. 151 1-1963

↑
SWIGER
VARIANCE APPL.
MAY 21, 1975
