Re: Public Comment Overview - File No. 2207-019 / 6950 SE Maker Street / Parcel
No. 9350900620

We are commenting on this proposed project because we believe the GFA calculation and the existing grades designated by the applicant do not comply with the Mercer Island City Code (MICC). We also have several concerns and questions for the City that pertain to the geotechnical and storm drainage report of which we request be answered. Additionally, due to the complexity of the proposed project, site considerations by the geotechnical consultant, and tight confines of Maker Street, we are requesting the City require a Construction Management Plan be filed. And lastly, based upon our understanding, the MICC tree code may have been violated, and we've provided information pertaining to that issue.

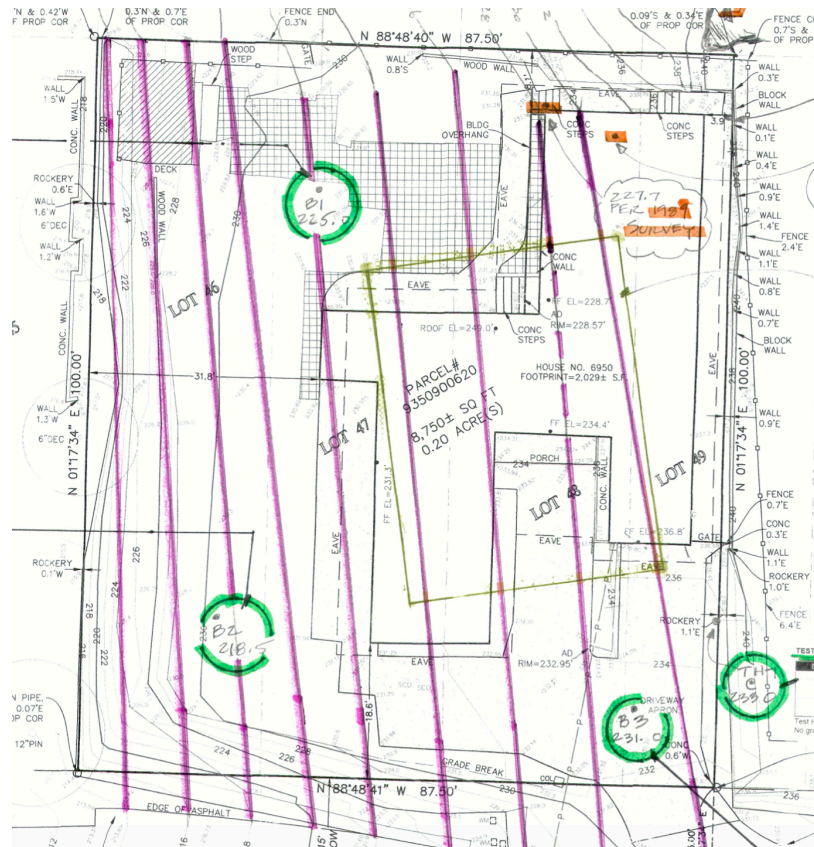
From this simple interpolation, the original topography of the 6950 site really takes shape, and again, is what you might expect both on paper and if you were out on site. Yes, the linear contours (highlighted in pink) lack the natural meander one would get had several shots been taken for each contour. But by the same token, all three parcels are laterally aligned with respect to the steep slope orientation and the contours line up in way that is expected. The adjusted existing grade for the borings and test holes are markedly in the ballpark on the 6950 site. And the basement floor spot elevation is within a foot of the floor elevation taken in the 2021 survey.

Lastly, the contours from the survey can be straight line interpolated with the contours of Maker Street. Maker likely received very little grading and filling along this stretch because of its steep course westward. Its contours lie mostly perpendicular to the fall line indicating that the road follows the steep slope downward with very little alteration. (In fact, this was corroborated by comparing a 60 year-old topographical map of First Hill and a not yet paved Maker Street with the current Lidar imaging available on the City’s GIS mapping portal.)

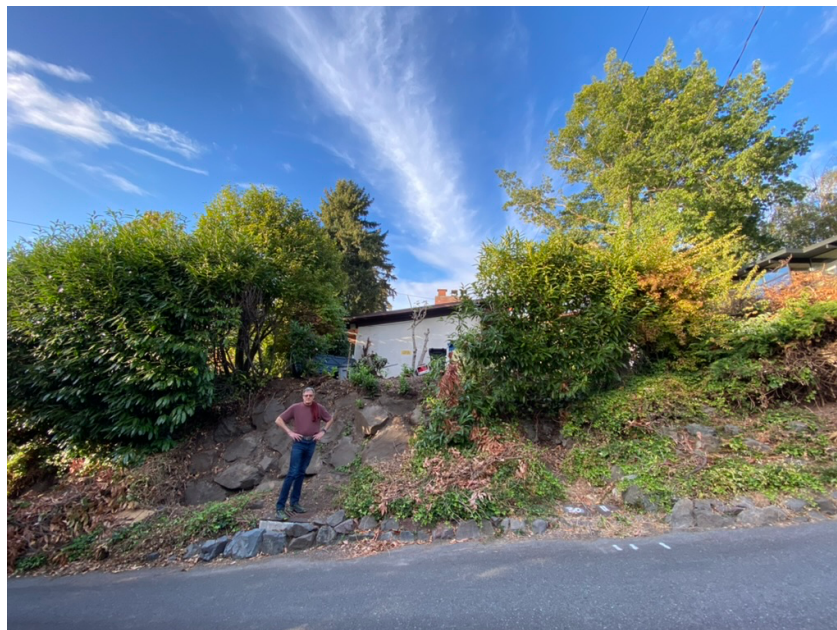
This rockery is identified on the map by atypical square-shaped map contours surrounding the property which clearly outline the man-made rockery supporting the fill. Even the south side of the rockery adjacent to SE Maker Street is over 6 feet tall (per photo). Note that Jim is standing on top of the catch basin as described in the Storm Drainage Report as Photo 3.

In the Critical Area Study, Geotechnical Consultants determined that this steep slope was created by fill. Per Geotech Consultants, the "flat yard area that appears to have been created by placing loose fill soils over the original ground surface during the original site development which was confirmed by test borings conducted for our study". "Borings found 5.5 to 11 feet of loose silty sand beneath the relatively flat yard" which is contained by an immense rockery on the south and west borders, at the highest point reaching 15.5 feet.

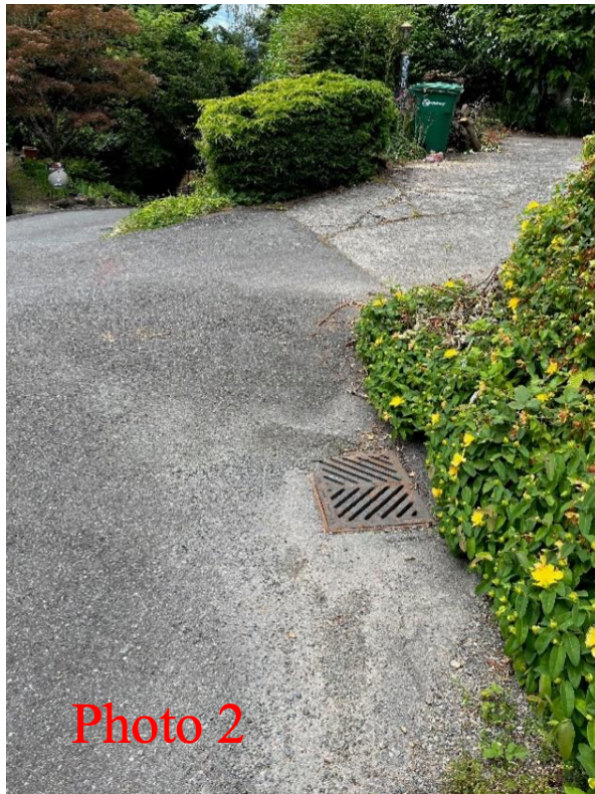
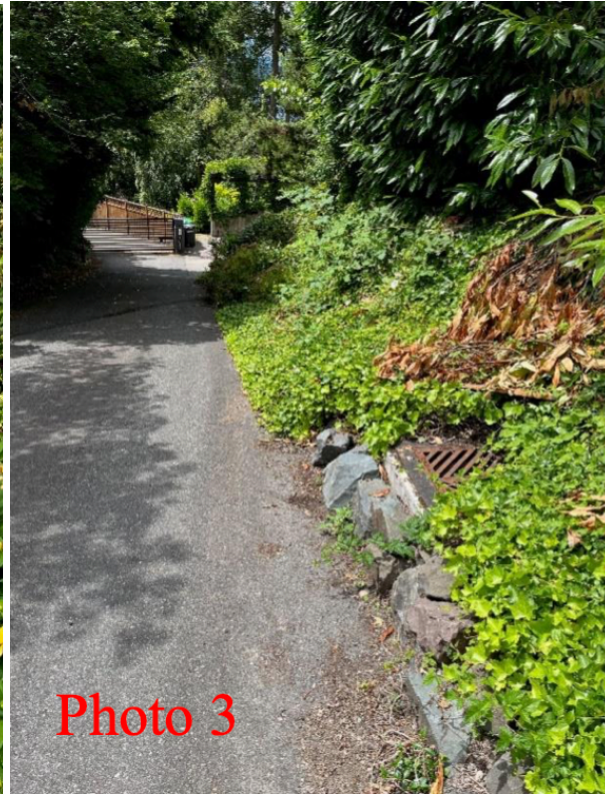
Photo 2 and Photo 3 from Stormwater Drainage report below. Note: Due to elevations and slope, No stormwater run-off is able to reach either culvert.

The challenge for the subject property, 6950 SE Maker Street, is that **neither** catch basin in Photo 2 and Photo 3, catch runoff from the subject property or the street, SE Maker. The one

catch basin just east of the driveway (Photo 2) is at a higher elevation than the subject's driveway and SE Maker Street. It was completely grown over from nonuse and recently cleared from weeds, i.e. St. John's Wort and ivy. This culvert doesn't collect rainwater coming down Maker Street due to the location and elevation.

The catch basin in Photo 3 is elevated in the rockery. The only way for this basin to collect stormwater is if water collection was directed in pipes to this culvert/catch basin. This storm drain is located midway below the subject property but is not located at road grade.

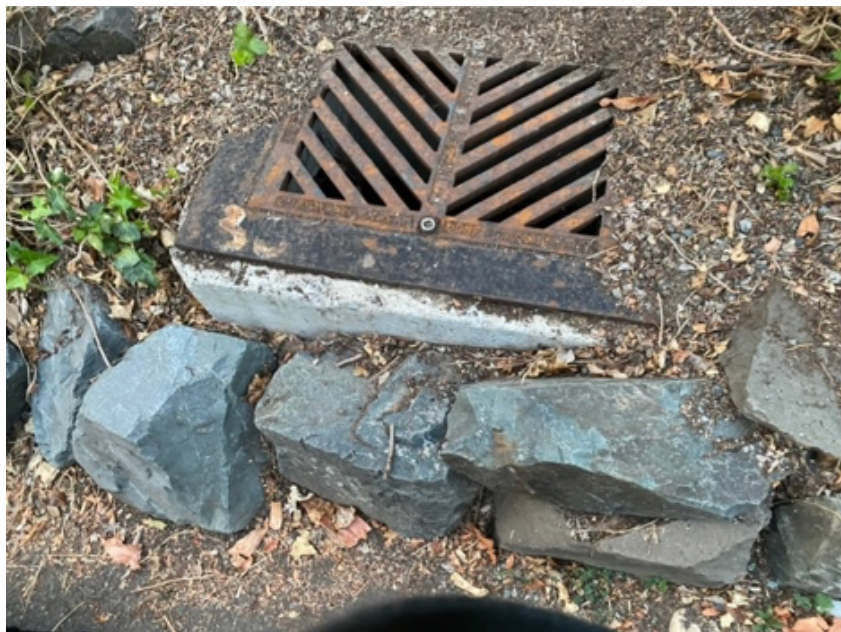
Photo of elevated catch basin on Maker Street (same culvert referred to per Photo 3 in Storm Drainage Report).

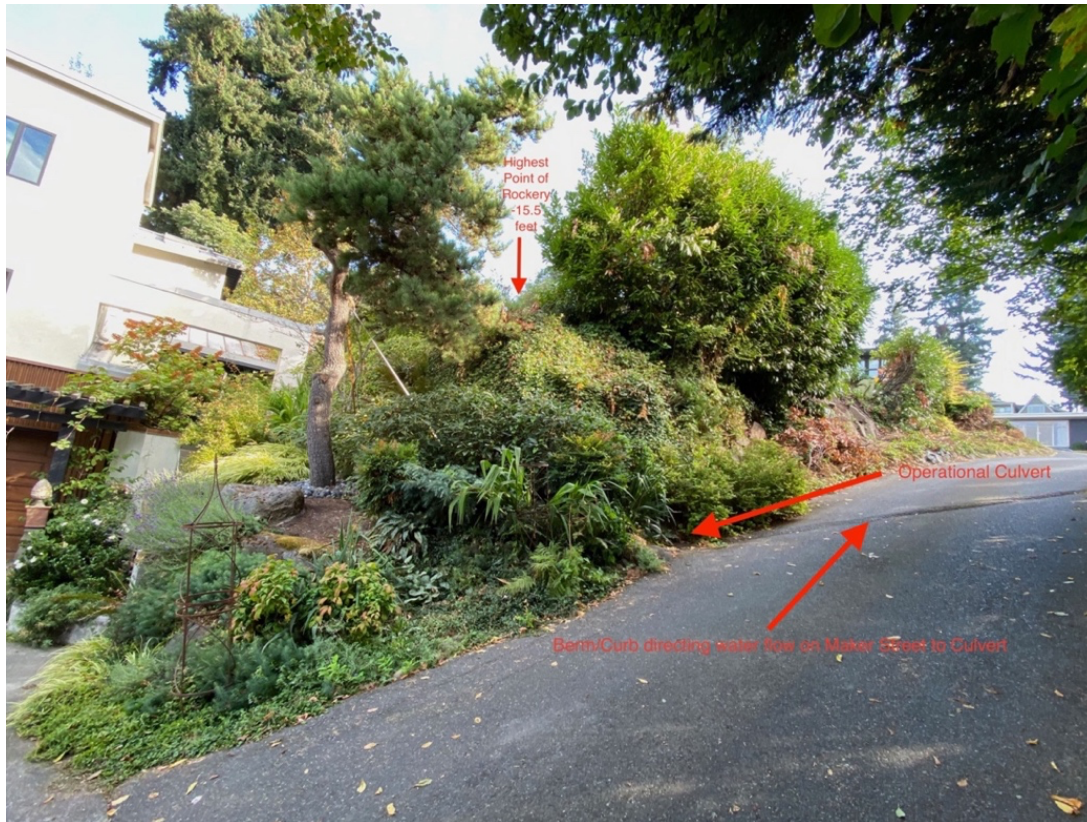
Photo of Maker Street: Looking up from house on 7030 Maker Street to adjacent uphill property, 6950 SE Maker Street. Arrows point to operational culvert and berm/curb that directs Maker Street runoff to culvert.

Therefore, we believe that the subject property should be required to tightline/pipe all stormwater during construction and construction runoff into one of the unused storm drains. In that case there is less chance that the construction project stormwater would breach the existing berms/curbs and overwhelm the two functional culverts located at 7030 SE Maker Street. See photos below and Appendix.

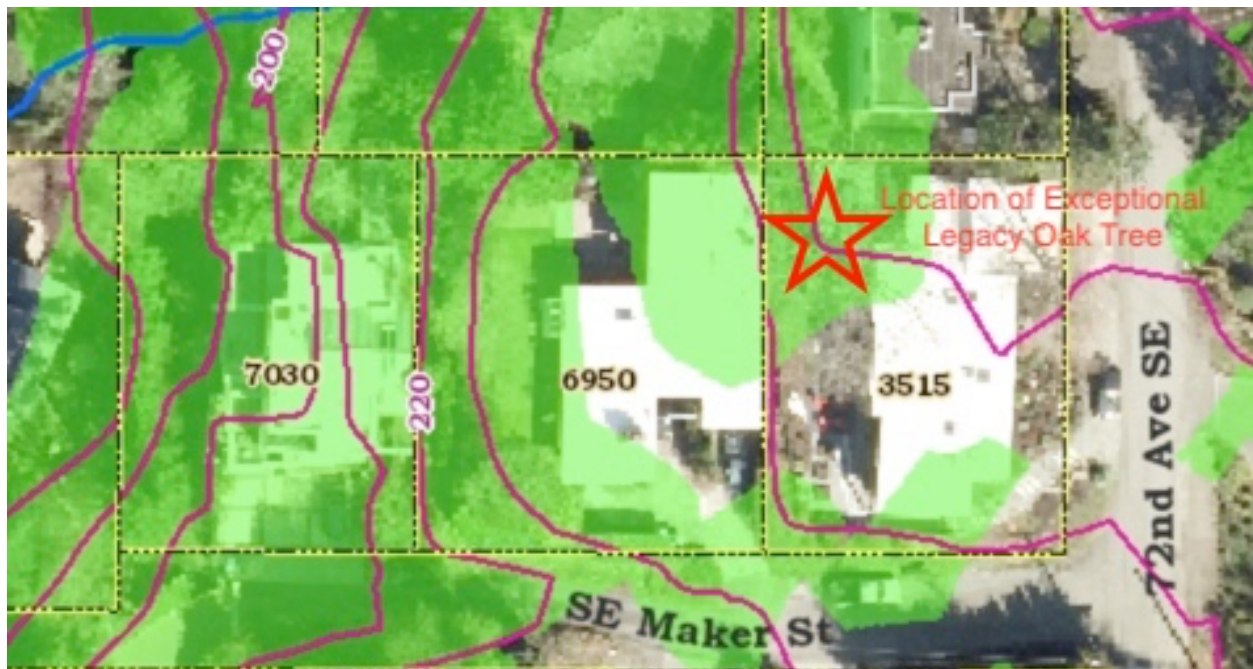
This Red Oak has a diameter of 46 Inches (measured by owner) or 3’ 10” and is located on a mapped critical area (indicated in green on map) on neighbor’s property (3515), adjacent to (6950) as shown on the map below:

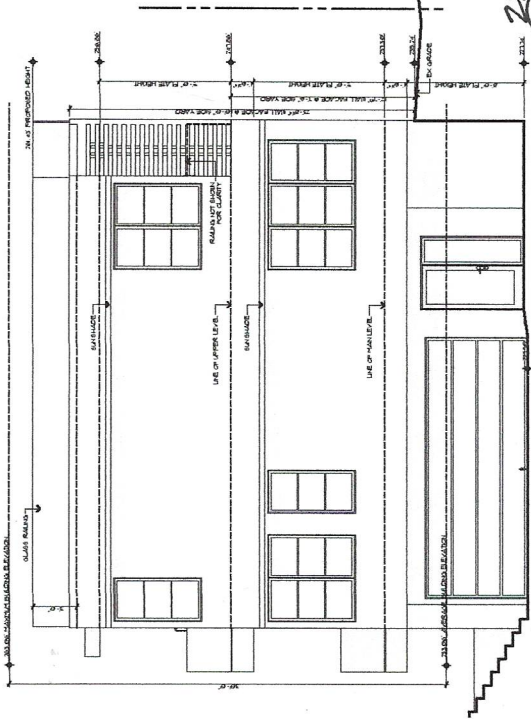
SOUTH ELEVATION
 SCALE: 1/4" = 1'-0"

1
 227.74 PROPOSED FINISH GRADE
 NONE OF WALL IS BELOW FF & EXIST. GRADE (COVERED)
 35'-0"

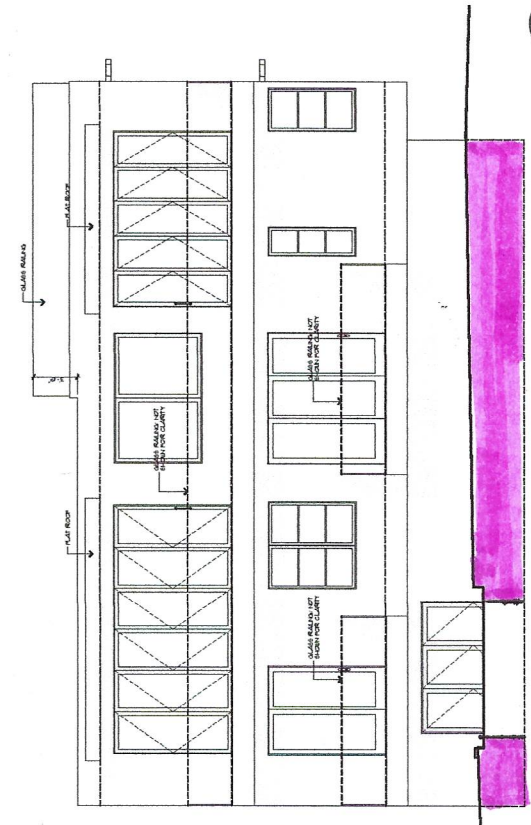
WEST ELEVATION
 SCALE: 1/4" = 1'-0"

2
 45'-0" APPROX. 50% OF WALL IS COVERED.
 10'-0"

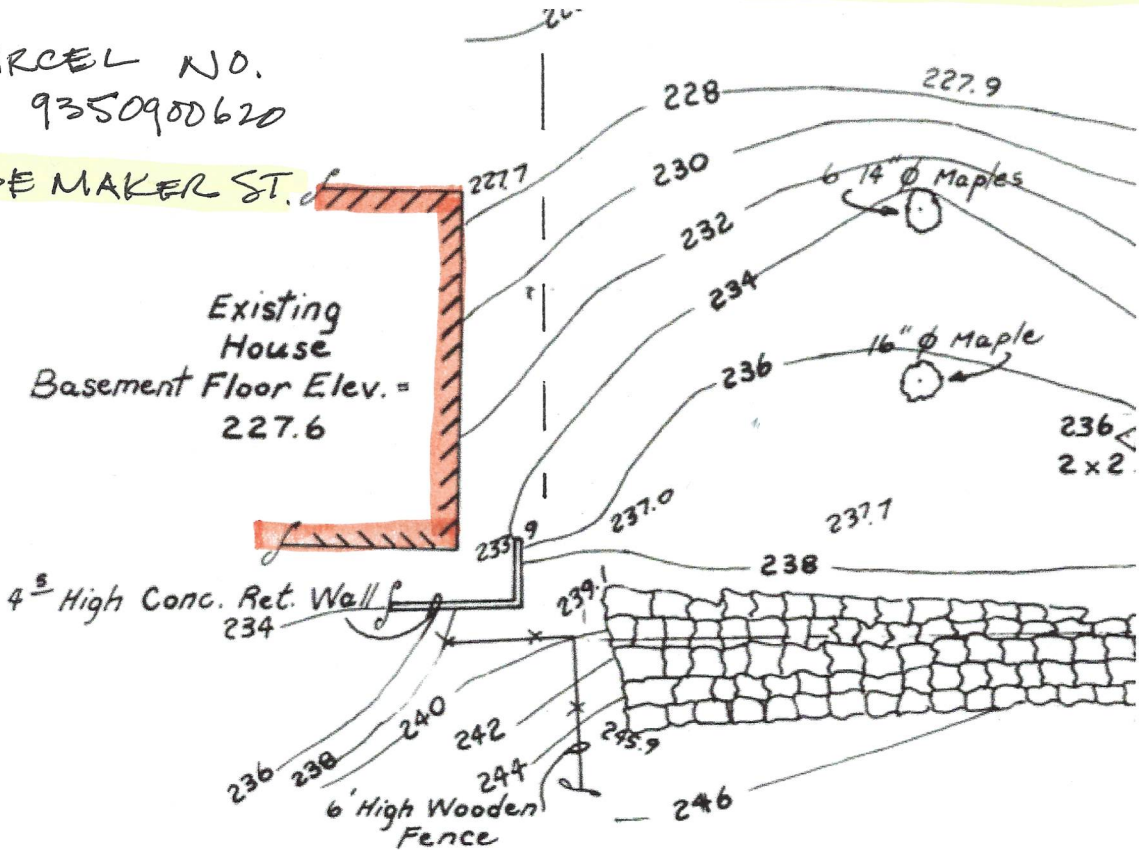
DRAWING CUT TAKEN FROM
MAY 1989 SURVEY
D.R. STRONG CONSULTING
ENGINEERS
