Earth Solutions NW LLC

August 25, 2022
Updated February 2, 2023
ES-8694

**Subject: Geotechnical and Geologically Hazardous Areas Evaluation
Proposed Residential Addition
6010 East Mercer Way
Mercer Island, Washington**

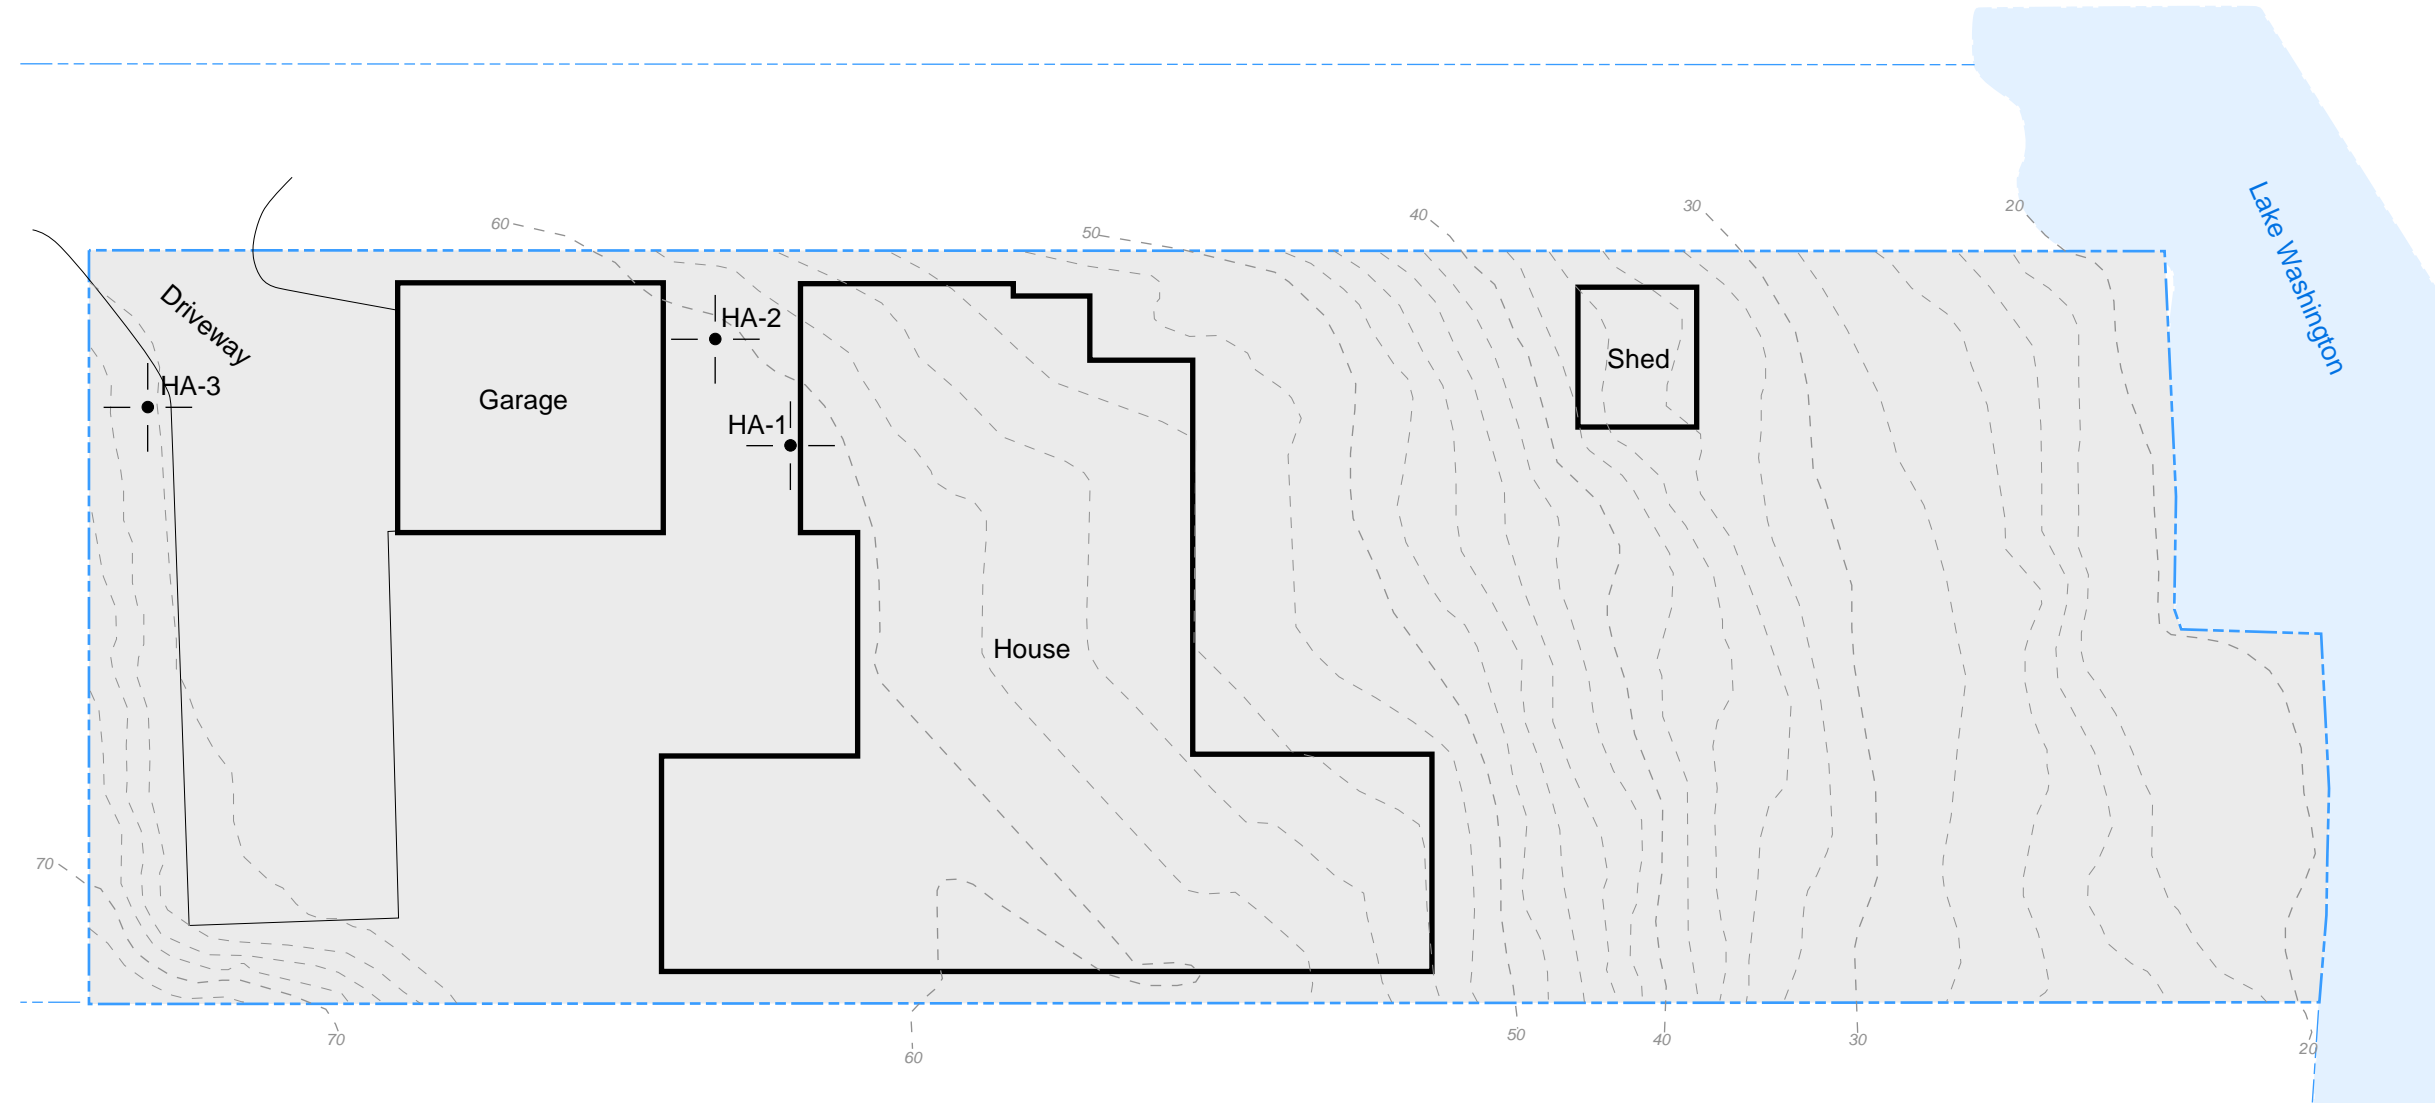
- HA-1 | • | Approximate Location of ESNW Hand Auger Boring, Proj. No. ES-8694, June 2022
- ▭ | Subject Site
- ▭ | Existing Building

The approximate locations of the borings are depicted on Plate 2 (Hand-Auger Boring Location Plan). Please refer to the attached boring logs for a more detailed description of subsurface conditions. Representative soil samples collected at our exploration sites were analyzed in general accordance with Unified Soil Classification System (USCS) and USDA methods and procedures.

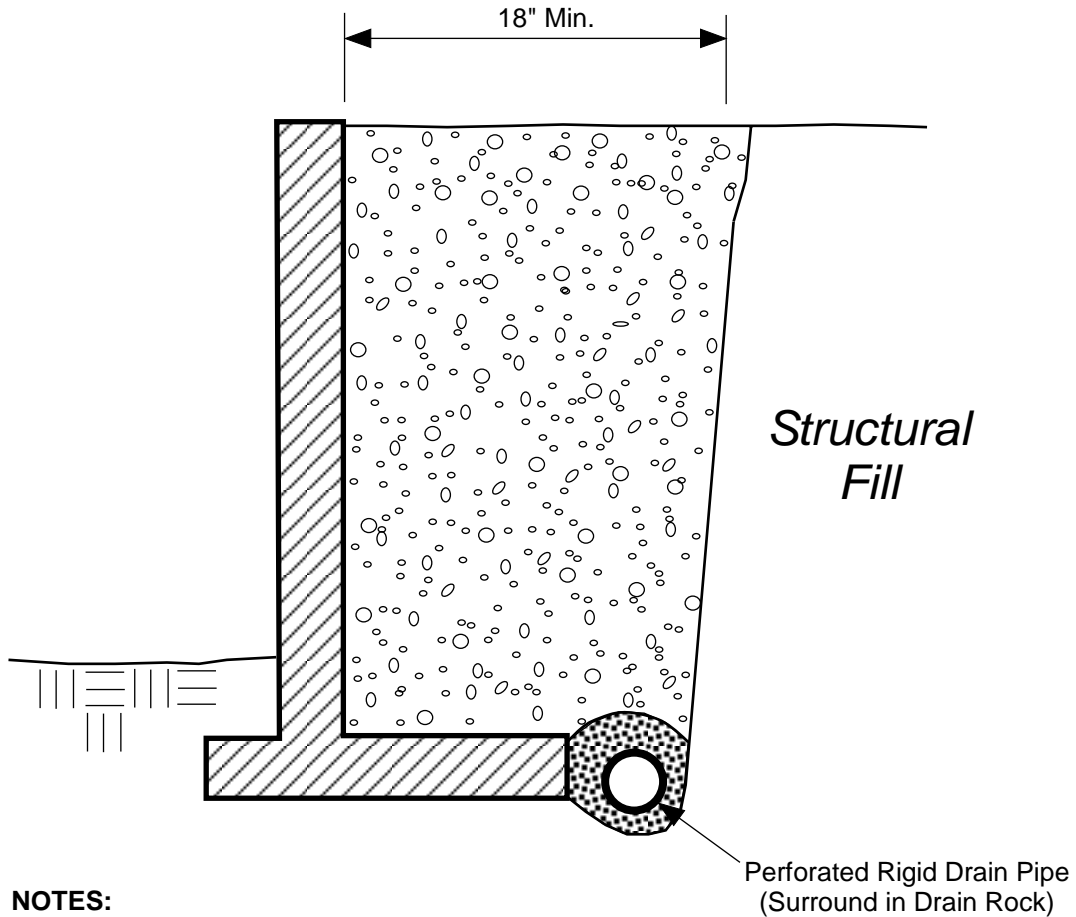
Earth Solutions NW_{LLC} Geotechnical Engineering, Construction Observation/Testing and Environmental Services	
Retaining Wall Drainage Detail Alexander Residence Mercer Island, Washington			
Drwn. CAM	Date 08/25/2022	Proj. No. 8694	
Checked SSR	Date Aug. 2022	Plate 3

- Free-draining Backfill should consist of soil having less than 5 percent fines. Percent passing No. 4 sieve should be 25 to 75 percent.
- Sheet Drain may be feasible in lieu of Free-draining Backfill, per ESNW recommendations.
- Drain Pipe should consist of perforated, rigid PVC Pipe surrounded with 1-inch Drain Rock.

1-inch Drain Rock

Drainage should be provided behind retaining walls such that hydrostatic pressures do not develop. If drainage is not provided, hydrostatic pressures should be included in the wall design. A perforated drainpipe should be placed along the base of the wall and connected to an approved discharge location. A typical retaining wall drainage detail is provided on Plate 3.

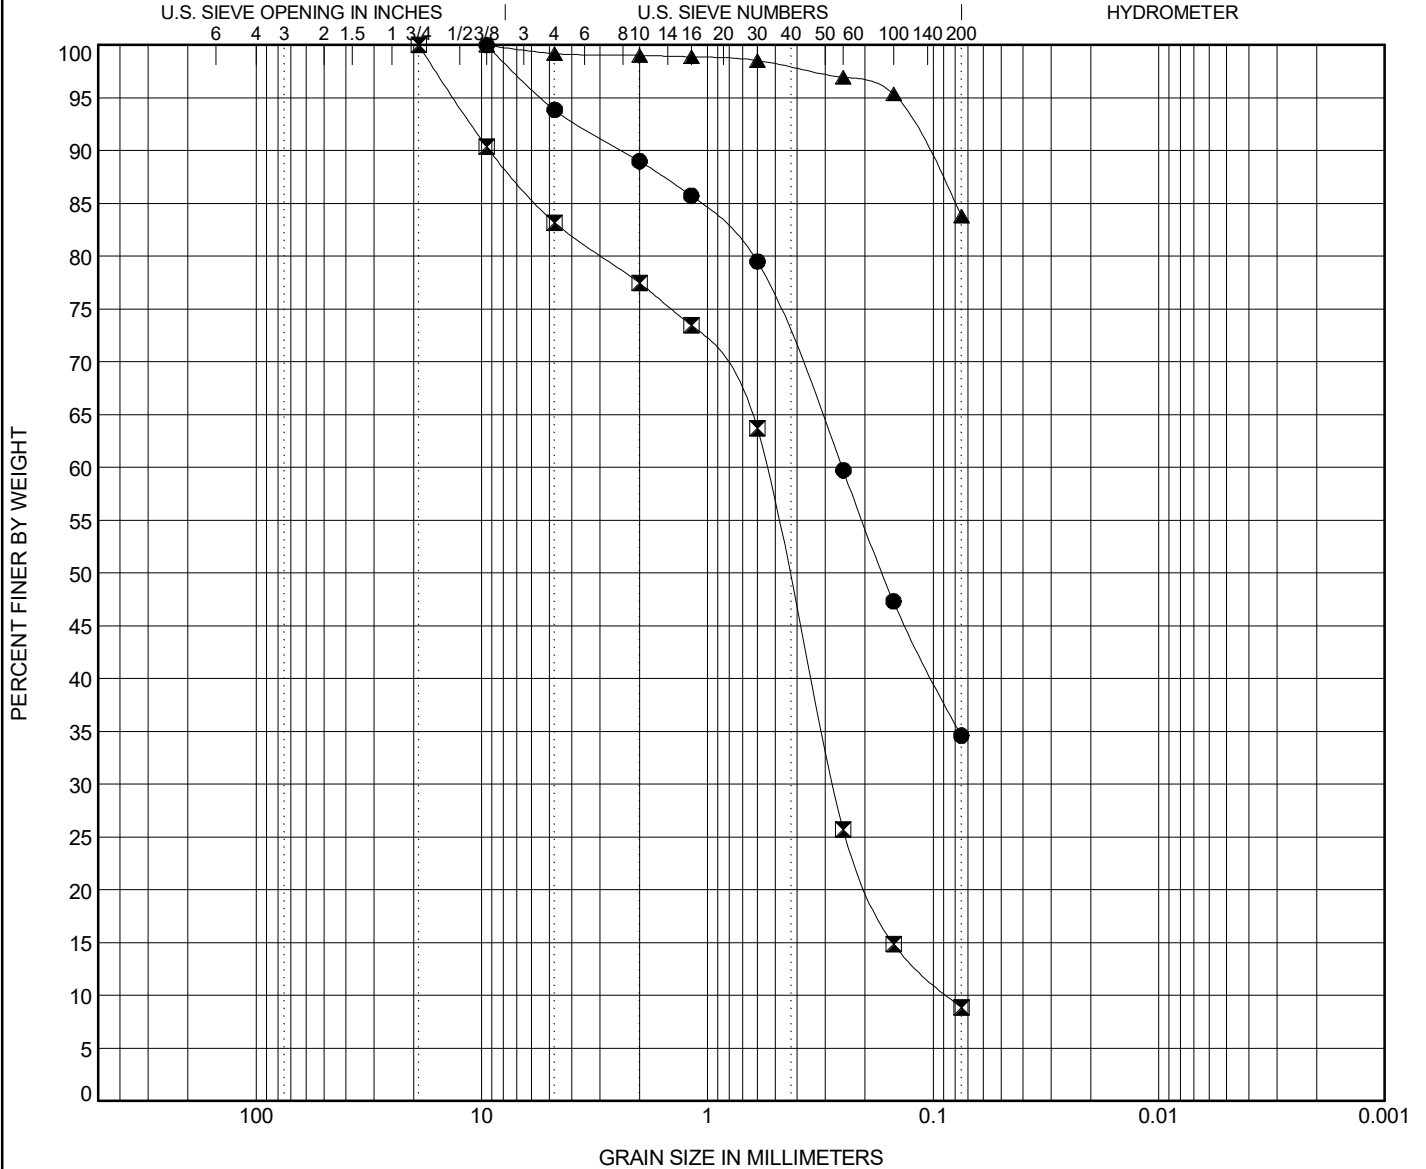
COBBLES	GRAVEL		SAND			SILT OR CLAY
	coarse	fine	coarse	medium	fine

Specimen Identification	Classification							Cc	Cu
● HA-01 2.00ft.	USDA: Gray Slightly Gravelly Sandy Loam. USCS: SM.								
☒ HA-02 4.00ft.	USDA: Gray Gravelly Sand. USCS: SW-SM with Gravel.							1.62	6.47
▲ HA-03 2.00ft.	USDA: Gray Slightly Gravelly Loam. USCS: ML with Sand.								
Specimen Identification	D100	D60	D30	D10	LL	PL	PI	%Silt	%Clay
● HA-01 2.0ft.	9.5	0.253						34.6	
☒ HA-02 4.0ft.	19	0.551	0.276	0.085				8.9	
▲ HA-03 2.0ft.	9.5							83.8
