# LEVEL 1 DOWNSTREAM ANALYSIS

## 8814 MI Single-Family Residence

8814 SE 40<sup>th</sup> Street

Date: December 9, 2022

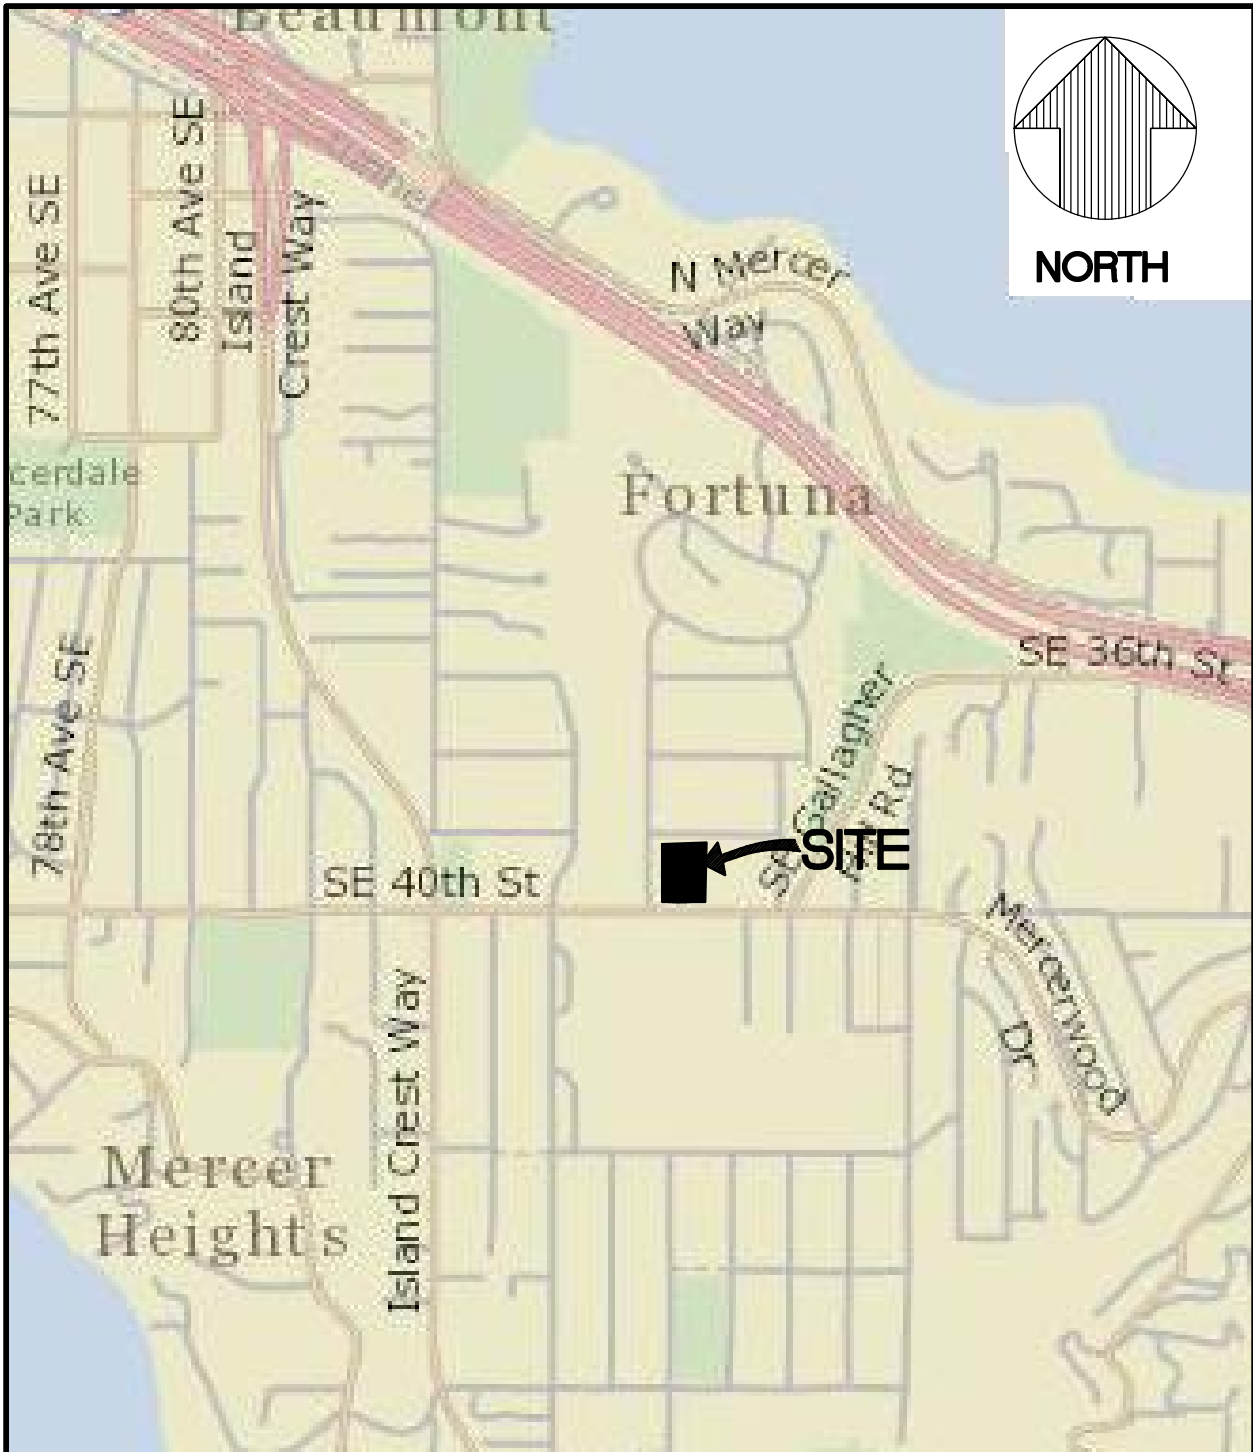
<b>TEBALDI ENGINEERING, LLC</b> <b>4625 - 126TH AVENUE EAST</b> <b>EDGEWOOD, WA 98372</b>	<b>FOR:</b> <b>40TH RESIDENCE</b>	<b>JOB #</b> 
	<b>TITLE:</b> <b>VICINITY MAP</b>

**NORTH**

**← SITE**

Figure 1.1 - Vicinity Map

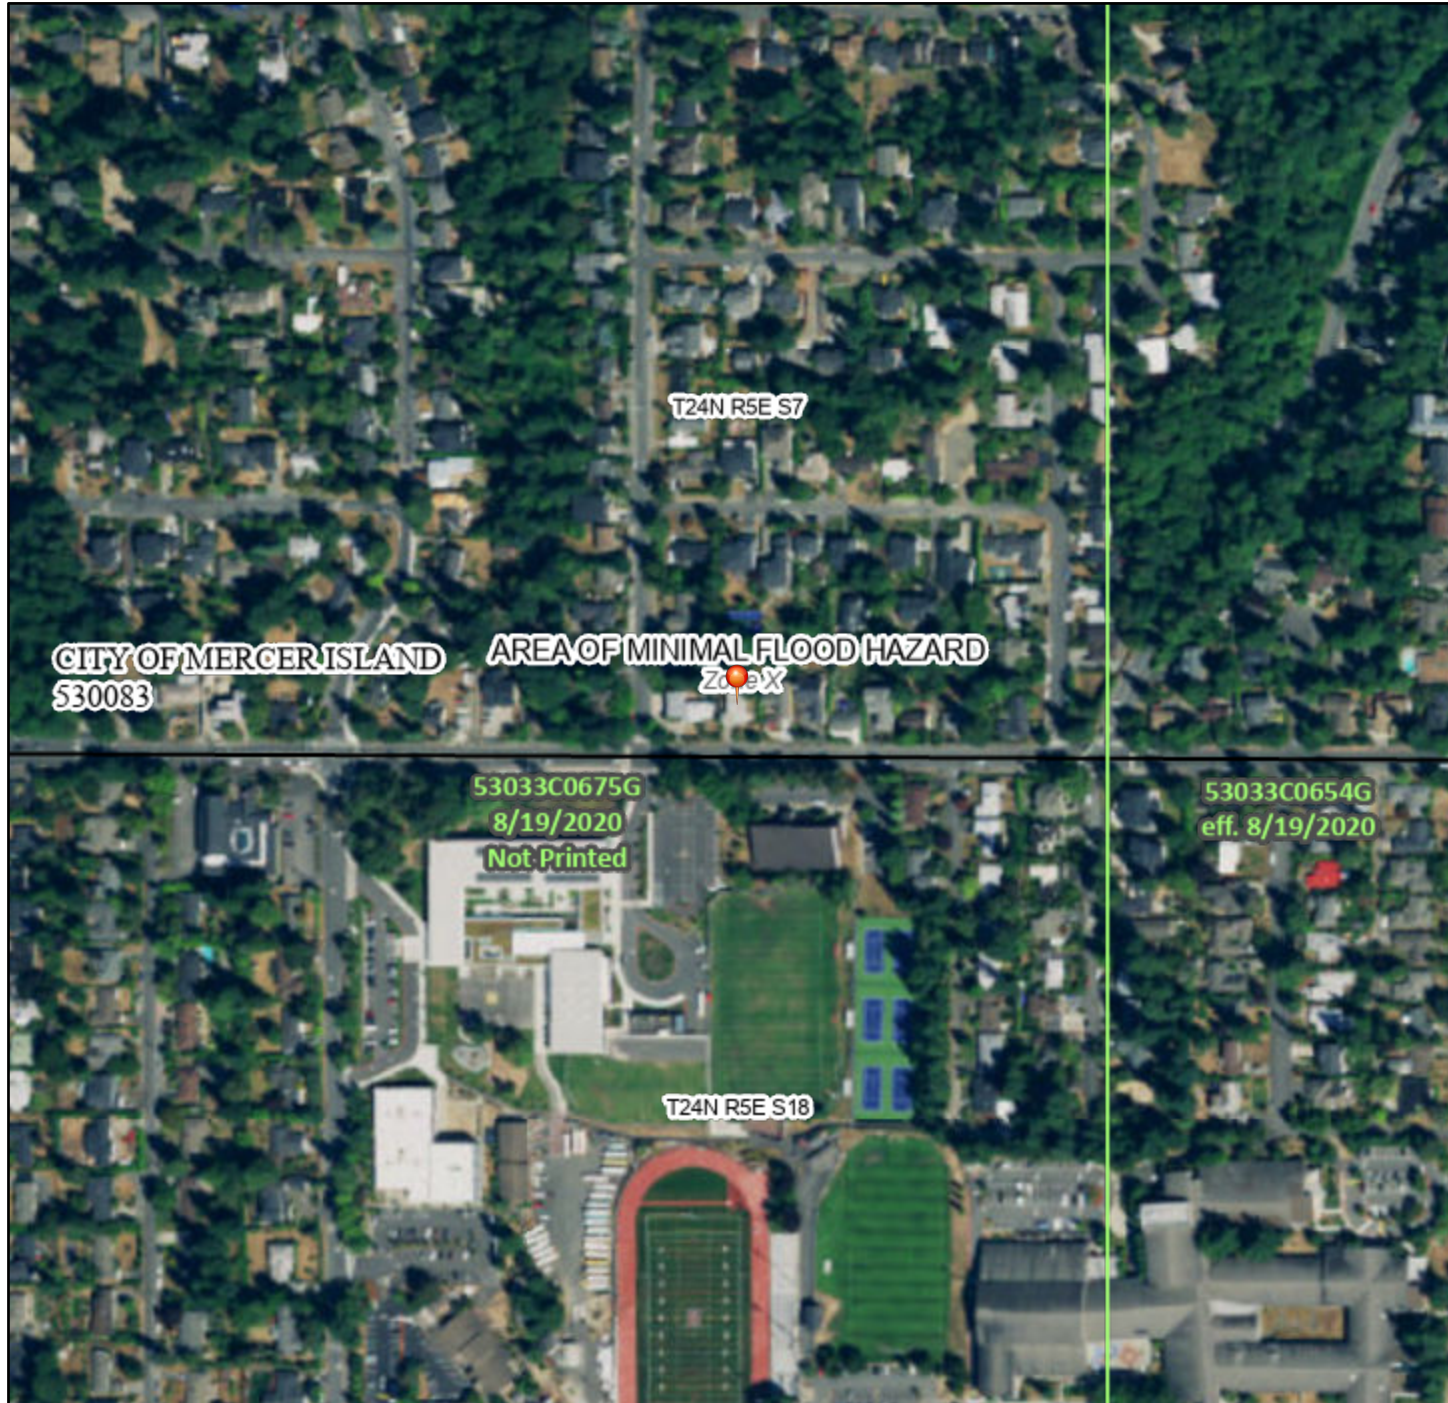
# National Flood Hazard Layer FIRMMette

The flood hazard information is derived directly from the authoritative NFHL web services provided by FEMA. This map was exported on **12/9/2022 at 8:24 PM** and does not reflect changes or amendments subsequent to this date and time. The NFHL and effective information may change or become superseded by new data over time.

Figure 1.3 – FEMA Map

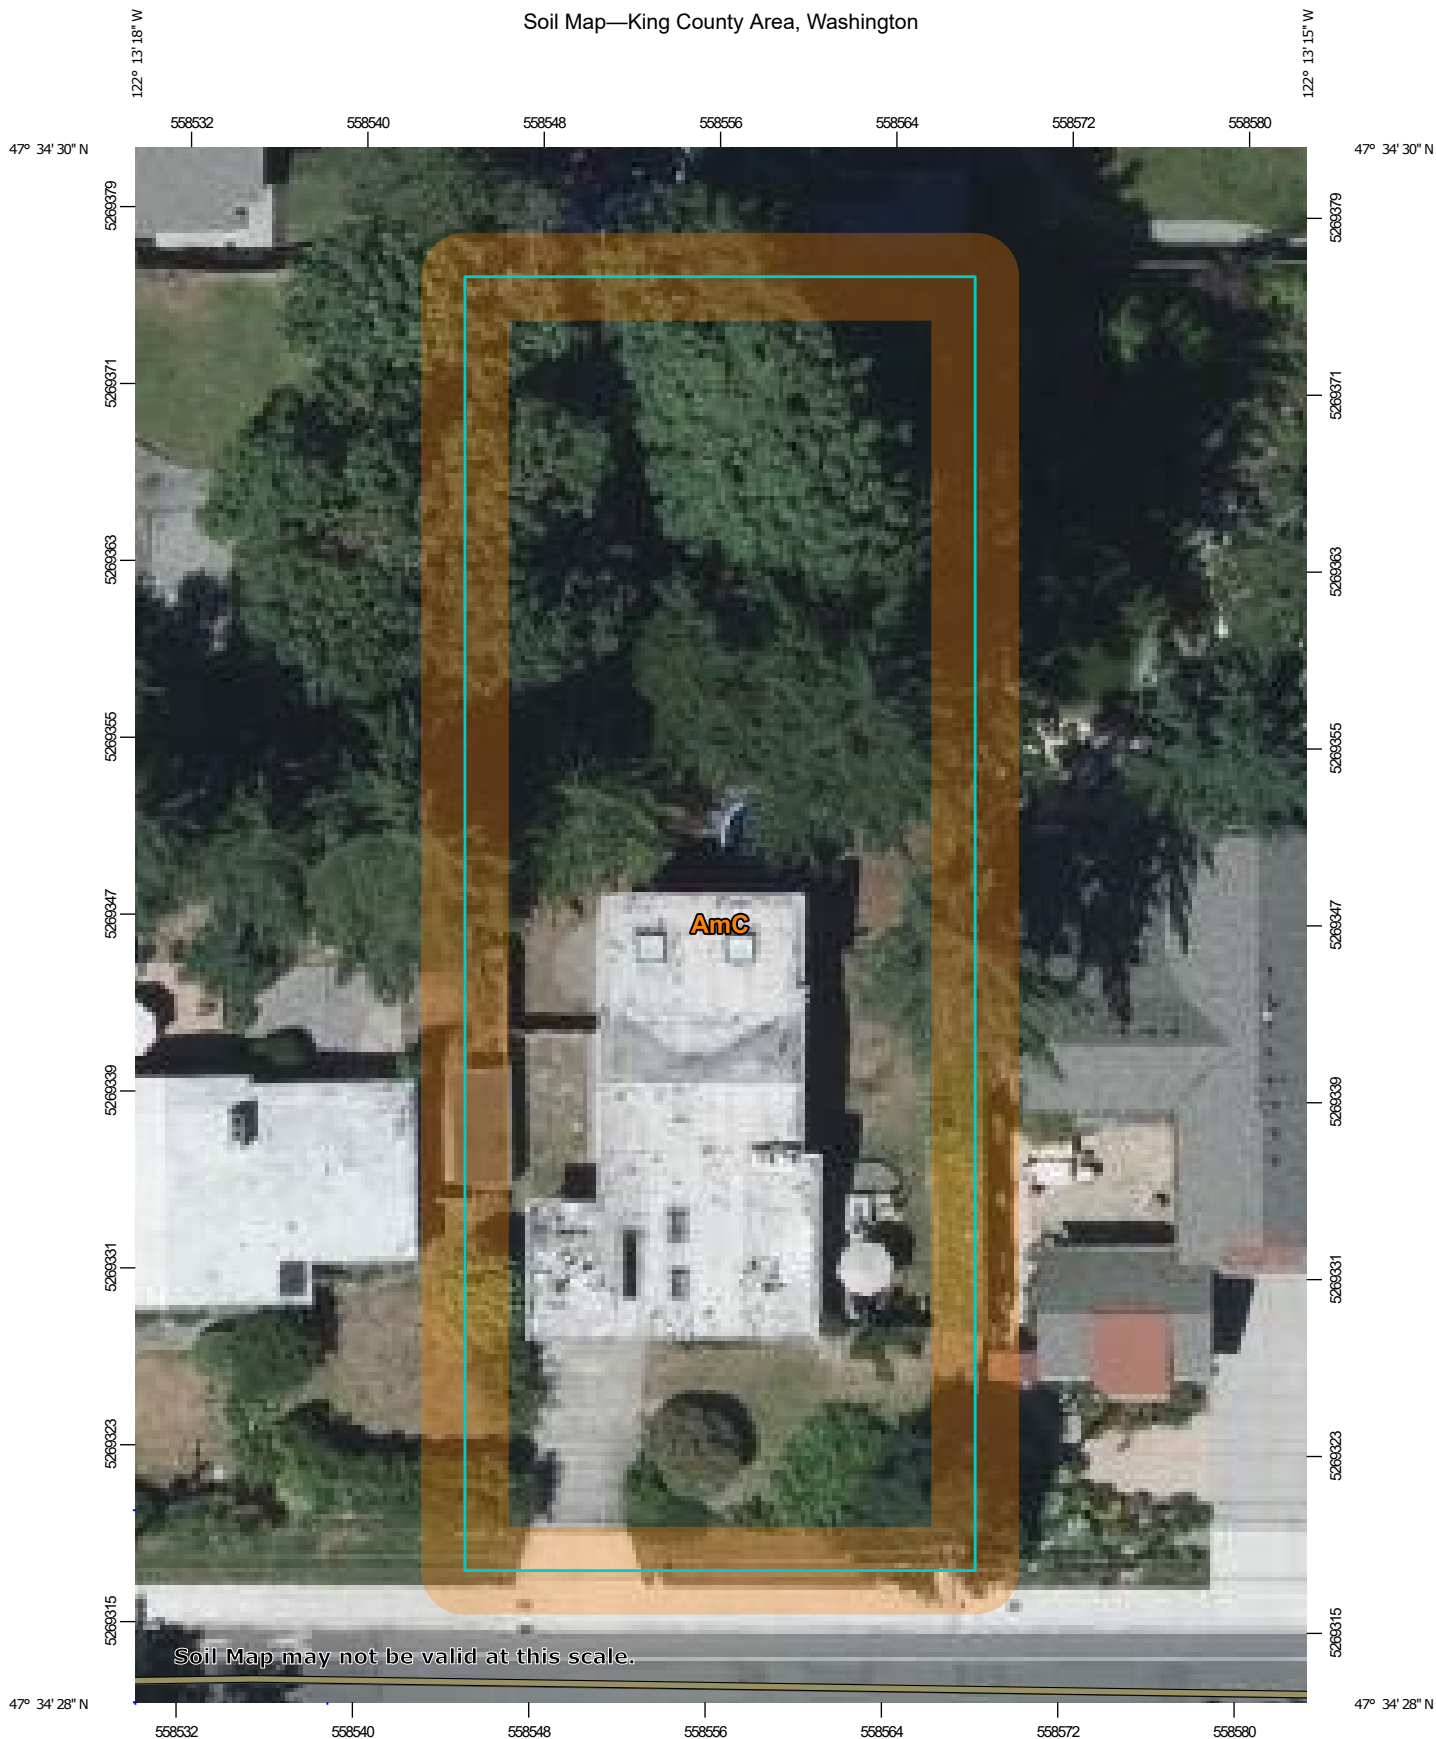
Soil Map—King County Area, Washington

Soil Map may not be valid at this scale.

Figure 2.1 - Soils Map

The proposed project site is located within a portion of the Section 7, Township 24 North, Range 5 East of the Willamette Meridian with a total project site area of 0.30 acres. More specifically, the site is located at 8814 SE 40<sup>th</sup> Street, Mercer Island, WA 98040. See Figure 1.1-Vicinity Map in this section for the location of the proposed project site. The existing property currently has an existing home along with the associated driveway and utilities. On-site native soils are classified as Arents-Alderwood per the NRCS soil survey. See soils map in section 2.0.

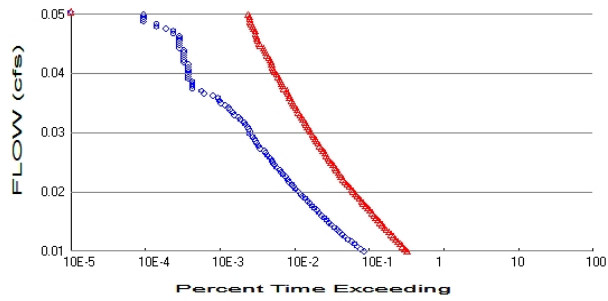
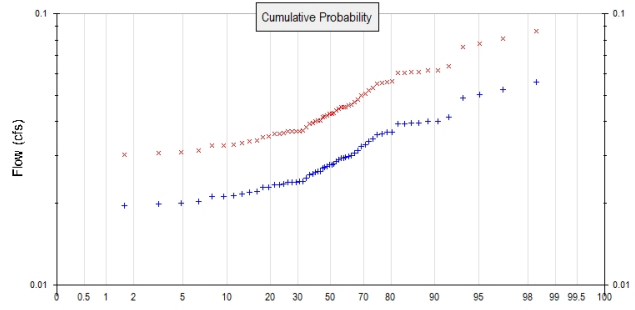
## POC 1

+ Predeveloped    x Mitigated

The Duration Matching **Failed**

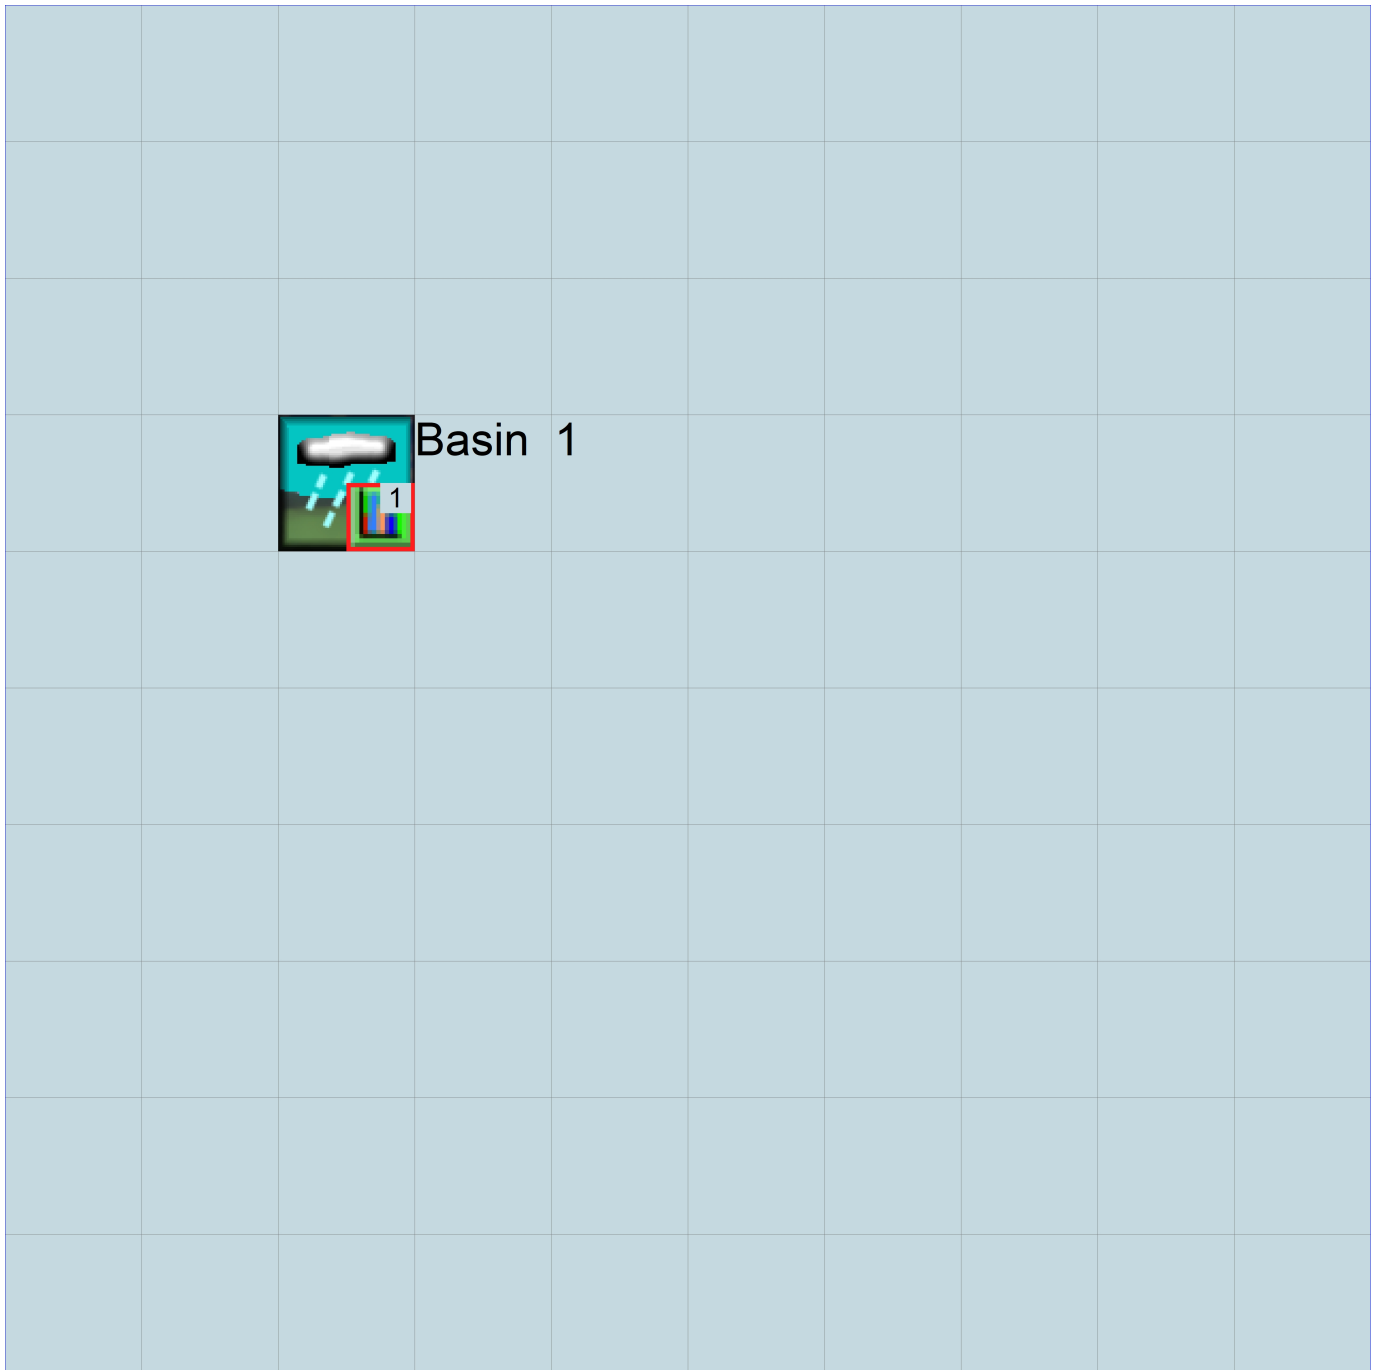
# Mitigated Schematic

Basin 1
