Drainage Report For Hatley Residence

Date Prepared: July 30, 2023
Site Address: 4114 83rd Ave SE
Mercer Island, WA 98040
Parcel Number: 362650-0035

Prepared By:
Lisa A. Harbert, P.E.

Drainage Report for
Hatley Residence
4114 83rd Ave SE, Mercer Island, WA 98040

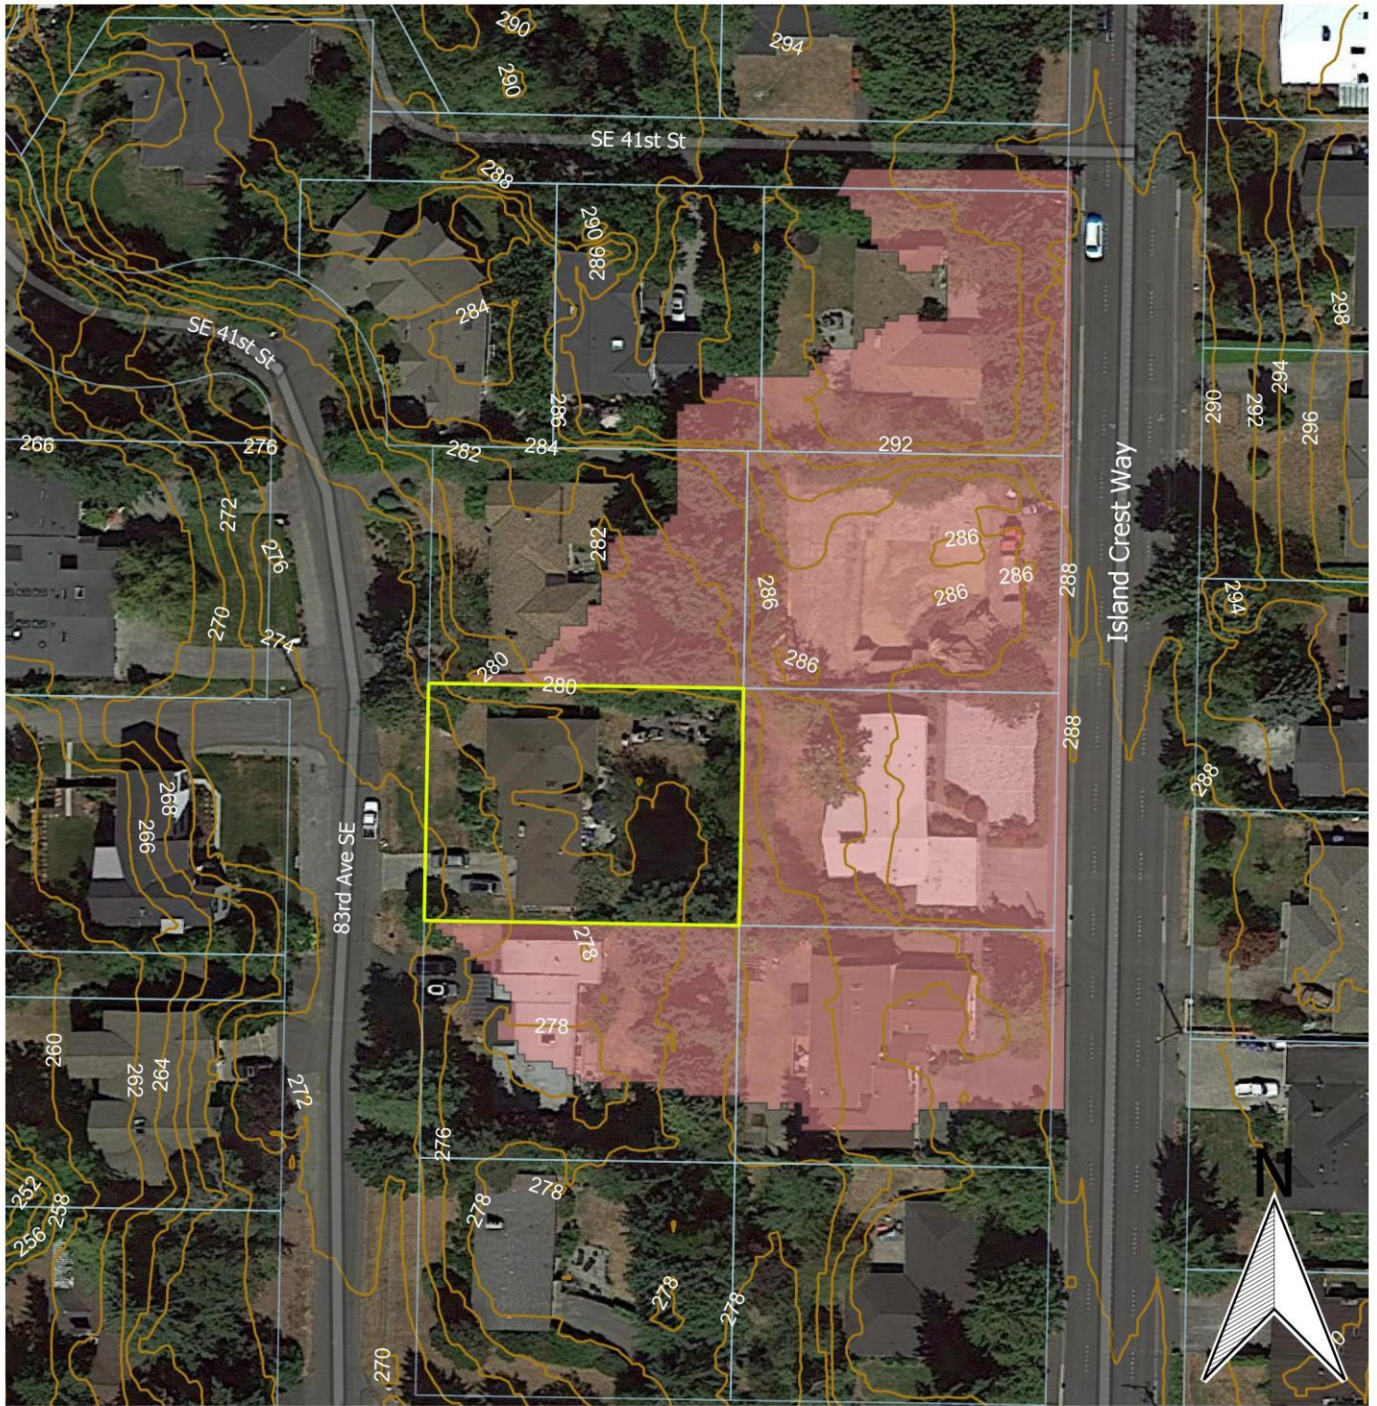
- Site
- Upslope Area

The upstream area was determined using LIDAR imagery and was observed during a site visit. The upstream area stretches east to the edge of Island Crest Way and north to the edge of SE 41st Street, covering portions of neighboring residential properties. The upstream area can be seen in Figure 3.
