# Storm Drainage Report

Atwal's Residence

At 4029 97<sup>th</sup> Ave SE

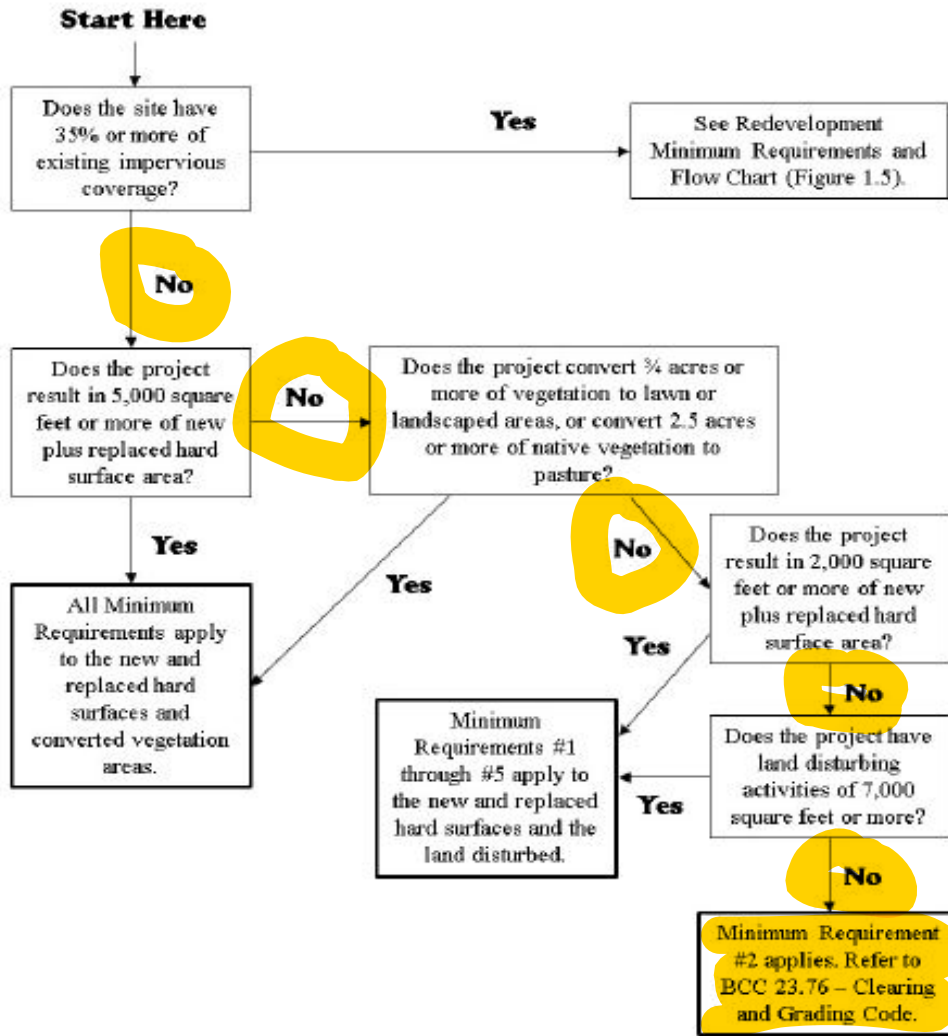
**Figure 1.4 – Flow Chart for Determining Minimum Requirements for New Development Projects**

Source: Adapted from Figure 2.4.1 of Volume I of the DOE Manual.

According to the above Flow Chart for determining requirements for New Development project, Minimum Requirements #2 SWWMM 2019 apply to the new and replaced impervious surfaces and the land disturbed.

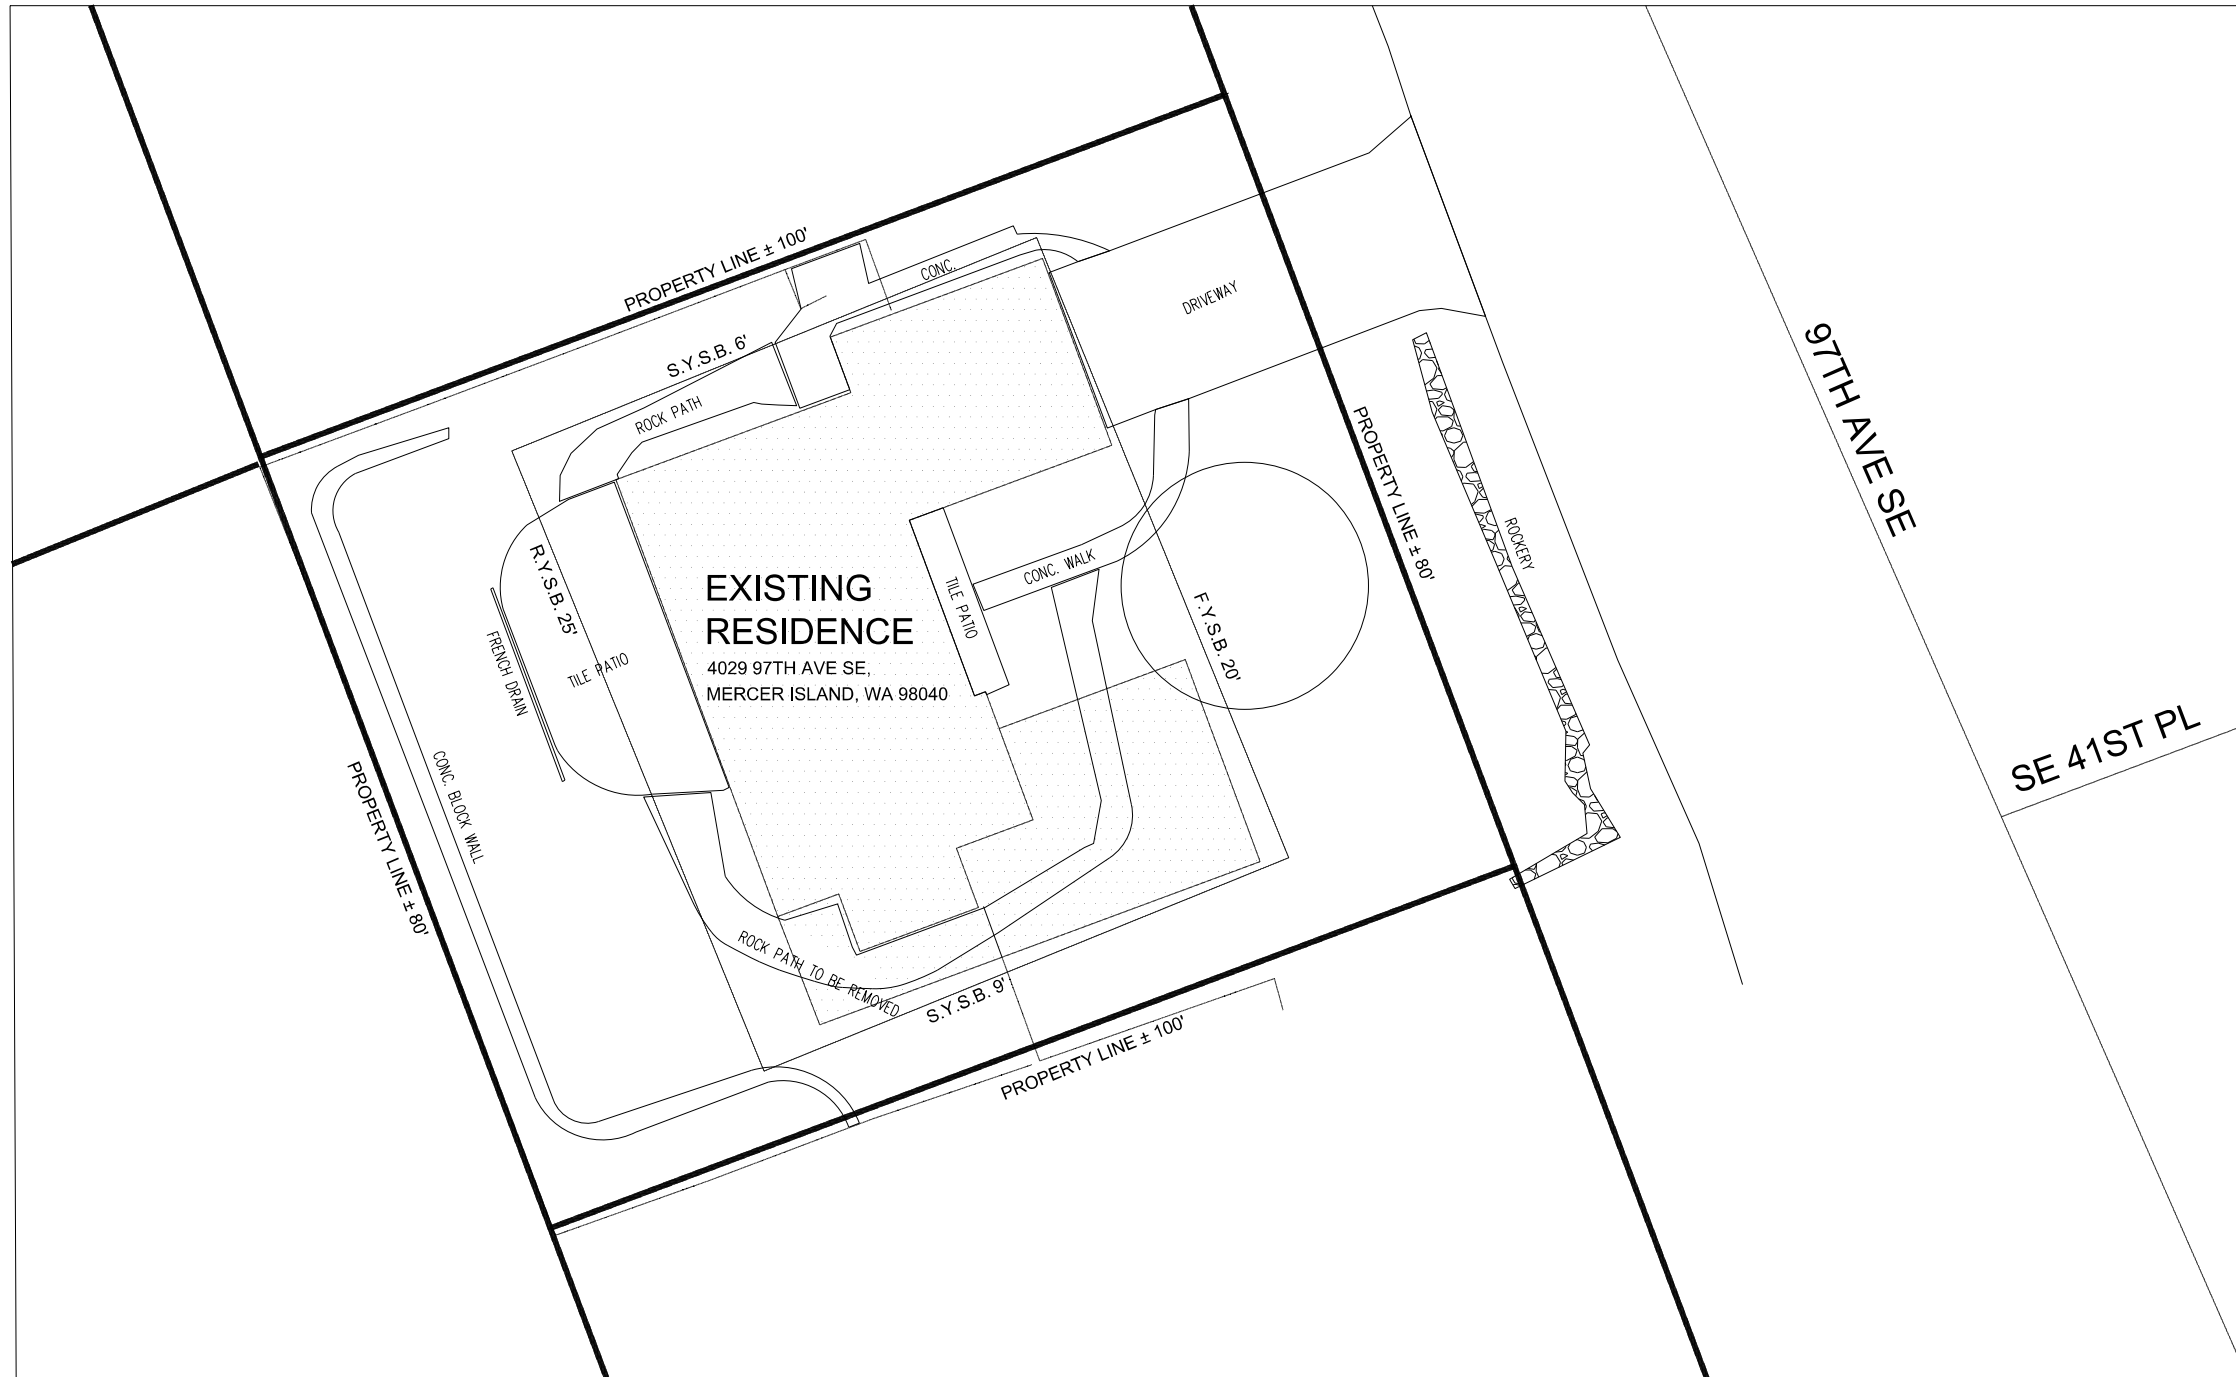
- PROPERTY LINE OF PROPOSED PROJECT
- PROPERTY LINE OF ADJACENT PROPERTIES
- CONTOUR LINE - 5' ELEVATION CHANGE
- EXISTING STRUCTURE W/ INTERIOR RENOVATION & UPPER LEVEL ADDITION
- EXISTING STRUCTURE TO BE REMOVED
- EXISTING STRUCTURE
- CENTER LINE OF STREET
- EDGE OF CONCRETE
- ROOF OUTLINE
- PROPERTY SETBACK
- EDGE OF GRAVEL
- EASEMENT
- EXISTING TREES/FOLIAGE
- PRIMARY ENTRANCE (FOR DADUS, ADUS AND SFRS)

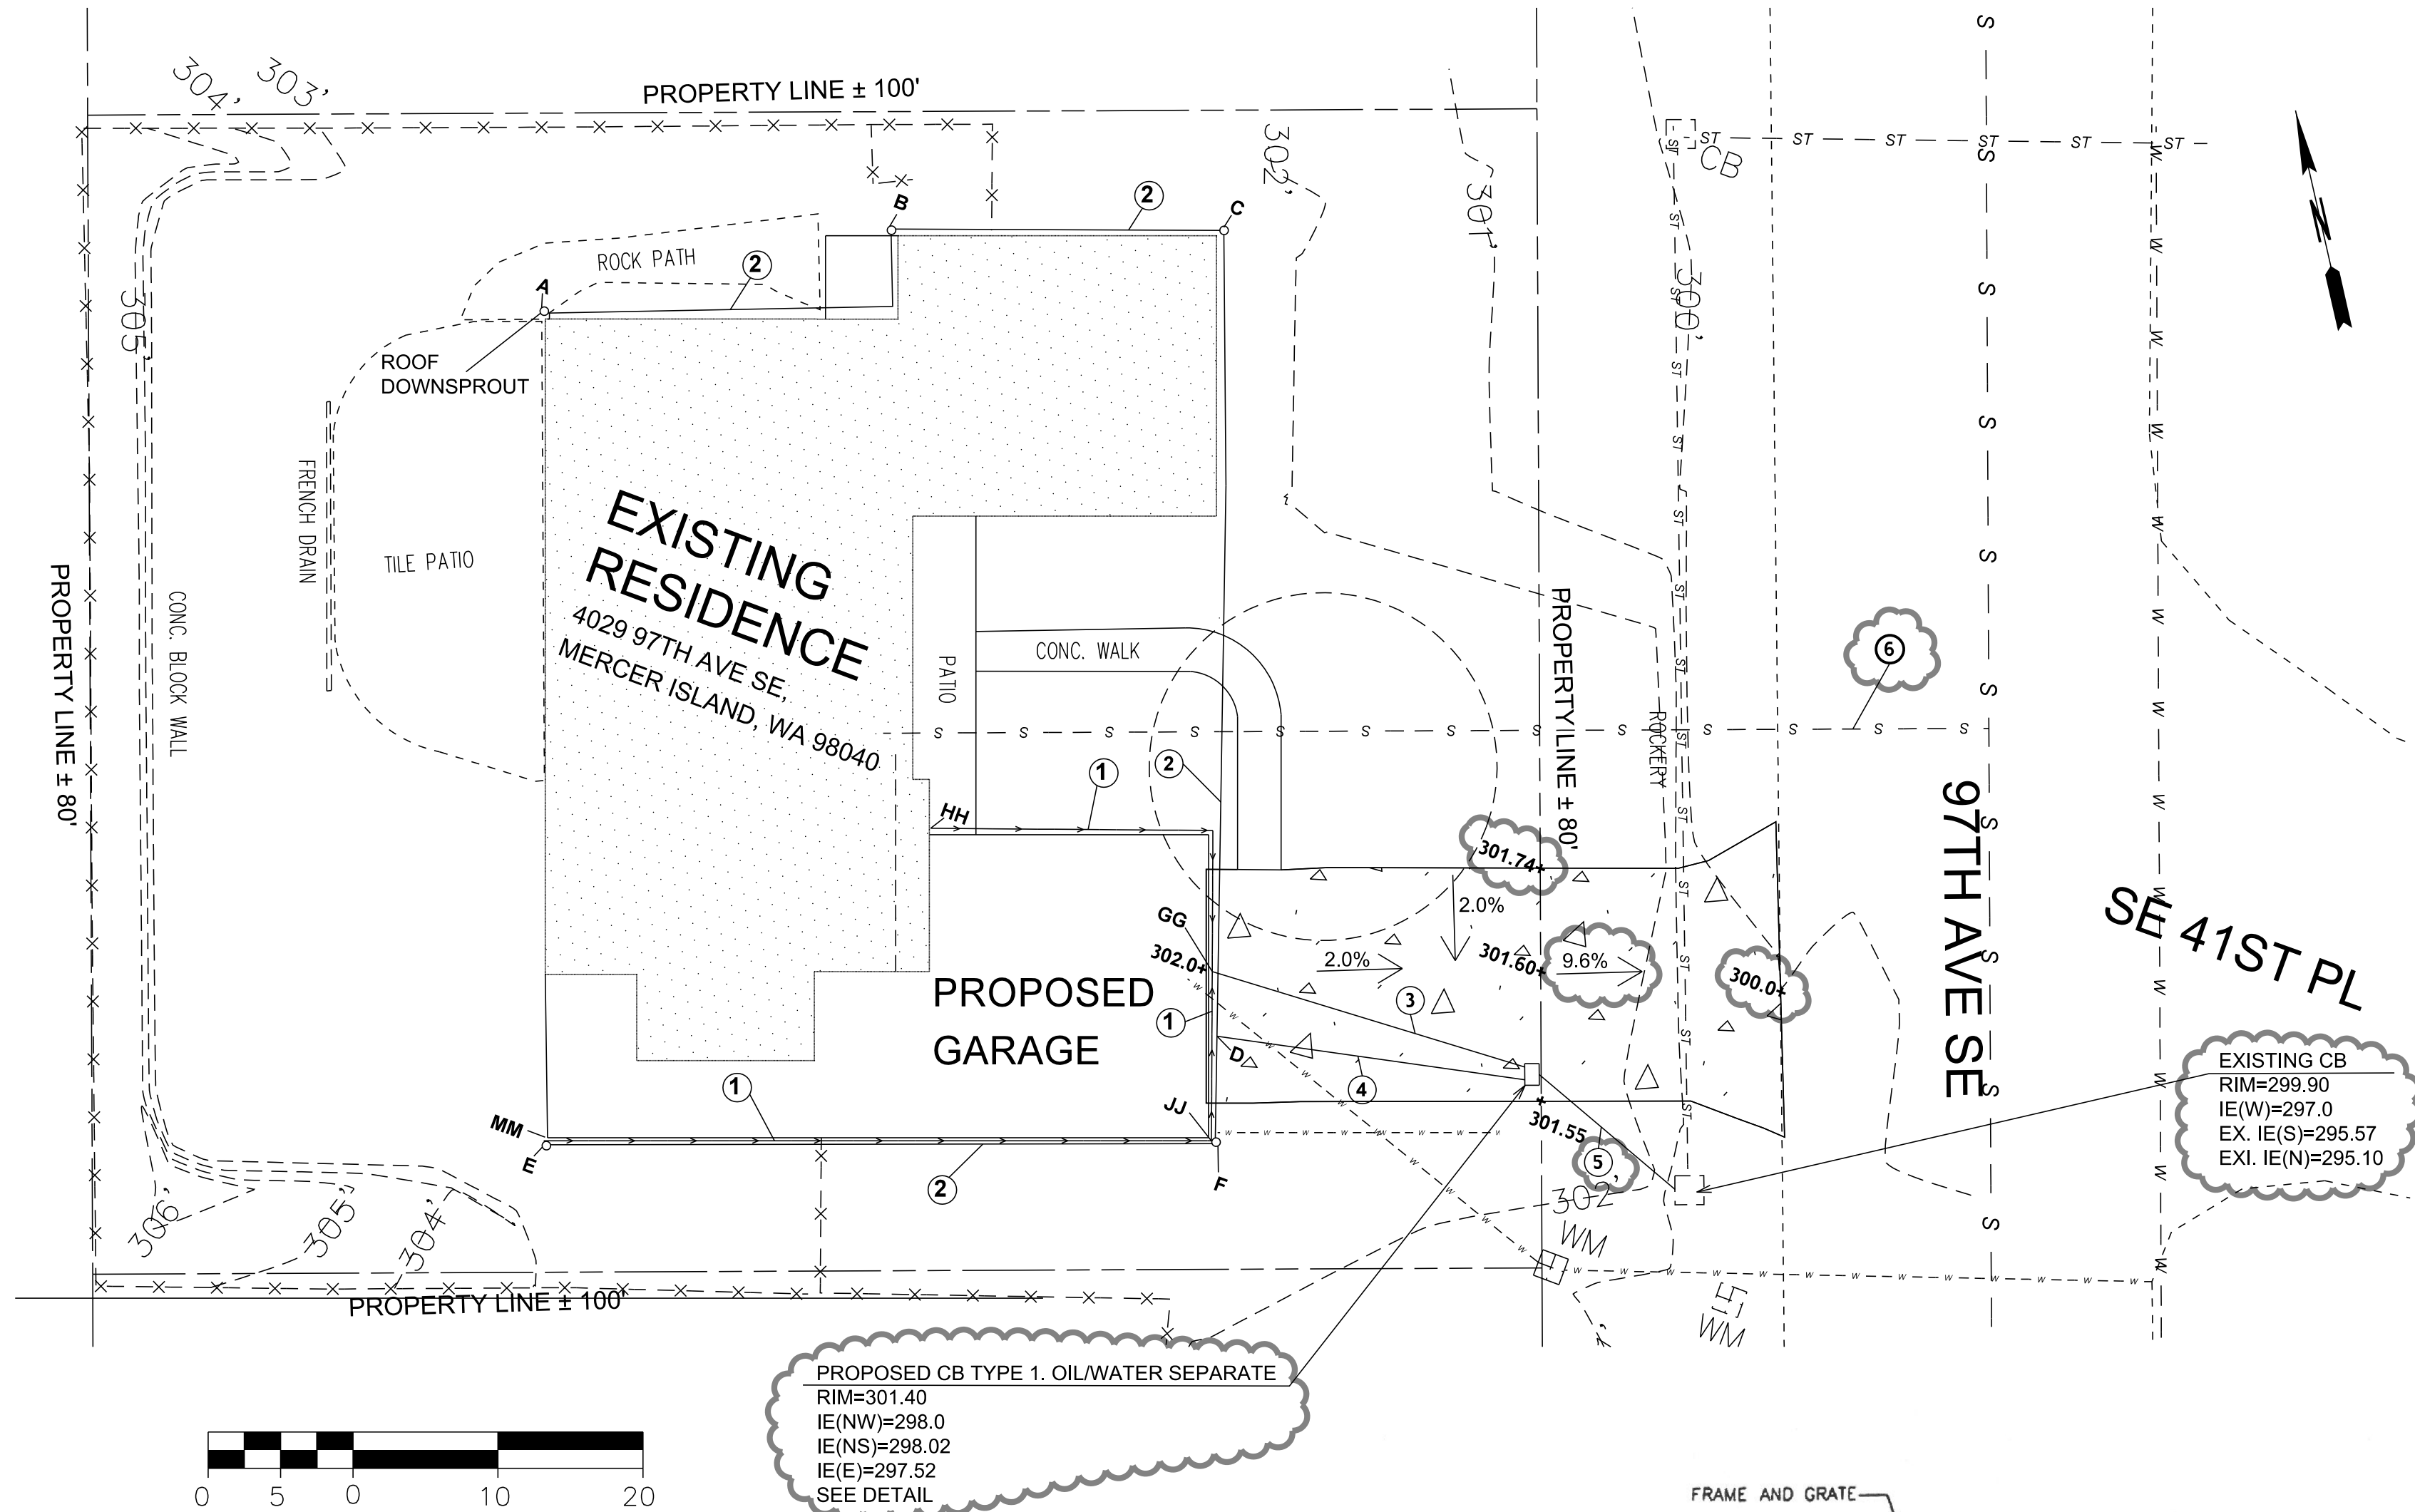
**DRAINAGE & GRADATION PLAN**

Developed Site  
Conditions and Drainage  
plan & Detail

ROOF DRAIN			
ELE.POINT	INVERT	LENGTH	S
A	300.84	30	2.0%
B	300.24	25	2.0%
C	299.74	64	2.0%
D	298.46	22	2.0%
CB	298.02		
E	300.0	46	4.0%
F	298.2	8	2.0%
D	298.02

PERFORATED FOOTING DRAIN			
ELE.POINT	INVERT	LENGTH	S
MM	299.0	46	1%
JJ	298.5	12	1%
GG	298.4	23	2%
CB	298.0		
HH	299.0	30	
GG	298.4		2%

This new developed project does not require to provide flow control due the total new plus replaced surfaces are below the threshold. The total added impervious for the project 1,393 sf minus the existing driveway removal of 355 sf, so the total impervious surface for the project is 1,038 sf. Therefore, the project does not require to implement On-Site stormwater management for the addition. The stormwater for the new added impervious surfaces will convey to the new catch basin then tightline to the existing catch basin on the shoulder of the 97<sup>th</sup> Ave SE where the public existing drainage system located. See Appendix B for drainage system location and details.

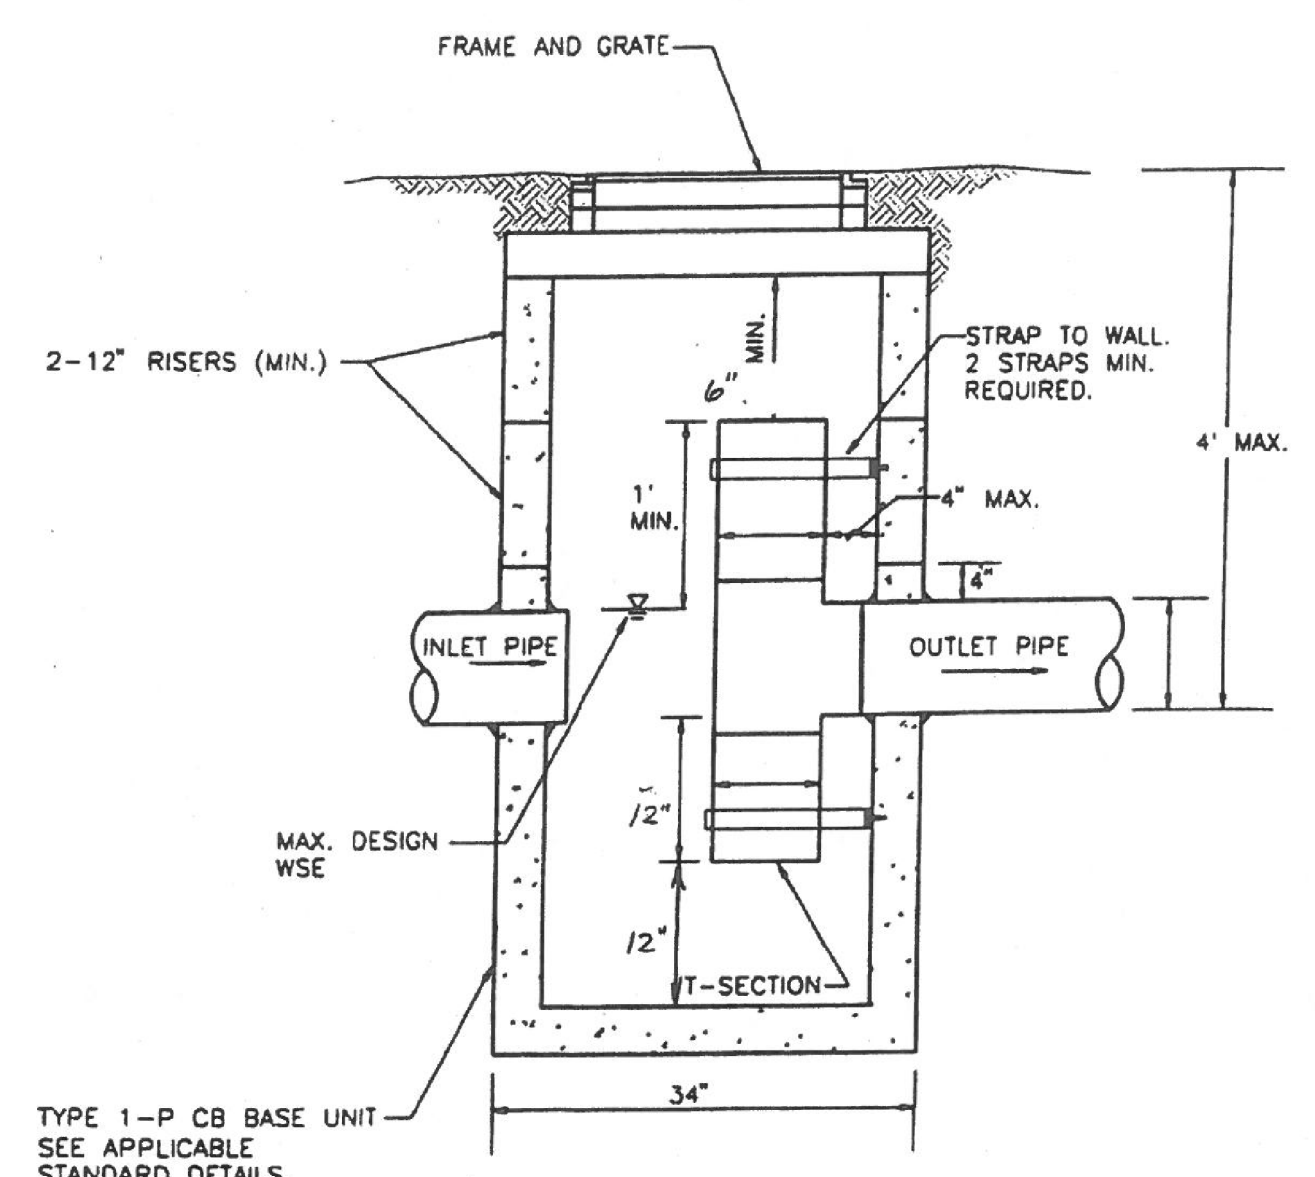
CATCH BASIN TYPE I WITH OIL/WATER SEPARATED  
 NTS

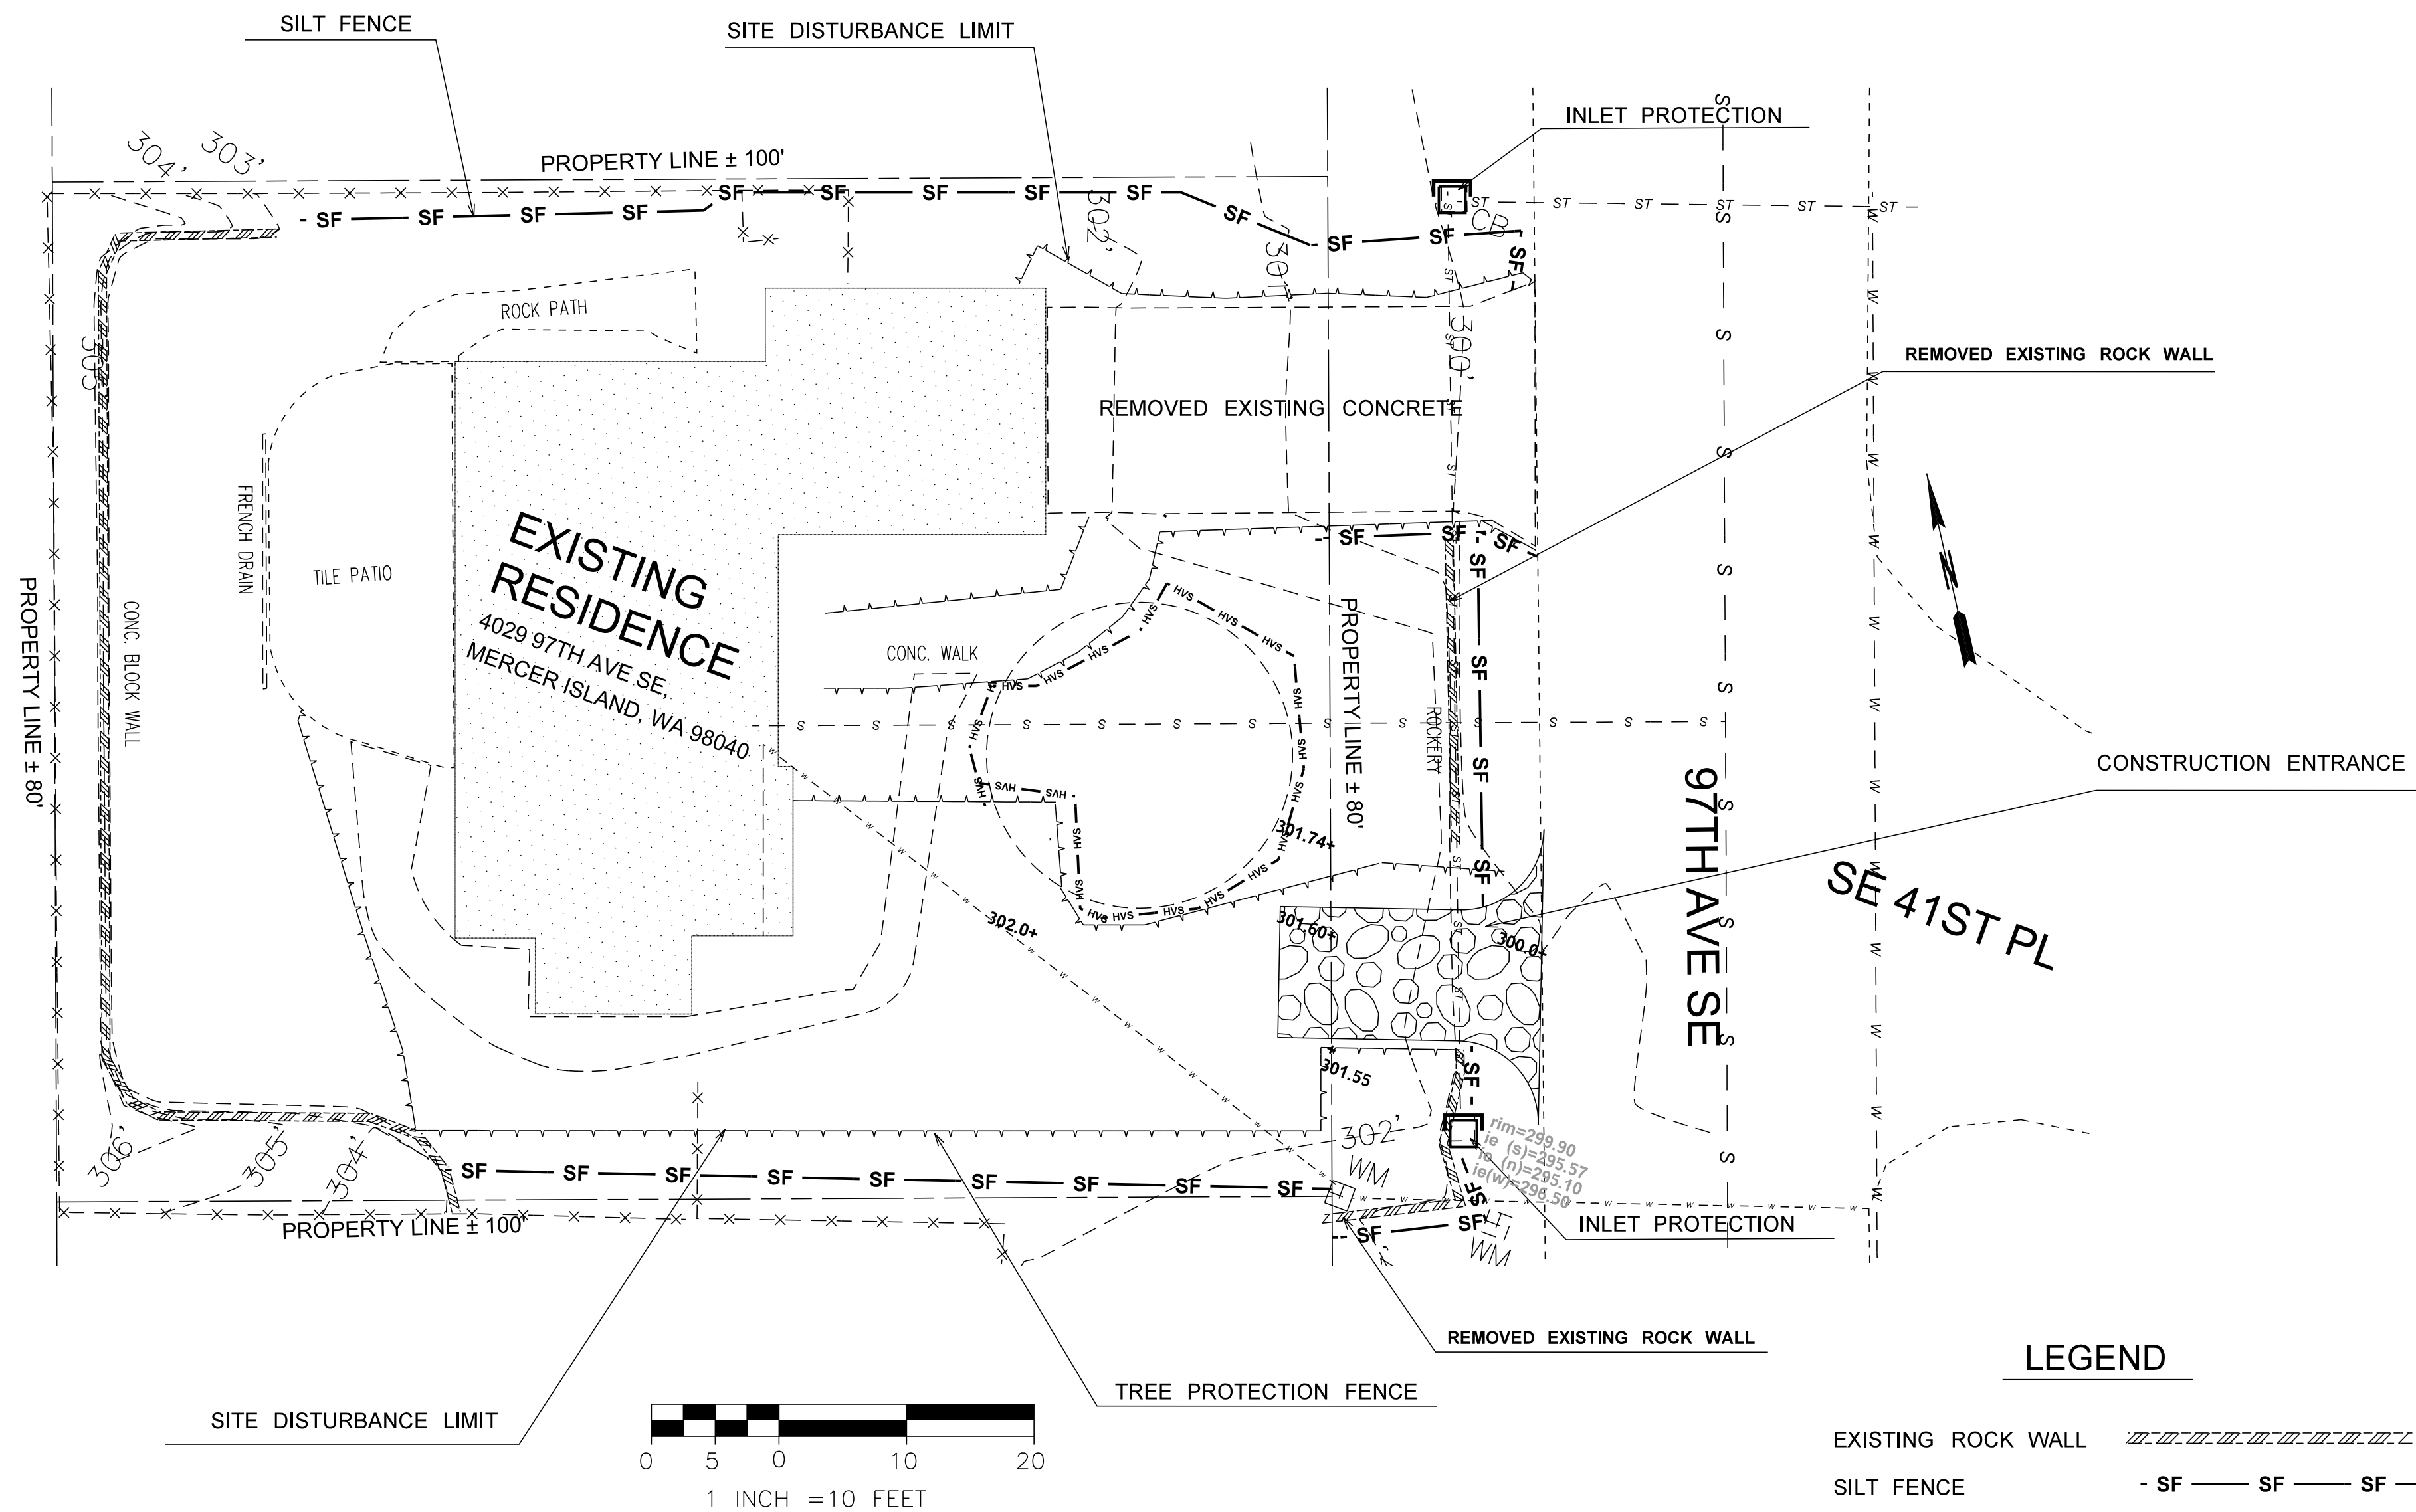
**TESC PLAN**

**EXPOSED & STOCKPILES SOIL BMP'S**

All exposed and unworked soils shall be stabilized per the following criteria:  
 From October 1 to April 30, no exposed and unworked soils shall remain unstabilized (exposed) for more than two days. Non-erodible, clean, granular base materials shall be applied to stabilize all trafficked areas.  
 From May 1 to September 30, no exposed and unworked soils on slopes shall remain unstabilized (exposed) for more than seven days.  
 Exposed and unworked soils will be stabilized with the application of effective BMPs to prevent erosion throughout the life of the project. The specific BMPs will be used on this project include:

- Preserving natural vegetation
- Sodding
- Topsoil
- Mulching
- Check dam
- Soil binding using polyacrylamide
- Wattles
- Biodegradable erosion control blanket
- Compost blanket
- Stabilized construction entrance
- Plastic covering
- Construction road stabilization
- Seeding and planting
- Dust Control
- Bonded Fiber Matrix
- Mechanically Bonded Fiber Matrix

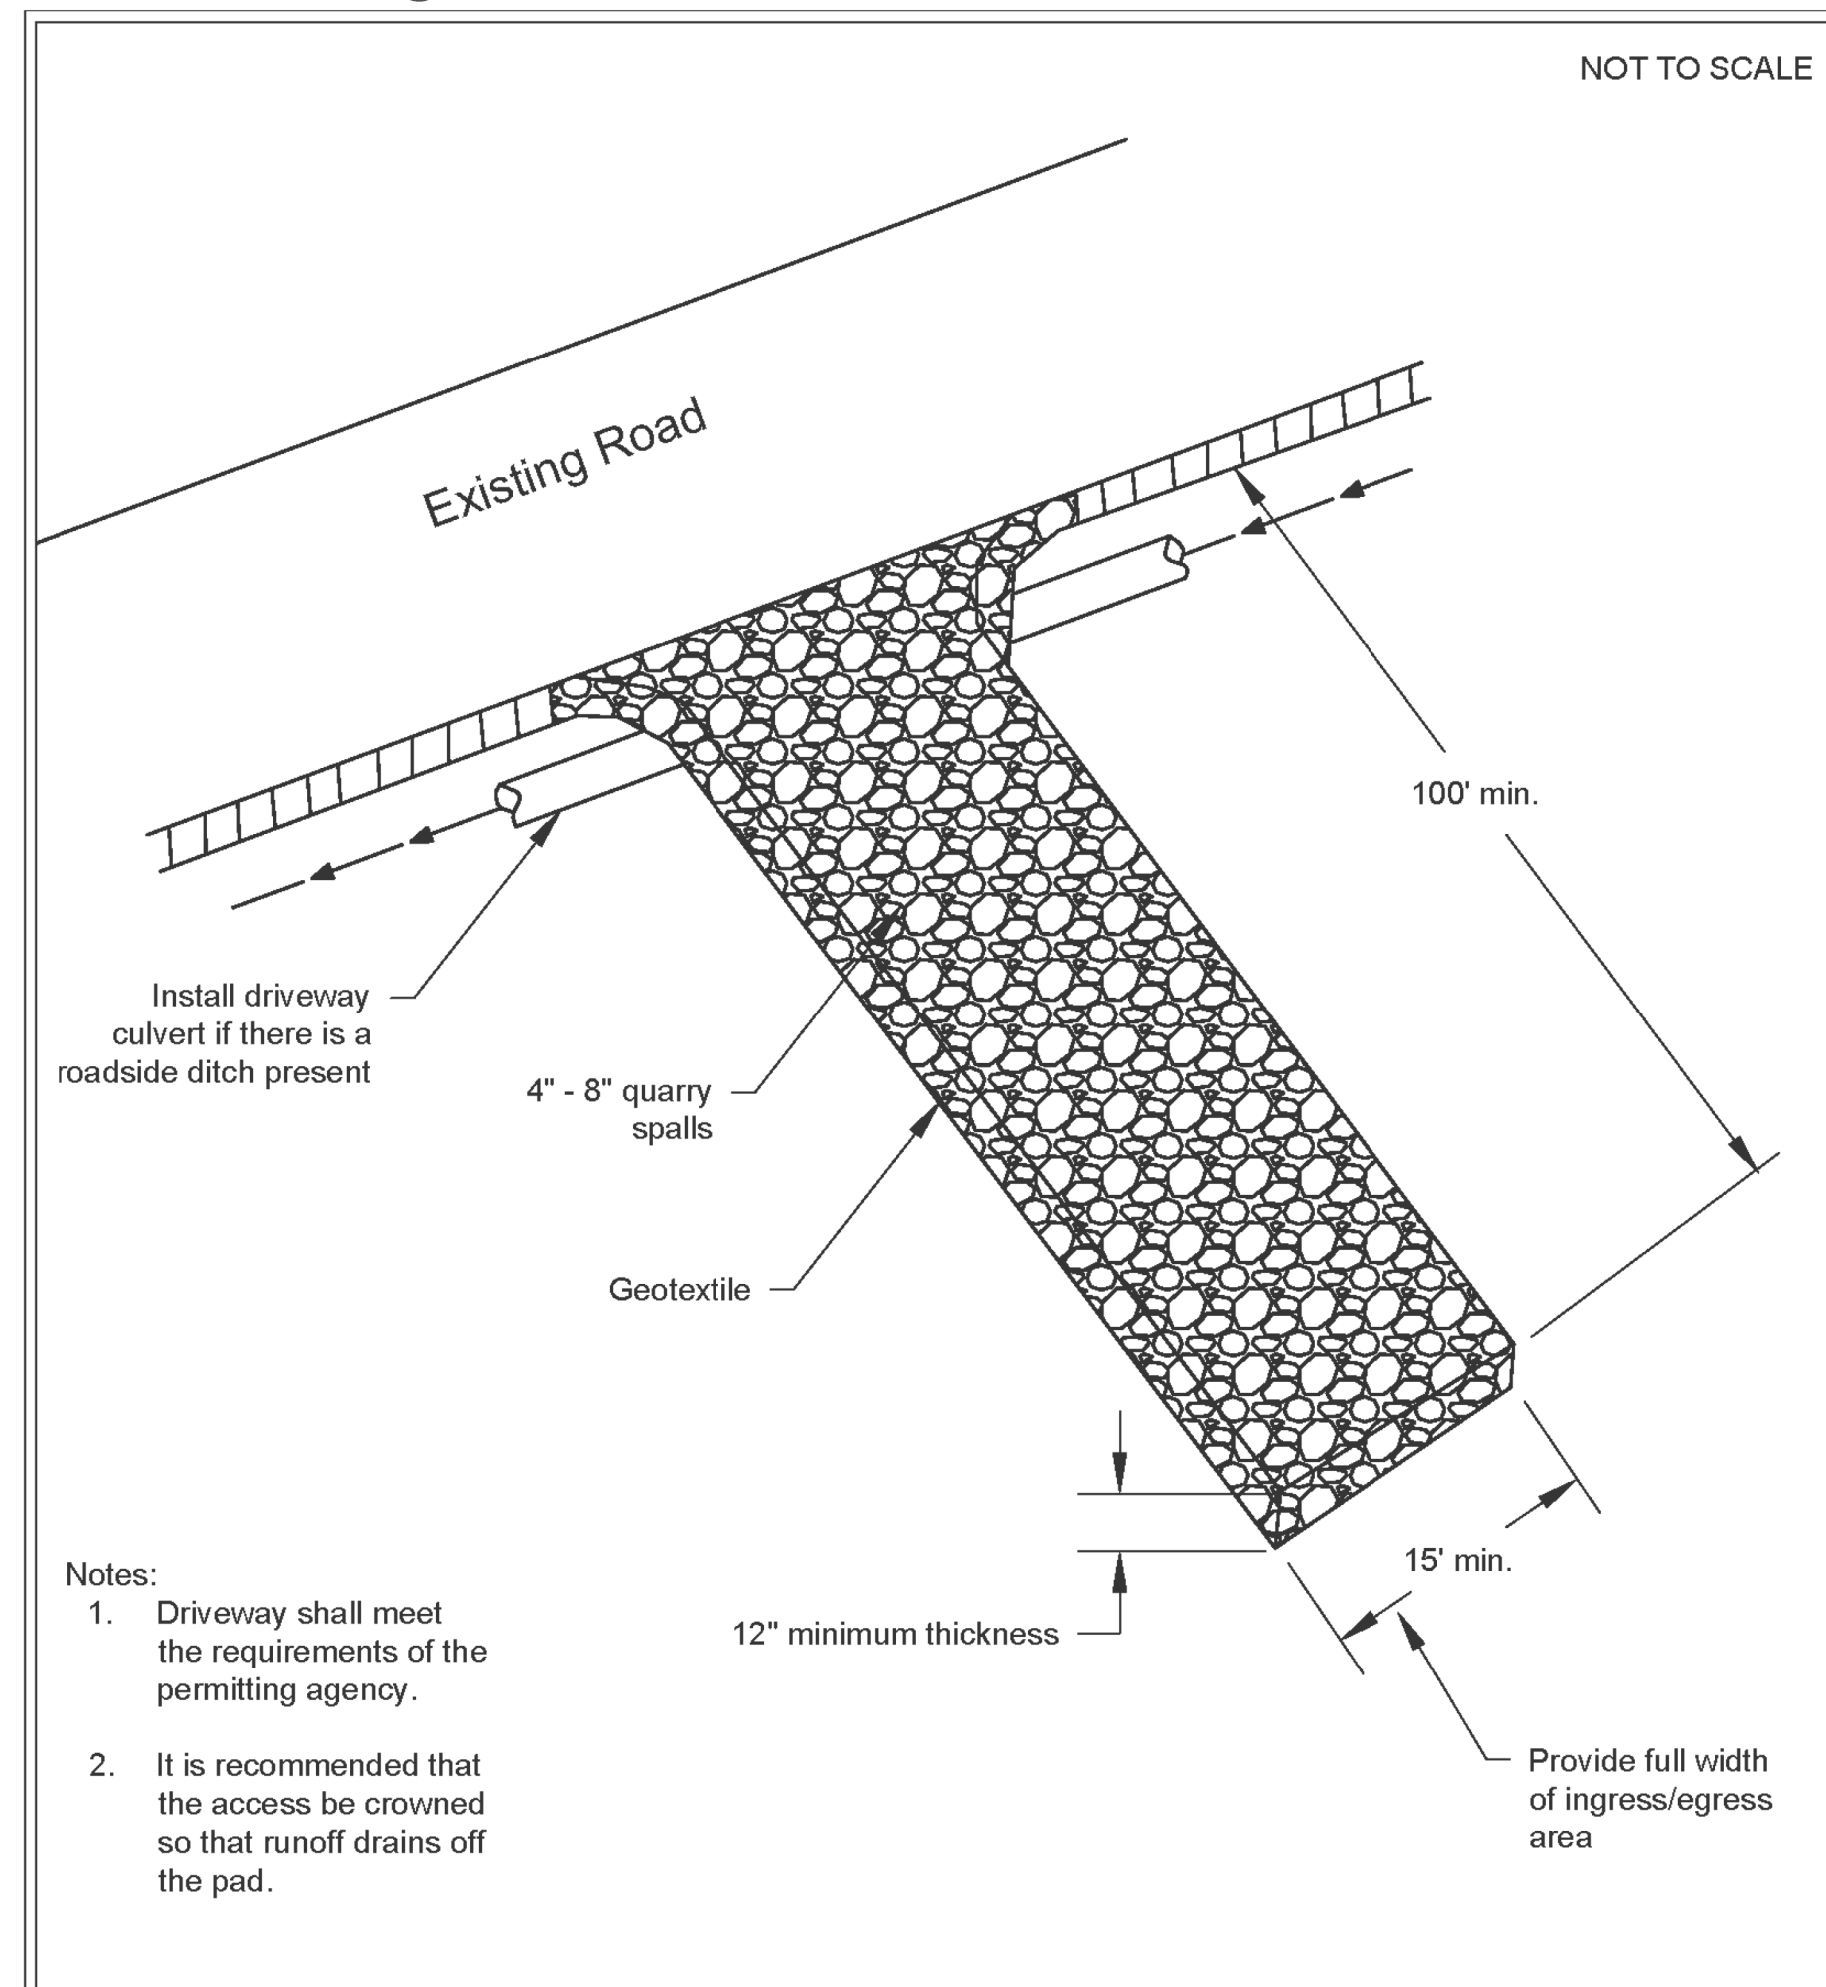
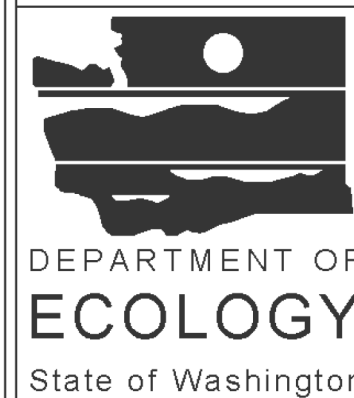
**Figure II-3.1: Stabilized Construction Access**

**Stabilized Construction Access**

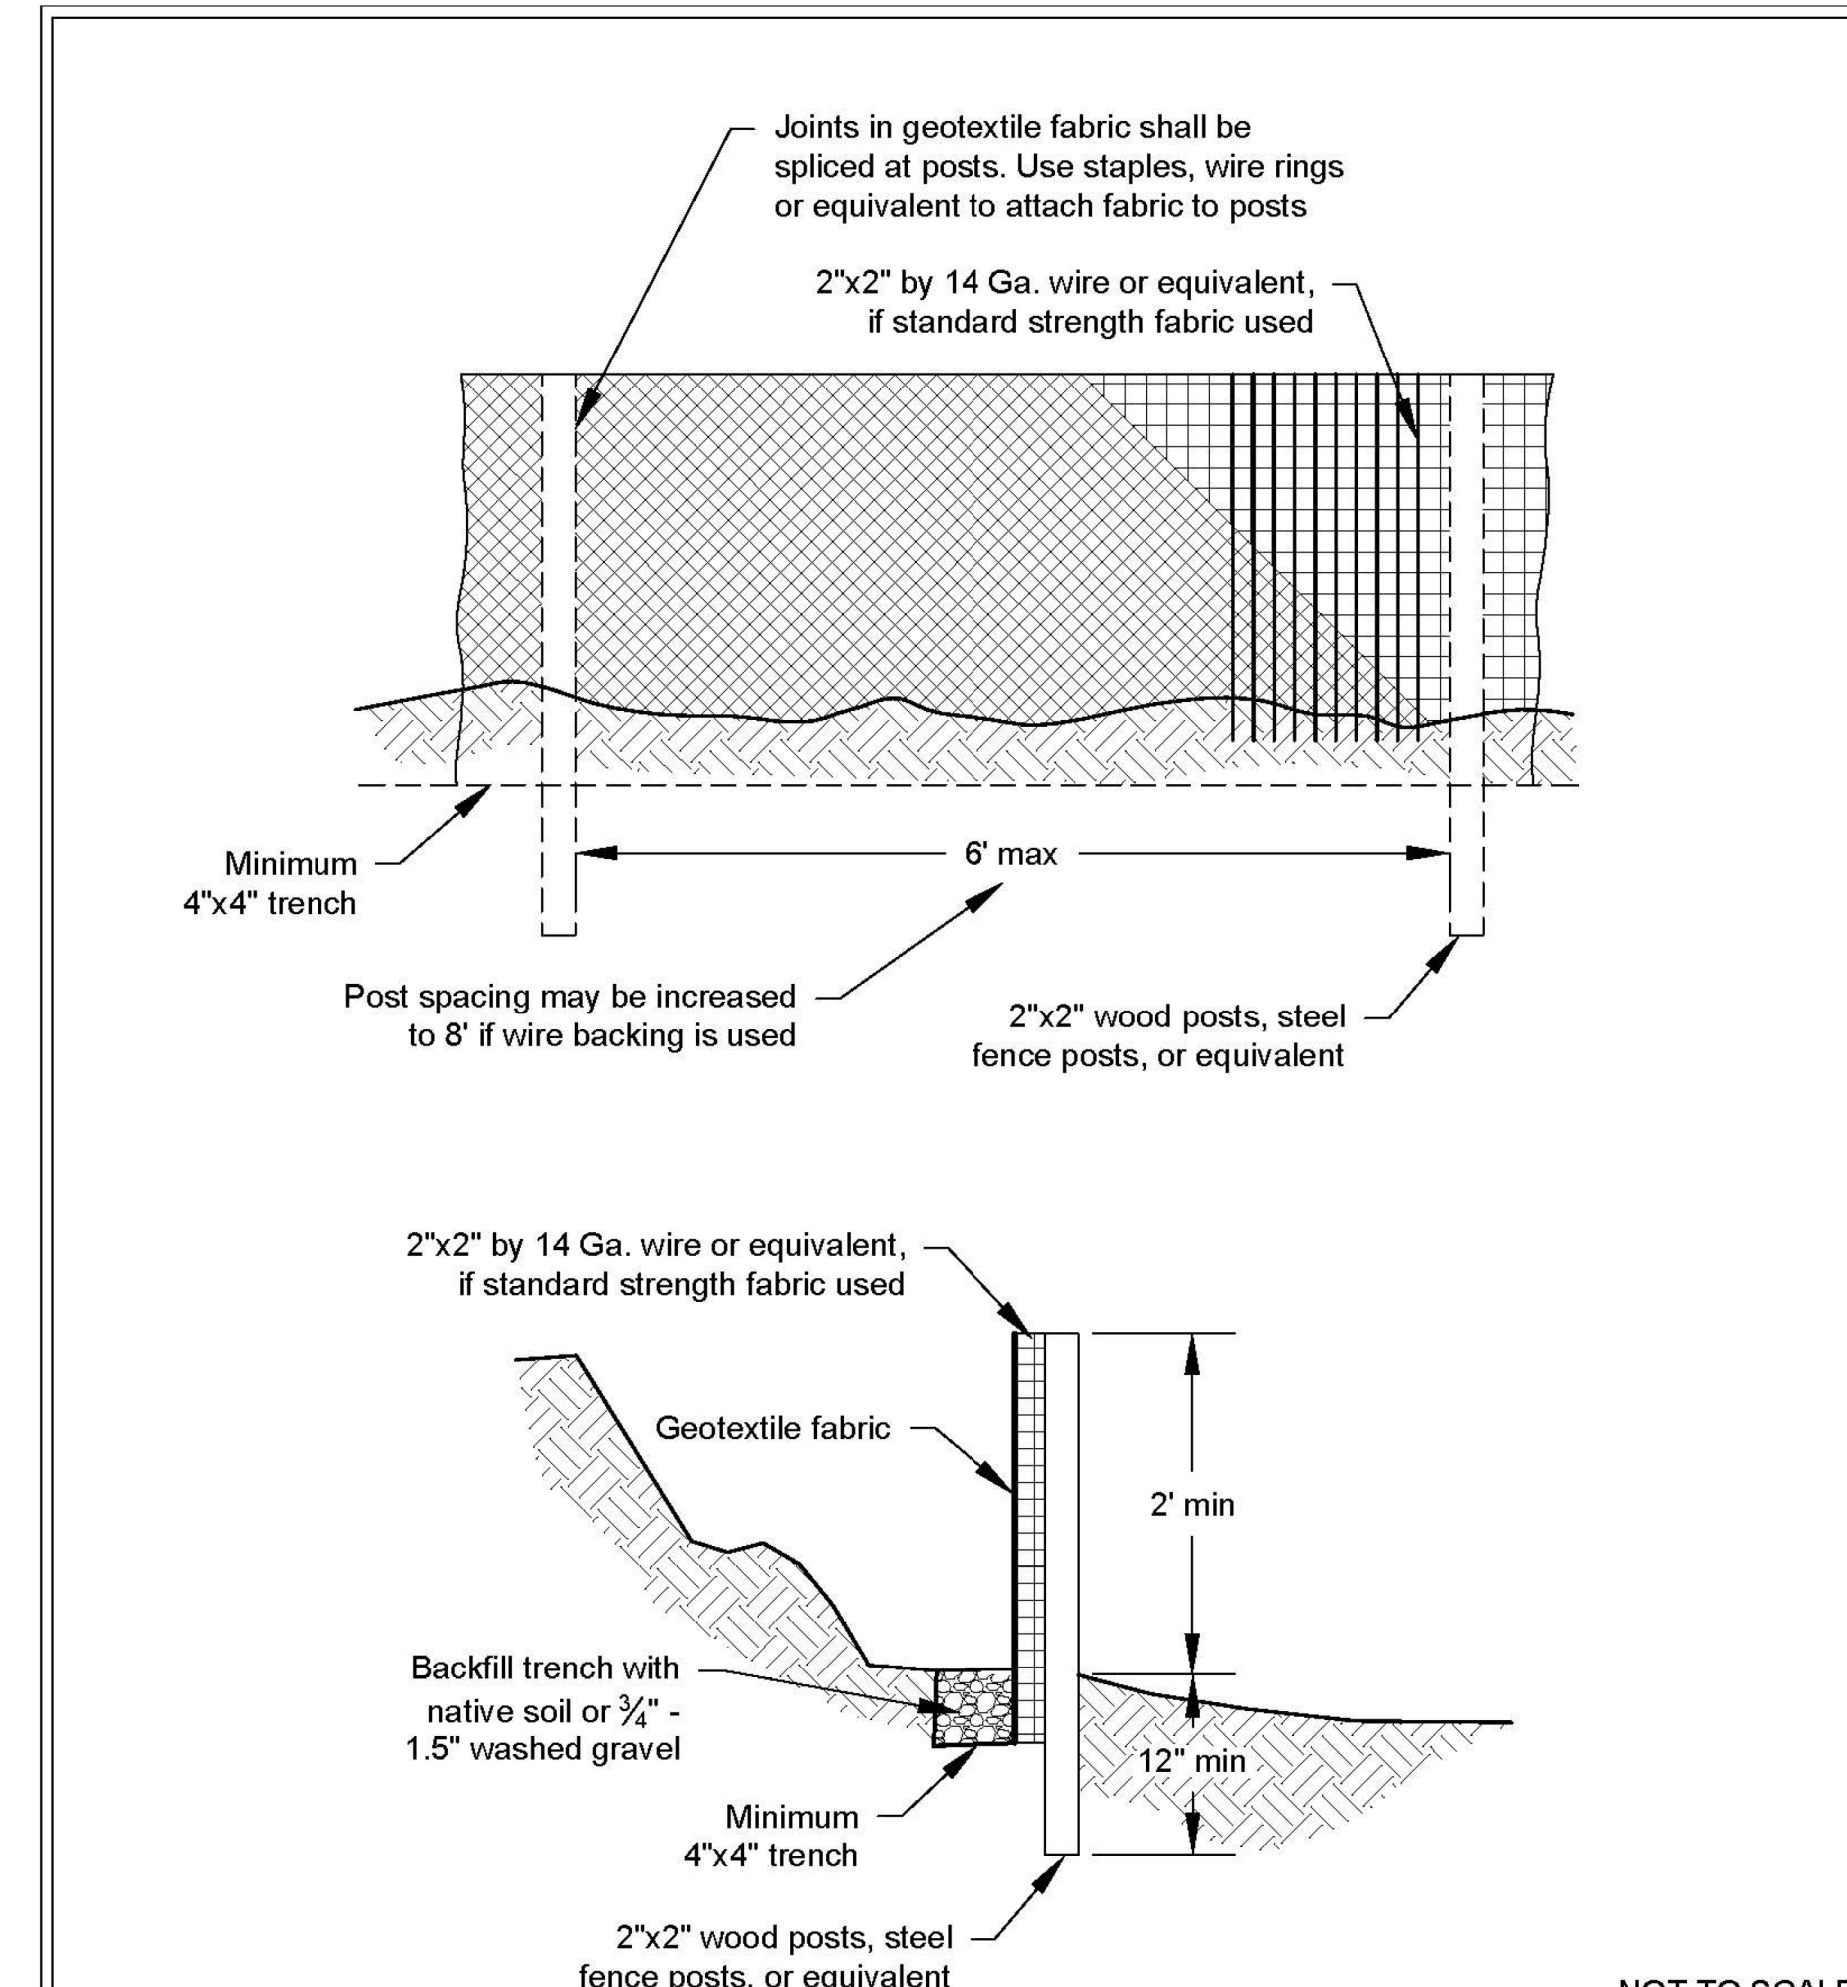
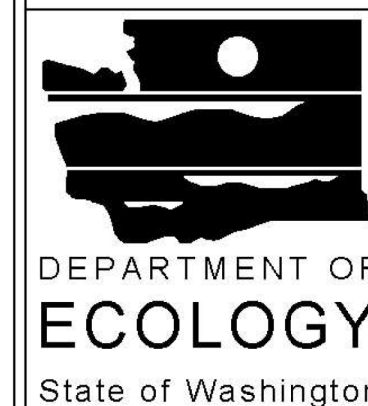
**Figure II-3.22: Silt Fence**

**Silt Fence**

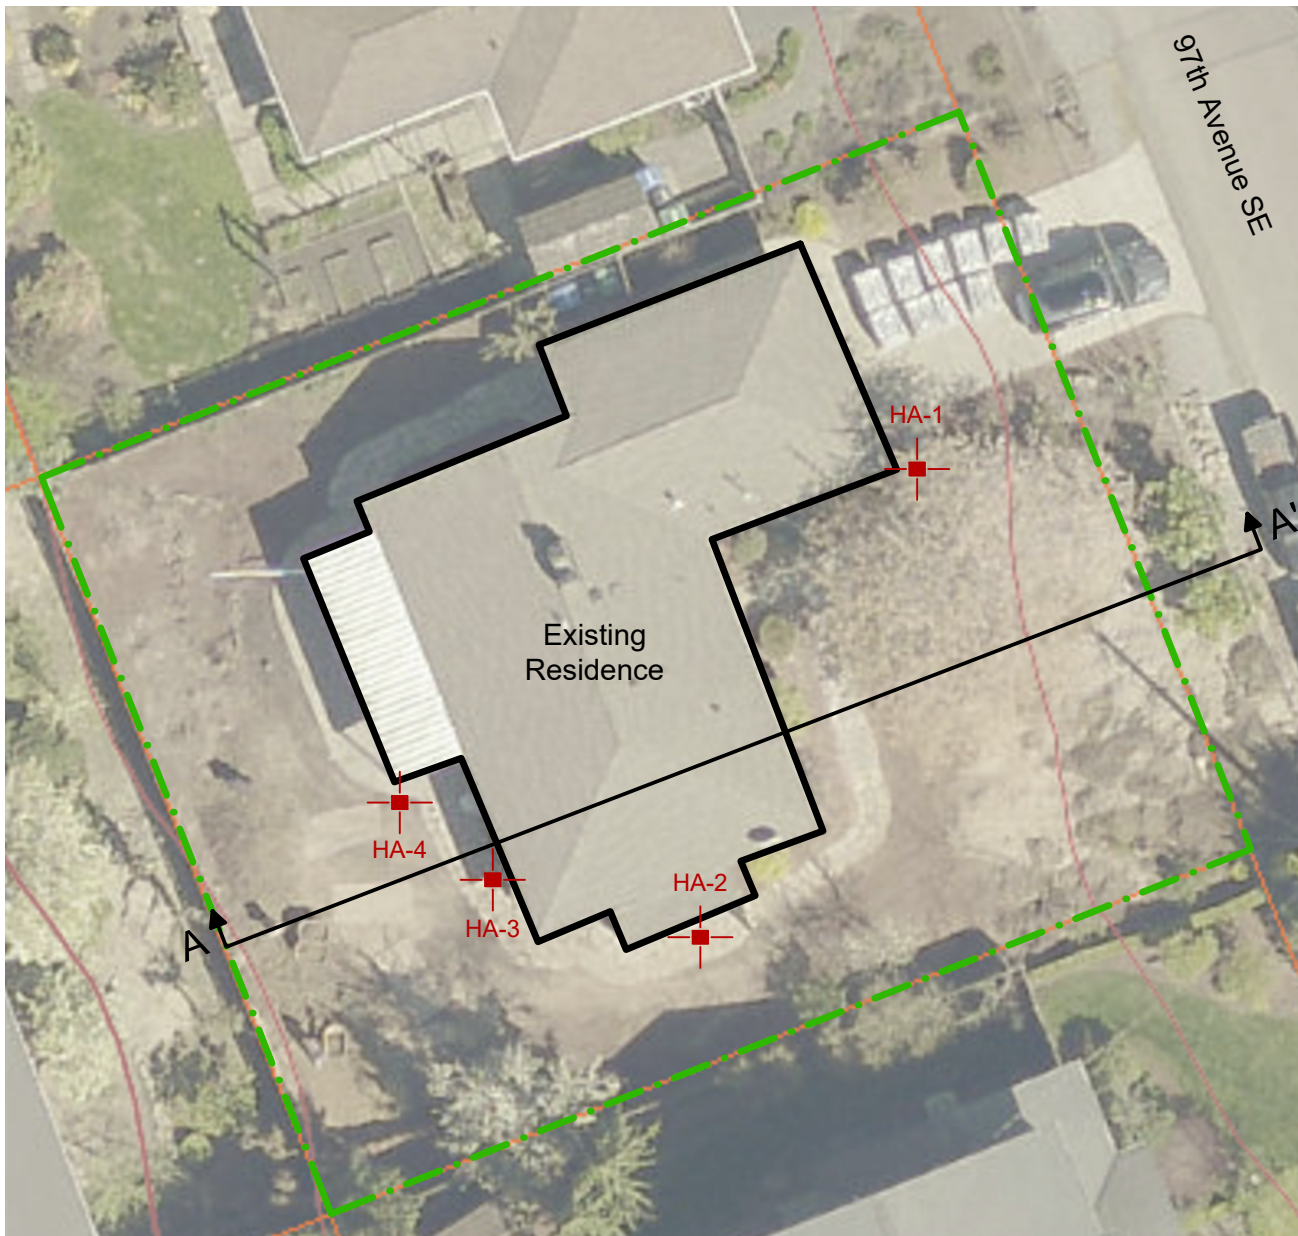
# Site Plan

Reference: Site Plan based on field measurements, observations, and aerial parcel map review.

Project Number 1408122	Atwal Residence Addition Site Plan	  <b>NELSON GEOTECHNICAL ASSOCIATES, INC</b> Woodinville Office 17311-135th Ave. NE, A-500 Woodinville, WA 98072 (425) 486-1669 / Fax: 481-2510 Wenatchee Office 105 Palouse St Wenatchee, WA 98801 (509) 665-7696 / Fax: 665-7692	No.	Date	Revision	By	CK
Figure 2			1	11/9/22	Original	FKS	SLD
