G-6047

Subject:     **Geotechnical Engineering Investigation**  
              **Proposed Addition**  
              5222 – West Mercer Way  
              Mercer Island, Washington 98040

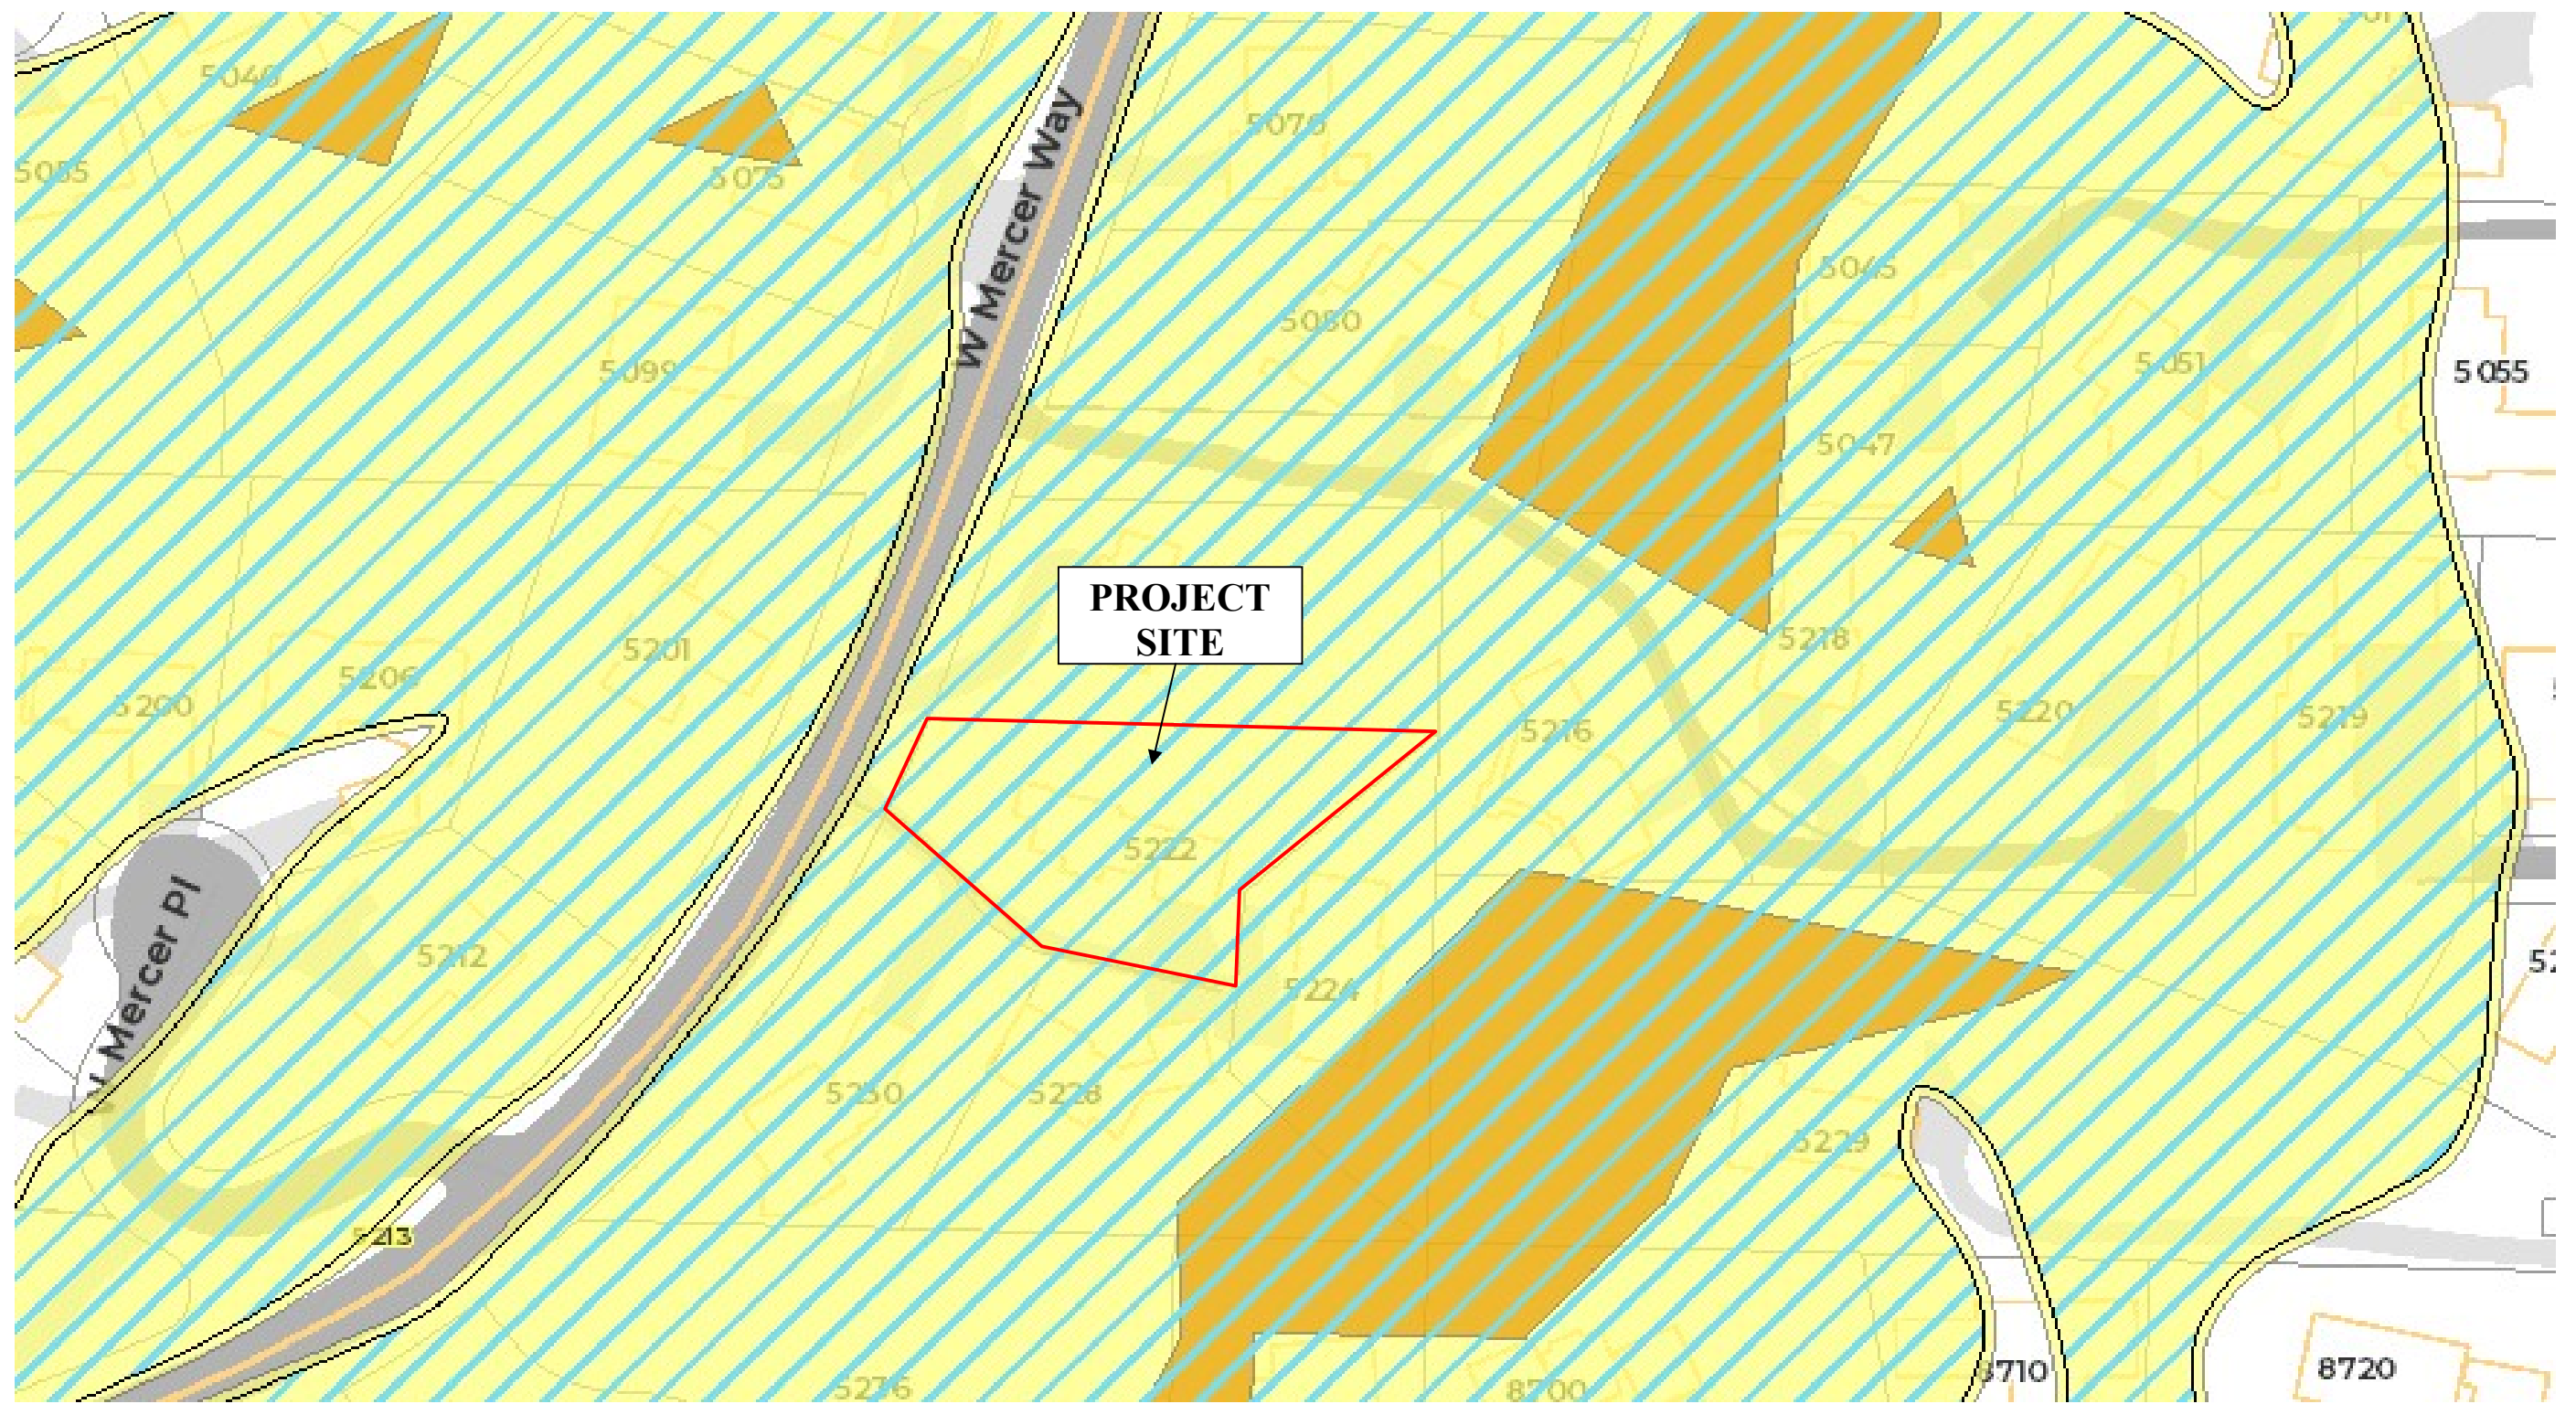
SCALE As Shown	DATE 4/22/24	MADE AH	CHKD WC	JOB NO. G-6047	PLATE 3
----------------	--------------	---------	---------	----------------	---------

EROSION HAZARD AREA

**GEOLOGIC HAZARD MAP**  
**PROPOSED ADDITION**  
**5222 W MERCER WAY**  
**MERCER ISLAND, WA 98040**

The City of Mercer Island's definitions for geological hazard areas are provided in Mercer Island's City Code Chapter 19.16.010 (MICC 19.16.010). It is our understanding that the existing garage (location of proposed addition) is located in areas mapped by Mercer Island as erosion, and potential landslide geological hazard areas. Areas mapped by Mercer Island as steep slope geologic hazard areas are located within 200 feet of the proposed addition. A map illustrating locations of the mapped geological hazard areas are provided on *Plate 3 – Geologic Hazard Map* (MICC 19.07.160.C).

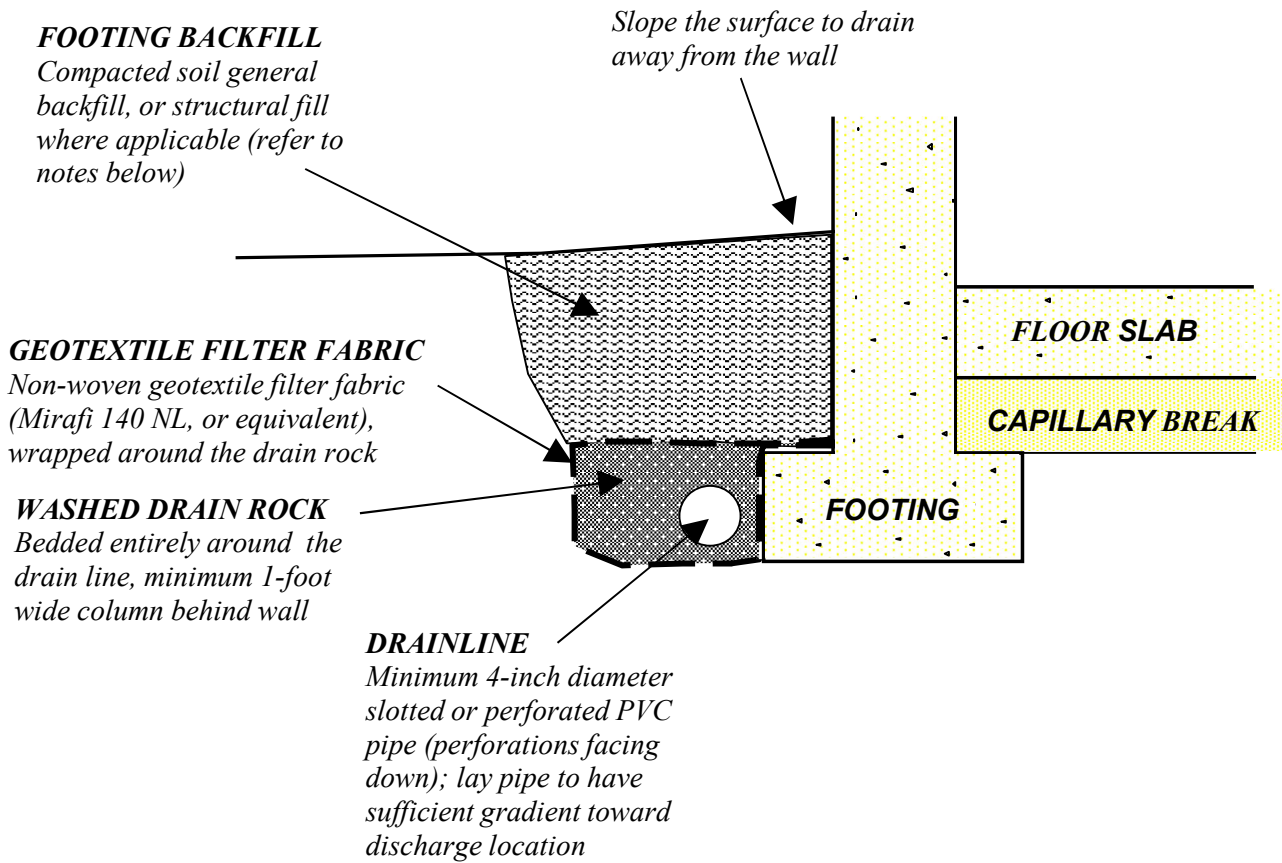
# FOOTING DRAIN DETAIL

- 1.) Perforated or slotted rigid PVC pipe should be tight jointed and laid with perforations or slots down, and with positive gradient toward discharge location(s). The pipe should be placed at or slightly above the elevation of the bottom of the footing. Do not replace rigid PVC pipe with flexible corrugated plastic pipe.

Under no circumstances should roof downspout drain lines be connected to the footing drainage system. All roof downspout drain lines must be separately tight lined to discharge into the approved storm water collection system. We recommend that sufficient cleanouts be installed at strategic locations to allow for periodic maintenance of the footing drains and downspout drains. For footing drain design details, please refer to the attached *Plate 4 - Typical Footing Drain*.
