Subject: Response to City Comments

Chase (Fused Elements) Residence

4525 Forest Avenue SE Mercer Island, Washington

Geotechnical Report: Subsurface Exploration, Geologic Hazard, and

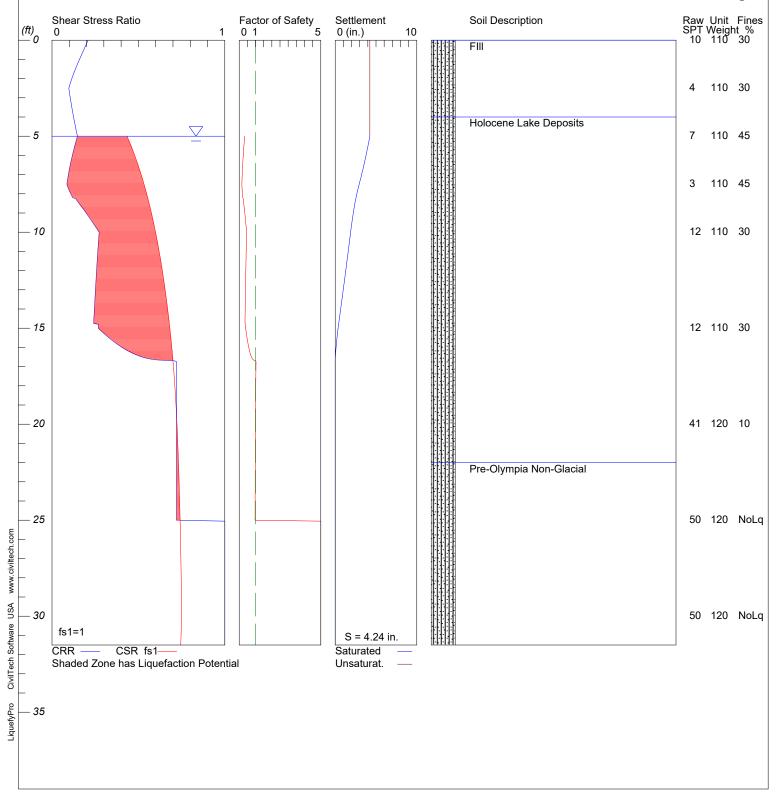
LIQUEFACTION ANALYSIS

Chase Residence - 20220141E001

Hole No.=EB-1 Water Depth=5 ft Surface Elev.=23 NA

Magnitude=6.5 Acceleration=0.676g

Yoshimine) and fines corrections (None, Idriss/Seed, Stark/Olson et al., and Modify Stark/Olson). The analyses predicting the lowest and highest settlement values are included in the Appendix.
