**GEOTECHNICAL ENGINEERING STUDY
PROPOSED RESIDENTIAL DEVELOPMENT
2430 AND 2436 – 74TH AVENUE SOUTHEAST
MERCER ISLAND, WASHINGTON**

ES-8332.01

BV HOMES, LLC

May 2, 2023

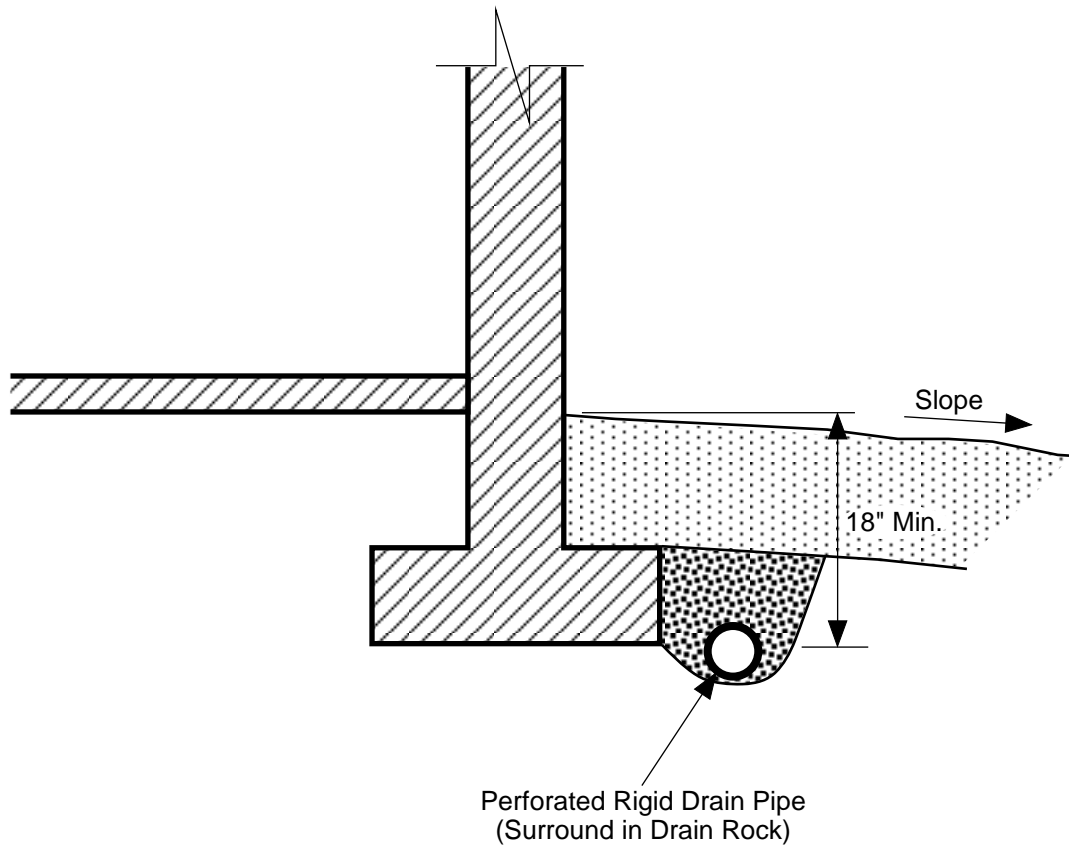
- Do NOT tie roof downspouts to Footing Drain.
- Surface Seal to consist of 12" of less permeable, suitable soil. Slope away from building.

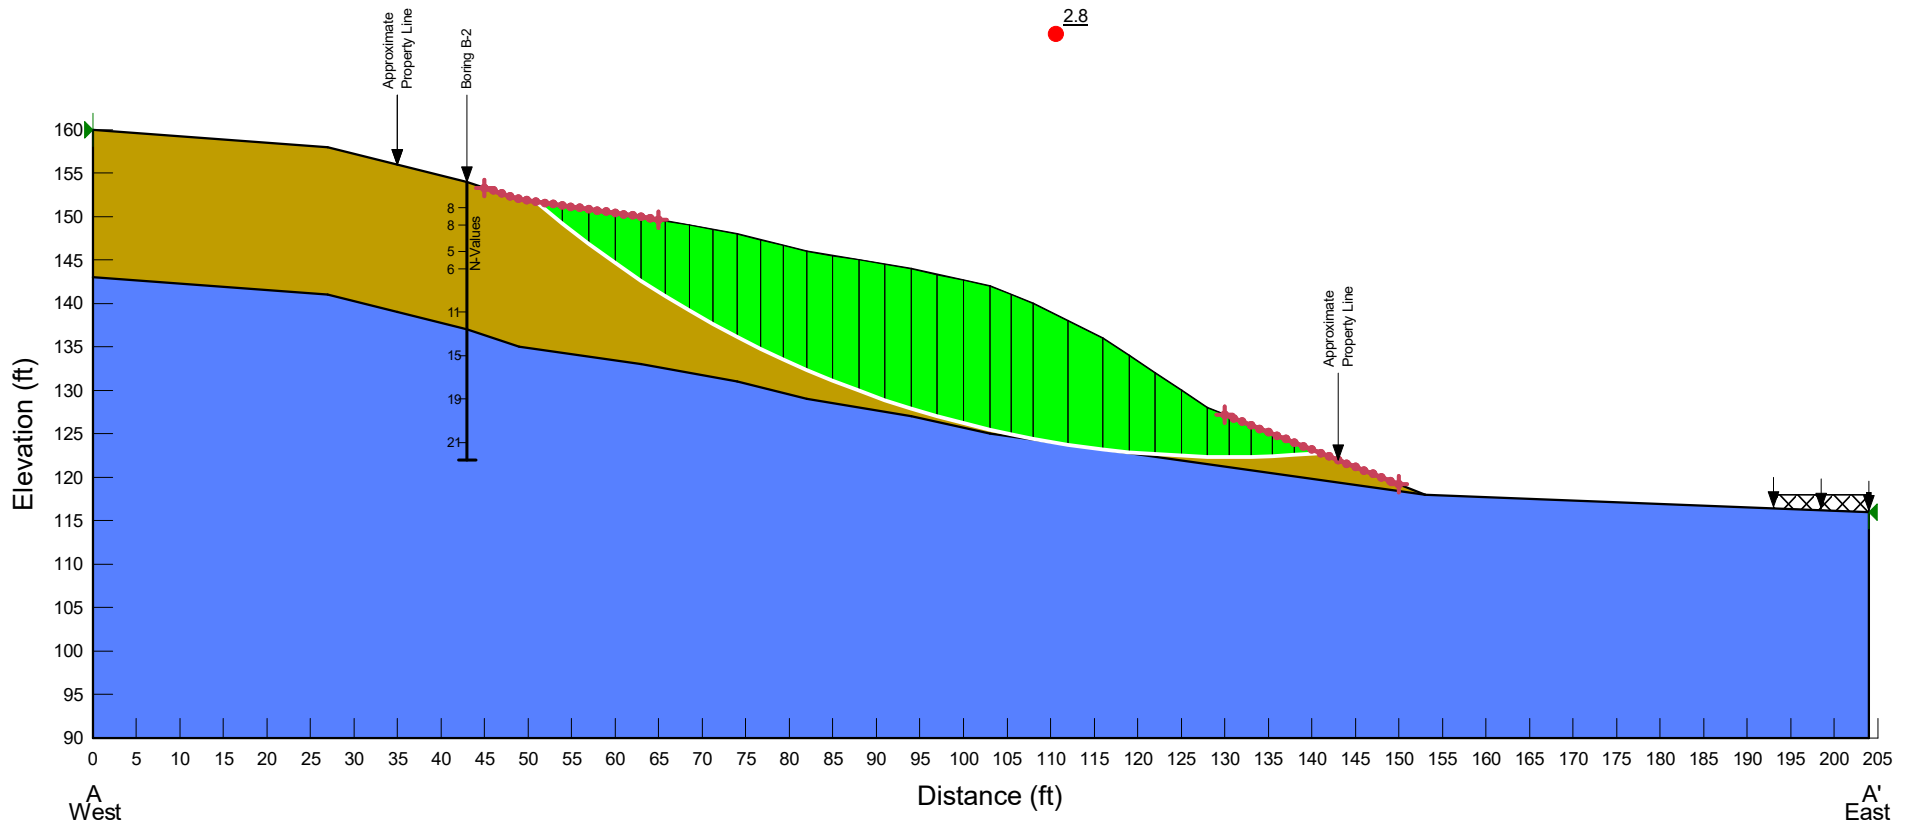
ES-8332.01
 74th Avenue S.E. Property
 Proposed Geometry
 Seismic Condition
 Horizontal Acceleration = 0.329

Color	Name	Unit Weight (pcf)	Effective Cohesion (psf)	Effective Friction Angle (°)
■	Disturbed Pre-Olympia Fine-Grained Glacial Deposits (Qpogf)	110	750	5
■	Undisturbed Pre-Olympia Fine-Grained Glacial Deposits (Qpogf)	115	1,500	7
