DRAINAGE REPORT

LORENZINI SFR LOT 1
4719 86TH AVE SE Mercer Island, WA

DRS Project No. 21071
Mercer Island Permit No. 2311-076

D. R. STRONG Consulting Engineers, LLC
620 7th Ave.
Kirkland WA 98033
(425) 827-3063

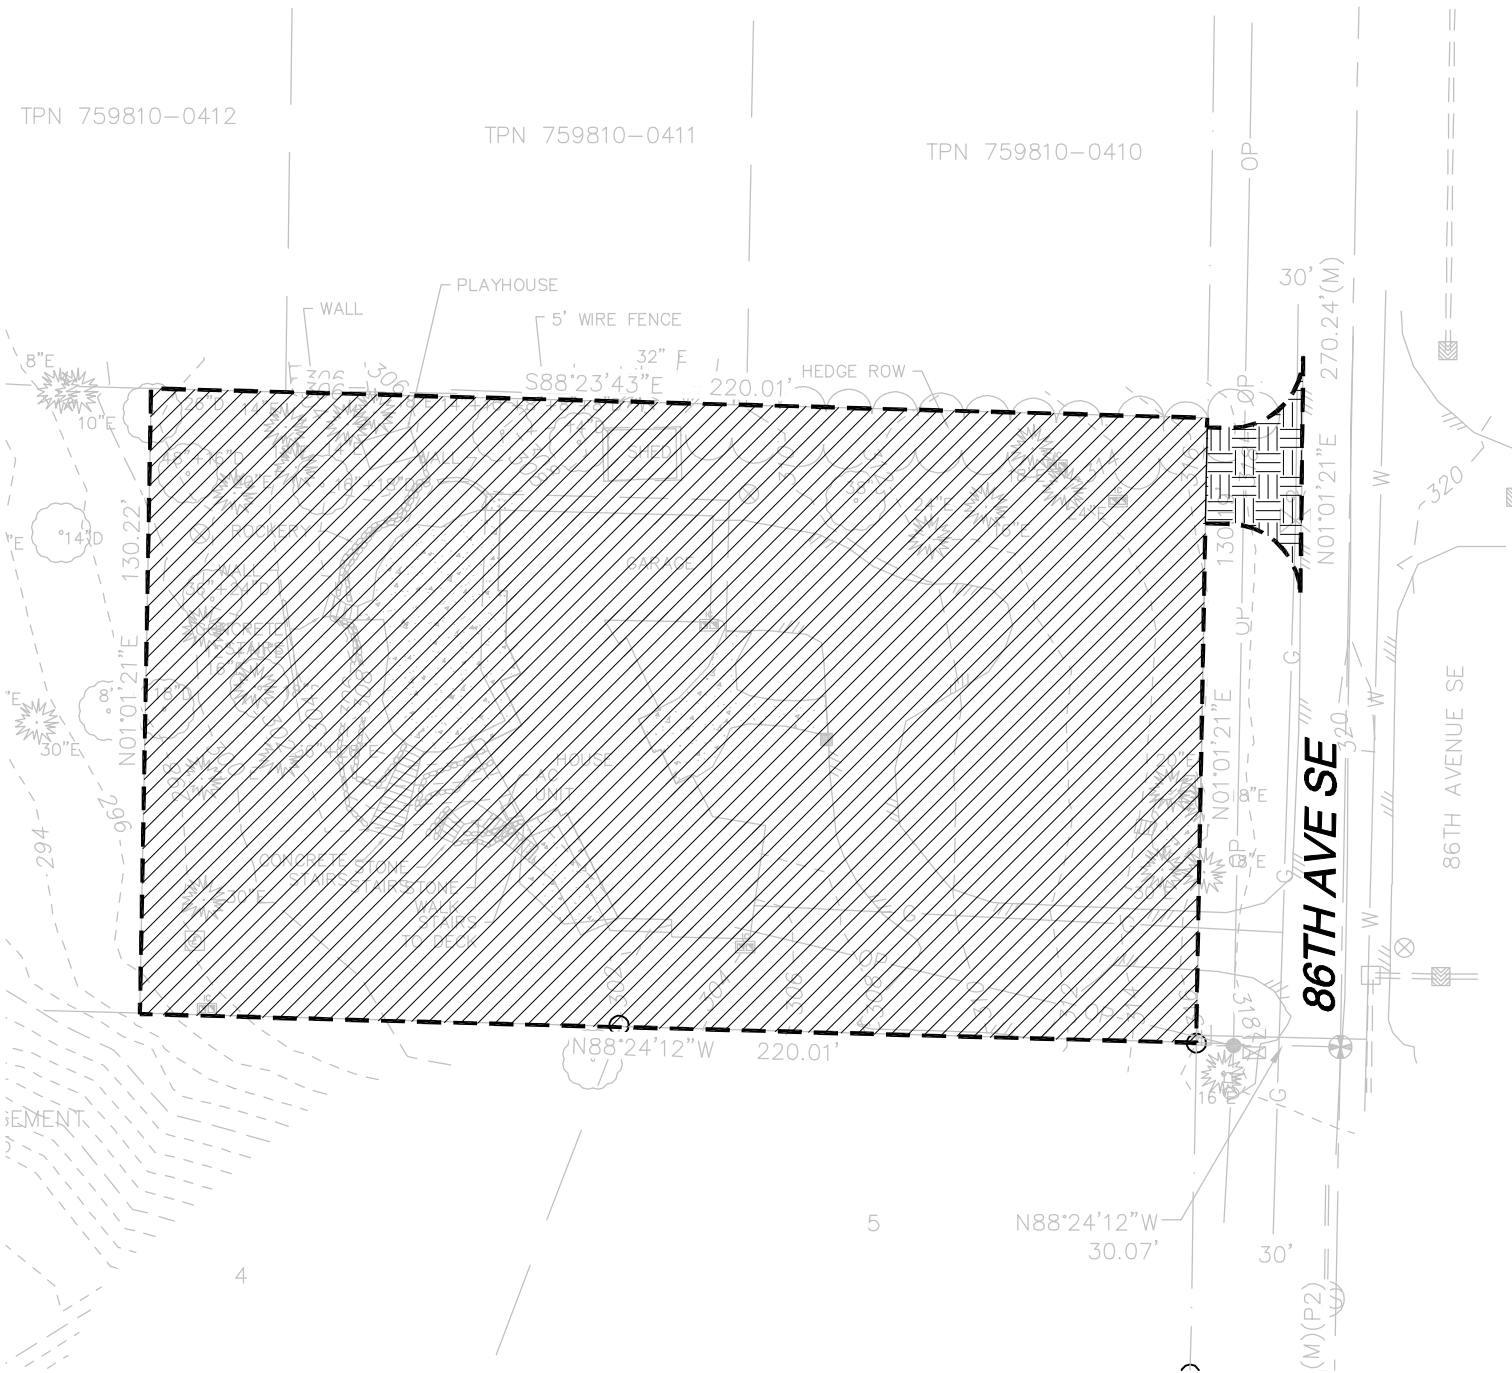
**FIGURE 3
DEVELOPED FIGURE**

AREA BREAKDOWN

TOTAL SITE/PROJECT AREA: 29,138 S.F. (0.669 ACRES)

| | PERVIOUS: | 0 S.F. (0.000 ACRES) |
| | IMPERVIOUS: | 494 S.F. (0.011 ACRES) |

| Figure 3 Developed Figure..... | 10 |

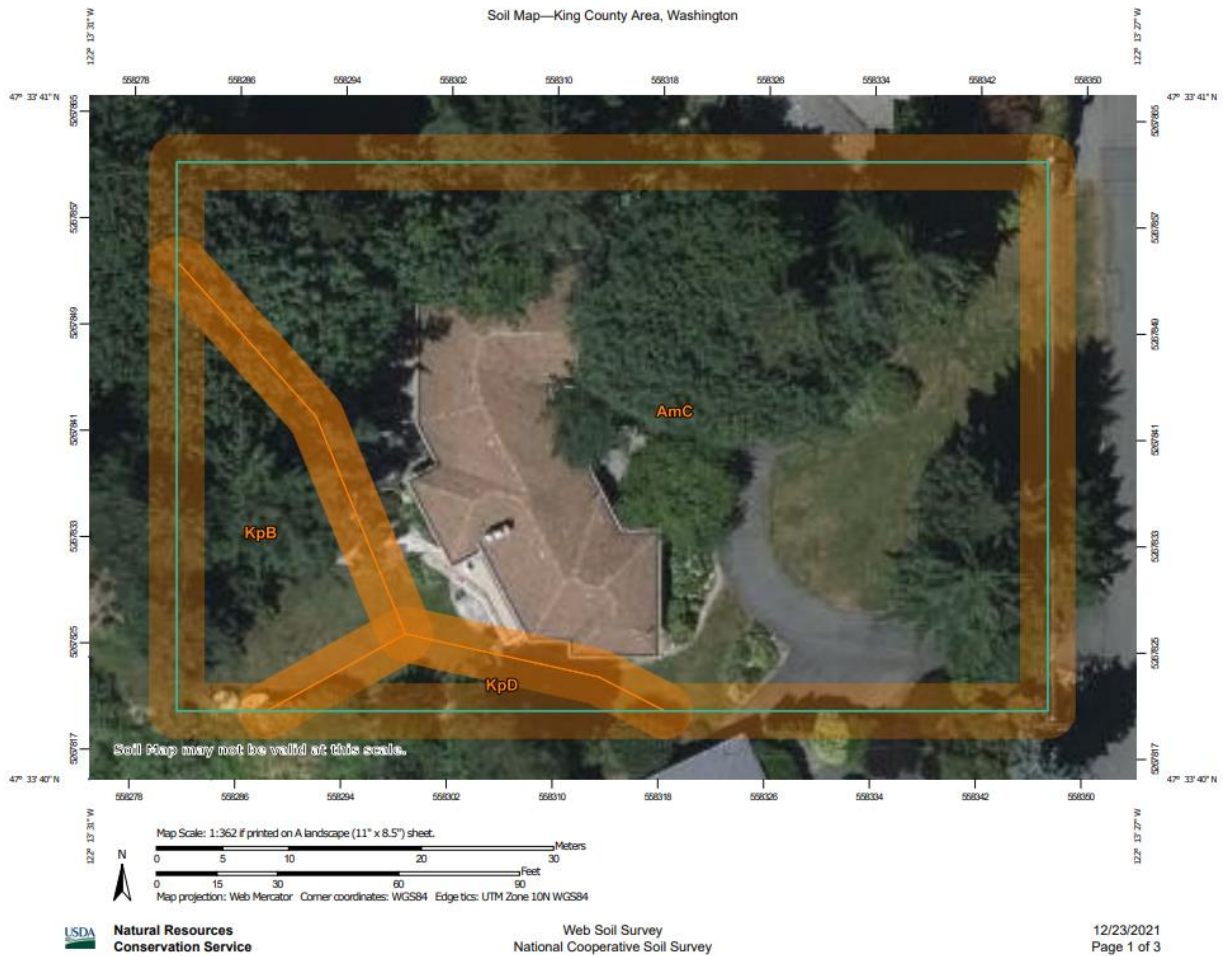
FIGURE 4 SOILS MAP

King County Area, Washington

AmC—Arents, Alderwood material, 6 to 15 percent slopes

A continuous simulation model, WWHM 2012, was used to analyze the pre- and post-developed runoff rates. The soil type is modeled as hydrologic soil group C for the Alderwood SCS classification as shown in Figure 4. In the pre-developed condition, the entire Site is modeled as %Forest+. In post-development conditions, the soil types are unchanged from the pre-developed conditions. Pursuant to the 2019 Department of Ecology Stormwater Management Manual for Western Washington, Volume III-Appendix C, all areas that meet the soil quality and depth requirement are to be entered

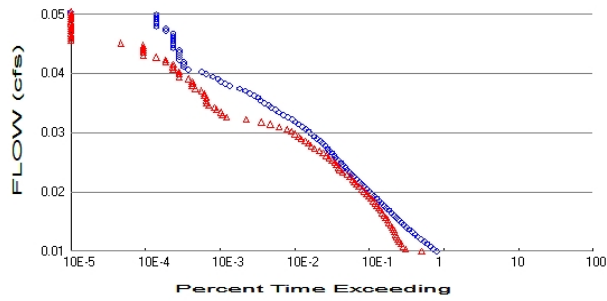
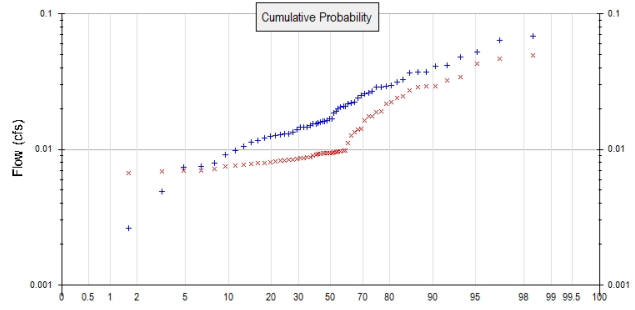
POC 1

+ Predeveloped x Mitigated

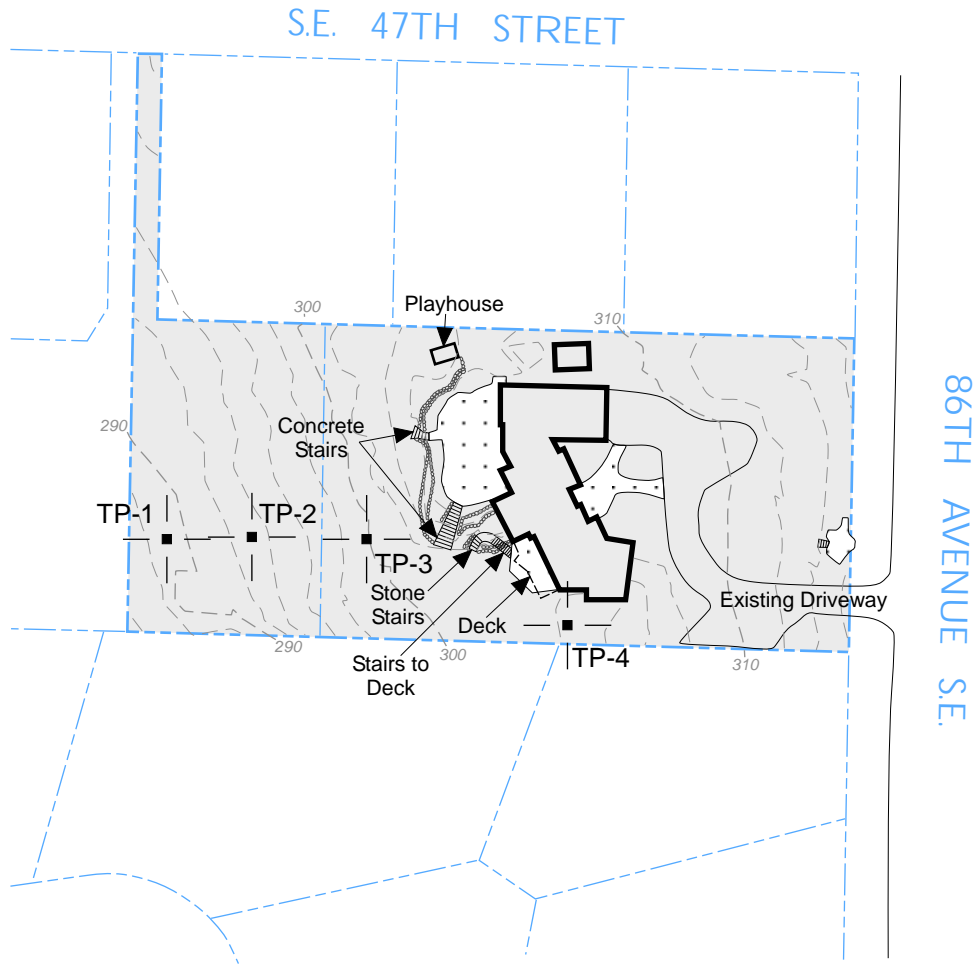
| Checked BCS | Date Jan. 2022 | Plate 2 |

TP-1 | — ■ — | Approximate Location of ESNW Test Pit, Proj. No. ES-8009.01, Dec. 2021

ESNW representatives observed, logged and sampled four test pits, associated with this report. The test pits were advanced using an excavator and operator contracted by the client. The approximate location of the test pits is depicted on the Test Pit Location Plan (Plate 2). Please refer to the soil logs provided in Appendix A for a more detailed description of the subsurface conditions. Test pit TP-4 was terminated at a shallow depth due to the presence of an irrigation pipe within the test pit.

The subsurface conditions at the site were explored by excavating a total of four test pits across accessible portions of the property. The subsurface explorations were completed in December of 2021. The approximate test locations are illustrated on Plate 2 of this report. Logs of the test pits are provided in this Appendix. The test pits were excavated to a maximum depth of seven and one-half feet below existing grades.

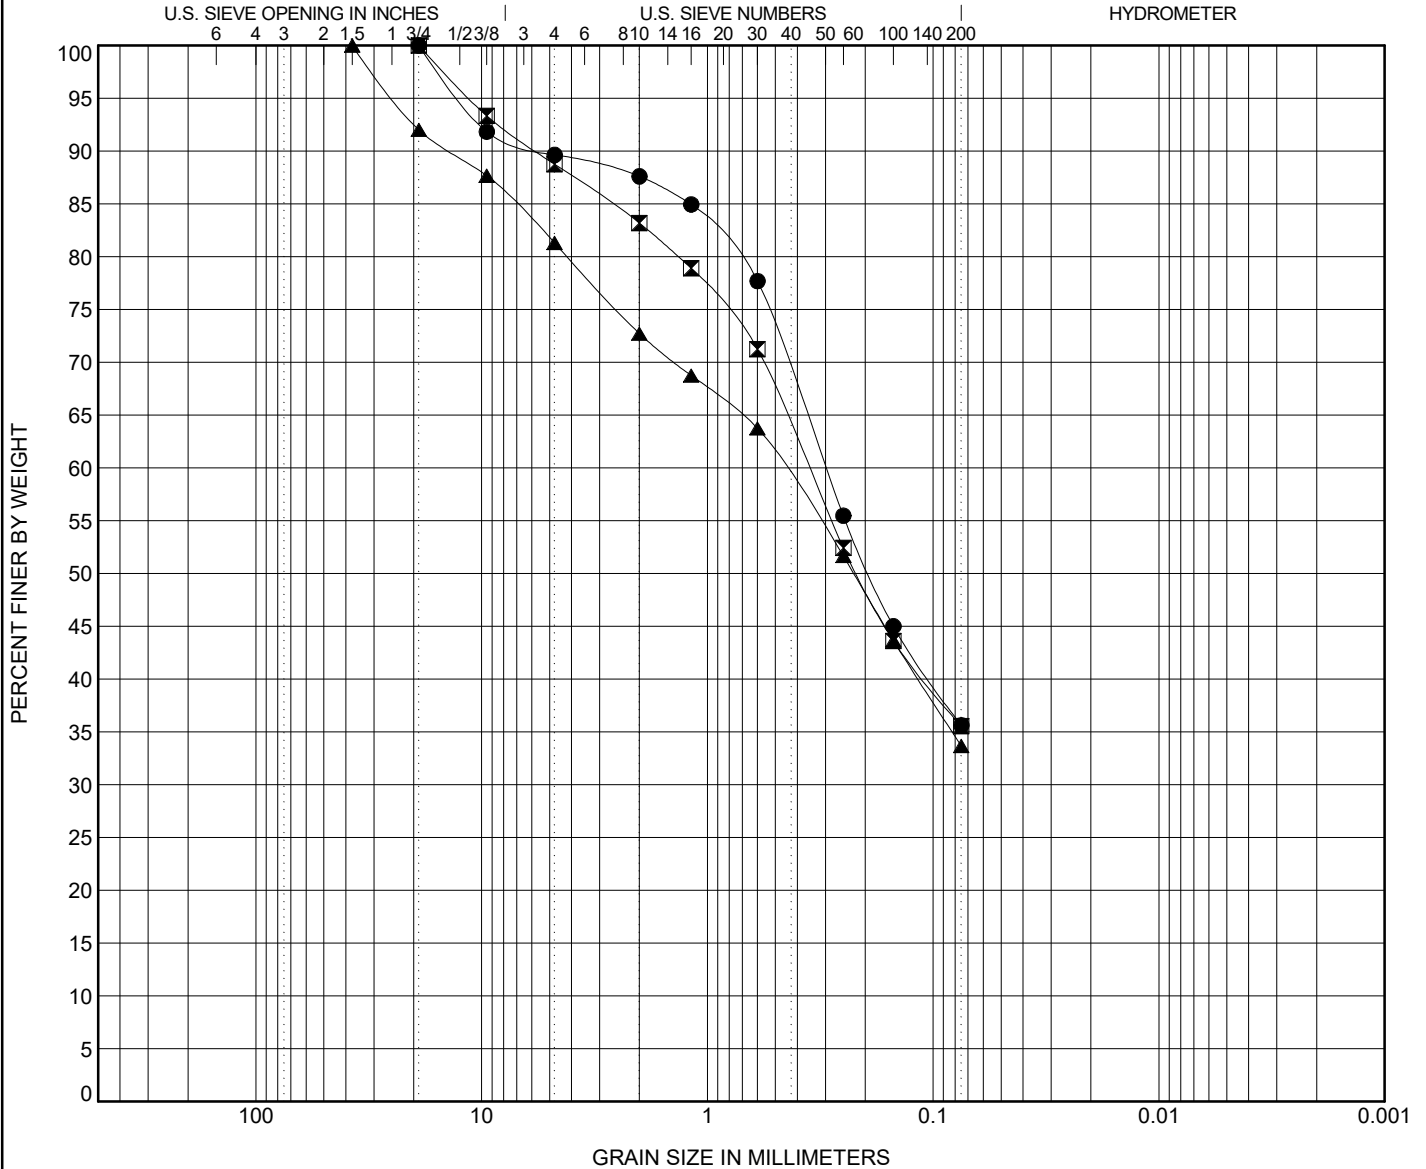
| COBBLES | GRAVEL | | SAND | | | SILT OR CLAY |
| | coarse | fine | coarse | medium | fine | |
