**Stormwater Drainage Report
9619 SE 34th Street
Su Residence
Mercer Island, Washington
KC Tax Parcel #413930-0025
Permit #: XXXX-XXX**

**Offe Engineers, PLLC
Darrell Offe, P.E.
13932 SE 159th Place
Renton, Washington 98058
425-260-3412
Darrell.Offe@comcast.net**

Section 1: Project Narrative:

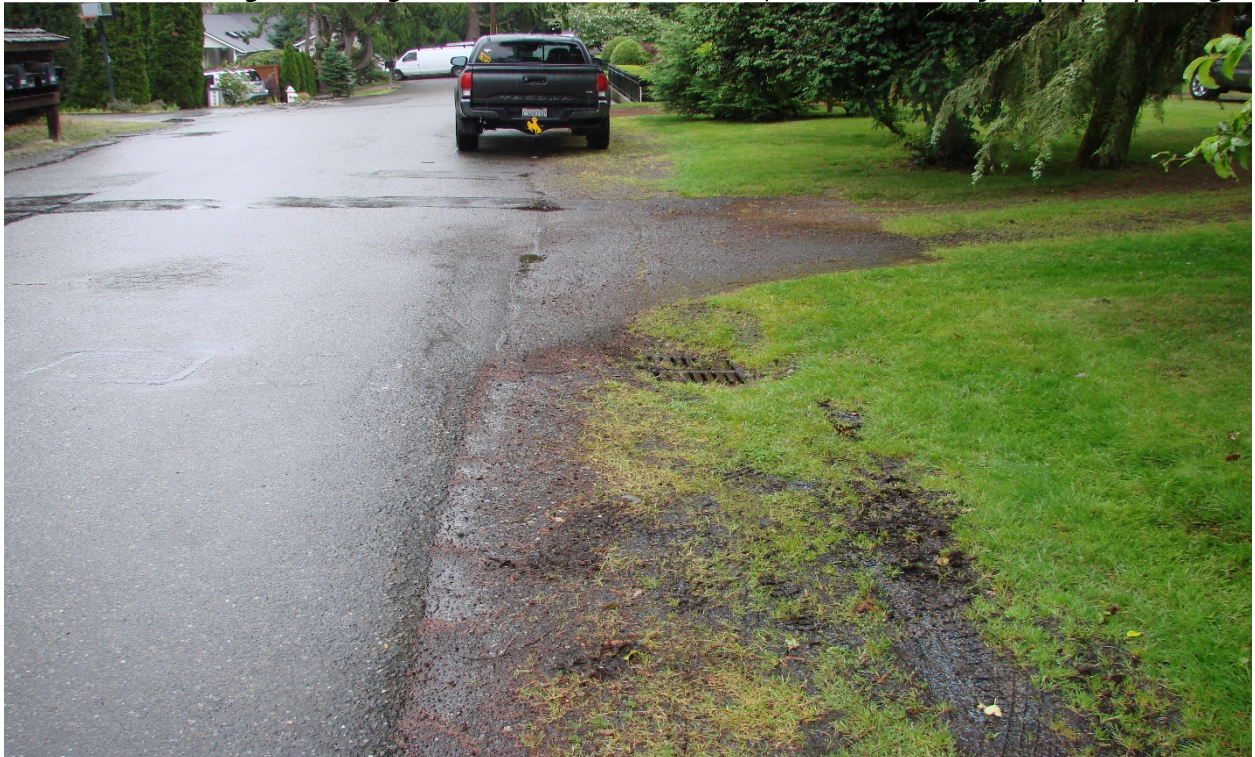
Photo #2 – Viewing east along south side of SE 34th Street, CB#3a-6 – Subject property to right

- CB# 3a-3 - Inlet clean, water flowing in conveyance pipe, CB sump has debris.
- CB# 3a-68 – Inlet clean, water flowing
- CB# 3a-64 – Inlet partially blocked, water flowing
- CB# 3a-65 – Looks like recently been replaced, inlet clean, water flowing, clean sump
- CB# 3a-66 – recently new CB, inlet clean, sump clean, flowing water
- CB# 3a-61 – solid locking lid, could not access
- CB# 3a-58 – solid locking lid, could not access
- Lake Outfall – flowing water, rip-rapped, no scouring or erosion present

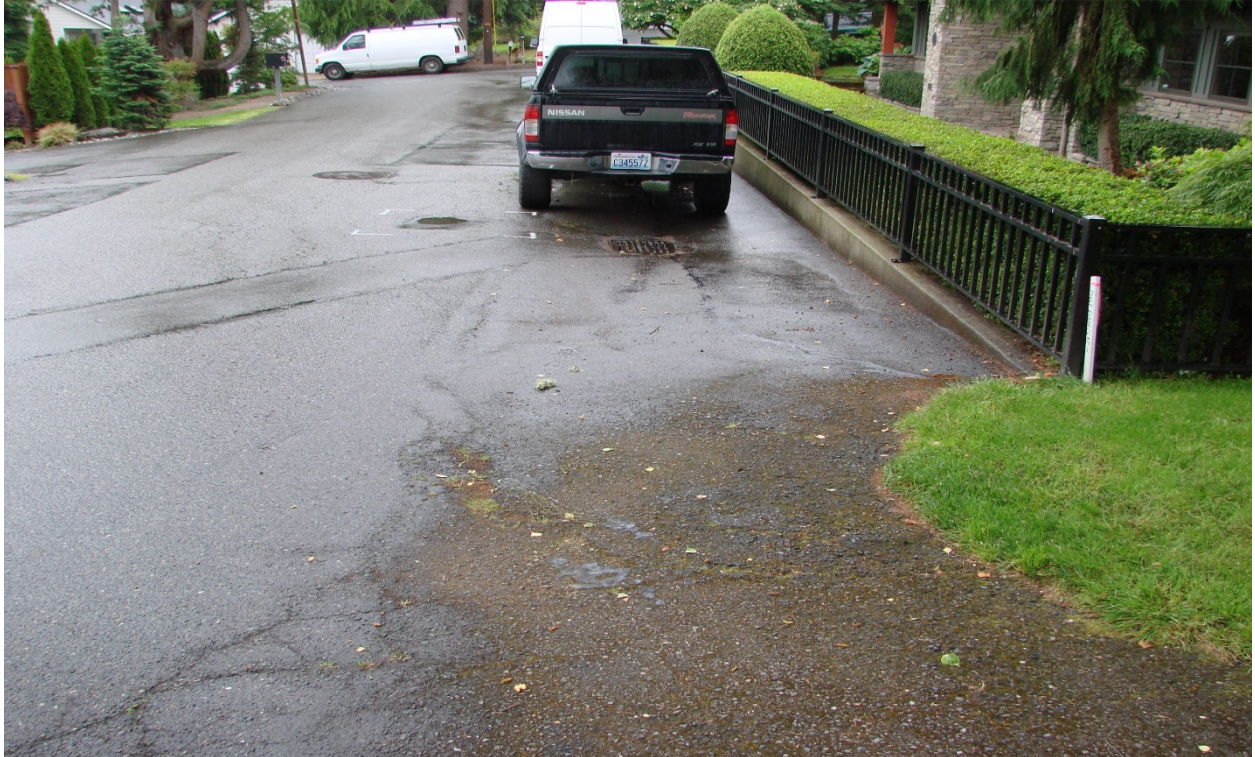
Photo #3 – Viewing east along SE 34th Street, subject property NE corner (white post).
CB#3a-3 located at back of pickup truck

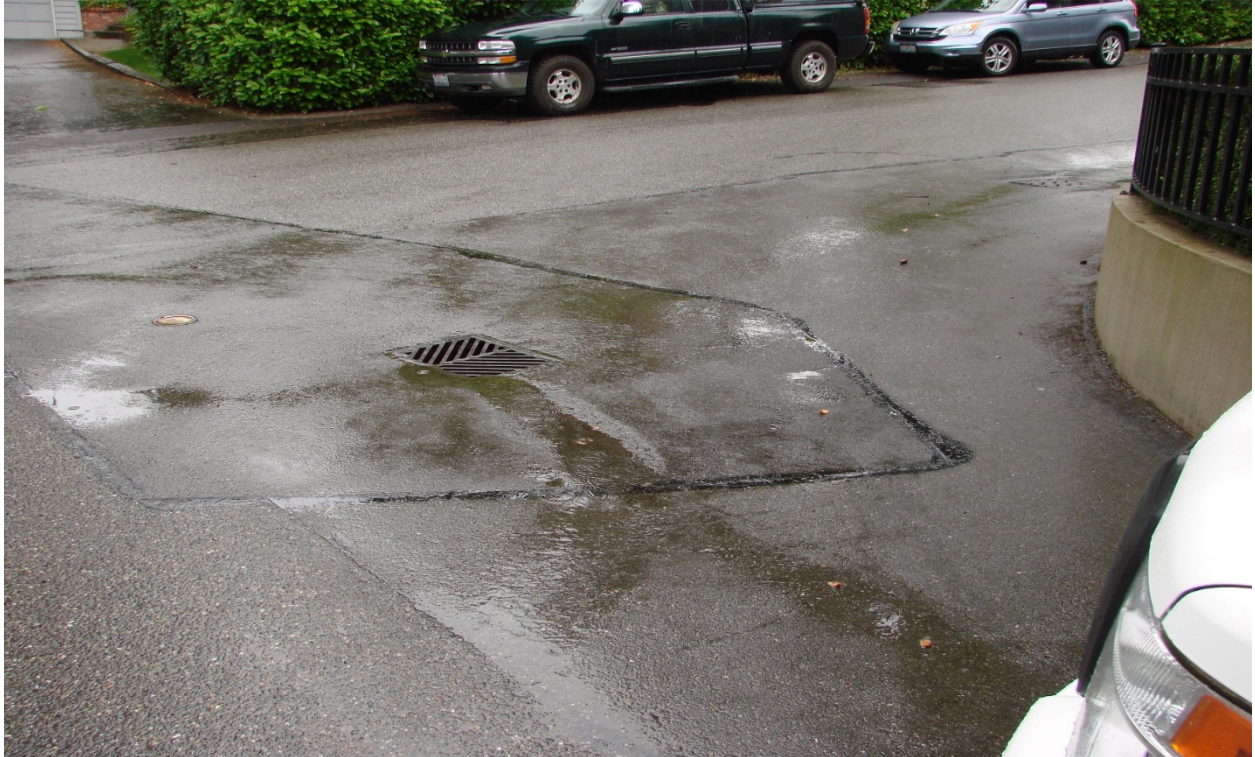
Photo #5 – Viewing east along SE 34th Street at int'x of 97th Avenue NE, CB #3a-68

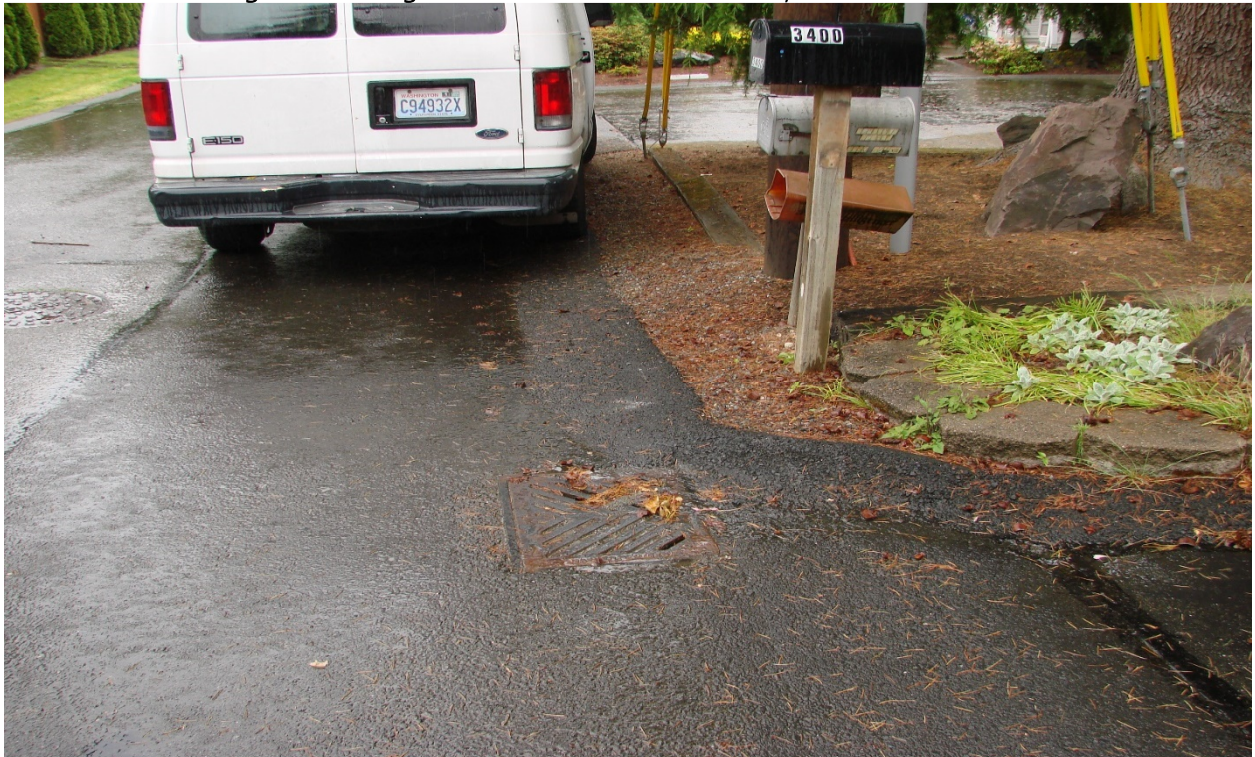
Photo #6 – Viewing north along east side of 97th Avenue NE, CB #3a-64

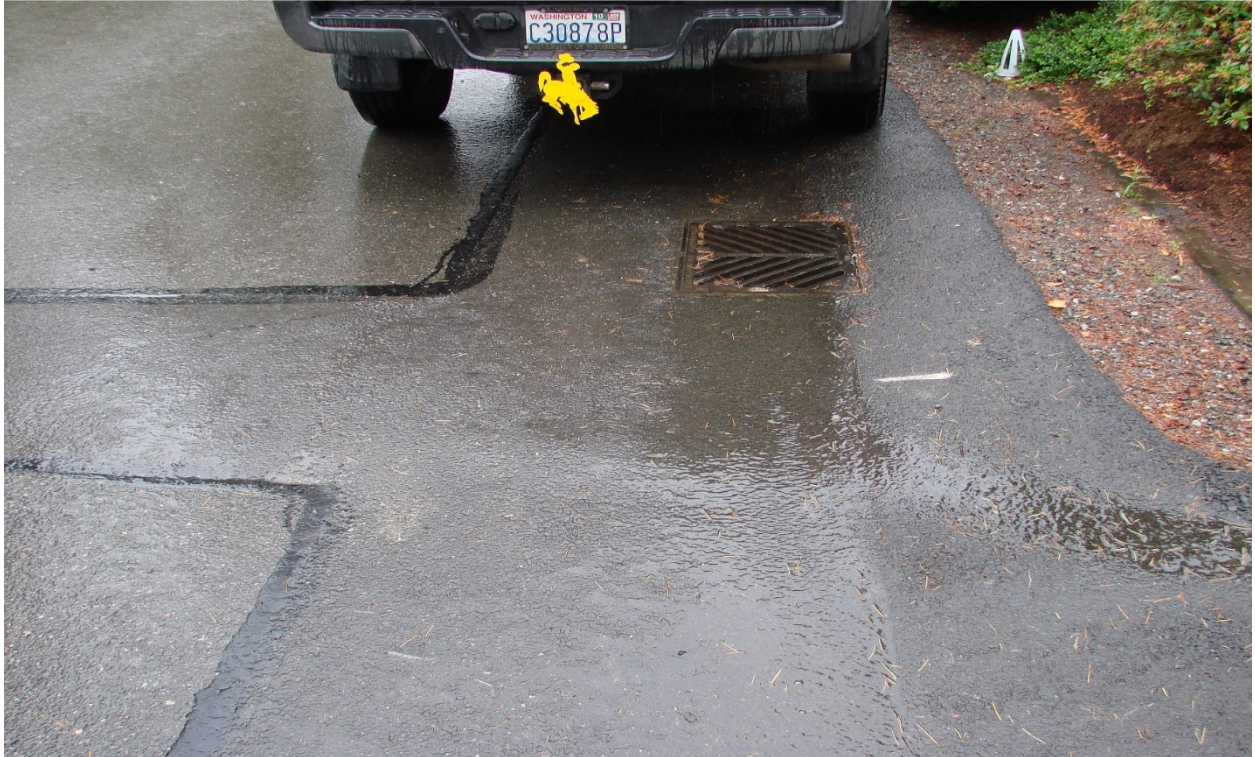
Photo #7 – Viewing north along east side of 97th Avenue NE @ CB# 3a-65

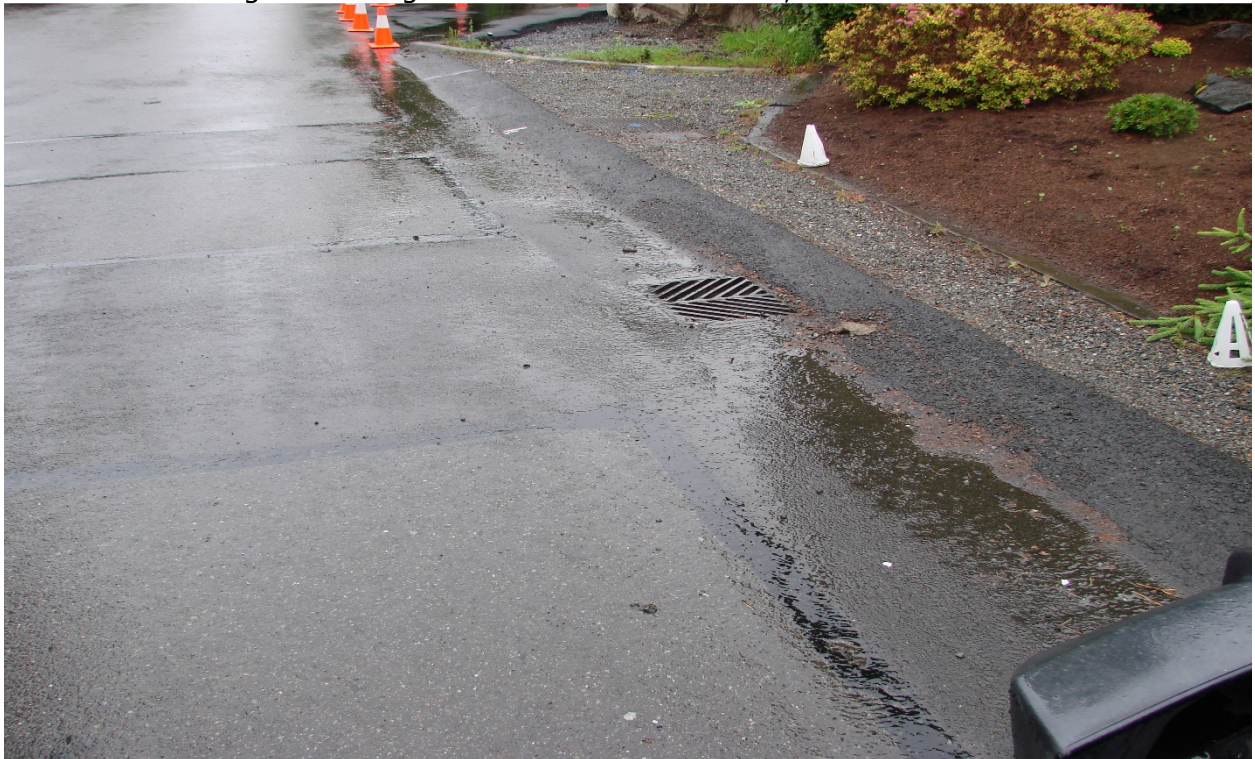
Photo #8 – Viewing north along east side of 97th Avenue NE, CB# 3a-66

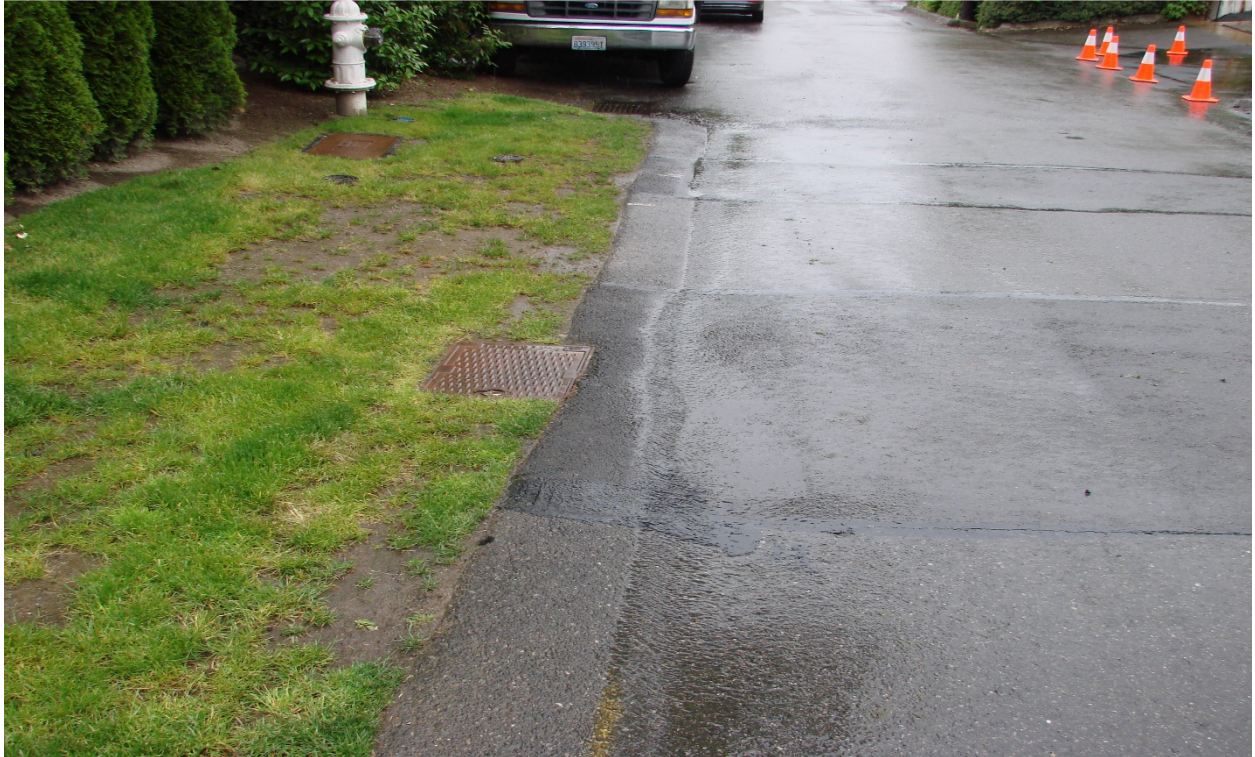
Photo #9 – Viewing north along west side of 97th Avenue NE, CB# 3a-61

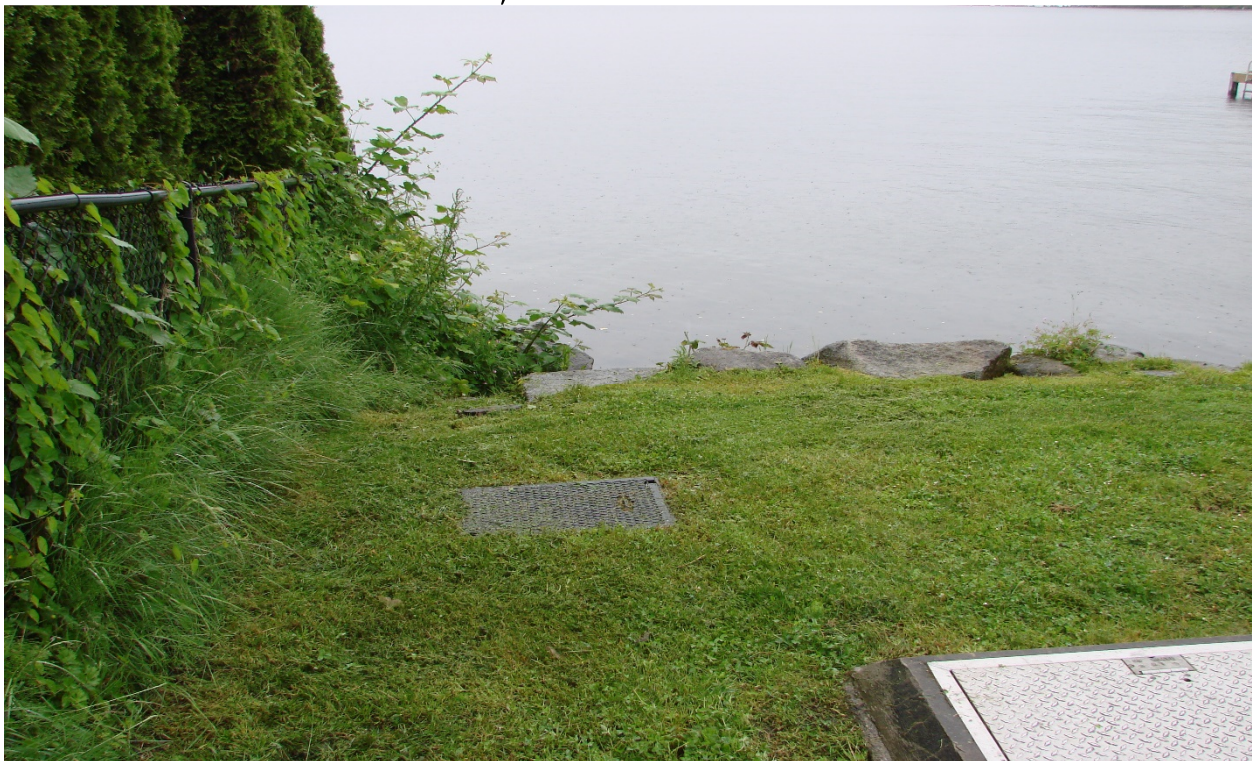
Photo #10 – Northwest corner of Park, CB# 3a-58

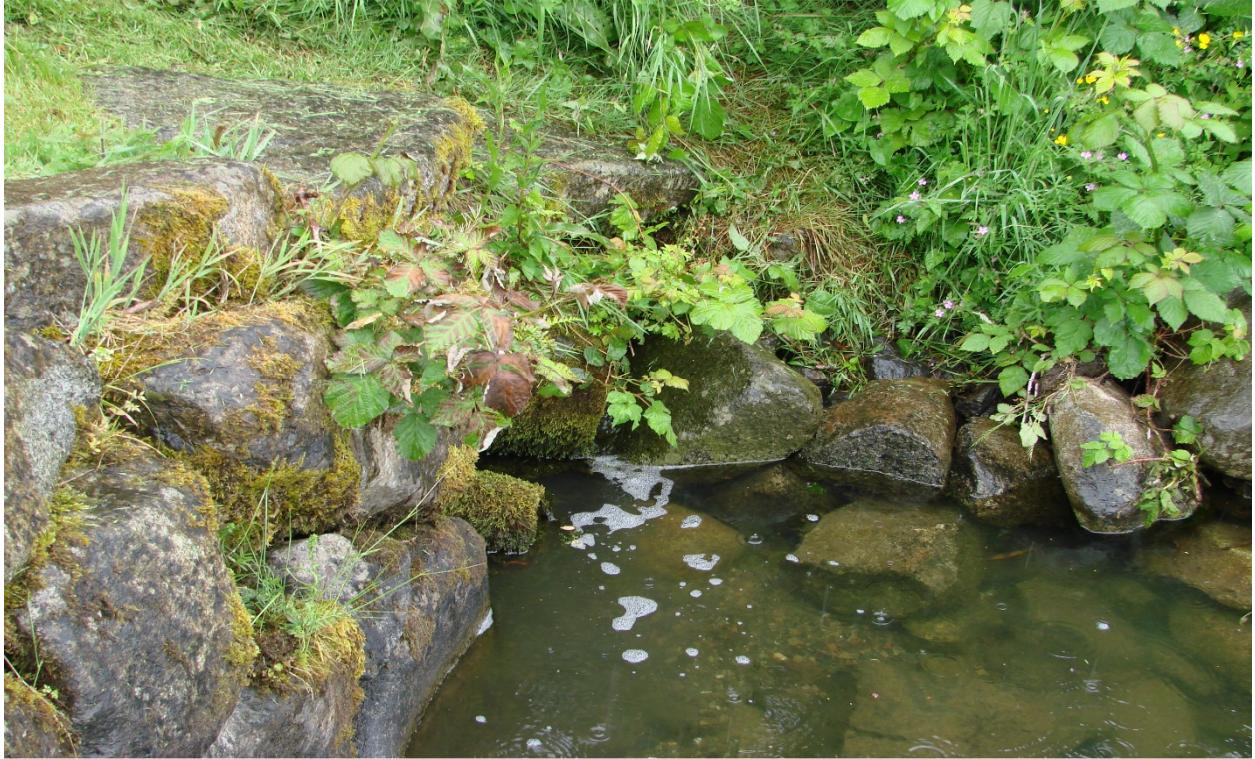
Photo #11 – Viewing west at outfall into Lake Washinton at north end of Park

The accessible portion of the downstream public storm system downgradient from the subject property natural outfall has no indications of flooding, overtopping, erosion, or scouring. The downstream system appears to have adequate capacity. A few of the existing catch basins need to have the sumps cleaned out due to debris build-up.

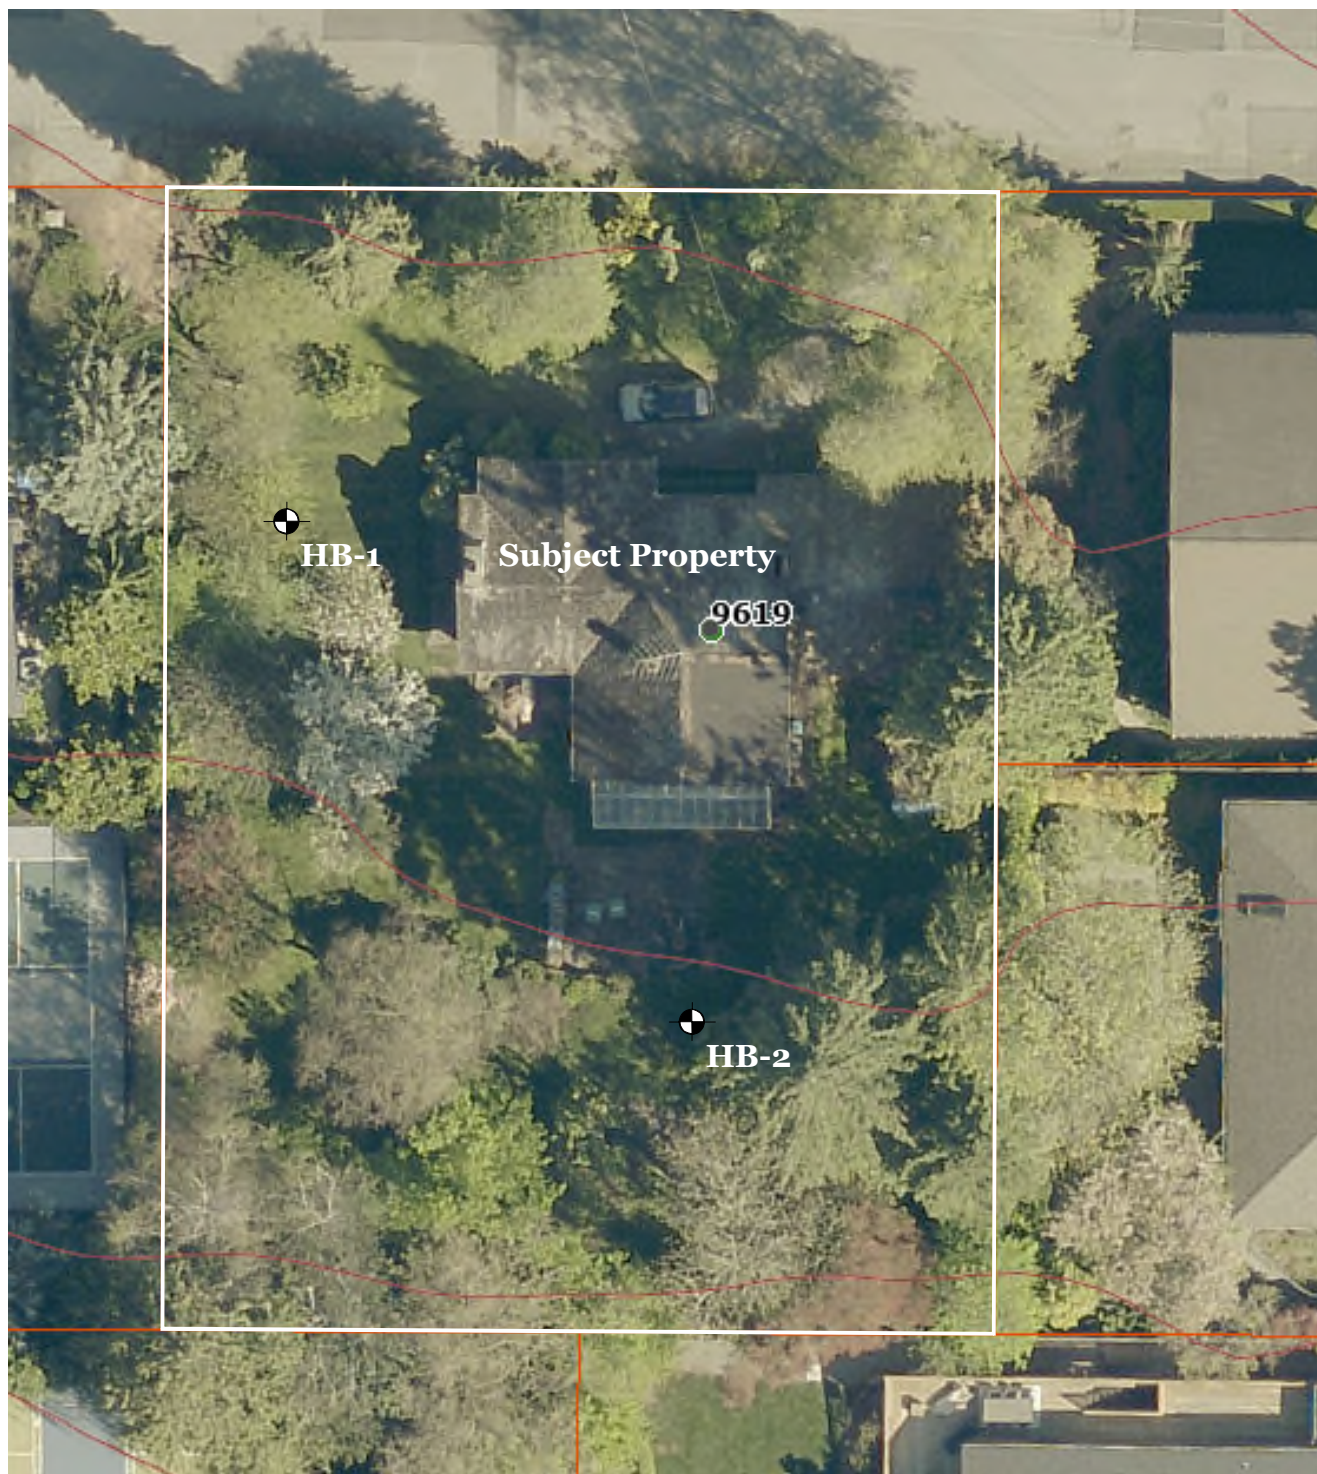
Site Image
Figure 1

Approximate Hand Boring Location
HB-1
