October 20, 2023
Revised June 5, 2024
Project No. 23-223

Subject: Geotechnical Report
Proposed Remodel and Alterations
8541 Southeast 82nd Street, Mercer Island, Washington

Proposed Remodel and Additions: 8541 Southeast 82nd Street, Mercer Island, Washington

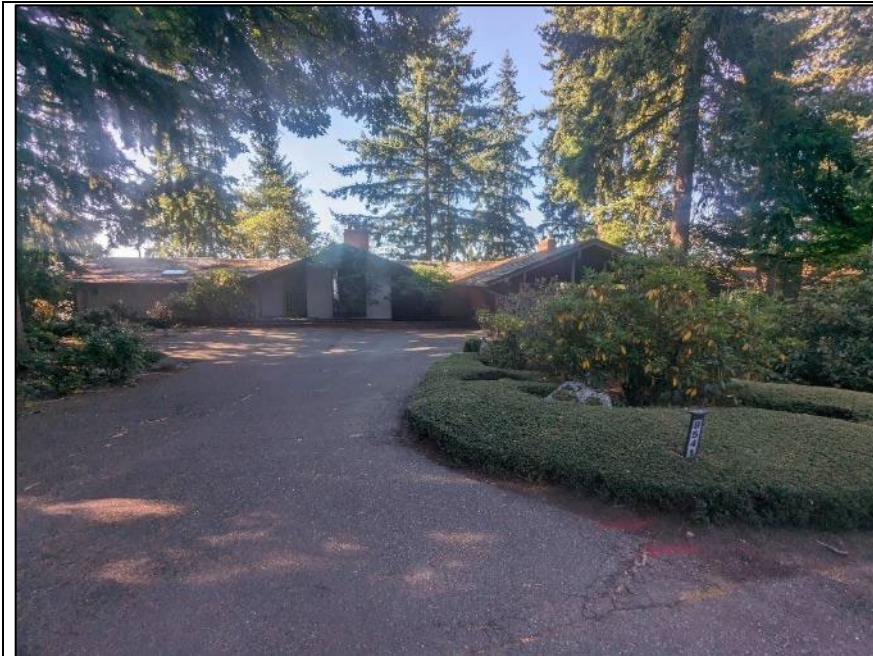
Plate 1: View of the north side of the site looking south from Southeast 82nd Street.

The site is generally vegetated with mature evergreen trees up to 40 inches in diameter, lawns, ivy, and small landscaping trees and shrubs. Plates 1 and 2 on the next page show current site conditions at the site.

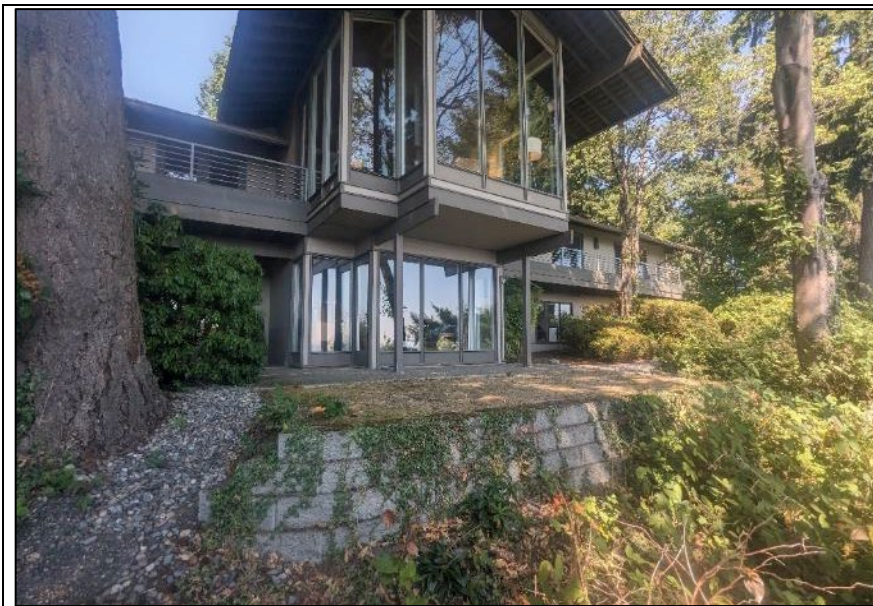
Plate 2: View of south side of the existing residence looking from south to north.

- The small block wall constructed at the top of the south slope (see Plate 2 on Page 2) appeared to be in fair condition and we did not observe any obvious evidence of wall movement or instability (i.e., tilting or toppling of the wall).
- The south slope was densely vegetated with mature Douglas fir, bigleaf maple trees and a dense understory of ferns, vine maple, and brush. At the time of our reconnaissance, the visibility of the ground surface was limited due to surface vegetation.
- The majority of the mature trees appeared to be generally straight, indicating that the slope is relatively stable.
- We did not observe groundwater seepage or hydrophytic or water loving plants at the site.
- The existing building foundation and deck were observed to be in fair condition.

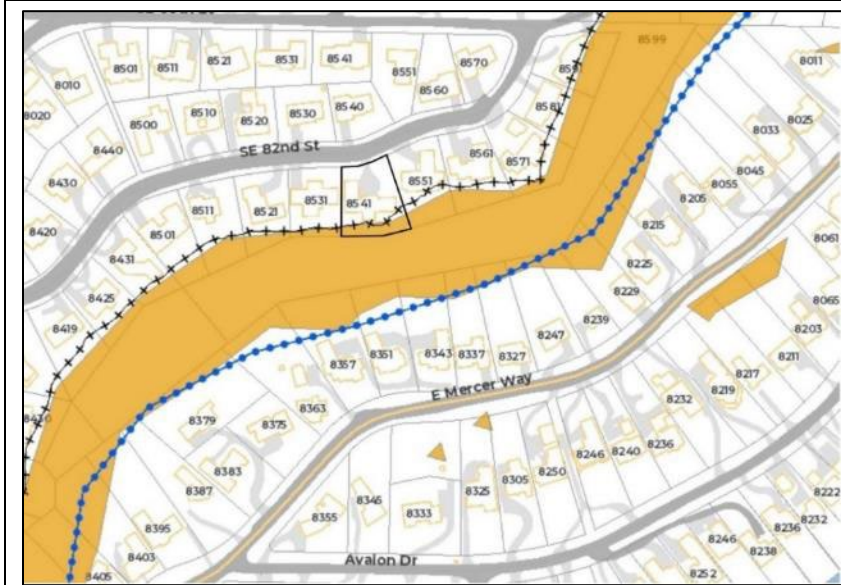
Plate 5: The orange shaded area is the approximate extent of 40 percent and steeper slope identified by Mercer Island.

The site is outlined in black.

Plate 4, on the following page, shows the approximate extent of landslide hazard areas mapped by the City of Mercer Island. Based on review of the City's mapping, the majority of the site is located in a landslide hazard area and potential landslide hazard area. Additionally, the slope on the south side of the property and beyond the property line is also mapped as a 40 percent and steeper slope area. The approximate extent of the 40 percent slopes mapped by Mercer Island are shown on *Plate 5*, also on the following page.

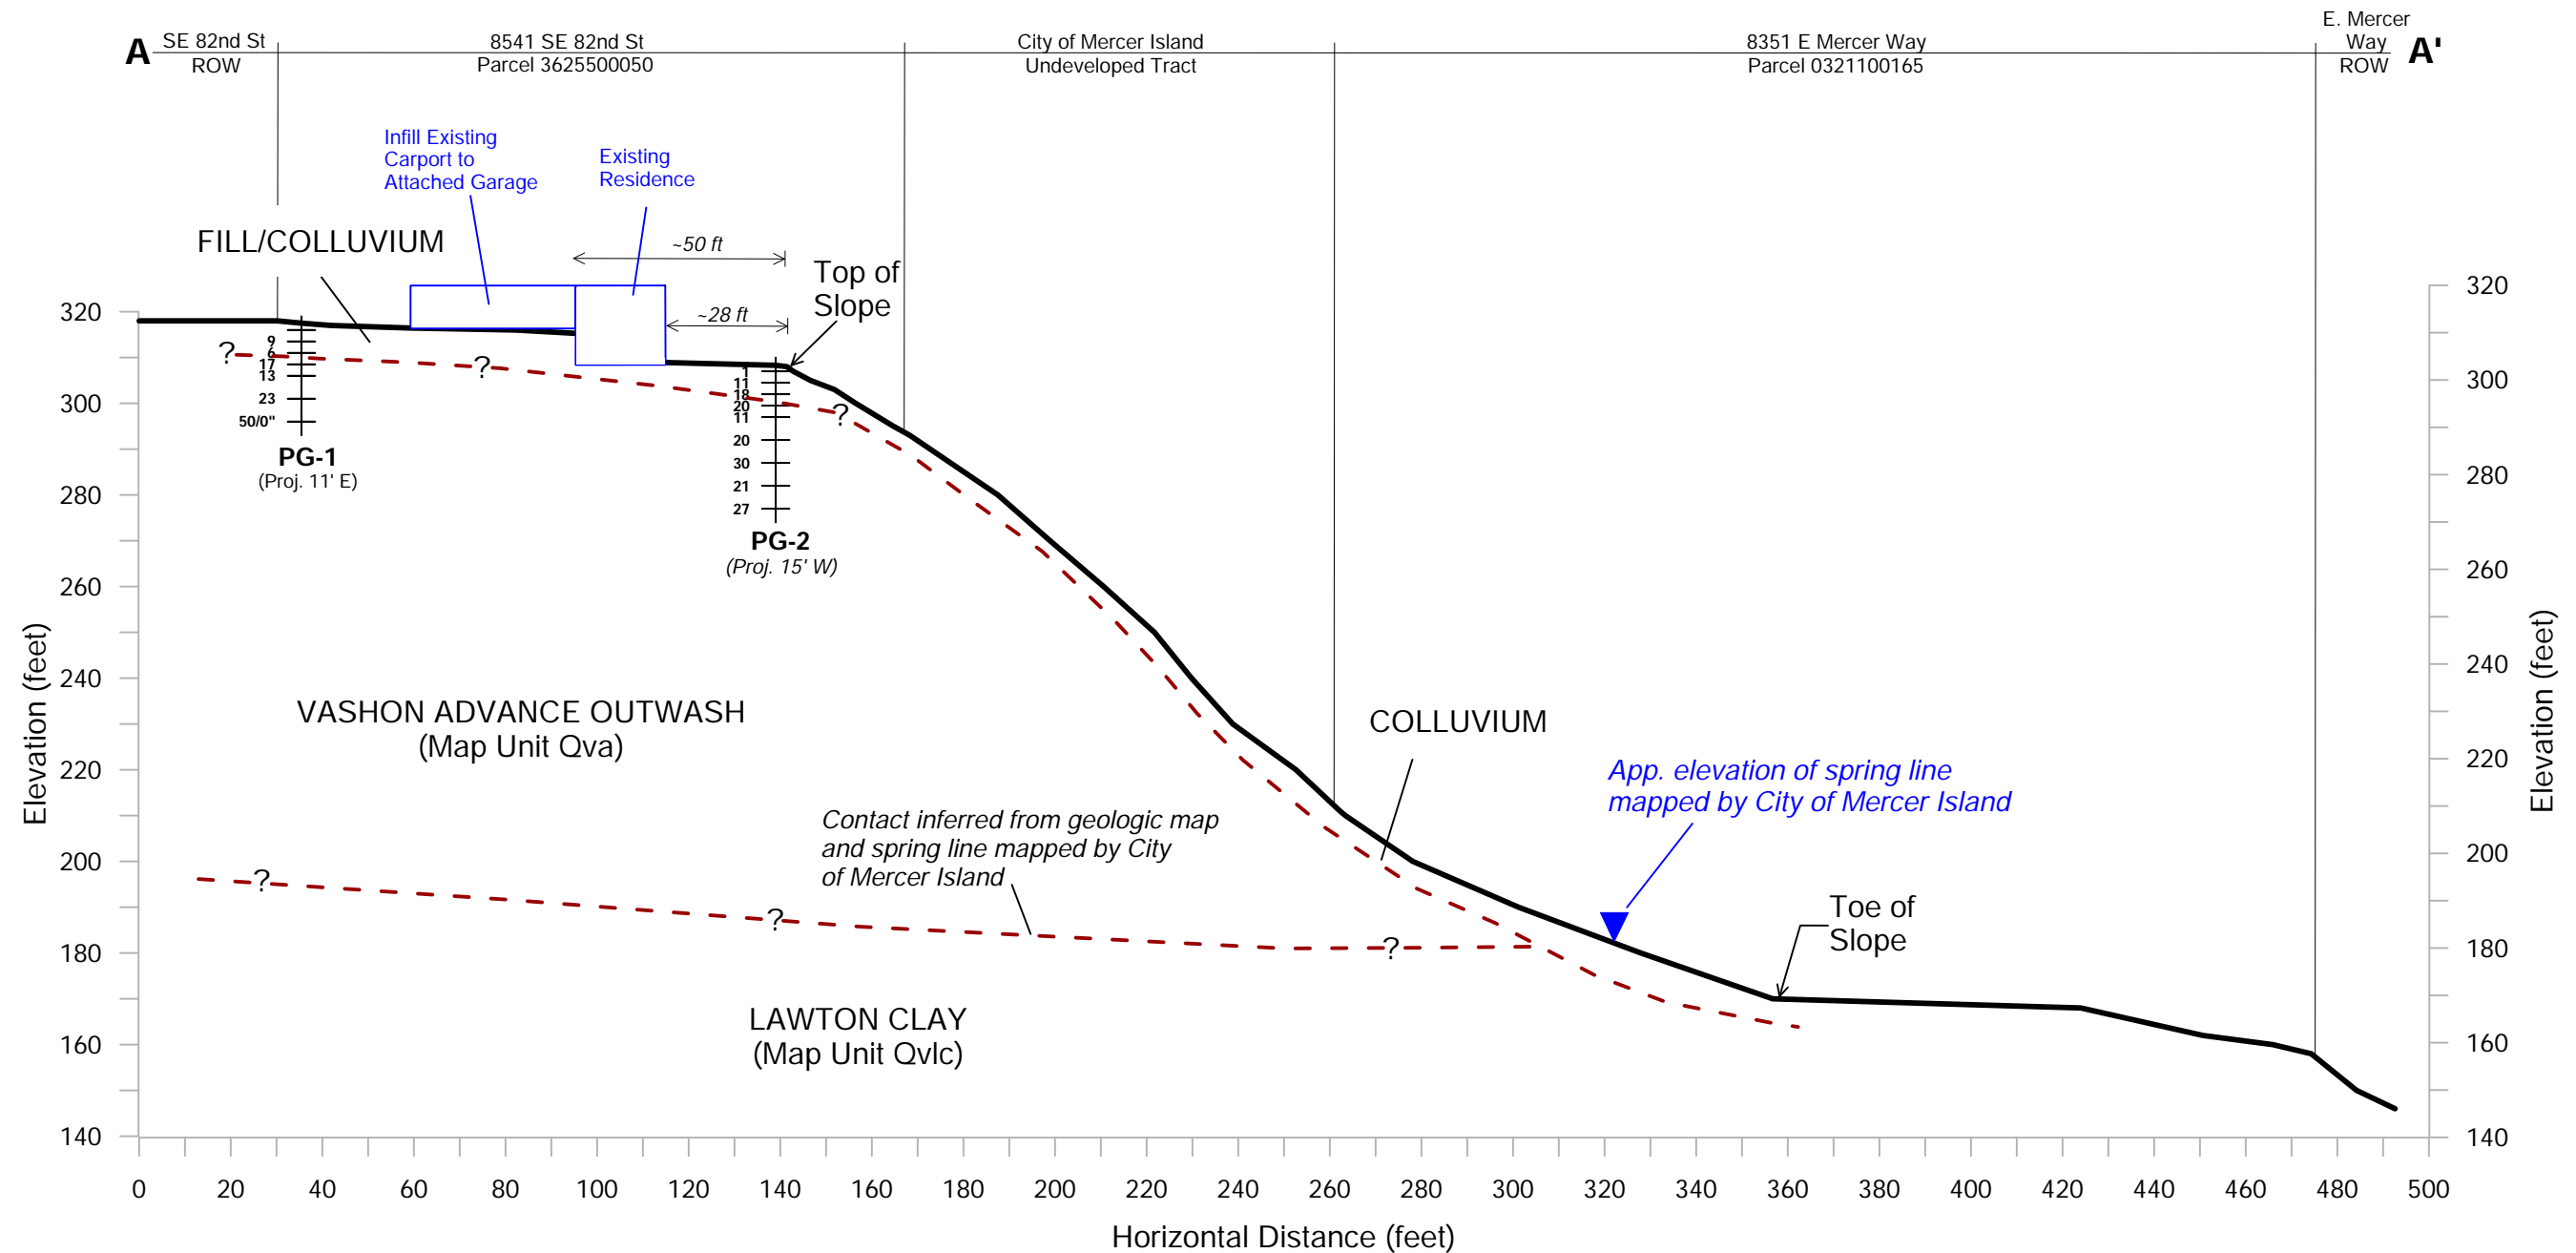
Proposed Remodel/Alterations 8541 SE 82nd Street Mercer Island, WA	GENERALIZED SUBSURFACE PROFILE SECTION A-A'	
		Project No. 23-223	Figure No. 3

Horizontal & Vertical Scale:
1 inch = 40 feet

- Existing ground profile on property and slope based on the topographic survey of 18541 SE 82nd St, Mercer Island, prepared by Terrane, dated November 11, 2022.
- Ground surface topography from site property line down to East Mercer way estimated from elevation contours obtained from City of Mercer Island GIS.
- See Figure 2 for location of Section A-A'.
- See report text for a detailed description of the subsurface conditions across the site.

The subsurface conditions encountered in our borings and the topography were used to develop the generalized subsurface profile included as *Figure 3, Generalized Subsurface Profile A-A'*. It should be noted that the stratigraphic contacts indicated on the boring logs and our subsurface profile represent the approximate depth to boundaries between soil units. Actual transitions between soil units may be more gradual or occur at different elevations.

Where new footings will be constructed adjacent to the existing basement walls (see *Figure 3*), we recommend the footings be located below a 1H:1V (Horizontal:Vertical) projection from the base of the existing basement footings to avoid surcharging the basement walls. If needed, the potential surcharge pressures can be evaluated using a lateral pressure coefficient of 0.35 (i.e., lateral pressure equal to about 35 percent of the vertical pressure)
