**FINAL**  
**STORM DRAINAGE REPORT**

**Foo Property**

**CITY OF MERCER ISLAND, WASHINGTON**

**Project Manager:** Michael A. Moody, P.E.  
**Prepared by:** Daniel J. Larson, E.I.T.  
**Approved by:** Michael A. Moody, P.E.  
**Date:** June 2020  
**Revised:** December 2020  
**Core No.:** 20034

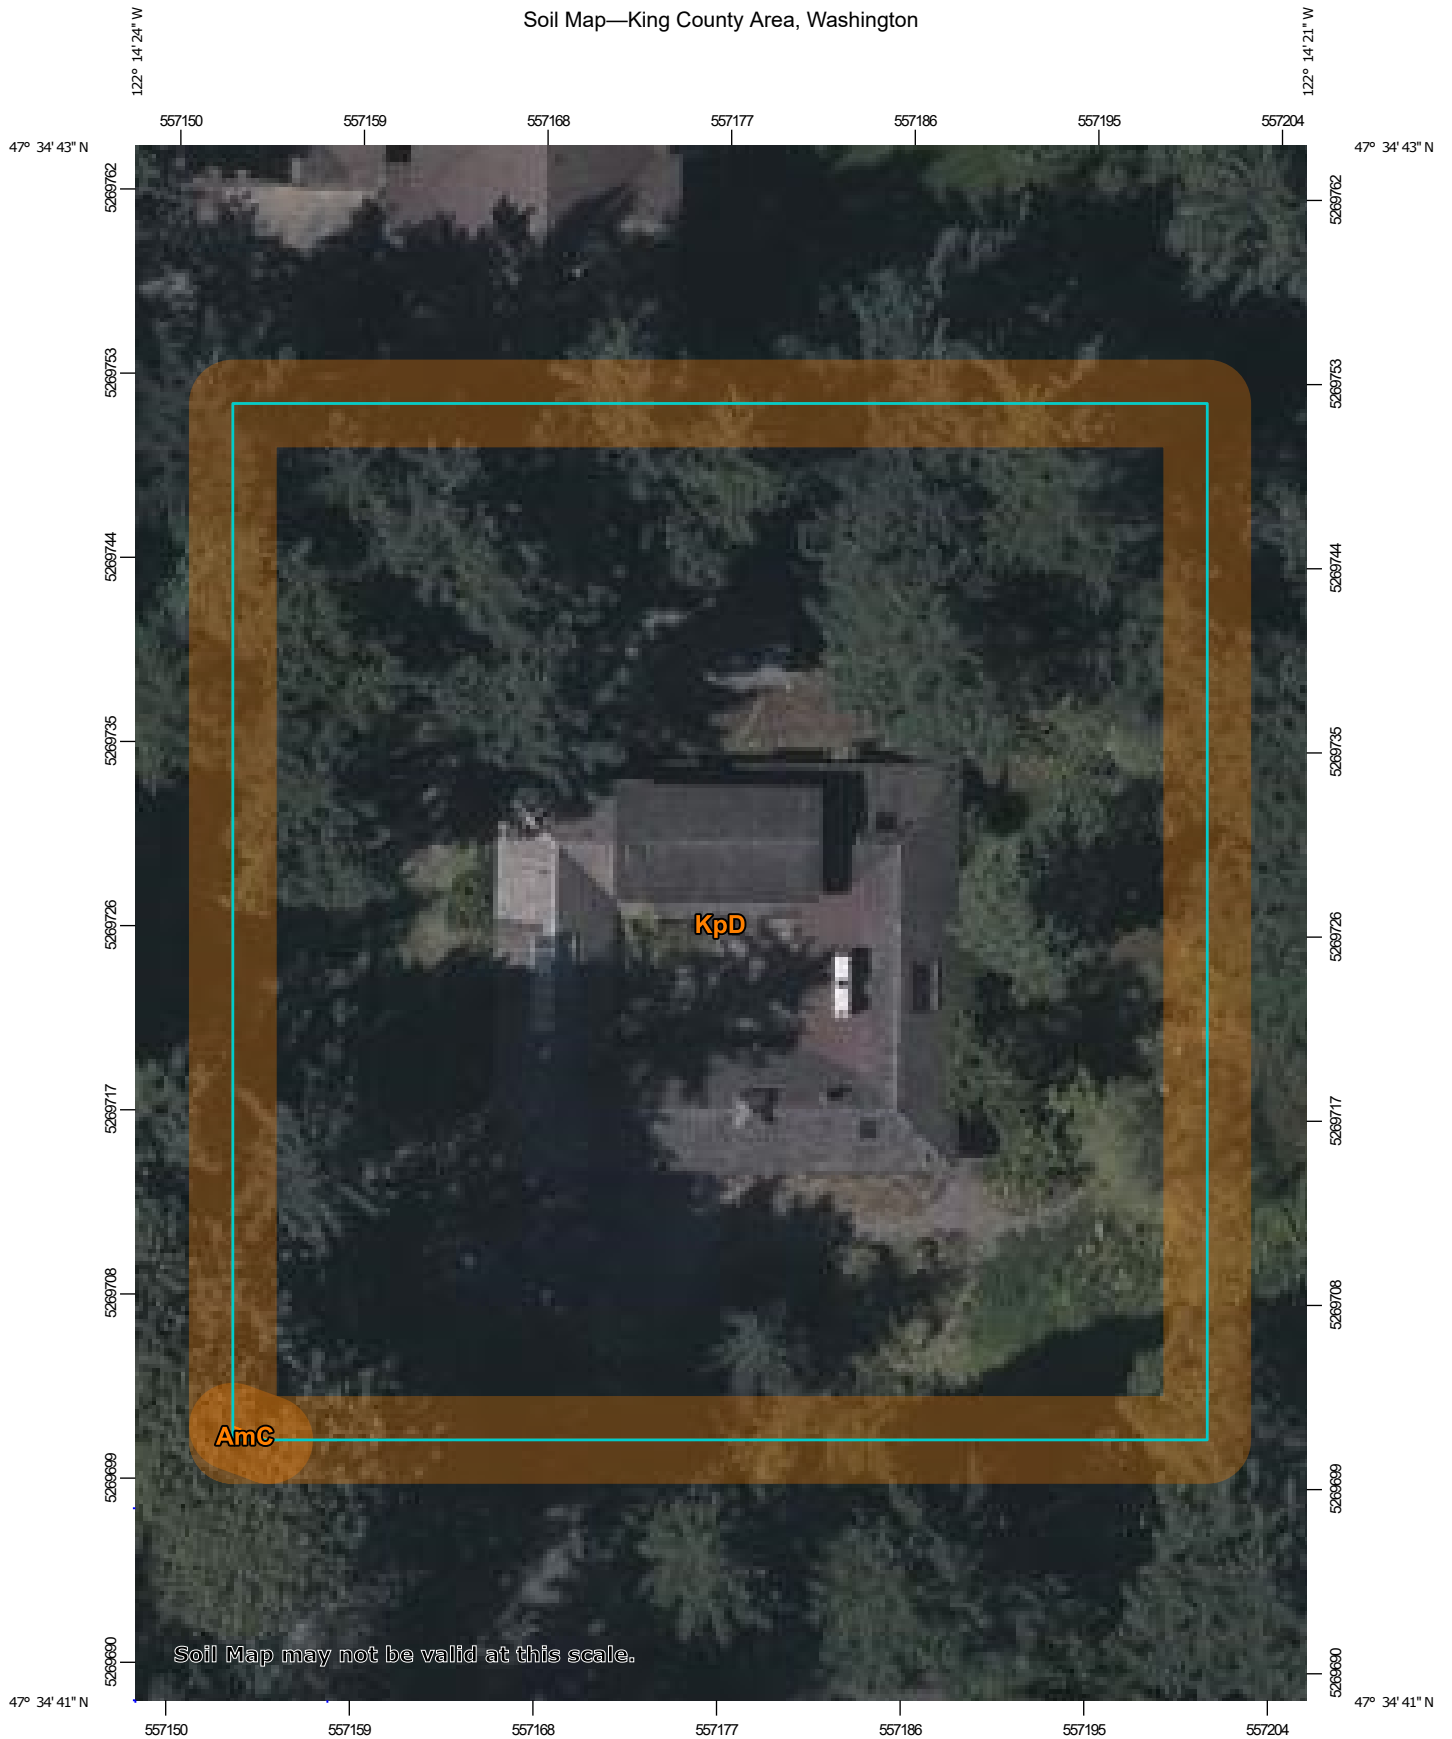
Soil Map—King County Area, Washington

Map Unit Symbol	Map Unit Name	Acres in AOI	Percent of AOI
AmC	Arents, Alderwood material, 6 to 15 percent slopes	0.0	0.0%
KpD	Kitsap silt loam, 15 to 30 percent slopes	0.6	100.0%
<b>Totals for Area of Interest</b>		<b>0.6</b>	<b>100.0%</b>

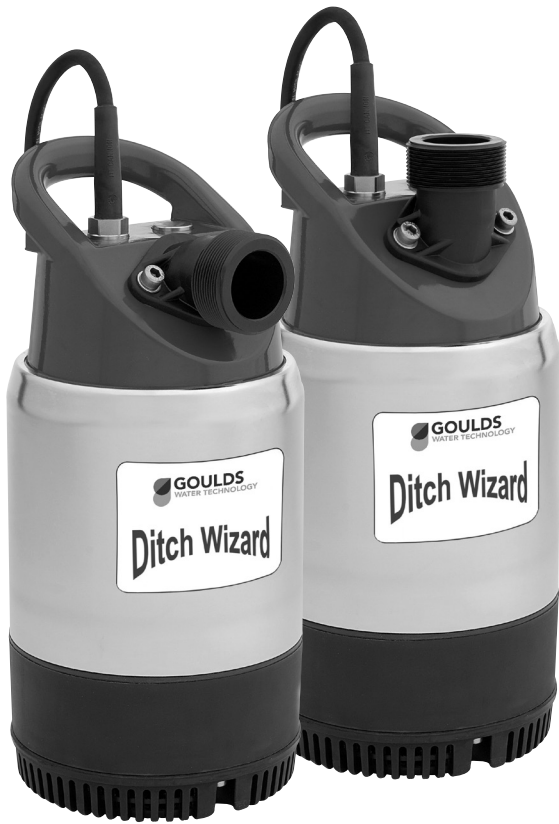
**FEATURES**

- Impeller:** Polyurethane for wear and corrosion resistance.
- Adjustable Discharge:** Discharge can be installed for either vertical or horizontal installation using only 2 screws.
- Diffuser:** Polyurethane for wear and corrosion resistance.
- Mechanical Seal:** Dual seals for double leakage protection, outer seal - silicon carbide.
- Rubber Liner:** Protects against wear around impeller.
- Bottom Strainer:** Made of impact absorbing EPDM rubber, suction holes allow for low pump down.

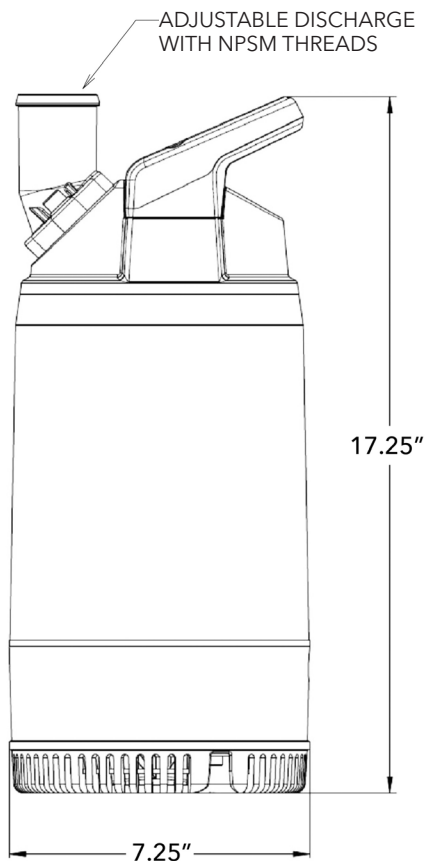
### DIMENSIONS

Order No.	HP	Volts	Phase	Maximum Amp	RPM	Height (in.)	Weight (lbs.)
2DW0511	½	115	1	5.5	3500	17.25	26
2DW0512		230		2.9			
2DW1011	1	115		9.8			
2DW1012		230		4.9			32

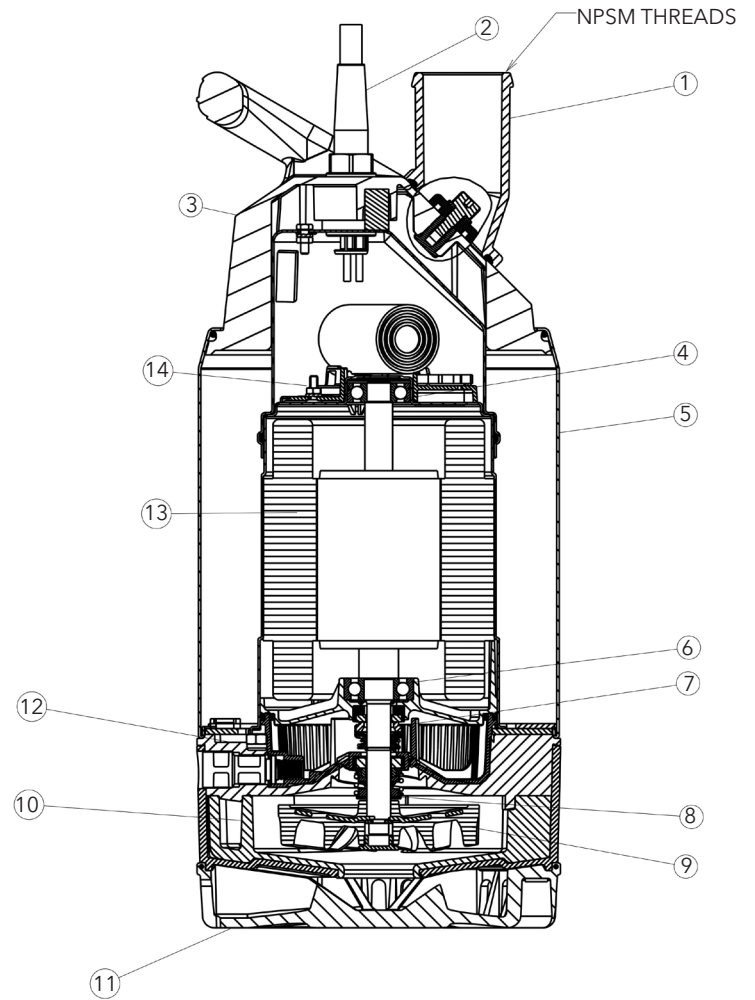
## COMPONENTS

Item No.	Description	
1	Discharge	Not Available
2	Power cord	Not Available
3	Handle/cover	Not Available
4	Support bearing	Not Available
5	Pump casing	Not Available
6	Main bearing	Not Available
7	Inner mechanical seal	Not Available
8	Outer mechanical seal	Available
9	Impeller	Available
10	Suction cover/diffuser	Available
11	Strainer	Not Available
12	Oil plug	Not Available
13, 14	Motor	Not Available

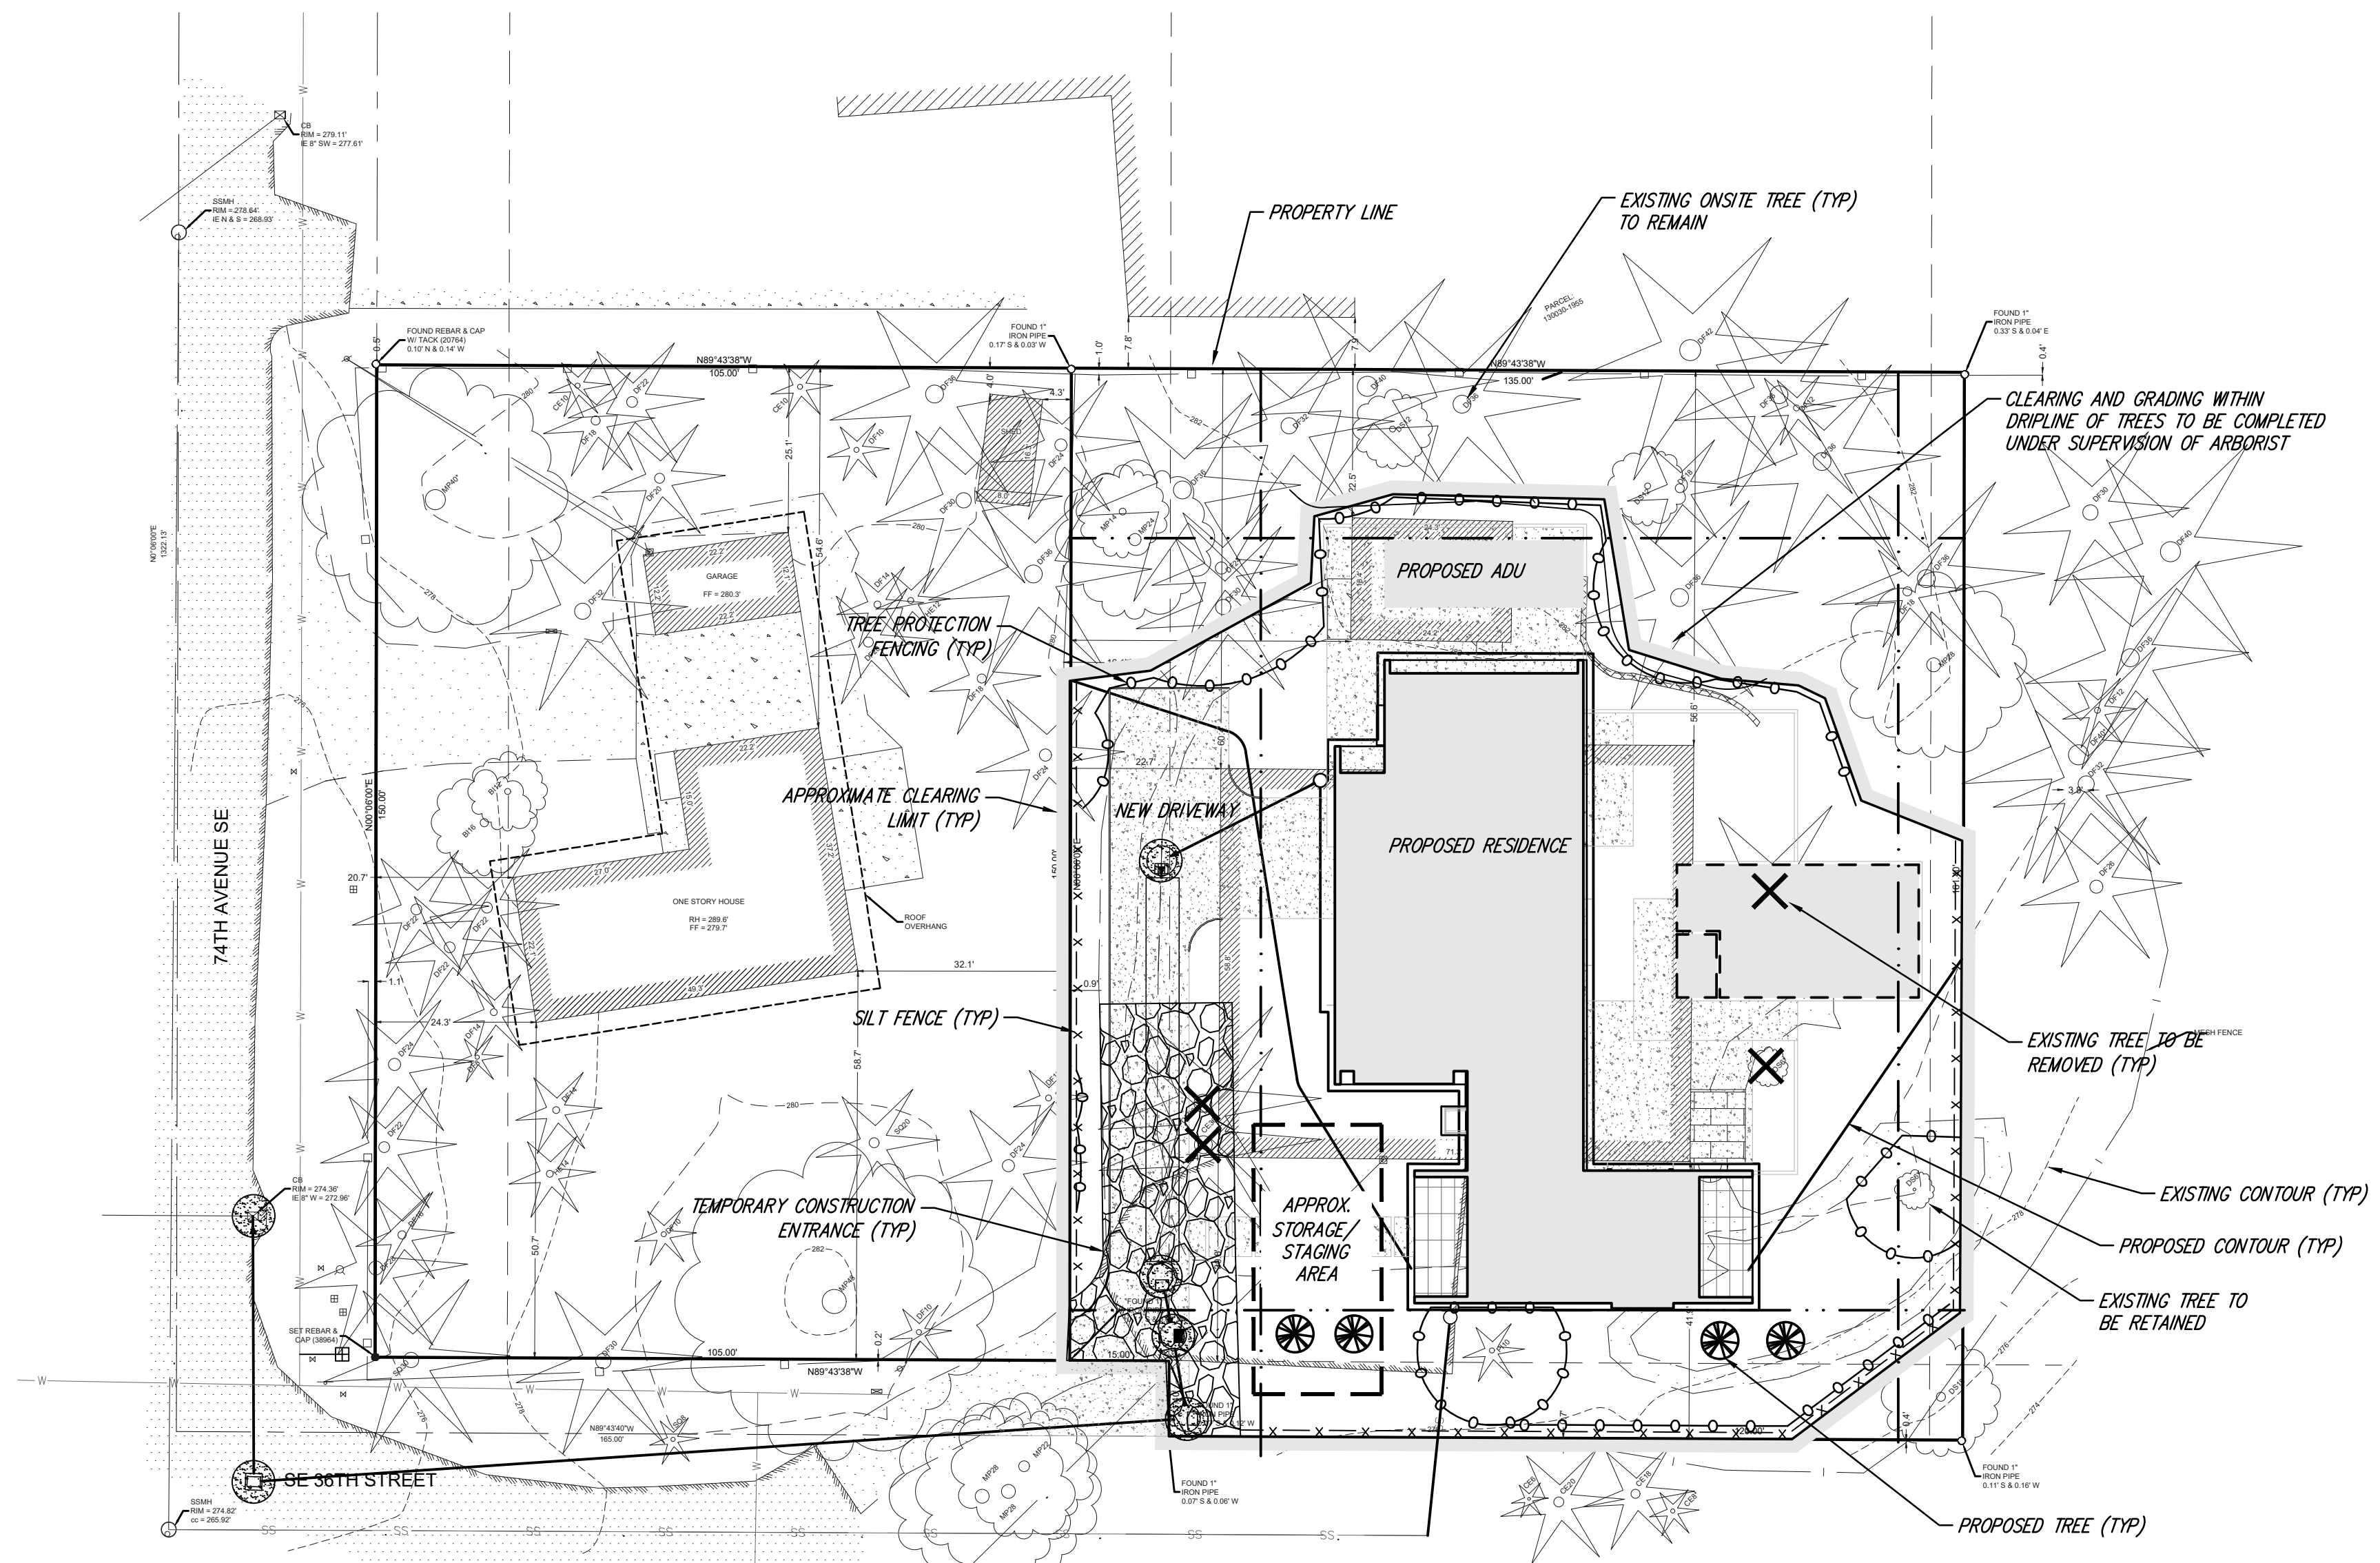
**LEGEND**

SEE SHEET C2.31 FOR DETAILS, NOTES AND CONSTRUCTION SEQUENCE.

INLET FILTER (M.S.D.O.T. STD. DTL. 1-40.20-00)	
FILTER FABRIC FENCE	
CONSTRUCTION ACCESS	
CLEARING LIMITS	
EXISTING CONTOUR	
PROPOSED CONTOUR	
EX TREE TO BE REMOVED

The erosion control plan will be comprised of temporary measures (stabilized construction entrance, silt fence, etc.) as well as permanent measures (hydroseeding, etc.). In general, construction activities will be sequenced such that the site disturbance is minimized at all times. Runoff from the site will sheetflow across cleared areas and disperse into vegetated, gently sloped areas.

Please refer to the Temporary Erosion and Sediment Control Plan (TESC Plan) that has been prepared for this project, included on the following page as Figure 8-1: TESC Plan.

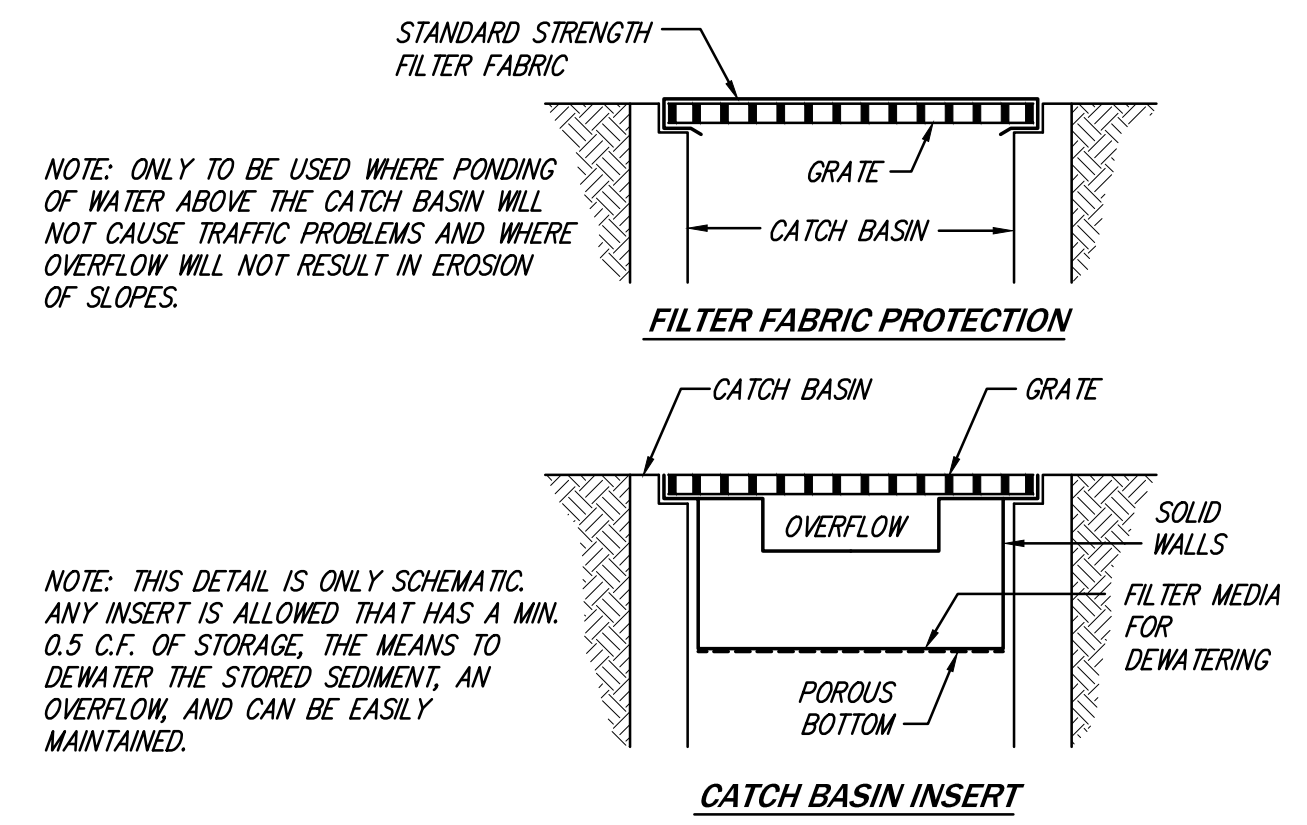
**FILTER FABRIC PROTECTION FOR CB'S**

- MAINTENANCE STANDARDS**
1. ANY ACCUMULATED SEDIMENT ON OR AROUND THE FILTER FABRIC PROTECTION SHALL BE REMOVED IMMEDIATELY. SEDIMENT SHALL NOT BE REMOVED WITH WATER, AND ALL SEDIMENT MUST BE DISPOSED OF AS FILL ON-SITE OR HAULED OFF-SITE.
  2. ANY SEDIMENT IN THE CATCH BASIN INSERT SHALL BE REMOVED WHEN THE SEDIMENT HAS FILLED ONE-THIRD OF THE AVAILABLE STORAGE. THE FILTER MEDIA FOR THE INSERT SHALL BE CLEANED OR REPLACED AT LEAST MONTHLY.
  3. REGULAR MAINTENANCE IS CRITICAL FOR BOTH FORMS OF CATCH BASIN PROTECTION. UNLIKE MANY FORMS OF PROTECTION THAT FAIL GRADUALLY, CATCH BASIN PROTECTION WILL FAIL SUDDENLY AND COMPLETELY IF NOT MAINTAINED PROPERLY.
