**NELSON GEOTECHNICAL
ASSOCIATES, INC.**
GEOTECHNICAL ENGINEERS & GEOLOGISTS

Geotechnical Engineering Evaluation
Pazarena Residence Additions
8430 SE 47th Place
Mercer Island, Washington
NGA File No. 996317

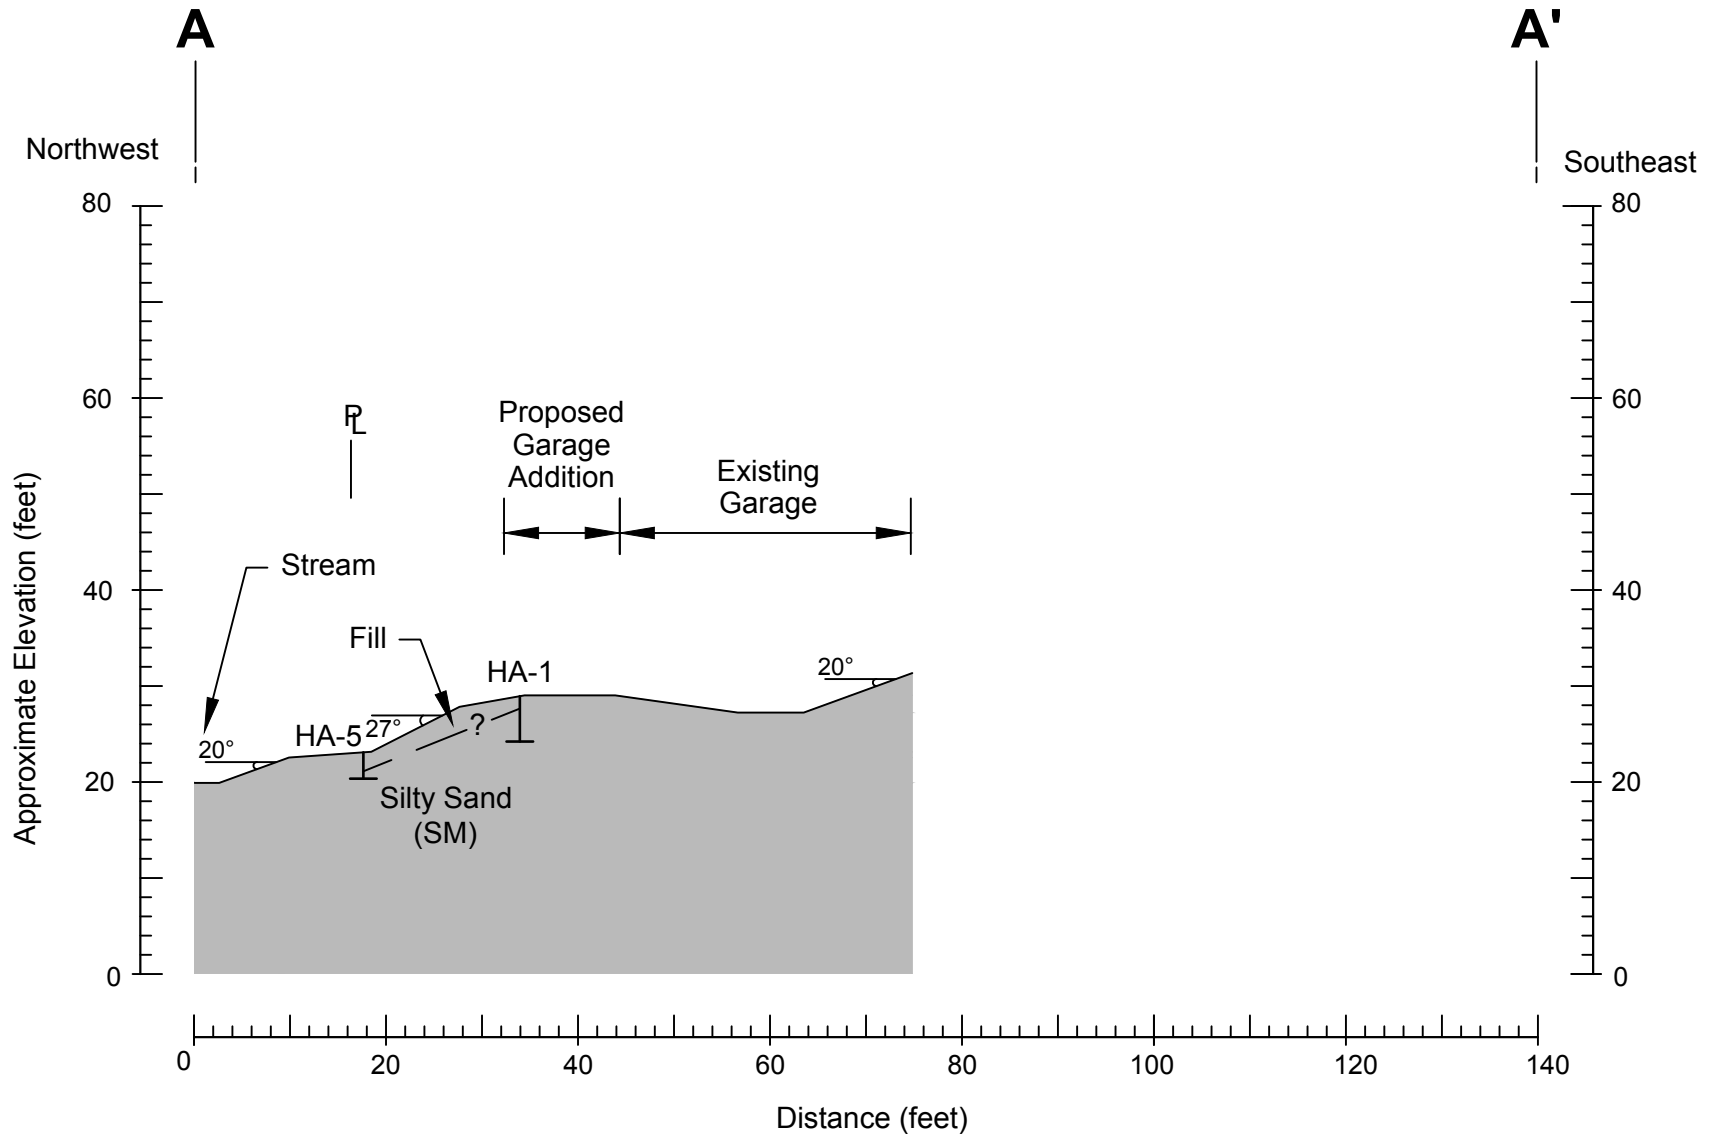
Exploration

- 1) Stratigraphic conditions are interpolated between the explorations. Actual conditions may vary.
- 2) Elevations are approximate.

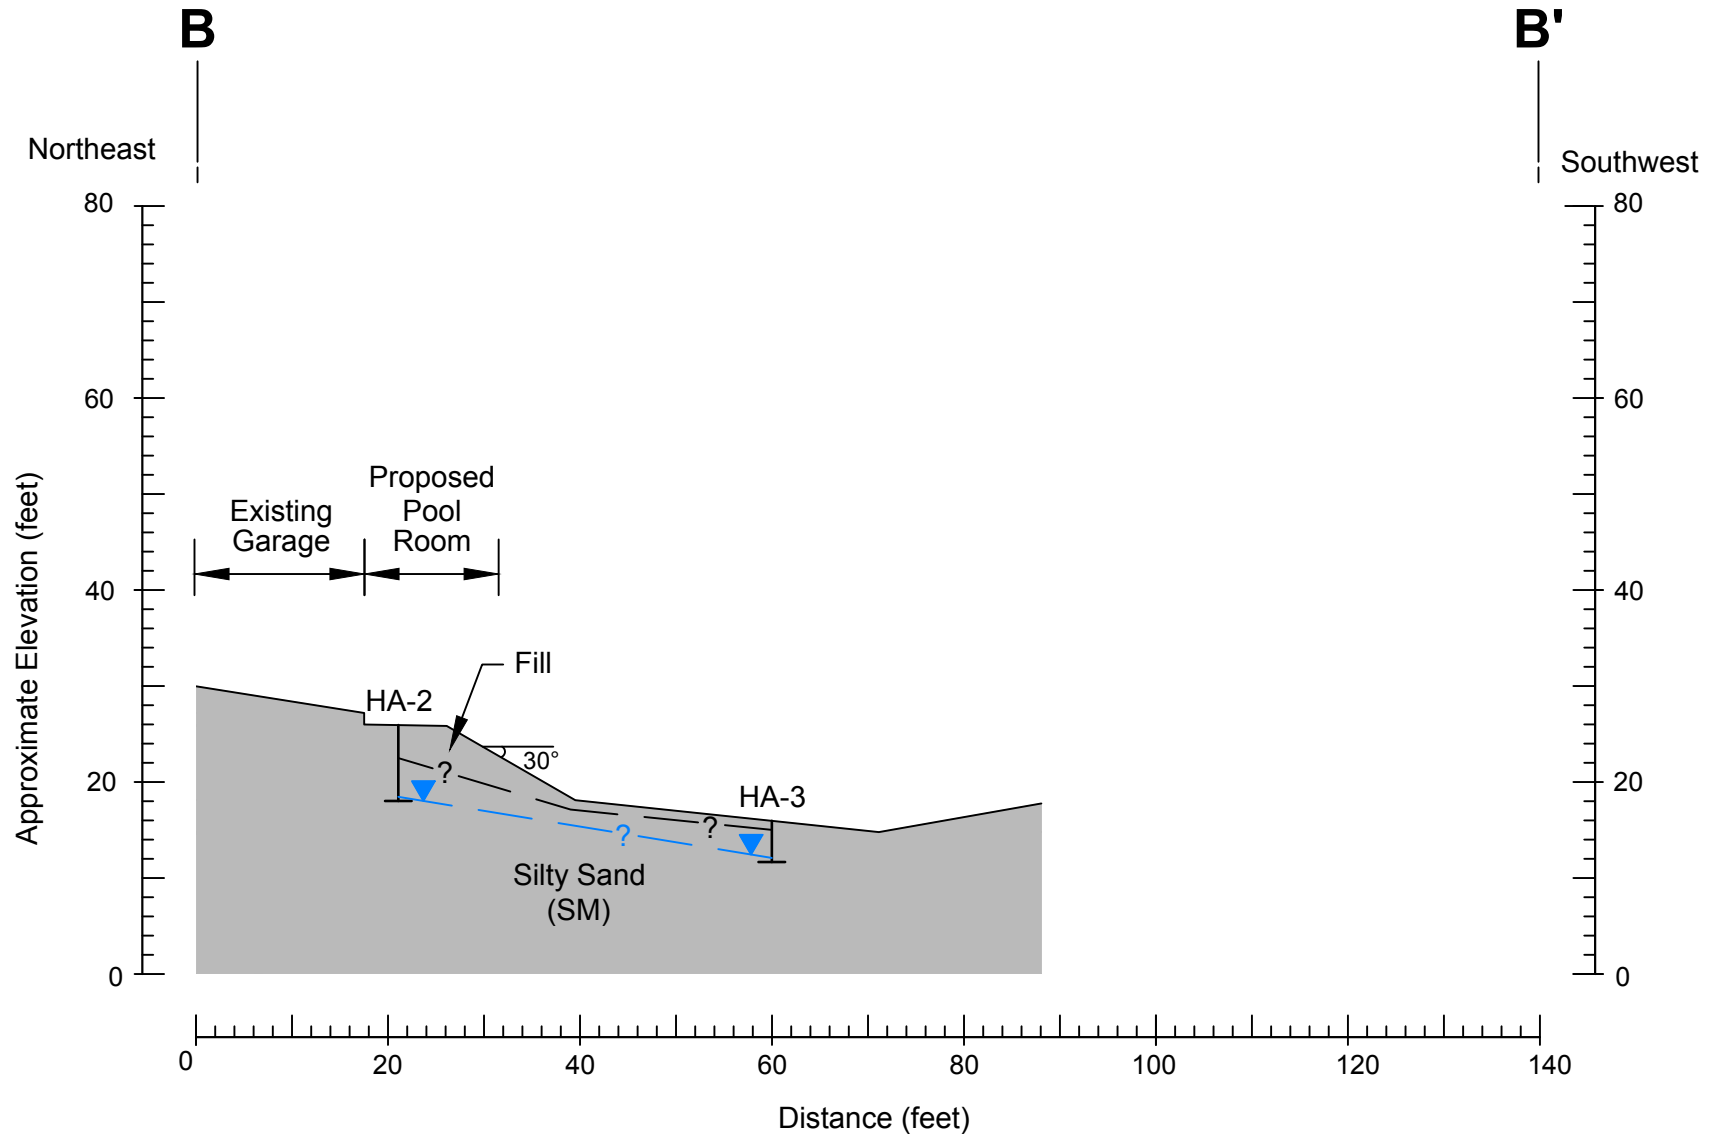
Exploration

- 1) Stratigraphic conditions are interpolated between the explorations. Actual conditions may vary.
- 2) Elevations are approximate.

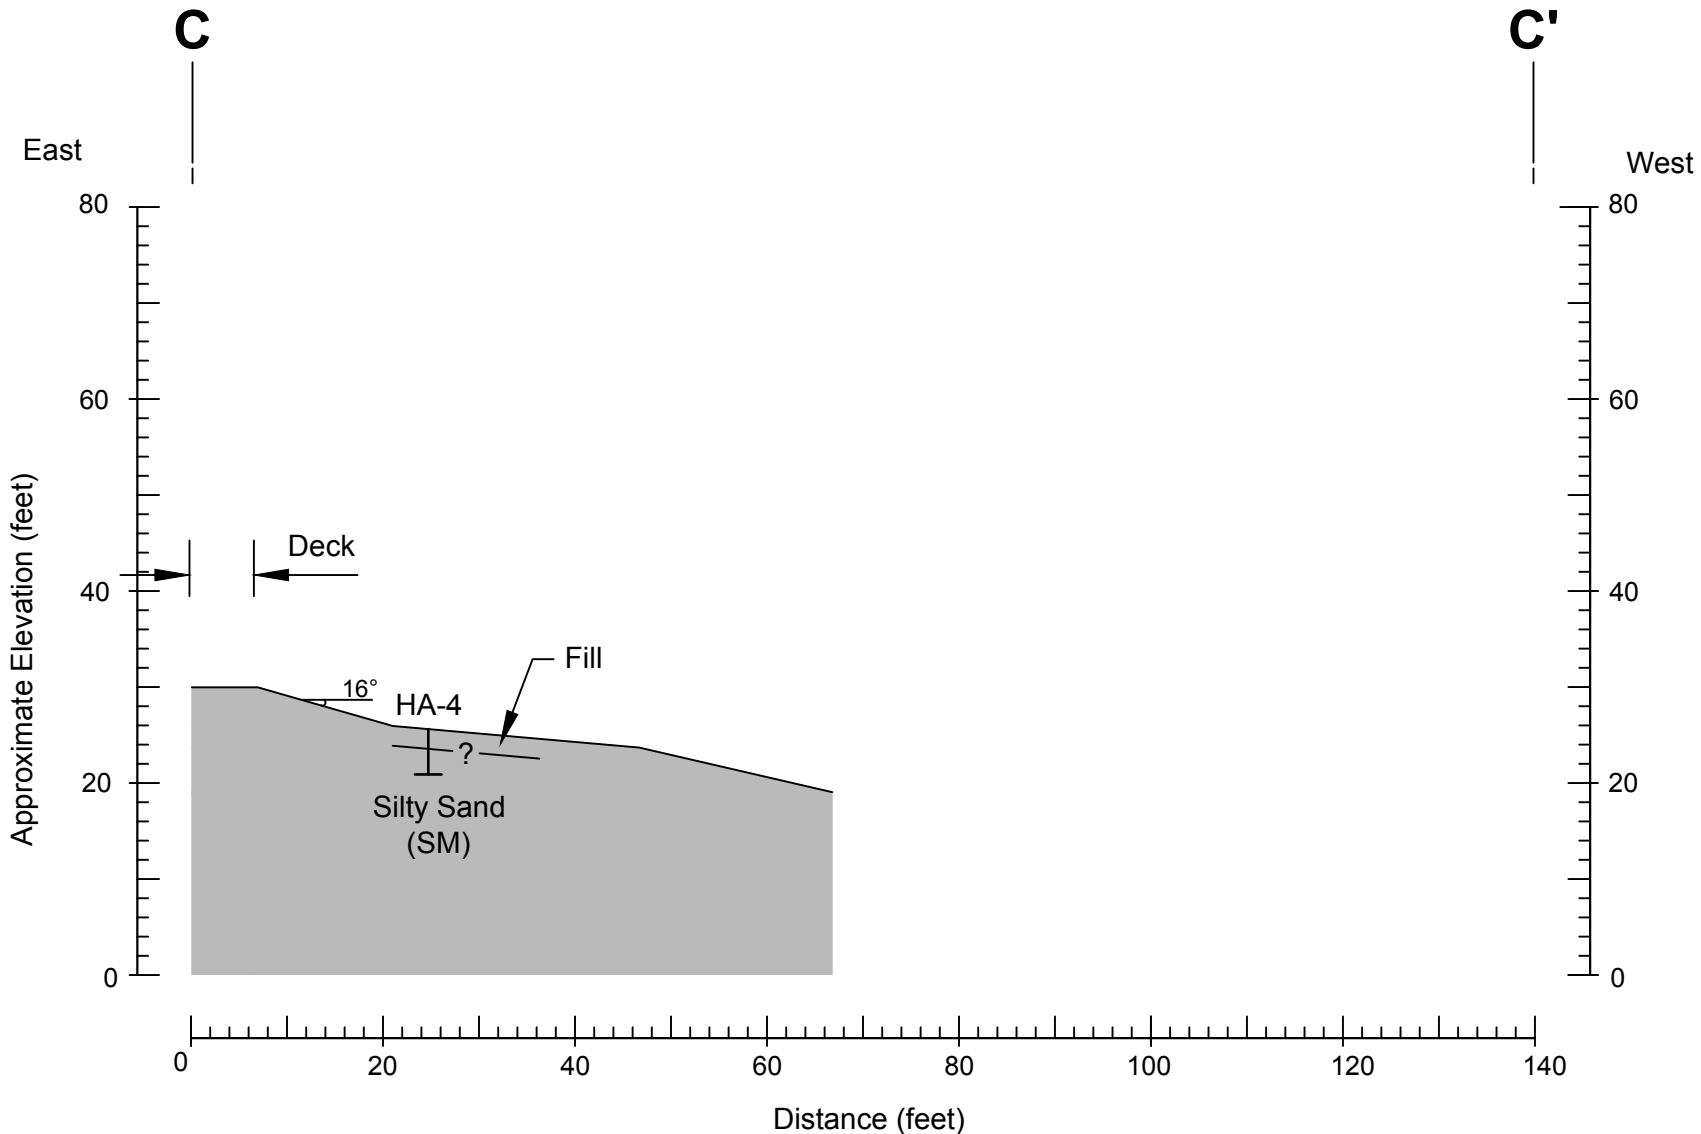
Exploration

- NOTES:
- 1) Stratigraphic conditions are interpolated between the explorations. Actual conditions may vary.
 - 2) Elevations are approximate.

Reference: Cross Section is based on field measurements using a hand-held clinometer and 100-ft tape measure.
