MEMORANDUM

DATE: July 17, 2019
TO: Ms. Moon Wu
FROM: Khaled M. Shawish, PE
Lee S. Bellah, LG
RE: Supplemental Geotechnical Engineering Memorandum
Wu Residence Slope Stabilization
5660 East Mercer Way
Mercer Island, Washington
NGA File No. 1024718

This memo presents the our updated supplemental geotechnical opinions and recommendations for the proposed Wu Residence slope stabilization project located at 5660 East Mercer Way on Mercer Island, Washington.

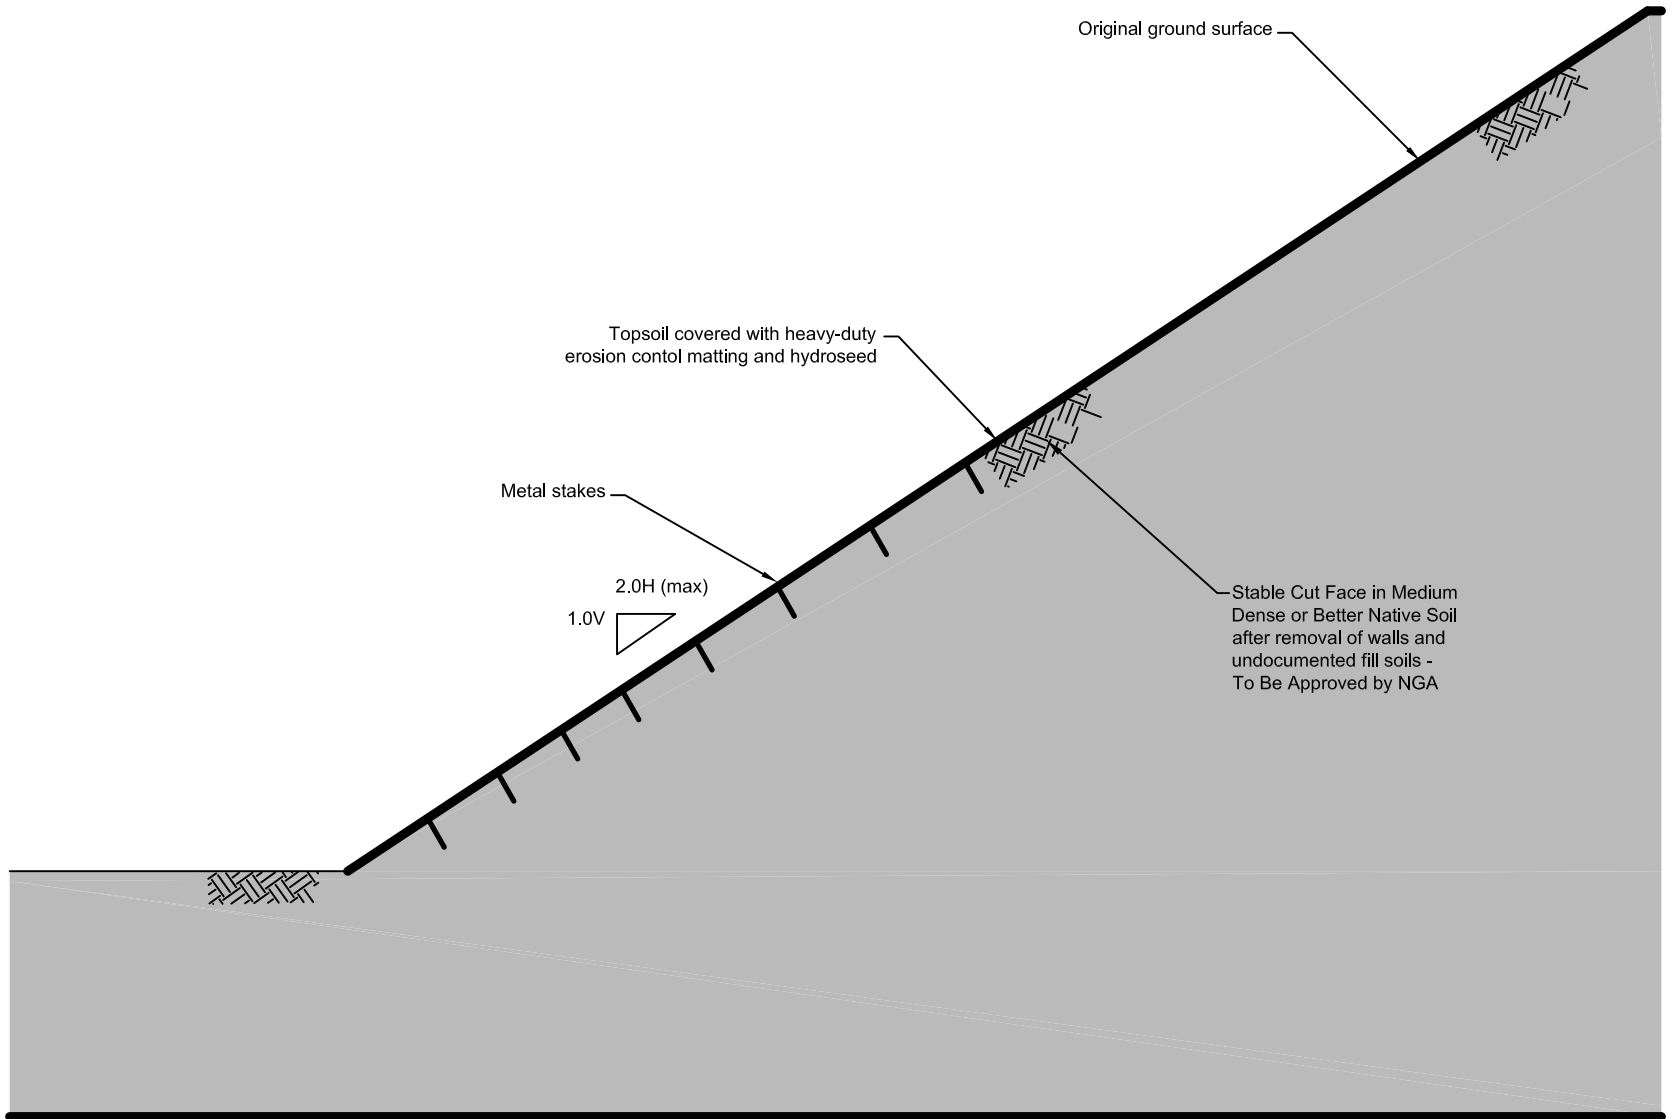
Schematic Slope Stabilization Cross Section Detail

(Not to Scale)

soils be compacted in place to an unyielding state. The final face inclination of the slope should not be steeper than 2 Horizontal to 1 Vertical (2H:1V). The resulting slope face should then be covered with a heavy duty erosion control matting such as Tensar C350 Turf Reinforcement Mat, or equivalent, and then hydroseeded. The matting should be staked with metal rebar that has a metal "T" welded to the end. The mat should be staked to the exposed soil every five feet. A cross-section detail titled "Schematic Stabilization Cross Section Detail" showing the proposed stabilization measures is presented as Figure 1. NGA should be retained to observe the recommended repairs on a full-time basis.

A cut-off drain trench should be constructed within the lower bench area along the toe of the steep slope to capture any runoff from the sloping area above before it has a chance to flow onto the neighboring property below. The trench should be a minimum of 18-inches wide and two feet deep. A minimum four-inch diameter, rigid, perforated, PVC drainpipe should be placed near the base of the trench and covered entirely with washed rock up to the ground surface. This pipe should be sloped to drain under gravity and outlet into a permanent stormwater system such as the existing stormwater pipe along the southern portion of the property.
