**Geotechnical Report  
Hart Residence  
6025 77<sup>th</sup> Avenue SE  
Mercer Island, Washington**

Project 1865-1  
July 6, 2017

Prepared by:  
The Galli Group  
PO Box 30759  
Seattle, Washington 98113  
206-525-5097

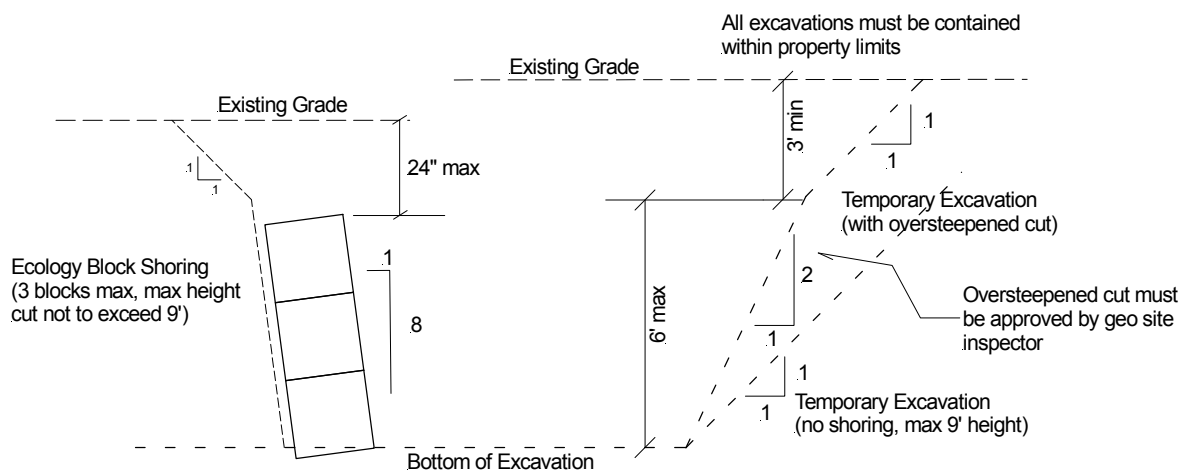
Temporary Excavation Schematic

Temporary excavations should be shaped or benched to protect workers below. Generally, temporary construction cuts within site soils should be inclined no greater than 1H:1V (Horizontal to Vertical). The very dense consistency of the soil might allow for oversteepened cuts as shown in the illustration below where it is necessary to contain cuts within the property limits. This assumes that the excavation is undertaken during the dry summer months and that no seepage is encountered in the excavations. Oversteepened cuts will not be permitted if the excavation occurs during the wet season. The geotechnical engineer must monitor the excavation as it progresses where oversteepened cuts are planned. Once cuts are exposed, the soils must be protected during wet weather.

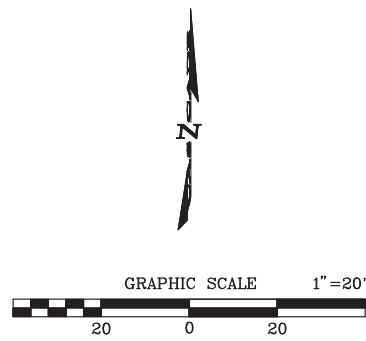
**SITE SURVEY**  
 Figure 2A

**TOPOGRAPHICAL SITE SURVEY**  
 LOCATED IN THE S.W. 1/4, OF THE S.E. 1/4,  
 OF SECTION 24, TOWNSHIP 24 NORTH, RANGE 4 EAST, W.M.,  
 KING COUNTY, WASHINGTON

The project site is located on the lower side of a slope that descends from 77<sup>th</sup> Avenue SE westerly toward Lake Washington (see Vicinity Map, Figure 1). The site is accessed from a shared driveway that descends from 77<sup>th</sup> Avenue southwesterly to the parcel. The topography of the parcel ascends moderately from an existing rock bulkhead on the shore of Lake Washington about 80 horizontal feet to the toe of a steep slope that ascends about 16 vertical feet in 16 horizontal feet to the relatively flat rear yard of the parcel above. The inclinations of the slope from the lake to the toe and from the toe to the top of the steep slope are about 13 percent and 100 percent respectively. The parcel is located within Environmentally Critical Areas due to geologic hazards identified in the Mercer Island Code as Landslide Hazard Areas, Erosion Hazard Areas, and Seismic Hazard Areas. The existing topography and site features are shown on Figure 2A, Site Survey.

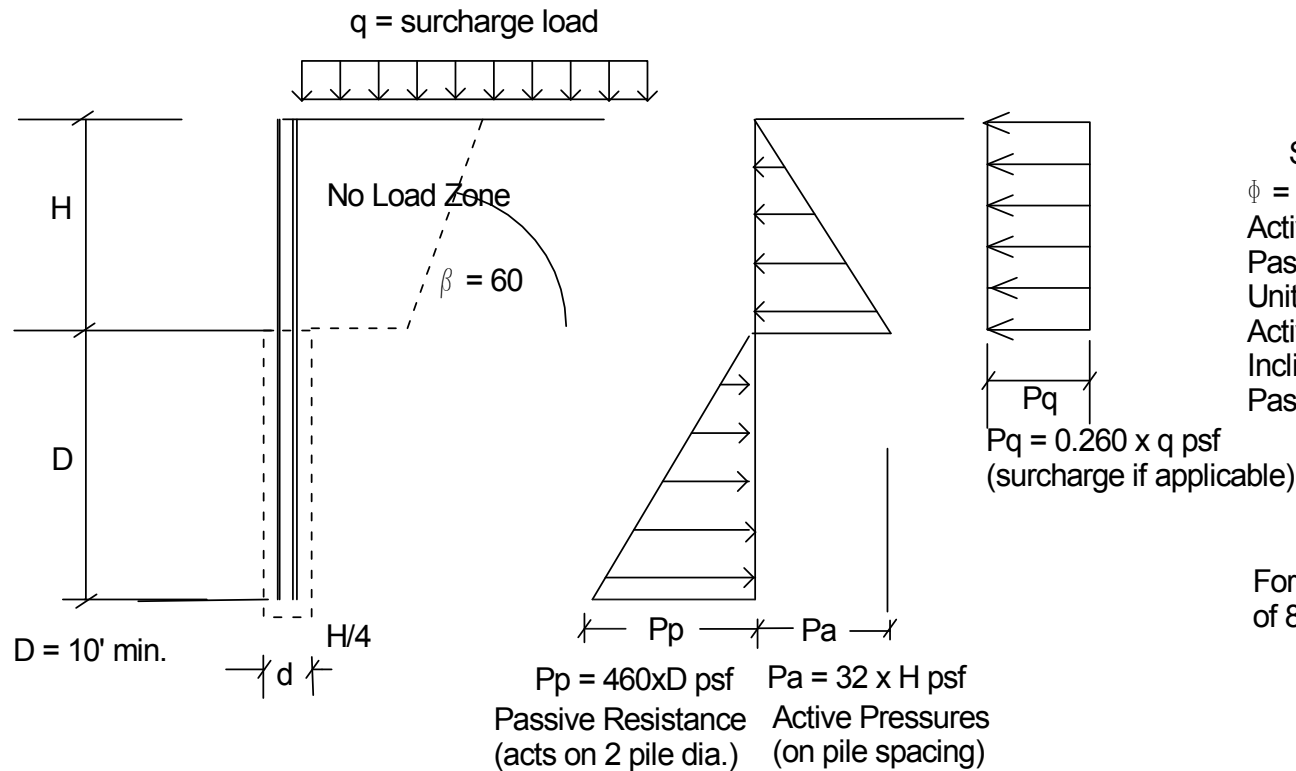
# Earth Pressure Diagrams Cantilevered Soldier Pile Shoring System (Level Backslope)

- $\phi = 36$  degrees
- Active  $K_a = 0.26$
- Passive  $K_p = 3.85$
- Unit weight,  $\gamma = 120$  pcf
- Active Pressure = 32 pcf (EFW)
- Inclined backslope = 40 pcf
- Passive Pressure = 460 pcf (EFW)  $\times 2d$

For permanent walls add seismic force of 8H uniform pressure against retaining wall.

- Based upon the consistency of the underlying soil encountered, we have recommended earth pressures as shown in Figure 6 for design of the shoring system with level backslopes. Forces above the base of the excavation should be considered to act on the spacing of the piles. Below the excavation, passive forces should be considered to act on 2 pile diameters. The bottom of the perimeter footings shall be the base of the excavation.

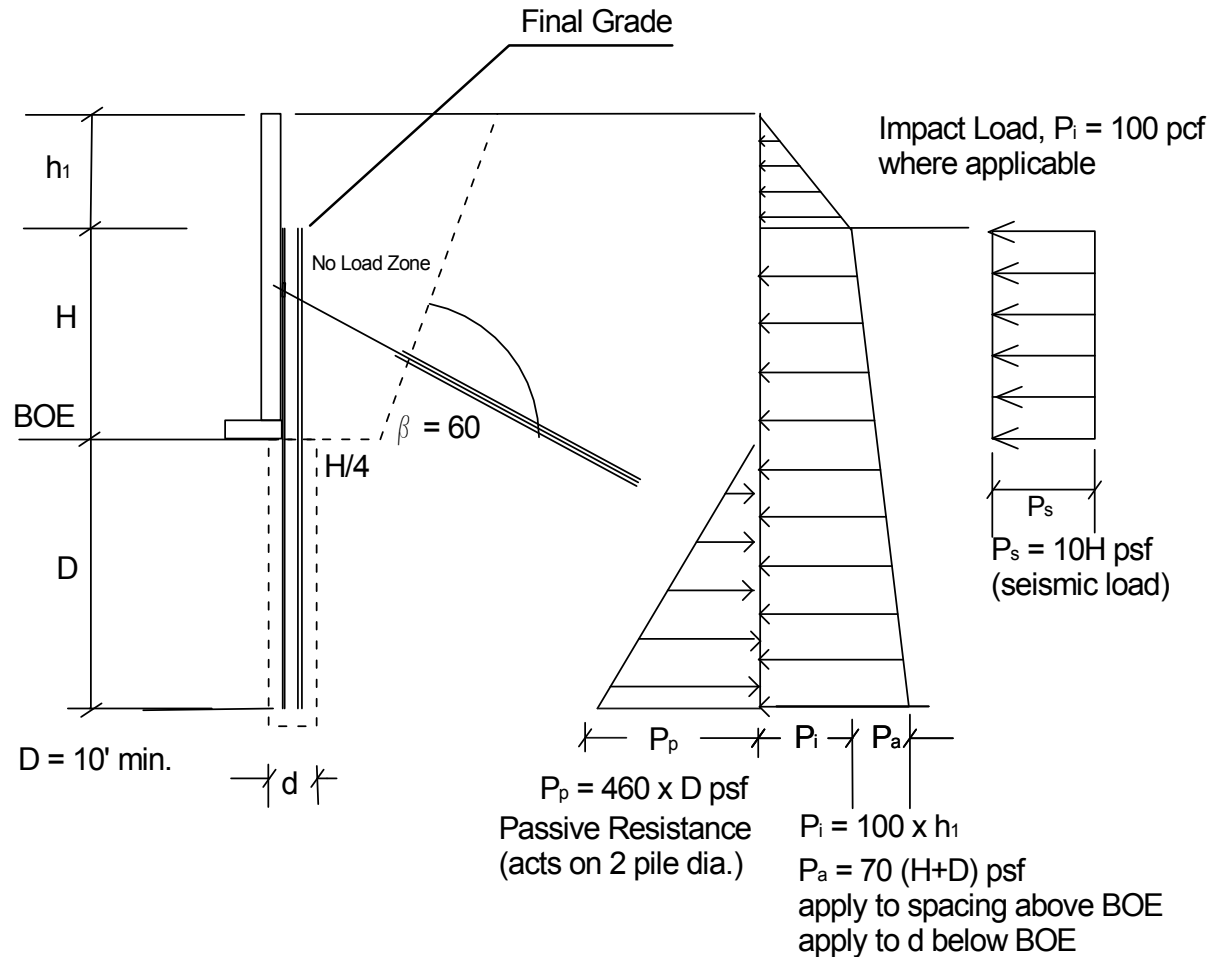
# Earth Pressure Diagrams Permanent Soldier Pile Catchment Wall (Inclined Backslope Condition)

$\phi = 36 \text{ degrees}$   
 Active  $K_a = 0.283$   
 Passive  $K_p = 3.53$   
 Unit weight,  $\gamma = 120 \text{ pcf}$   
 Active Pressure = 32 pcf (EFW)  
 Active Inclined Slope = 40 pcf  
 Passive Pressure = 460 pcf (EFW)  $\times 2d$   
 (values ultimate)

- If anchors are required (for example on the catchment wall) then we recommend use of pressure grouted anchors installed at each pile location. The anchors should be designed assuming an ultimate capacity of 8 kips/foot of bonded length. The anchor should include a bond breaker in the no load zone as depicted in Figure 7. The anchor should be designed to resist 200 percent of the design values.

We recommend constructing the uphill wall as a catchment wall to reduce potential negative impacts of earth slides or debris in the event of a failure from upslope or upslope utilities. The catchment wall should be extended a minimum of 5 feet above finish grade on the eastern or uphill side of the residence. An additional impact load of 100 pcf should be used to design the wall for the potential earth or debris slide. We have provided an earth pressure diagram for use in design of the catchment wall. It seems likely given the additional loading that the wall will require installation of anchors to resist the lateral forces. Design earth pressures and values are provided in Figure 7, Catchment Wall Earth Pressures.
