August 1, 2018
Revised on September 18, 2018
File No. 18-240

**Subject: Geotechnical Engineering Evaluation (Revised)
Proposed Deck Expansion
4884 Forest Avenue SE, Mercer Island, Washington**

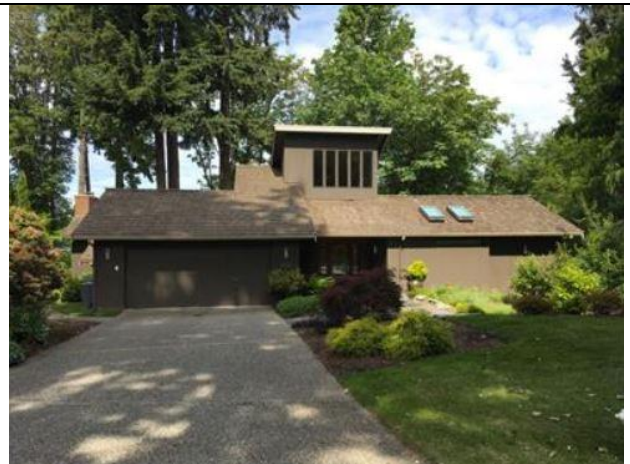
Plate 1. East (Lake side) view of the house, looking west from Forest Avenue SE.
