STORMWATER SITE PLAN REPORT

Perla Residence

42XX Holly Lane
Mercer Island, WA 98040

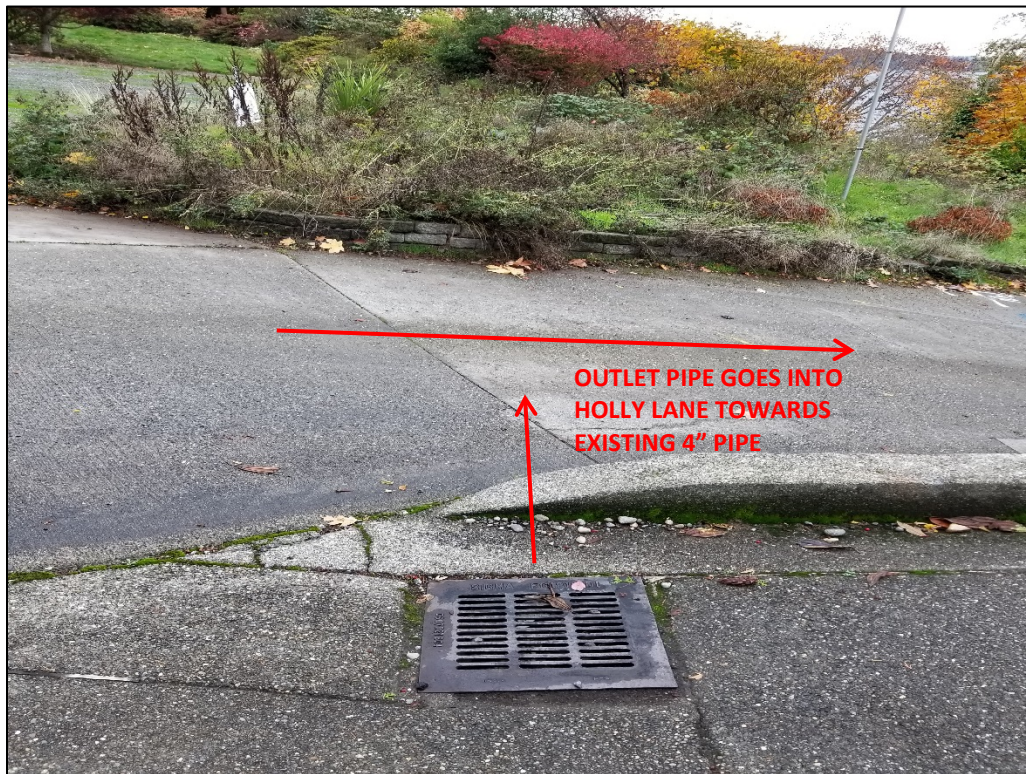
Figure III-5. Area drain in neighbor's driveway across street.

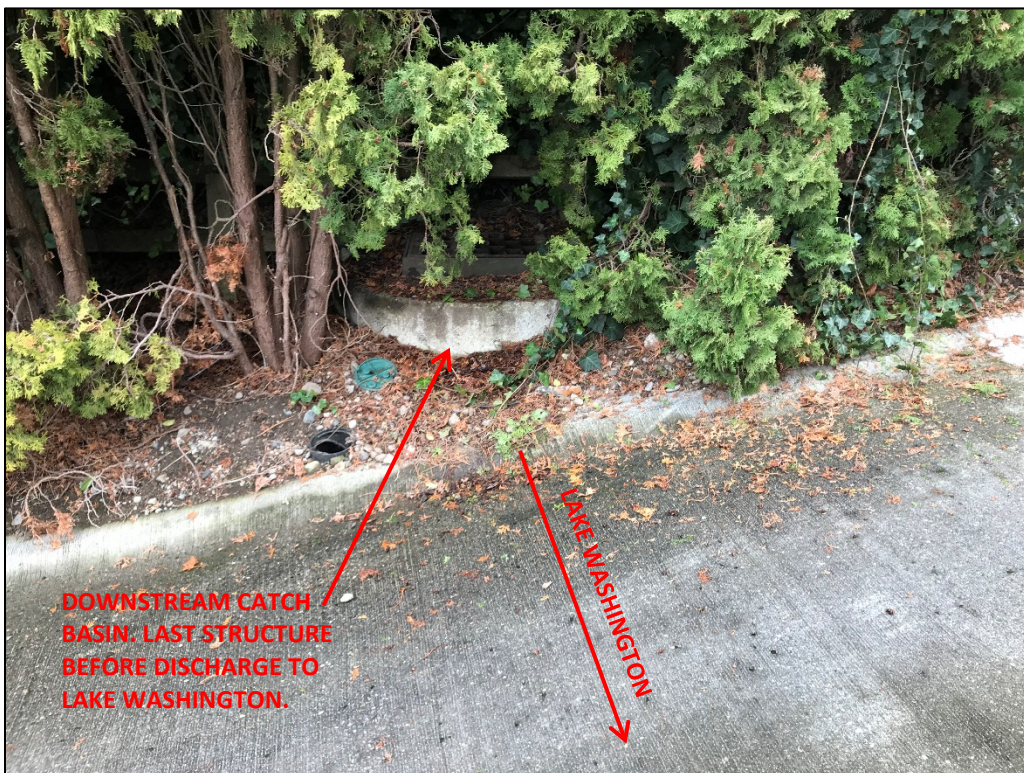
Figure III-7 – Trench drain near bottom of Holly Ln in front of 10 Holly Ln.

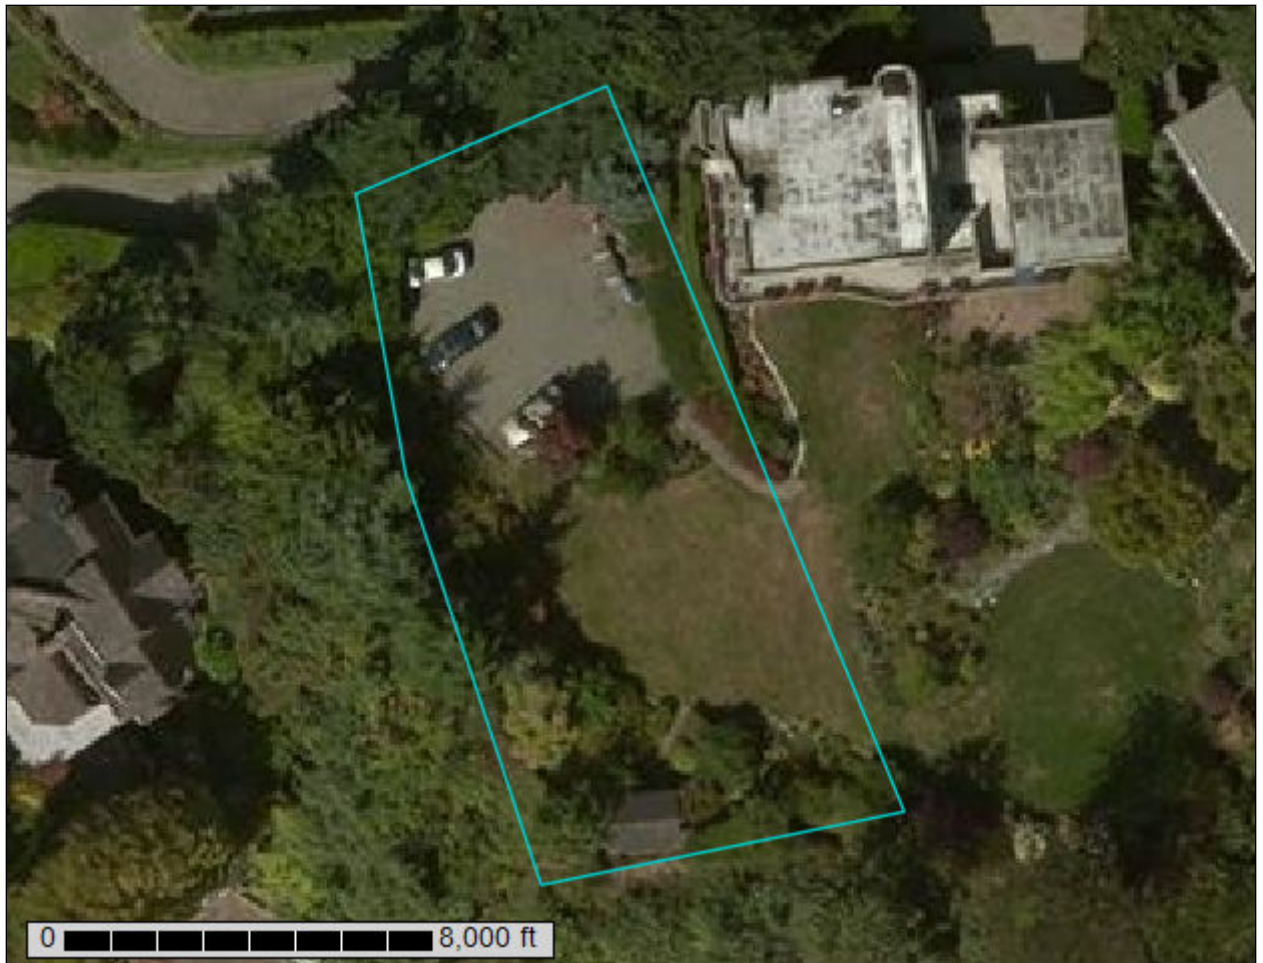
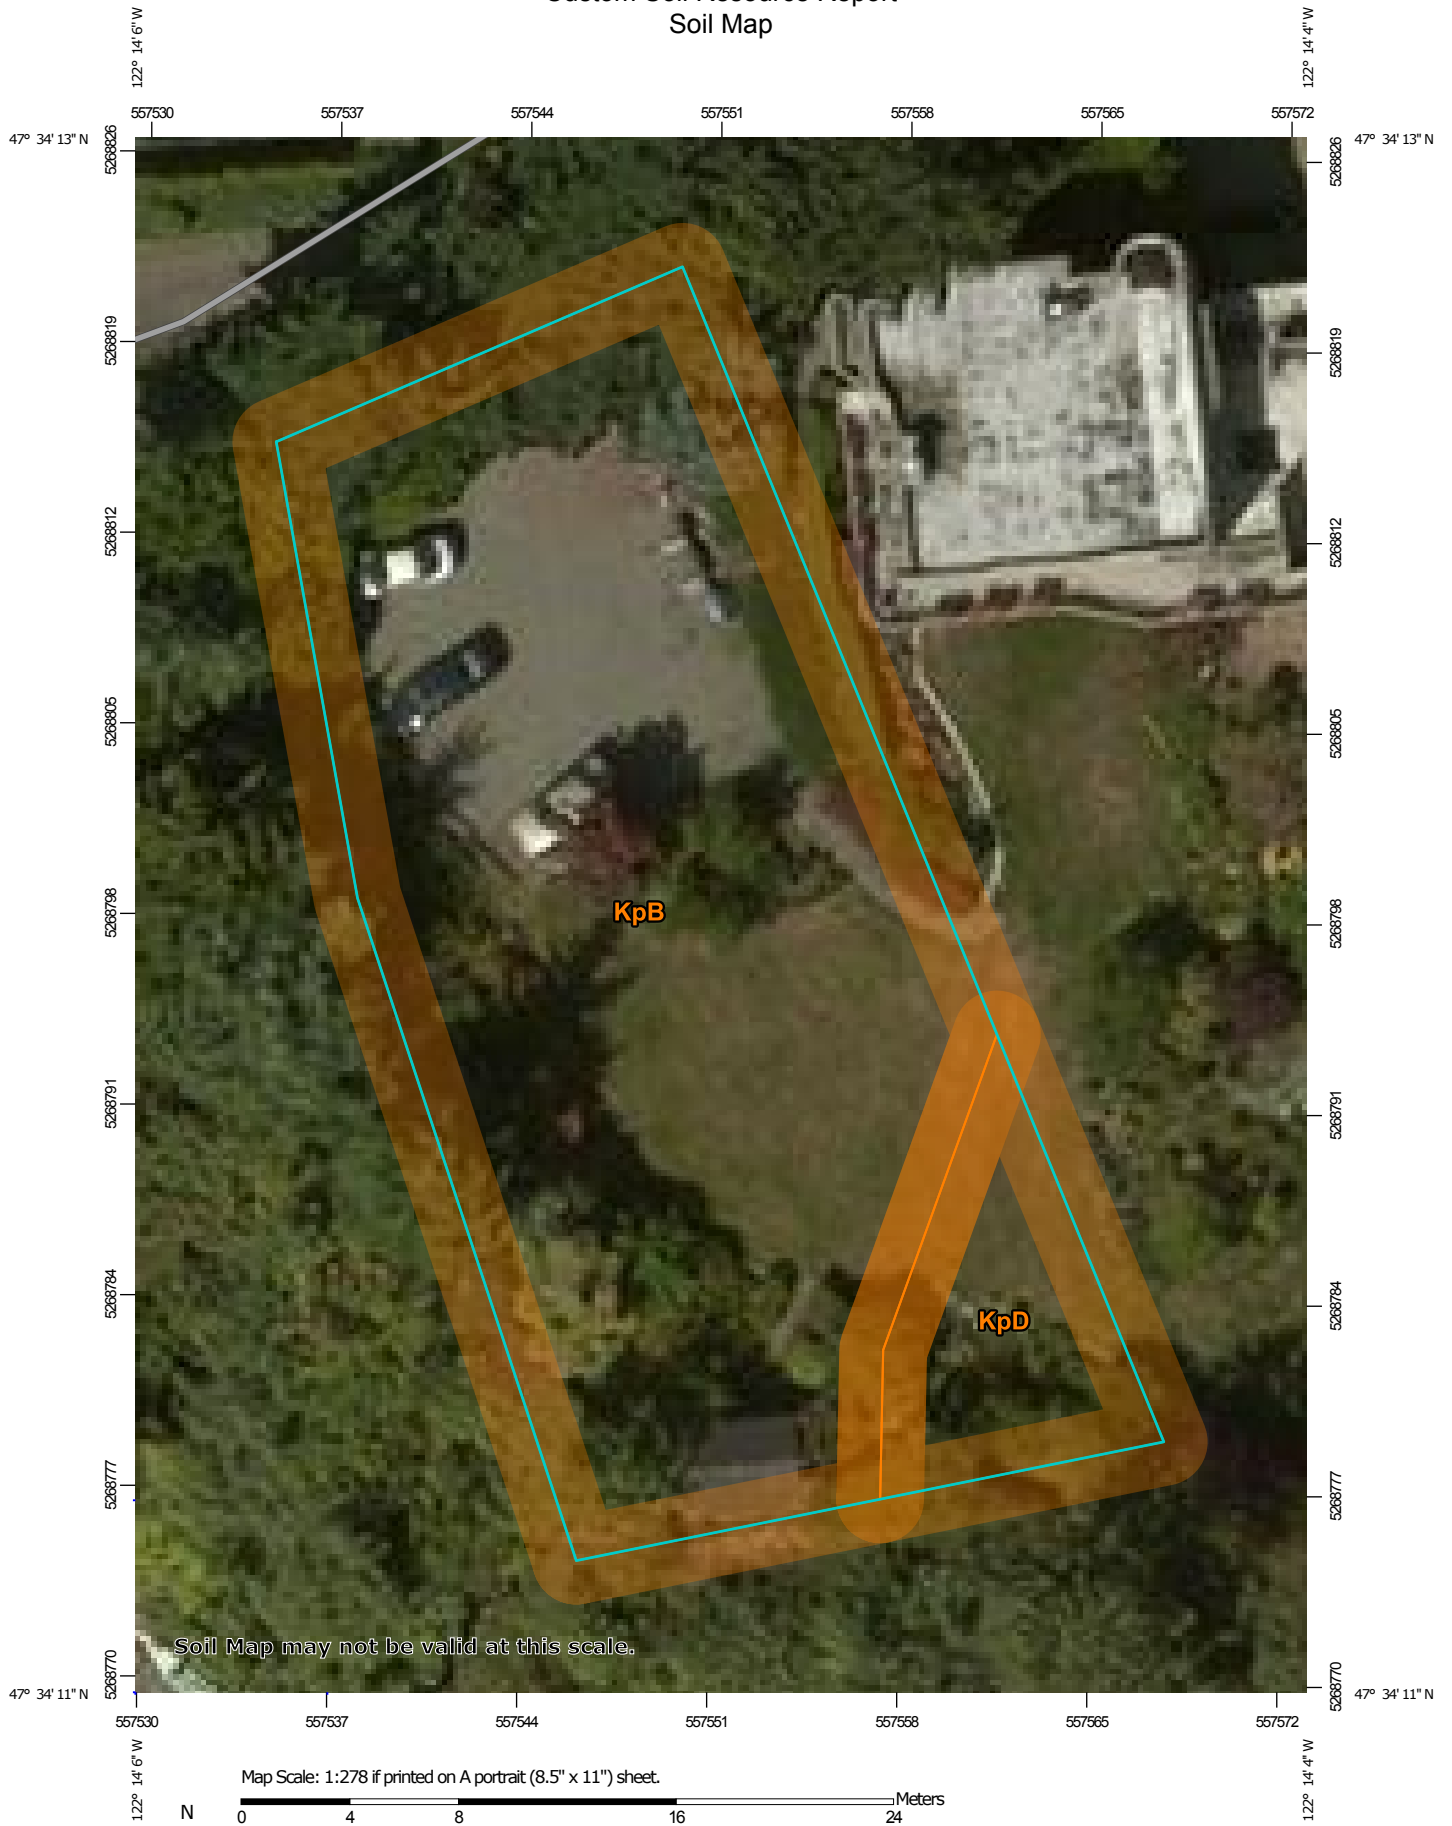
Custom Soil Resource Report Soil Map

Map Scale: 1:278 if printed on A portrait (8.5" x 11") sheet.

Underlying soils were found to be Kitsap Silt Loam, 2 to 8% slopes for most of the site, corresponding to hydrologic soil group "C" per the Natural Resources Conservation Service Soil Survey resource. Groundwater was encountered at depths of 10 feet below existing grade during the geotechnical exploration.
