# MOUNGER RESIDENCE

4006 East Mercer Way

## Storm Drainage Report

Mercer Island, Washington  
April 29, 2022

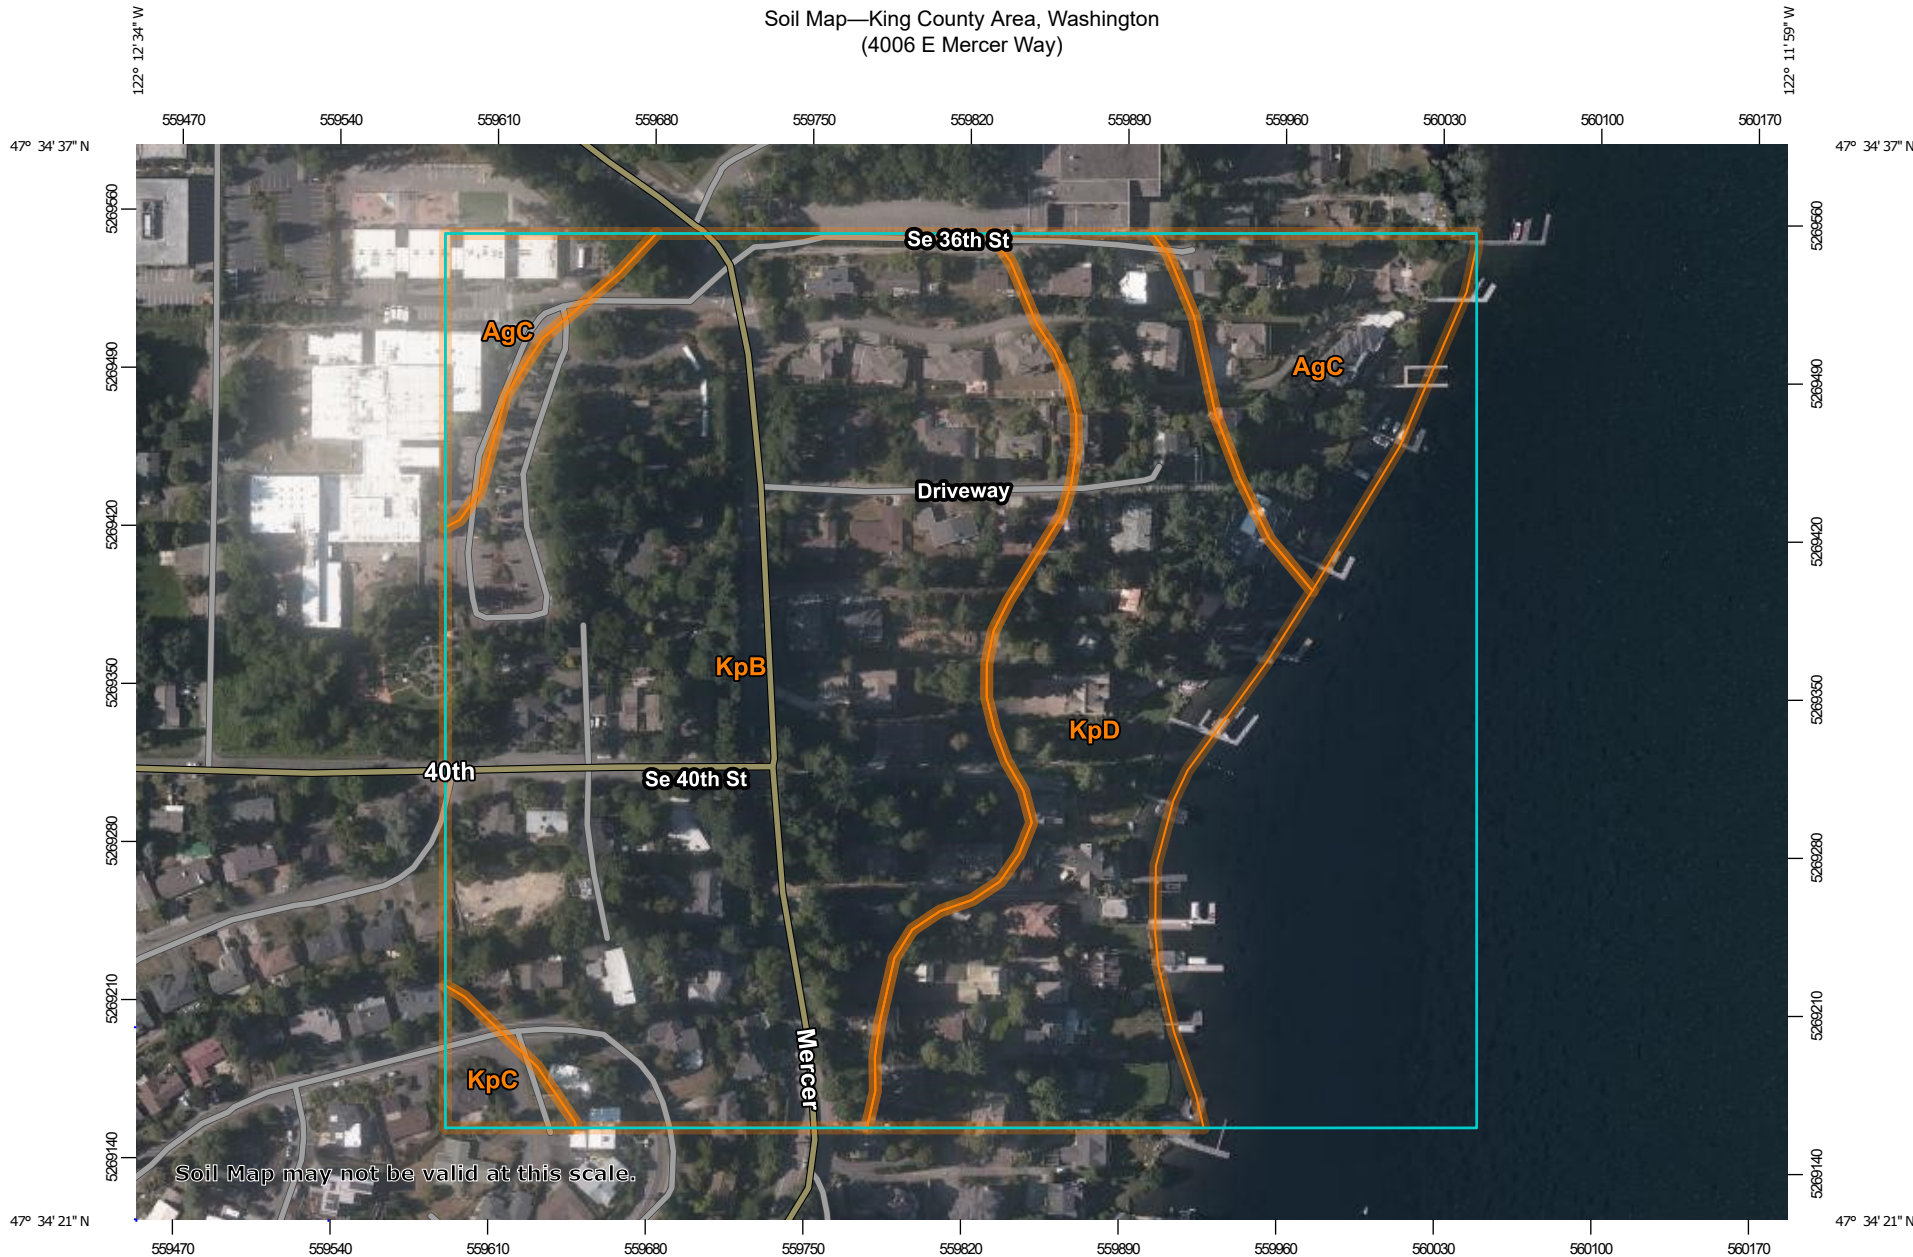
Soil Map—King County Area, Washington  
(4006 E Mercer Way)

Soil Map may not be valid at this scale.

The existing terrain west of the house slopes down to the east at about 20%, steepening as it approaches the house pad. The landscaped area between the house and the lake also slopes at an average of 20%. Soil type is Kitsap Loam according the NRCS. The site is in an area mapped as Infiltrating LID Facilities Not Permitted on the City's map.
