Subject: **Transmittal Letter – Geotechnical Engineering Study**  
Proposed Landscape Project  
7643 Southeast 72<sup>nd</sup> Place  
Mercer Island, Washington

**GEOTECHNICAL ENGINEERING STUDY**  
**Proposed Landscape Project**  
**7643 Southeast 72nd Place**  
**Mercer Island, Washington**

**SITE EXPLORATION PLAN**  
 7643 Southeast 72nd Place  
 Mercer Island, Washington

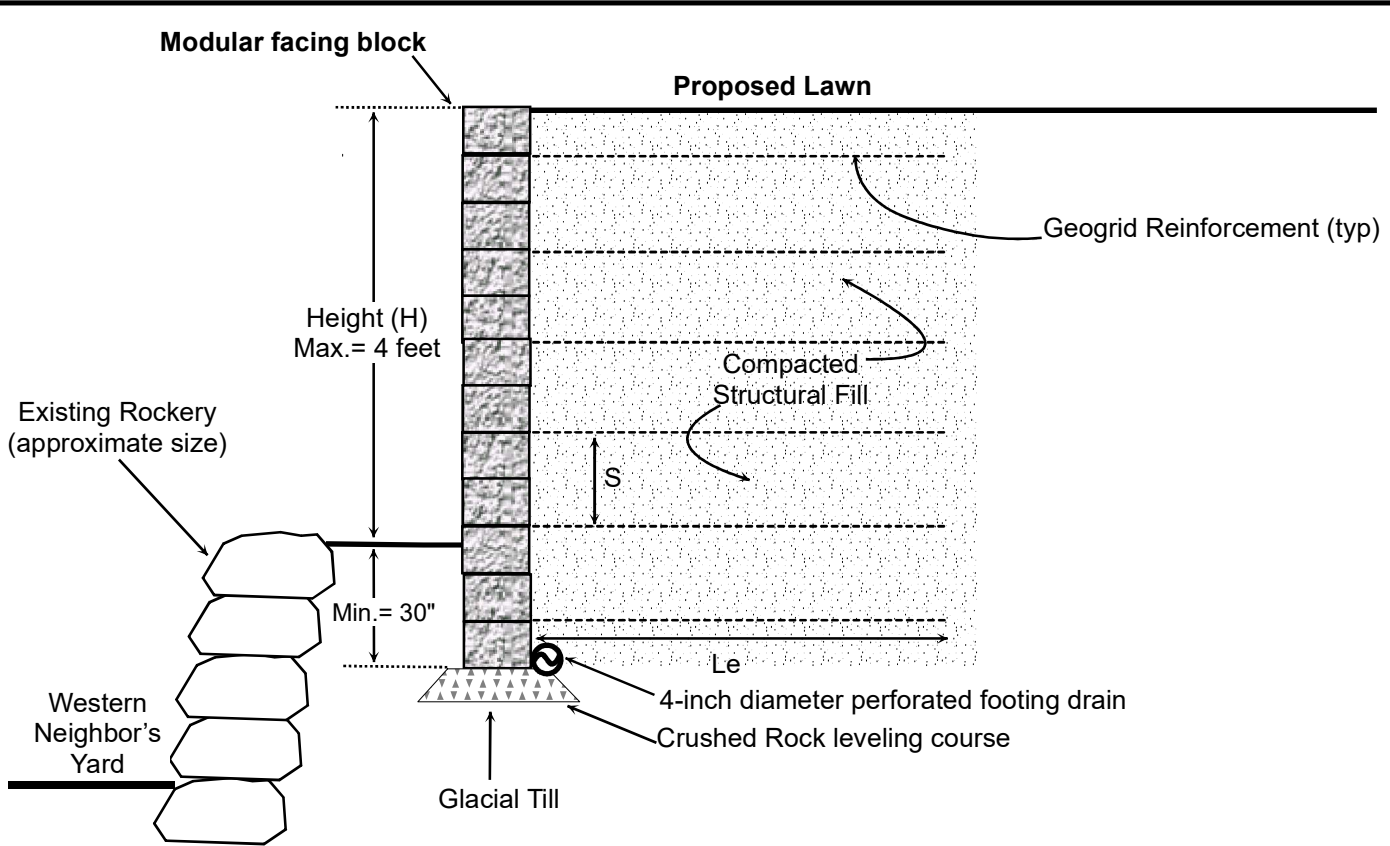
**MODULAR BLOCK WALL DETAIL**  
 7643 Southeast 72nd Place  
 Mercer Island, Washington

1. The modular block wall should be constructed by an experienced contractor. Construction of the geogrid-reinforced fill and the modular block facing should be monitored by the geotechnical engineer.

6. Geogrid spacing (S) is 16 inches. The geogrid reinforcement, Le, should be 6 feet in length for the above shown wall height.
7. Compacted Fill, and Structural Fill placed below the modular block wall and geogrids, should be an imported, free-draining granular fill. Samples of the proposed fill materials should be submitted to the geotechnical engineer for approval prior to starting construction. All fill should be placed with a maximum loose lift thickness of 12 inches and be compacted to at least 95 percent of the maximum Modified Proctor dry density (ASTM D-1557).

8. Surface water must be prevented from infiltrating into the Compacted Fill behind the wall blocks. The ground surface behind each modular block wall should be sloped so that no standing water can develop, as excessive water in the backfill can cause failure of the reinforced fill. During wet weather, the Compacted Fill behind the wall should be covered with plastic until the ground surface is sloped for proper drainage.

9. A Footing Drain consisting of a 4-inch perforated PVC pipe should be installed in the base of the Crushed Rock layer.
10. The final slope should be vegetated or landscaped to provide erosion protection.
