October 2022  
Luther Burbank Park Waterfront Improvements

# Critical Areas Study

Prepared for City of Mercer Island

**Prepared by**  
Anchor QEA, LLC  
1201 3rd Avenue, Suite 2600  
Seattle, Washington 98101

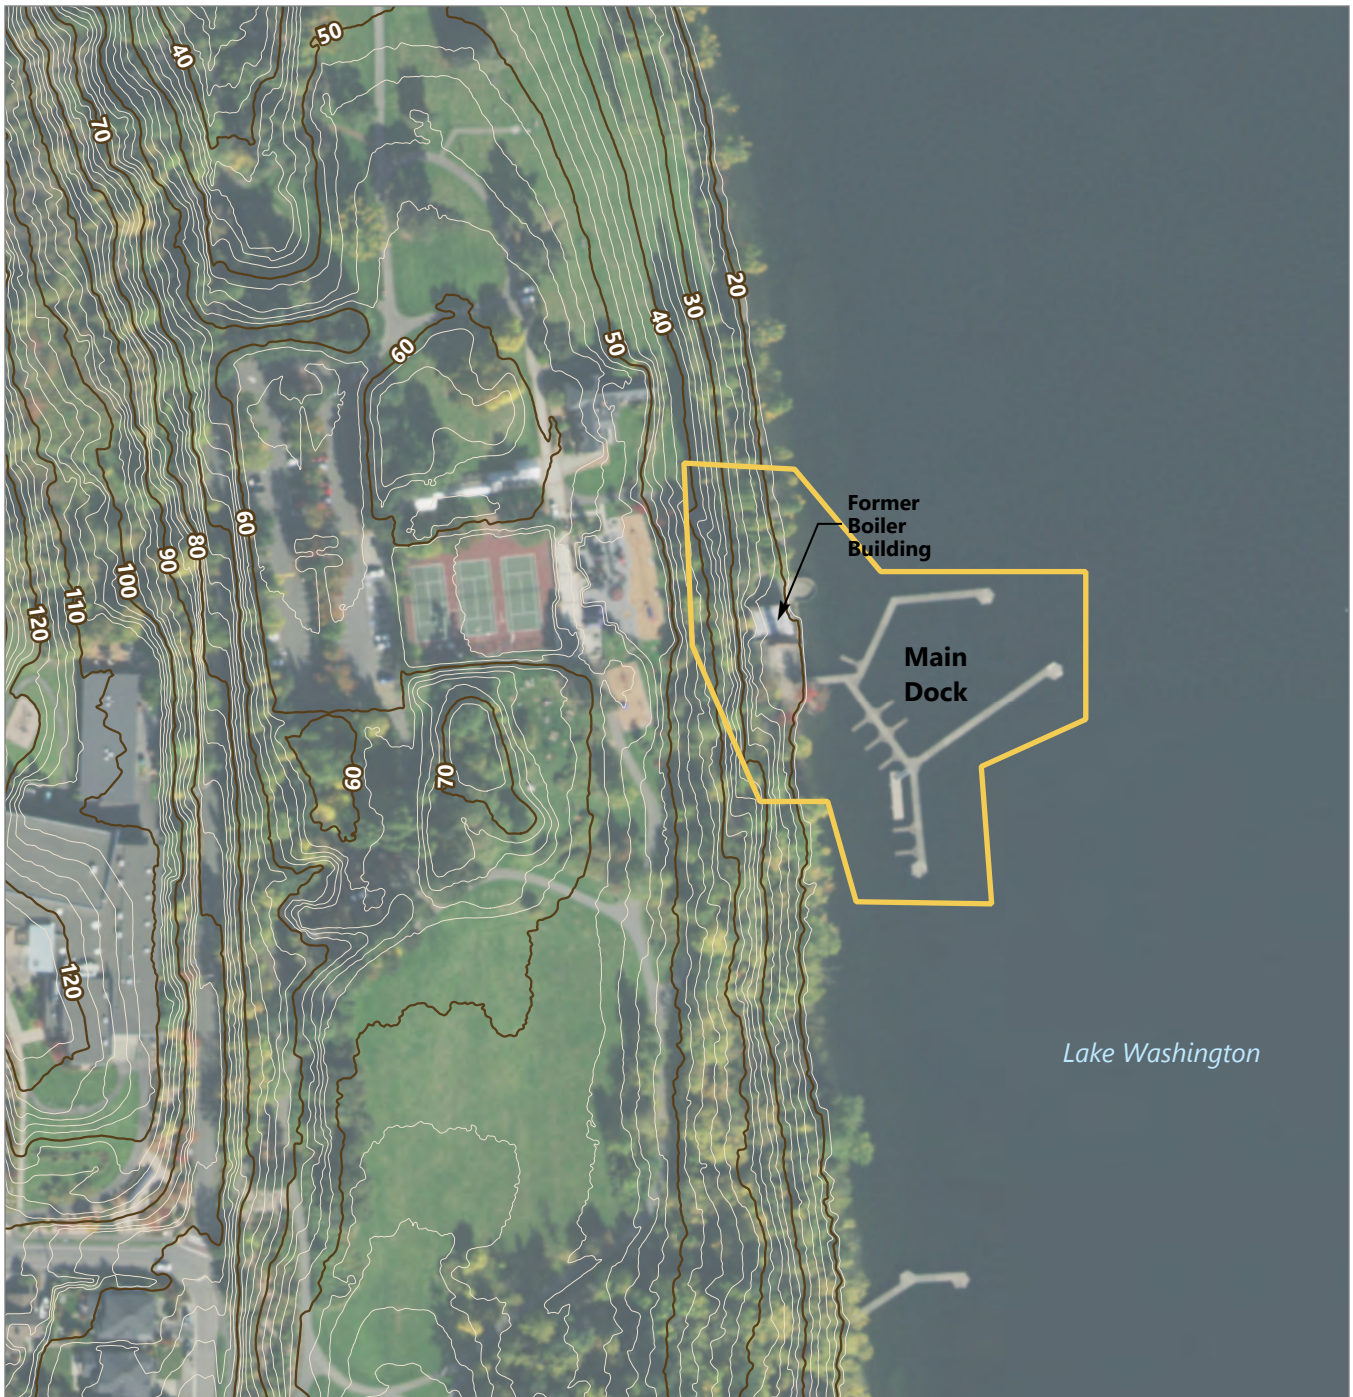
**Figure 7**  
**Project Area Boundary and Topography**  
 Critical Areas Study  
 Luther Burbank Park Waterfront Improvements

- Project Area
- Major 10-foot Contour
- Minor 2-foot Contour

The topography of the Park and Project area slopes down from the inland side of the Park to the Lake Washington shoreline. Topographic maps identify the highest elevation in the Project area as approximately 44 feet North American Datum of 1988 (NAVD88), sloping down toward the shoreline (Figure 7).

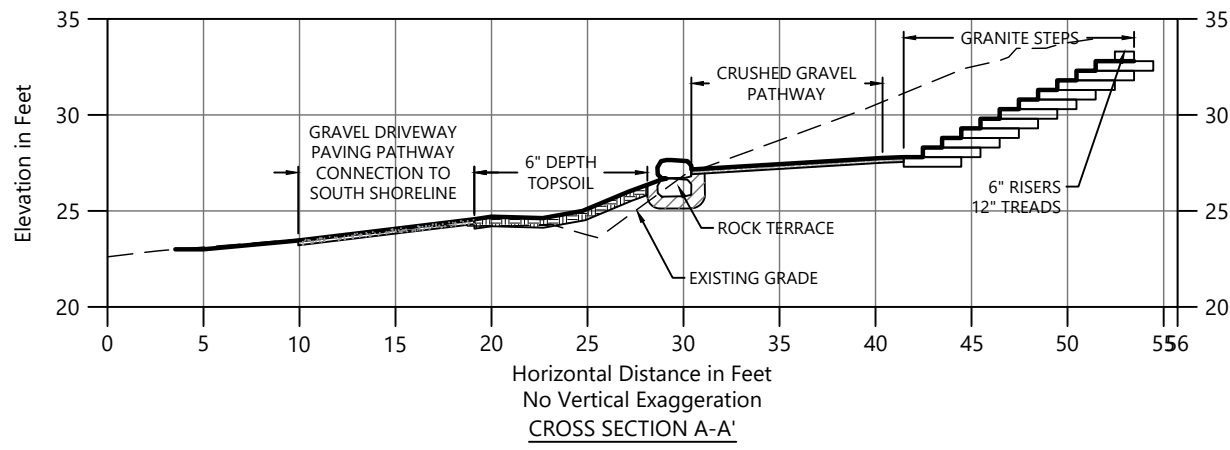
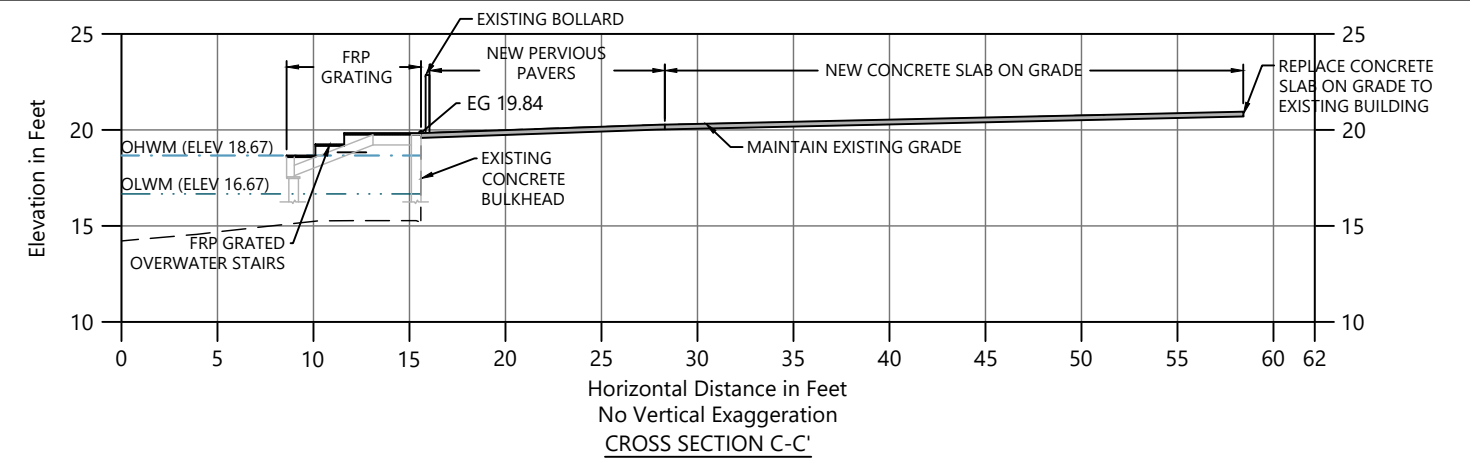
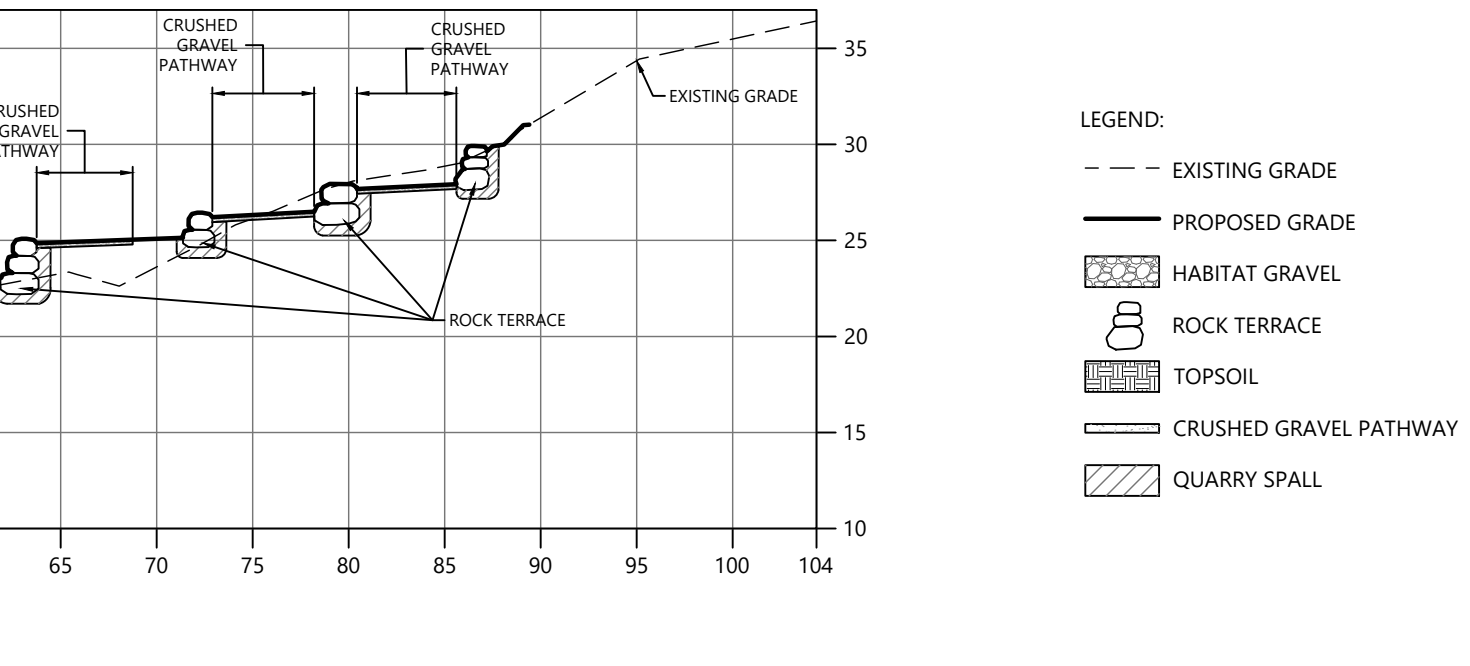
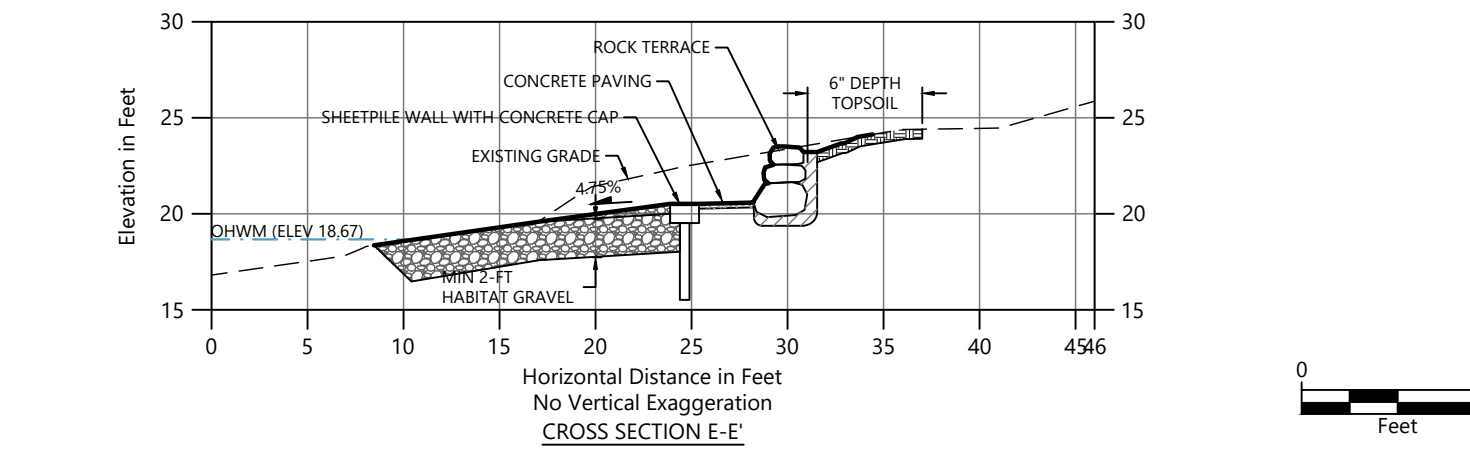
- LEGEND:**
- - - EXISTING GRADE
  - PROPOSED GRADE
  - HABITAT GRAVEL
  - ROCK TERRACE
  - TOPSOIL
  - CRUSHED GRAVEL PATHWAY
  - QUARRY SPALL

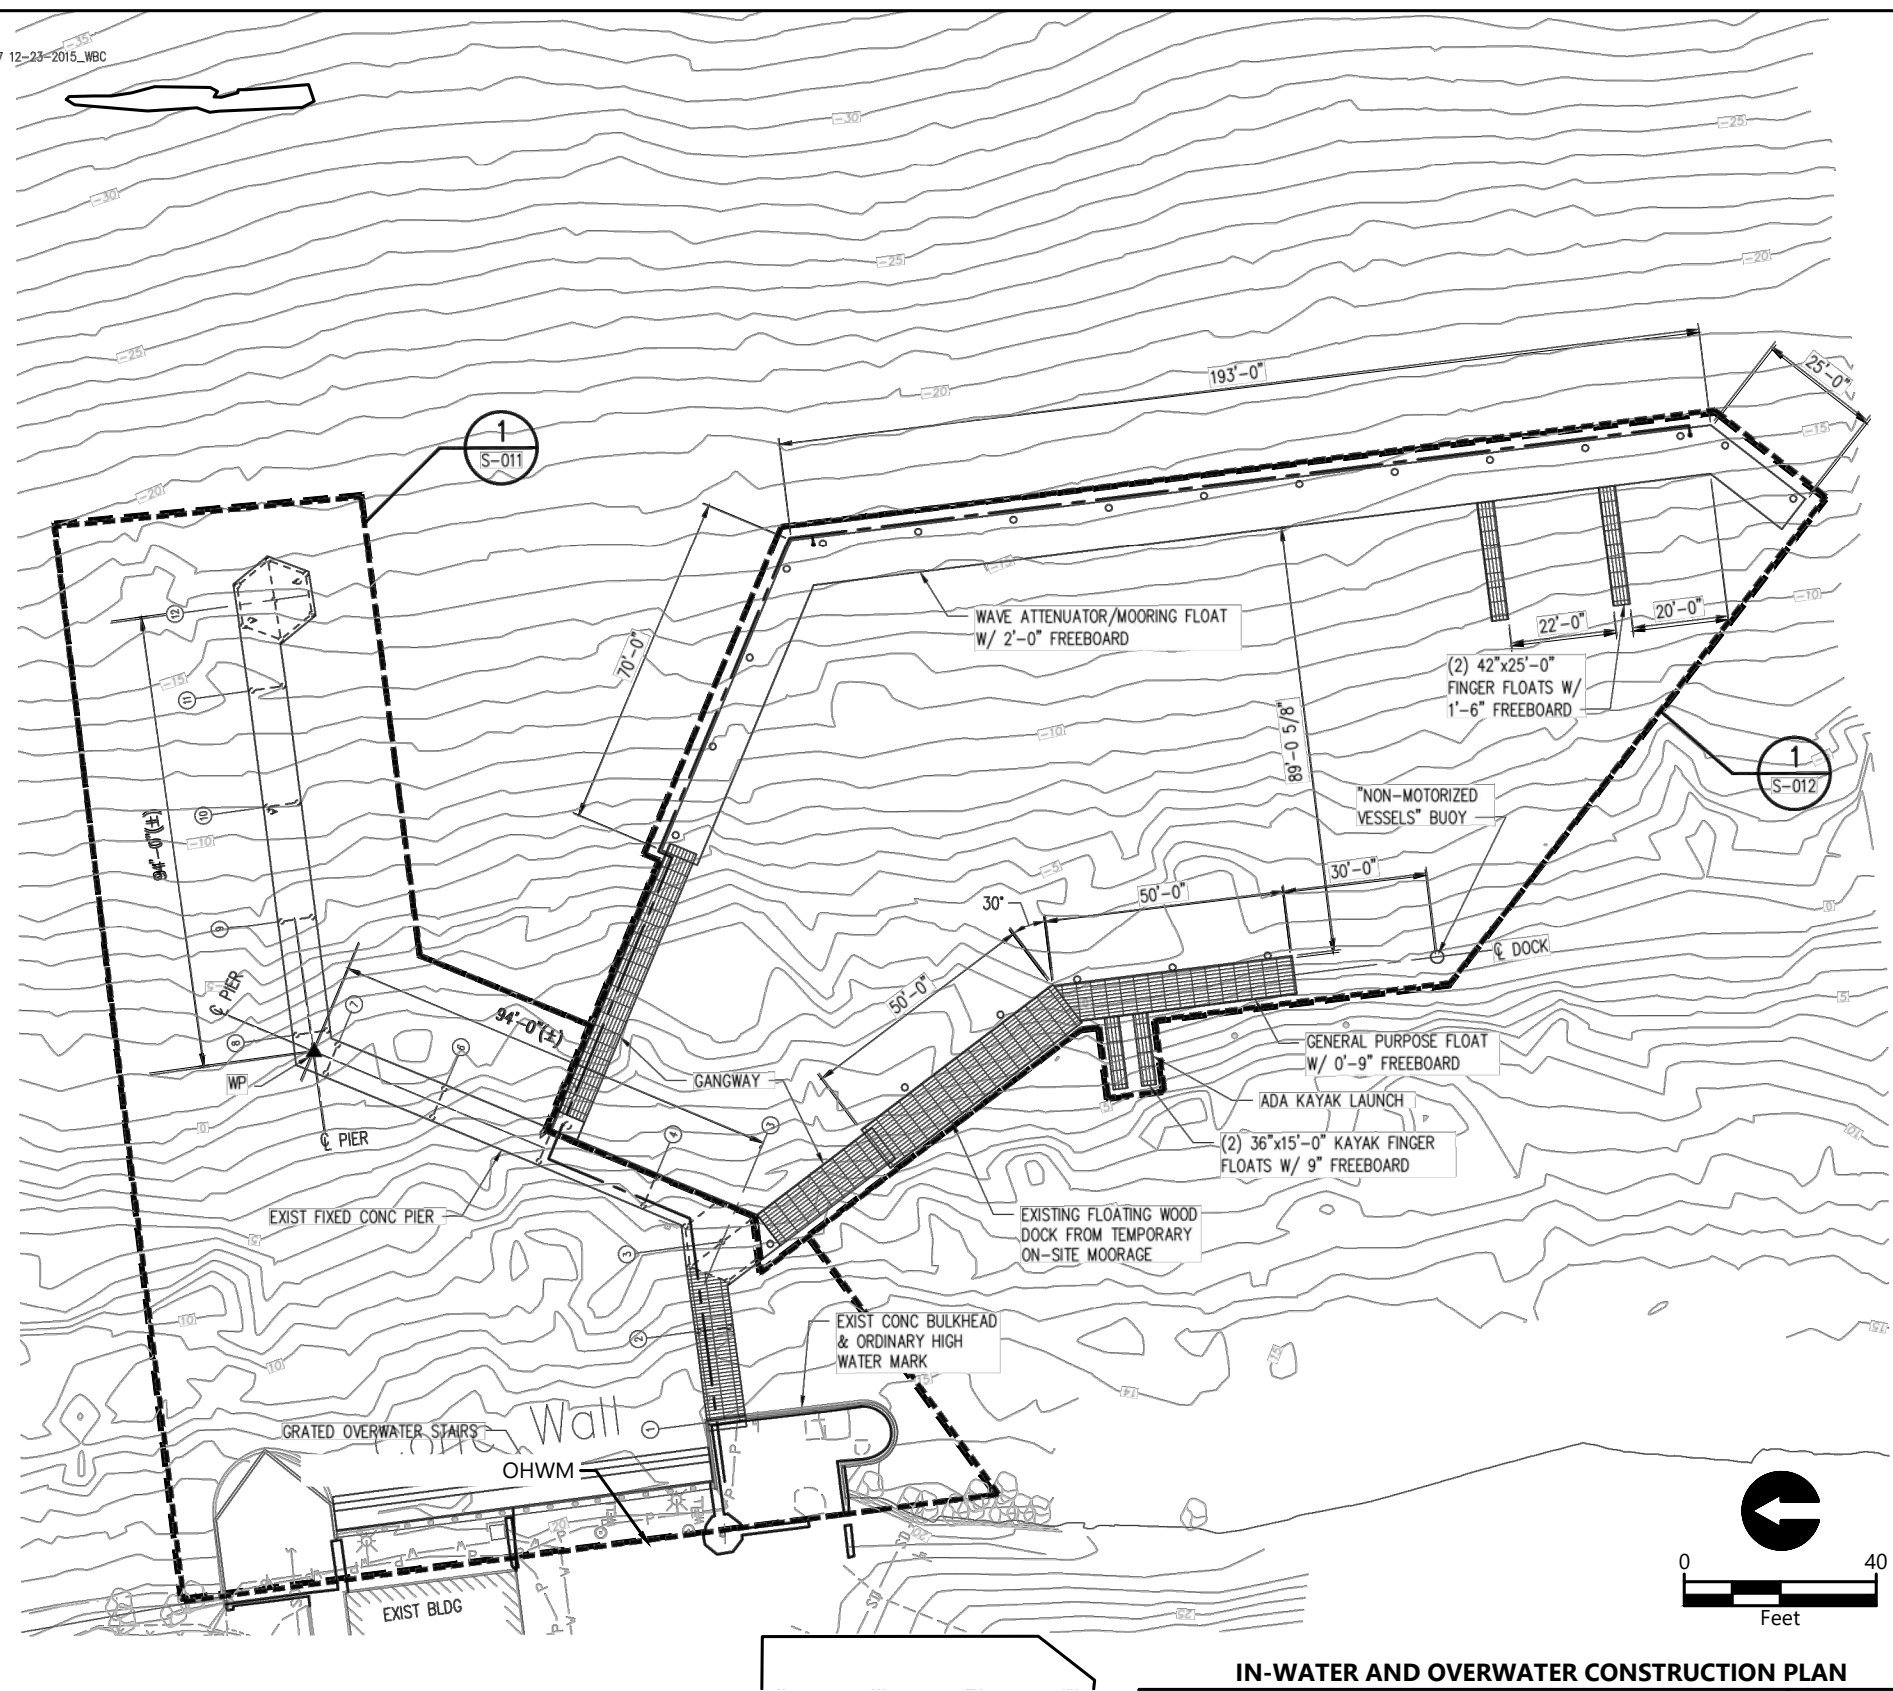
**IN-WATER AND OVERWATER CONSTRUCTION PLAN**

1. PROPOSED IMPROVEMENTS OVERWATER COVERAGE: ±4425 SF.
2. EXTENDS TO EXISTING BOUNDARY CORNER AT N 217653.411, E 1297450.919.
3. EXTENDS TO EXISTING BOUNDARY CORNER AT N 220320.192, E 1296873.931.

The in-water and overwater Project elements are described in this section and shown in Figures 3 and 4. A detailed plan set is provided in Appendix A.

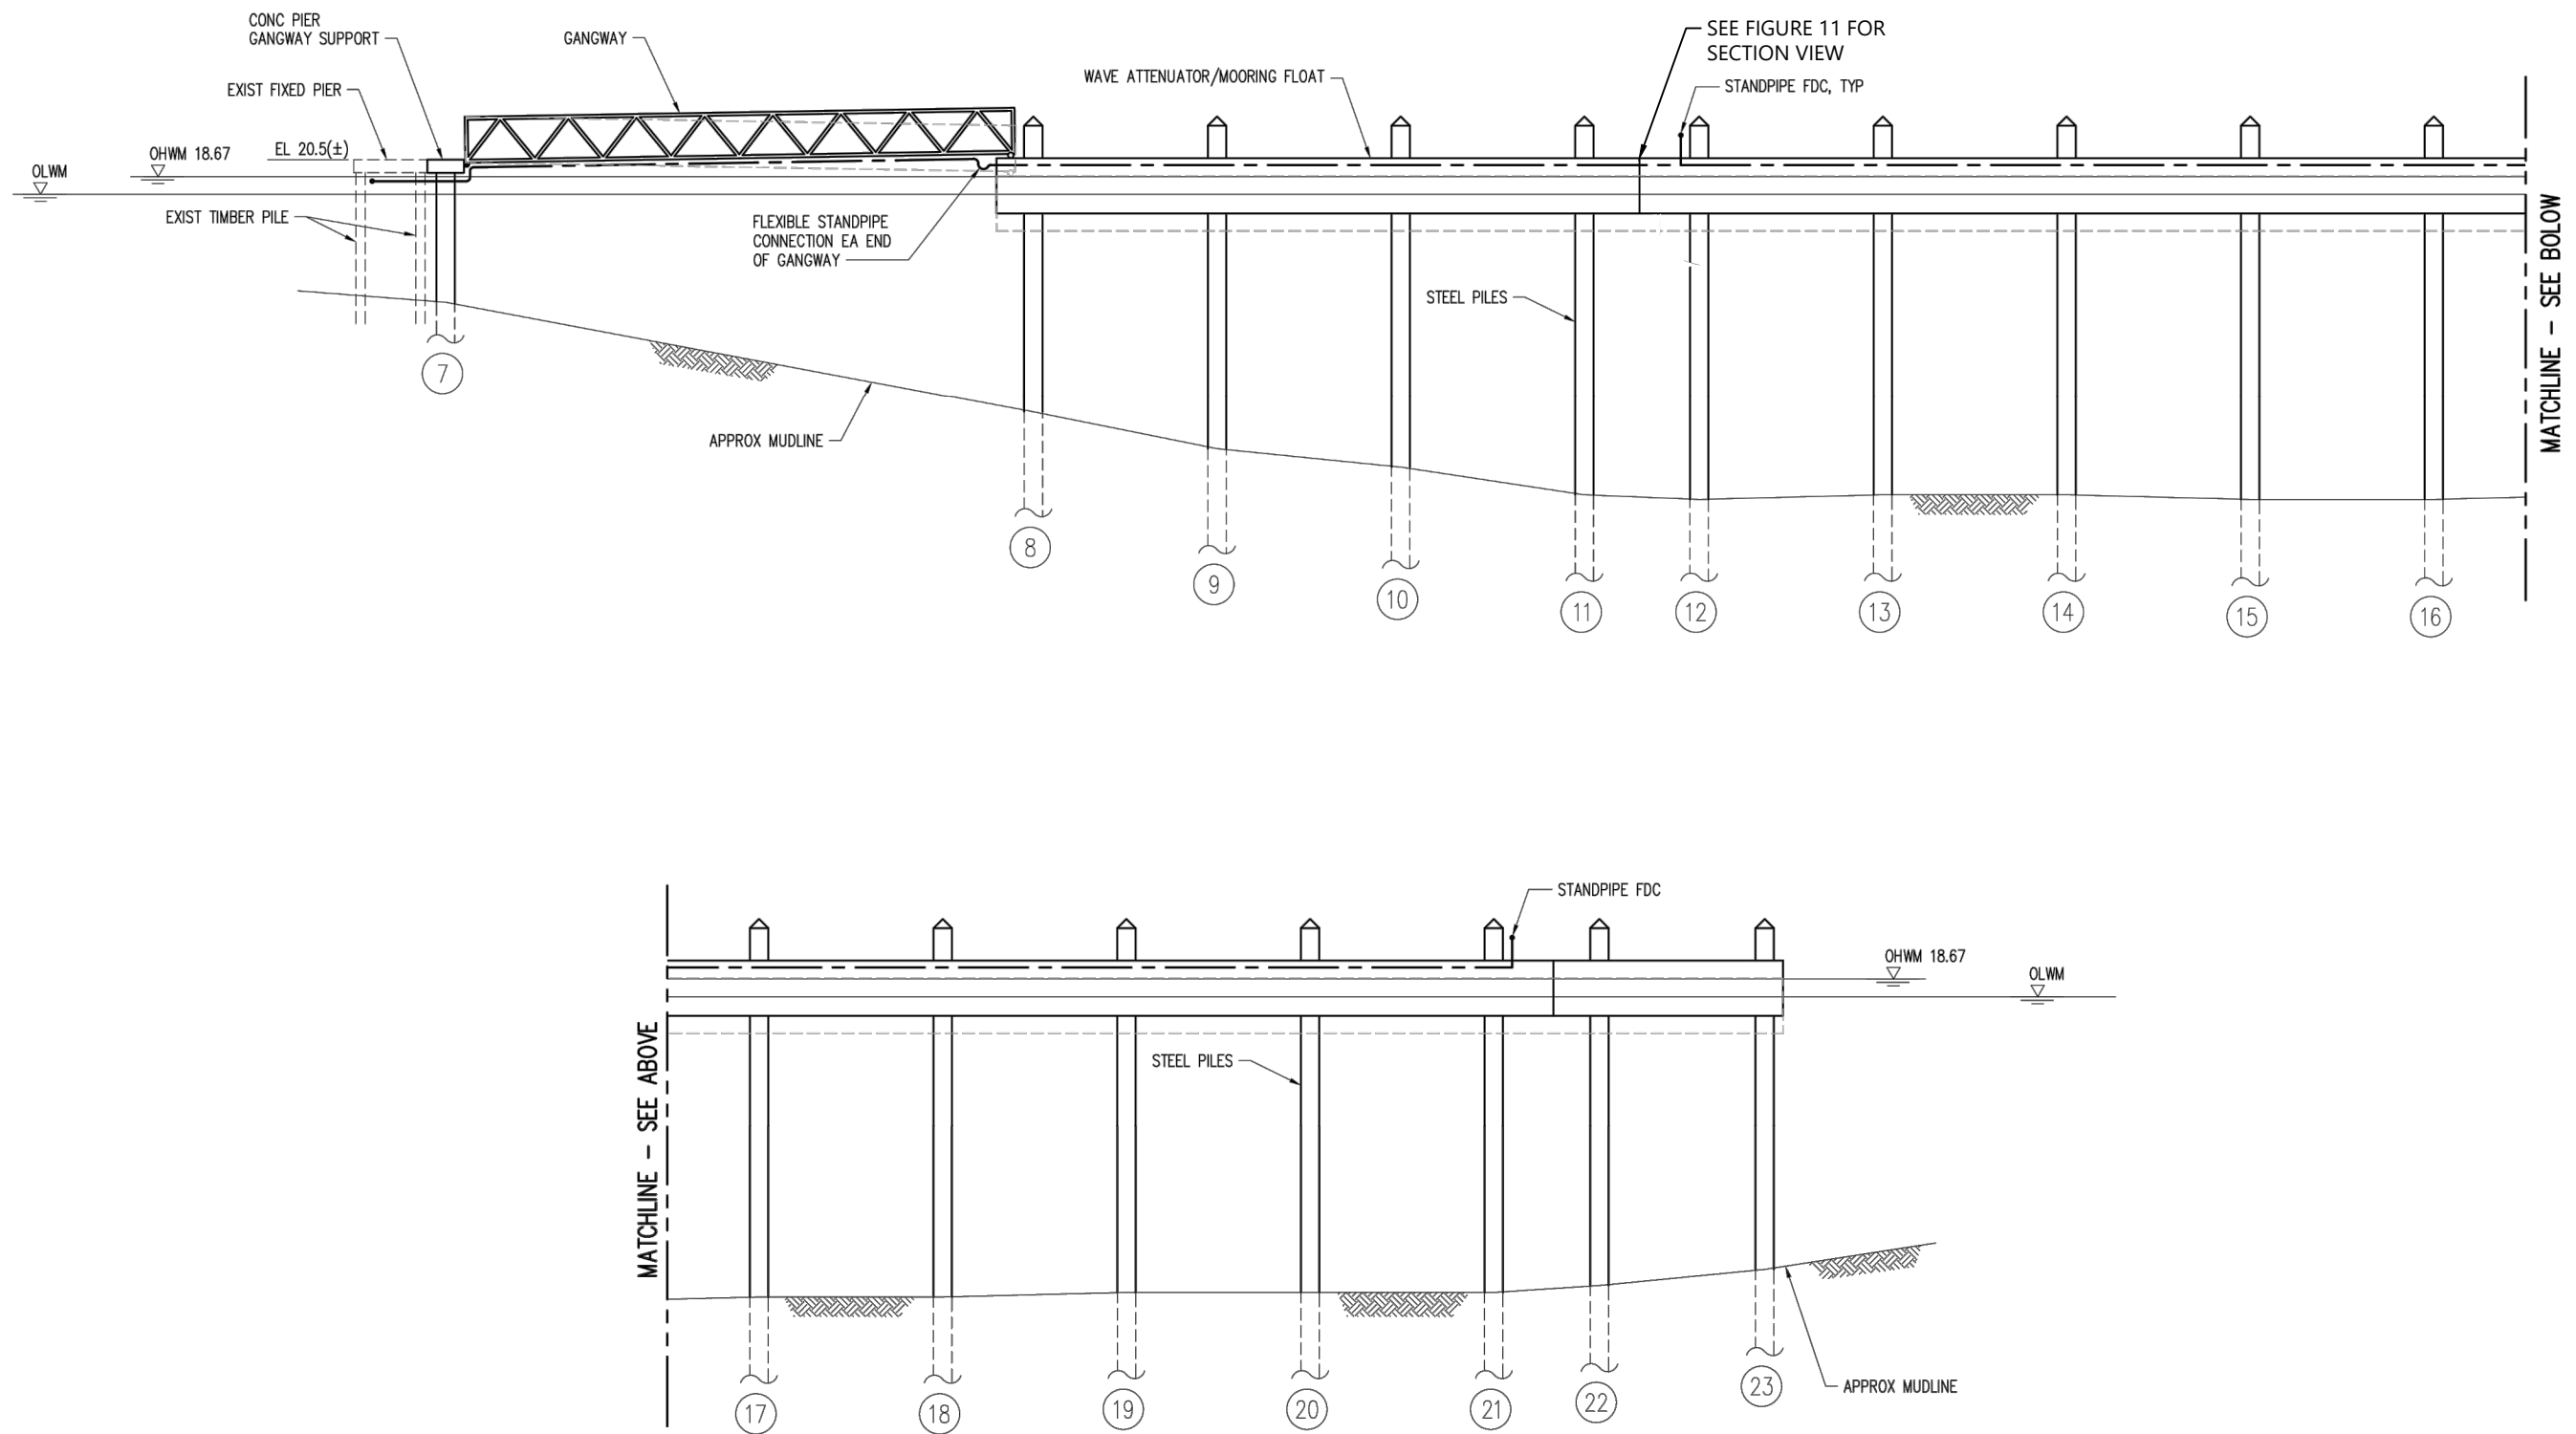
**CENTRAL DOCK RECONFIGURATION - ELEVATION VIEW**

SOURCE: CENTRAL DOCK RECONFIGURATION - ELEVATION VIEW PROVIDED BY KPFF.

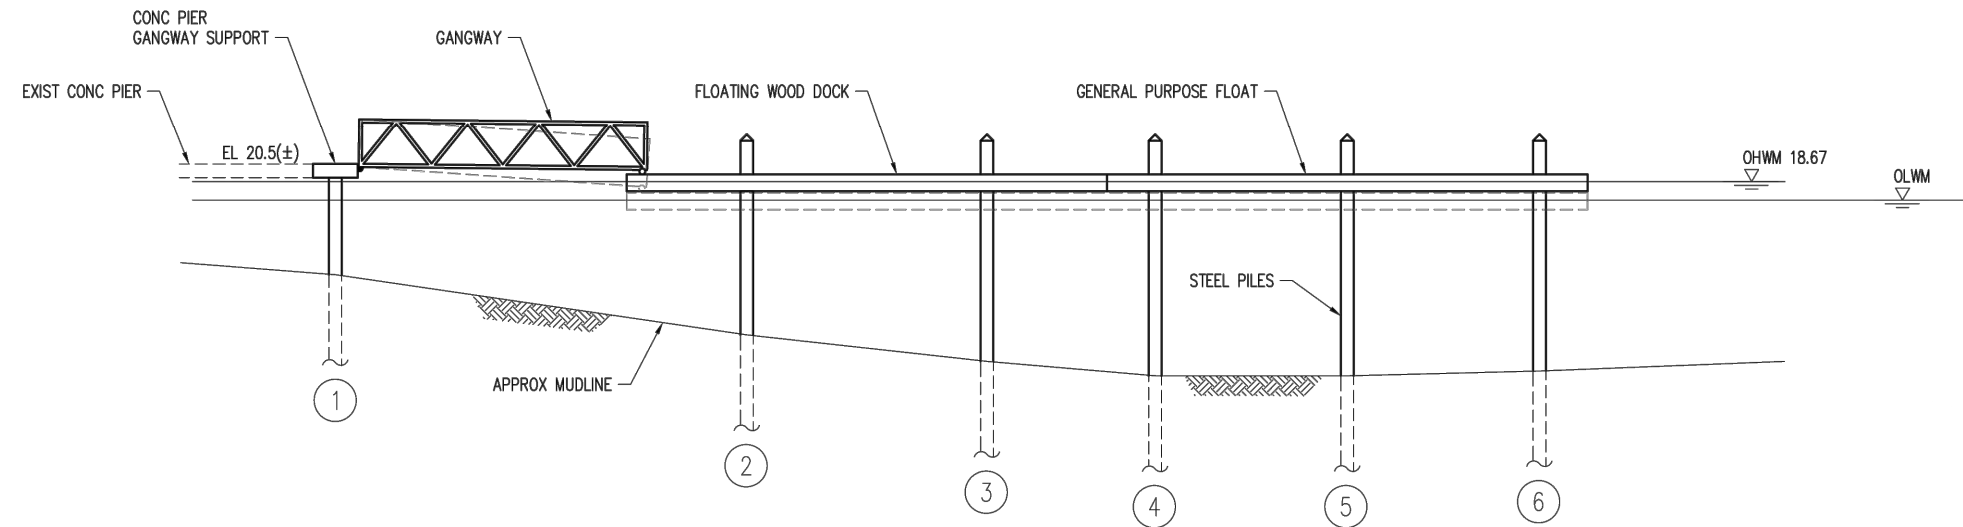
**SOUTH DOCK RECONFIGURATION - ELEVATION VIEW**

SOURCE: SOUTH DOCK RECONFIGURATION - ELEVATION VIEW PROVIDED BY KPFF.

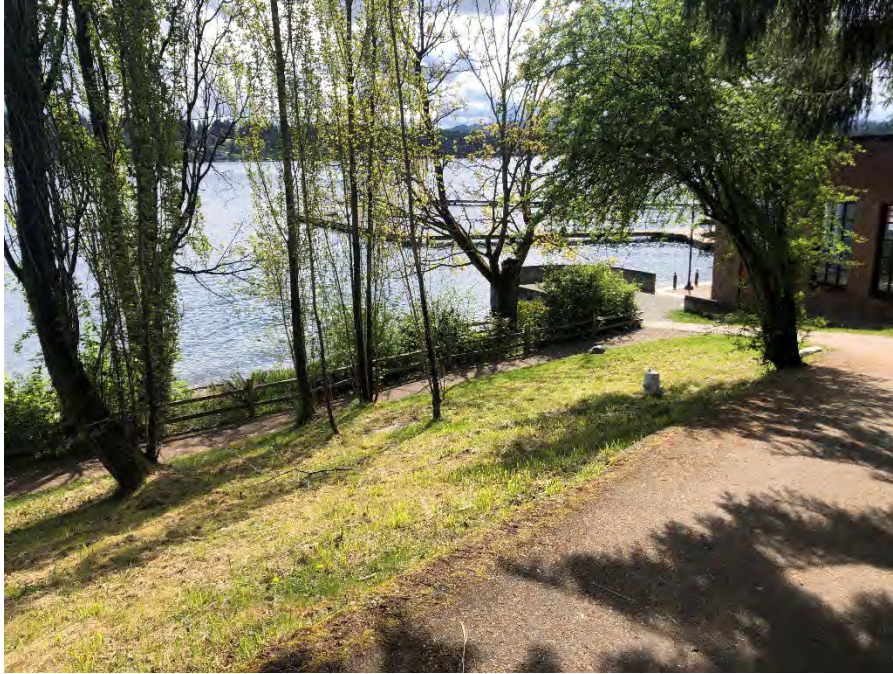
Photograph 1. Looking southeast from existing pathway toward Boiler Building and existing docks (April 2021).

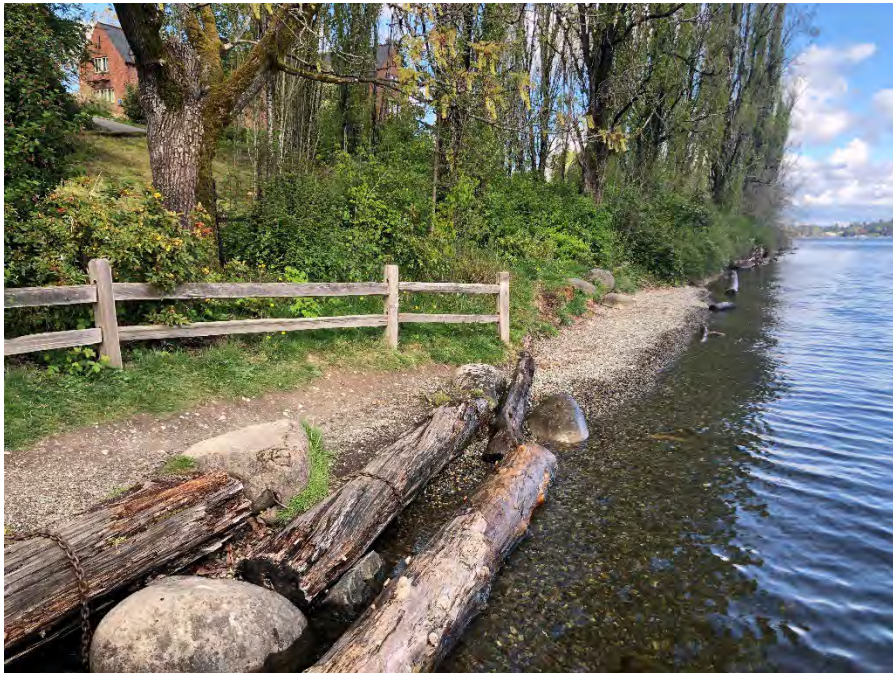
Photograph 2. Looking northwest over existing north beach (April 2021).

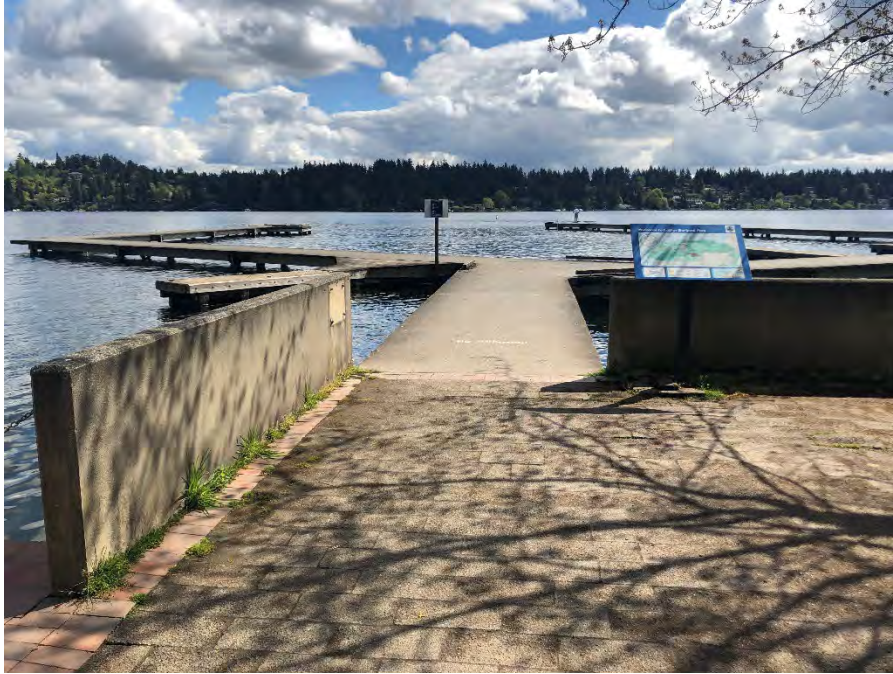
Photograph 3. Looking east from plaza over existing docks (April 2021).

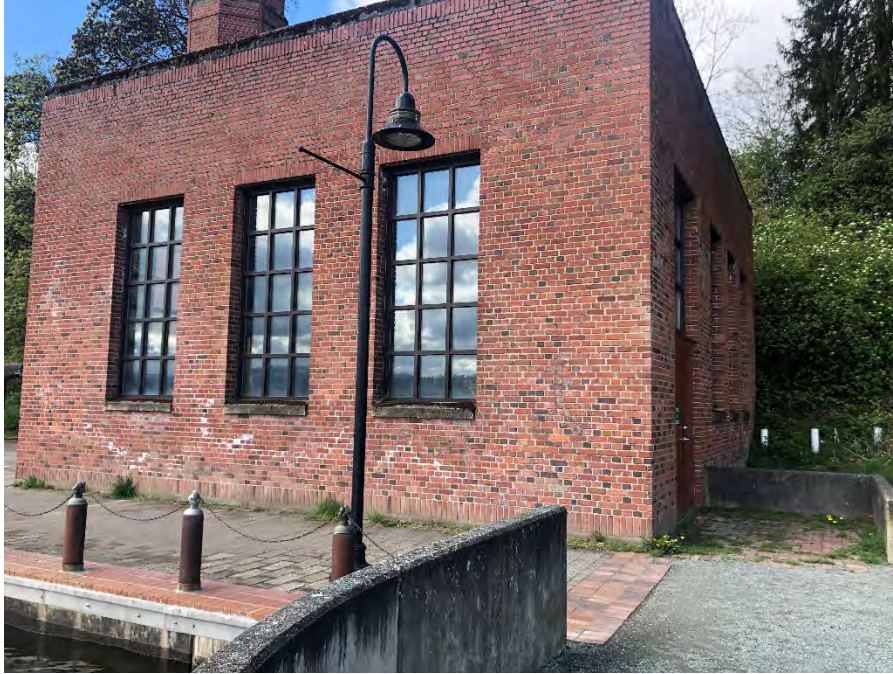
Photograph 5. Existing Boiler Building (April 2021).

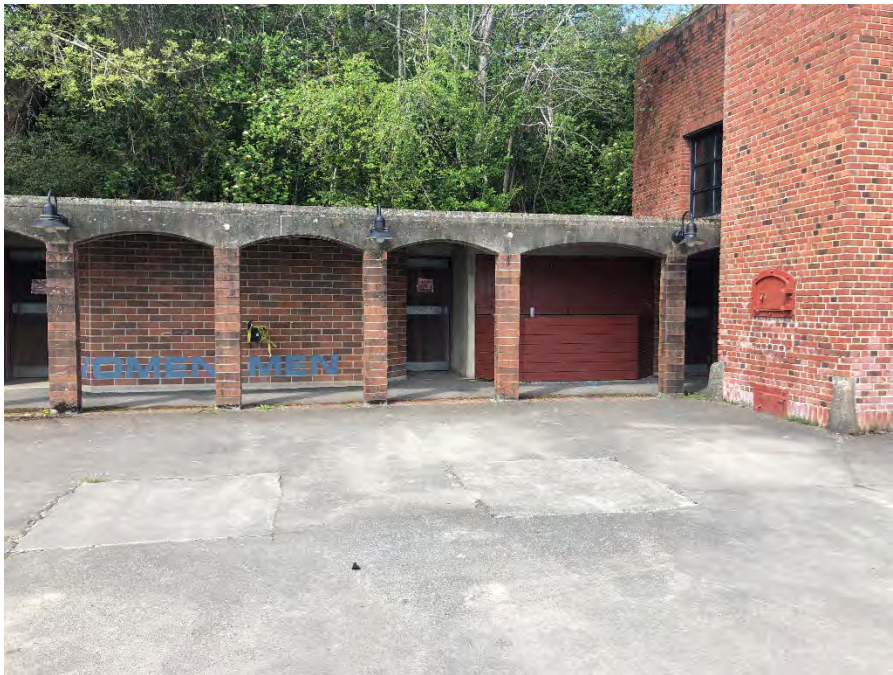
Photograph 6. Existing restroom annex building (April 2021).

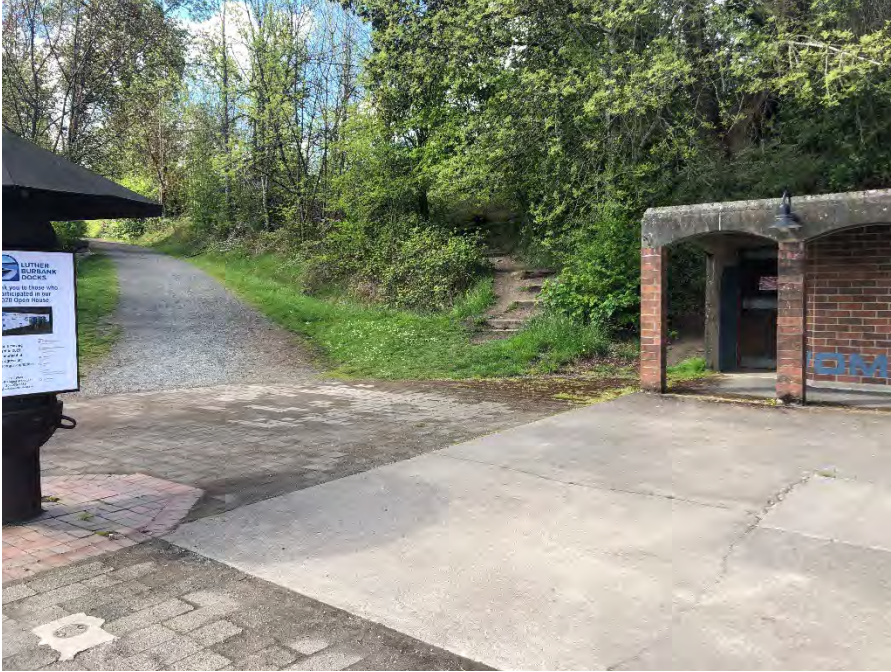
Photograph 7. Existing gravel access driveway and footpath with wooden stairs at south end of plaza (April 2021).

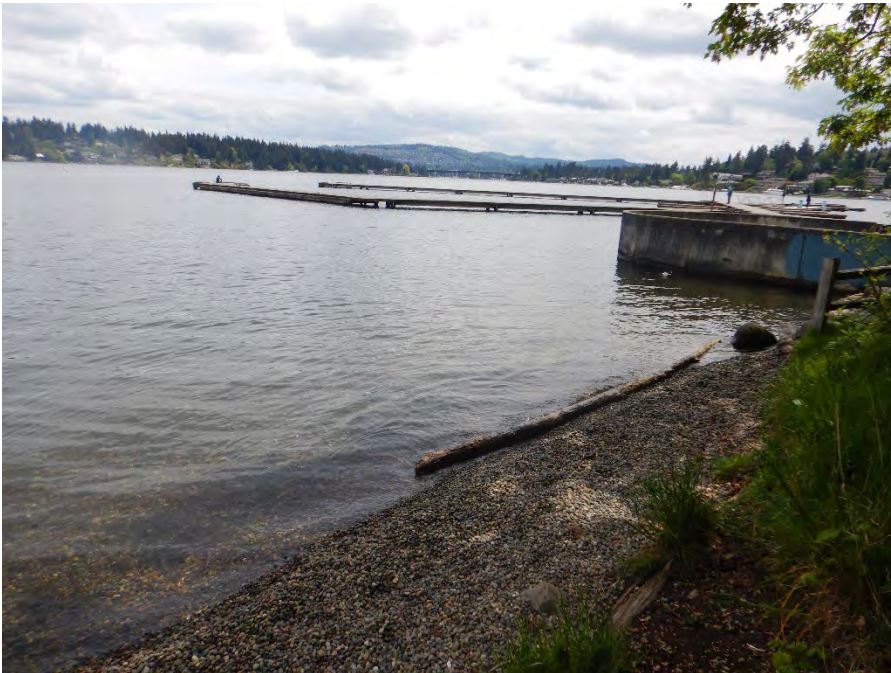
Photograph 8. Looking southeast from north beach over existing docks (May 2022).

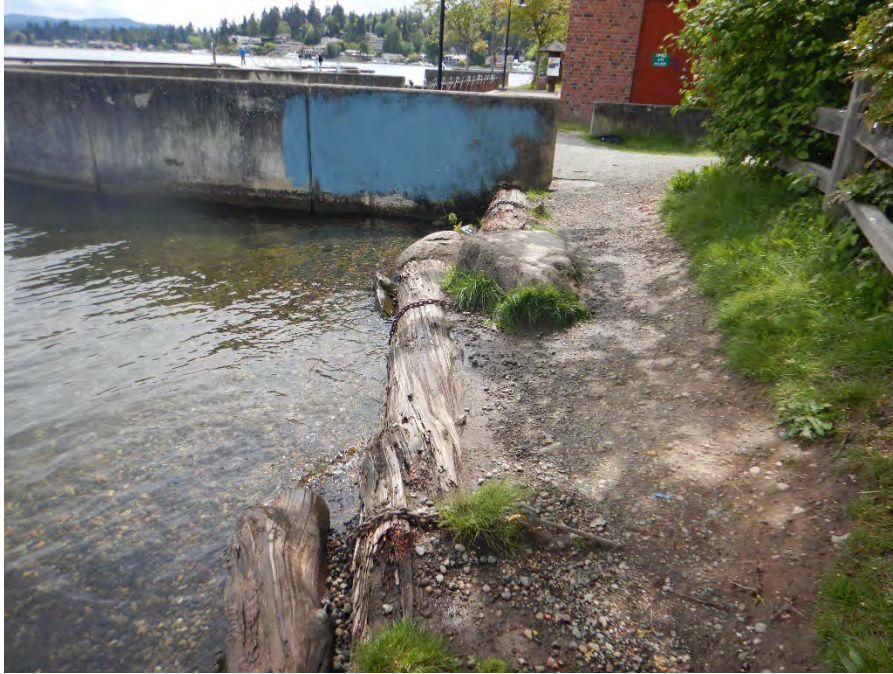
Photograph 9. Looking south from north beach toward existing bulkhead and Boiler Building (May 2022).

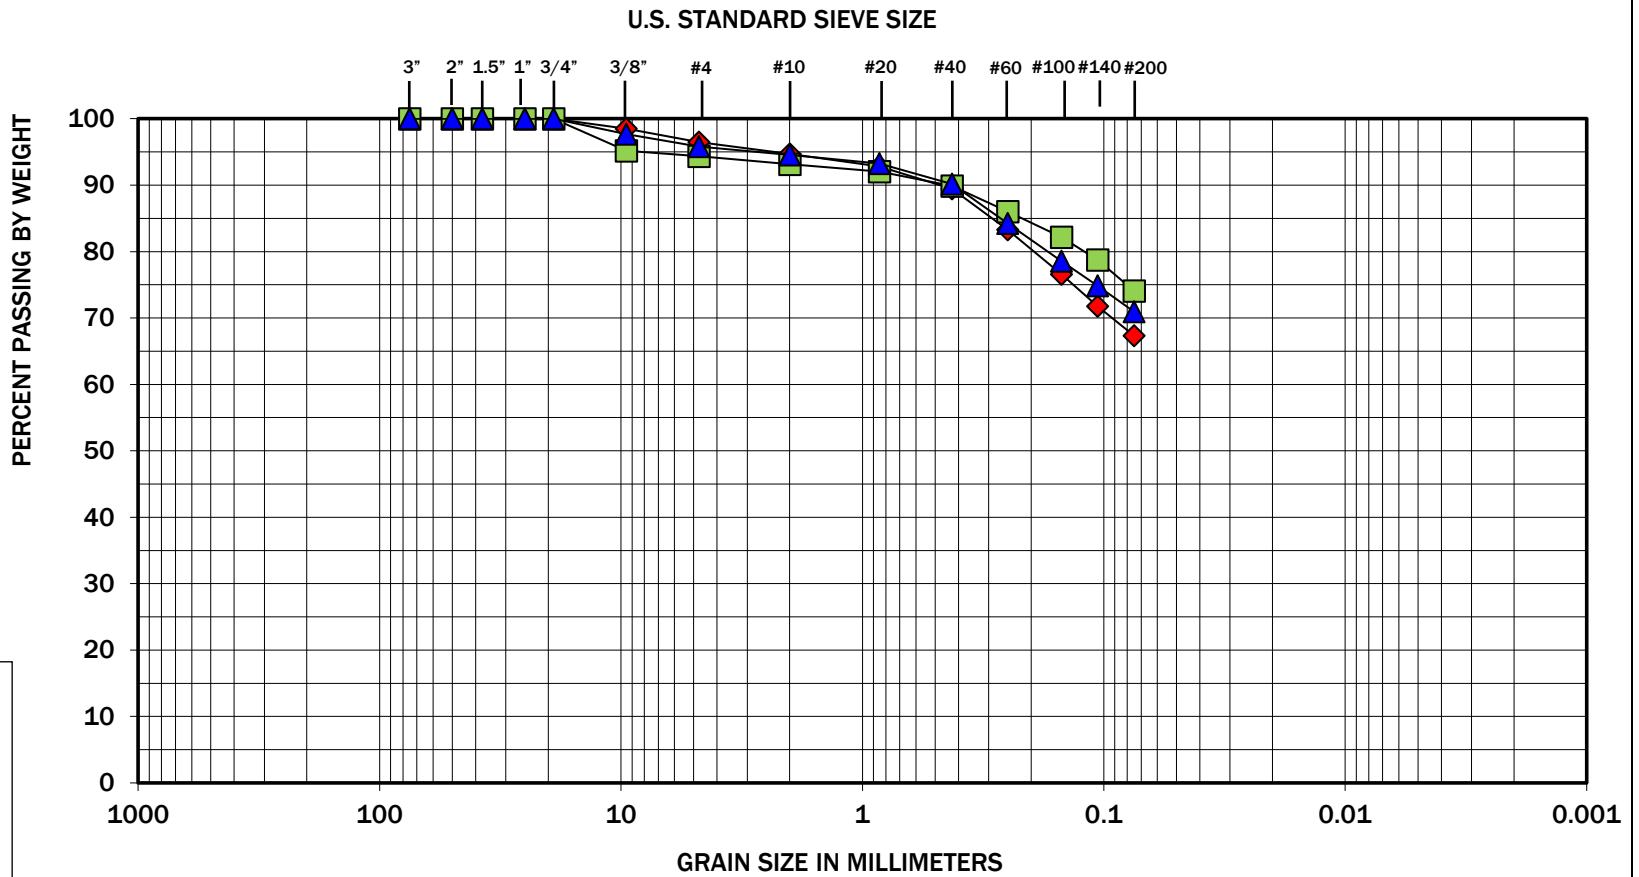
Figure A-4  
Sheet 1 of 1

Symbol	Boring Number	Depth (feet)	Moisture (%)	Soil Description
◆	B-1	2.5	13	Sandy silt (ML)
■	B-1	10.5	16	Silt with sand (ML)
▲	B-2	2.5	14	Silt with sand (ML)

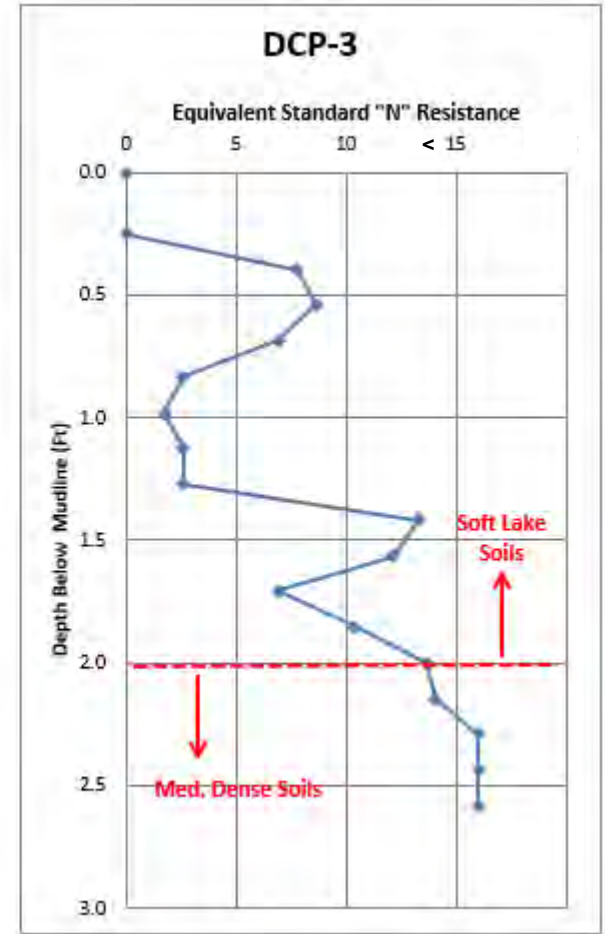
Figure 3

**DCP Logs**

The DCP explorations extended 2 to 2½ feet below mudline. Plots of the estimated Standard Penetration Test (SPT) “N” value versus depths for each DCP exploration is shown on Figure 3. The SPT values presented are based on published correlations between DCP penetration rate and SPT N values.
