October 2022  
Luther Burbank Park Waterfront Improvements

# Critical Areas Study

Prepared for City of Mercer Island

**Prepared by**  
Anchor QEA, LLC  
1201 3rd Avenue, Suite 2600  
Seattle, Washington 98101

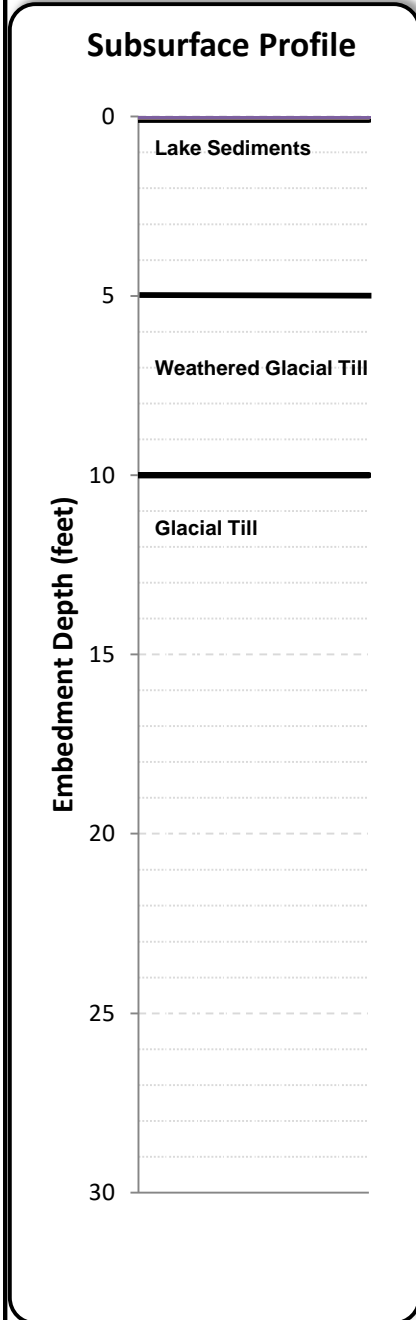
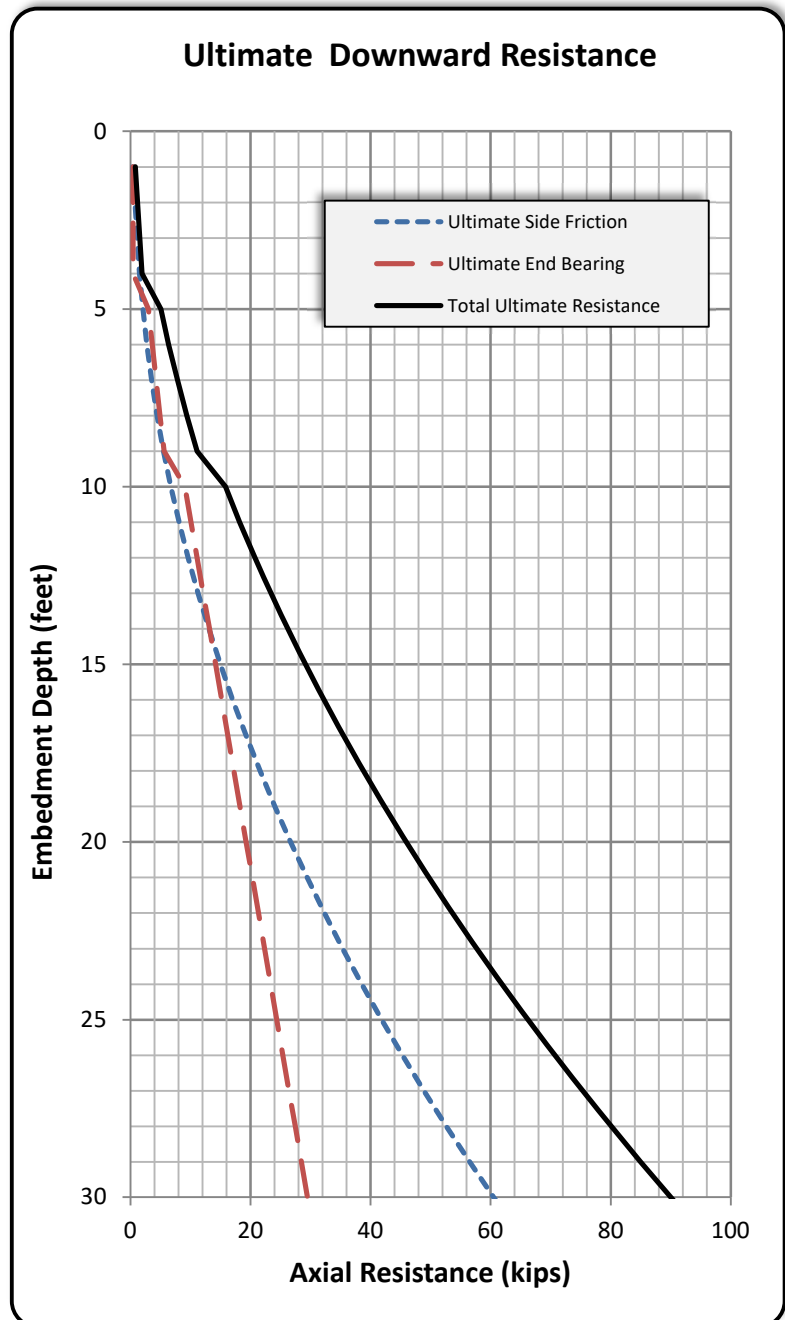
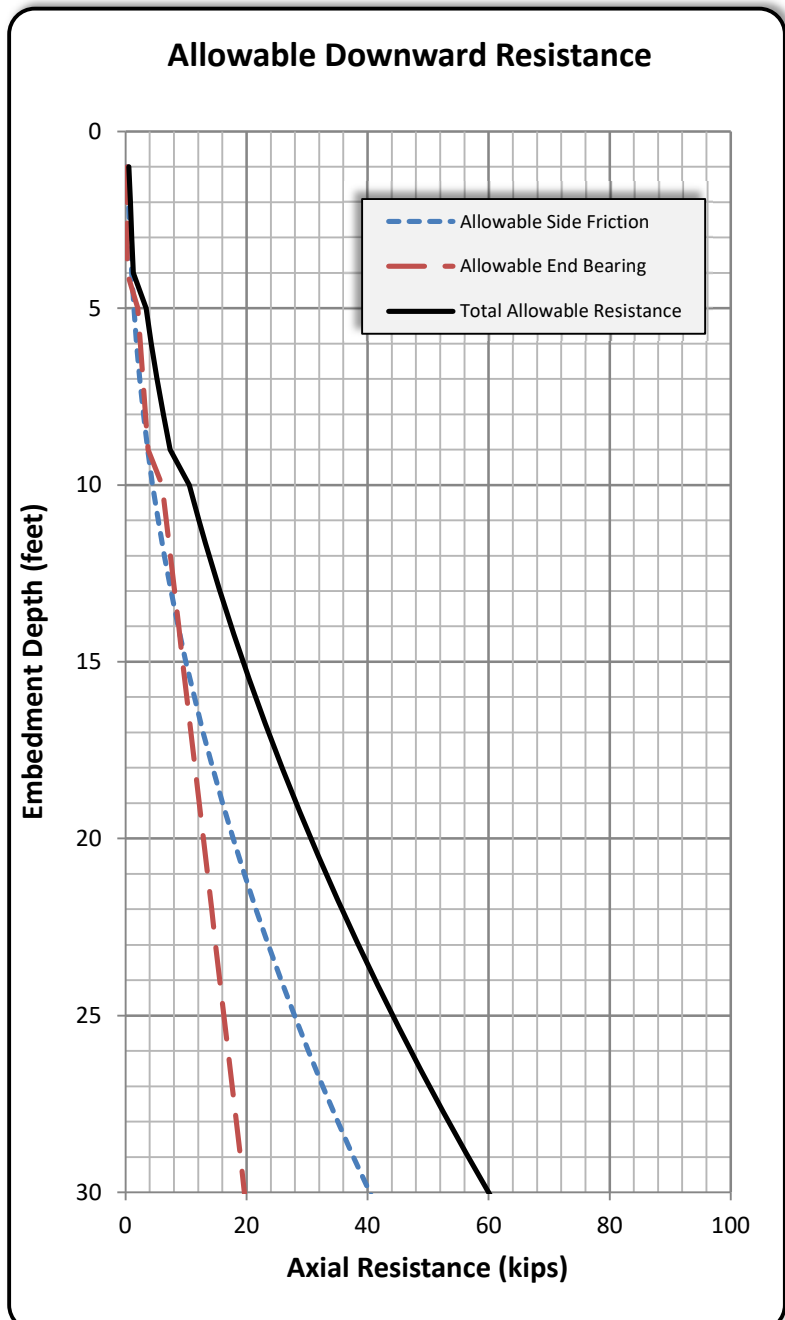
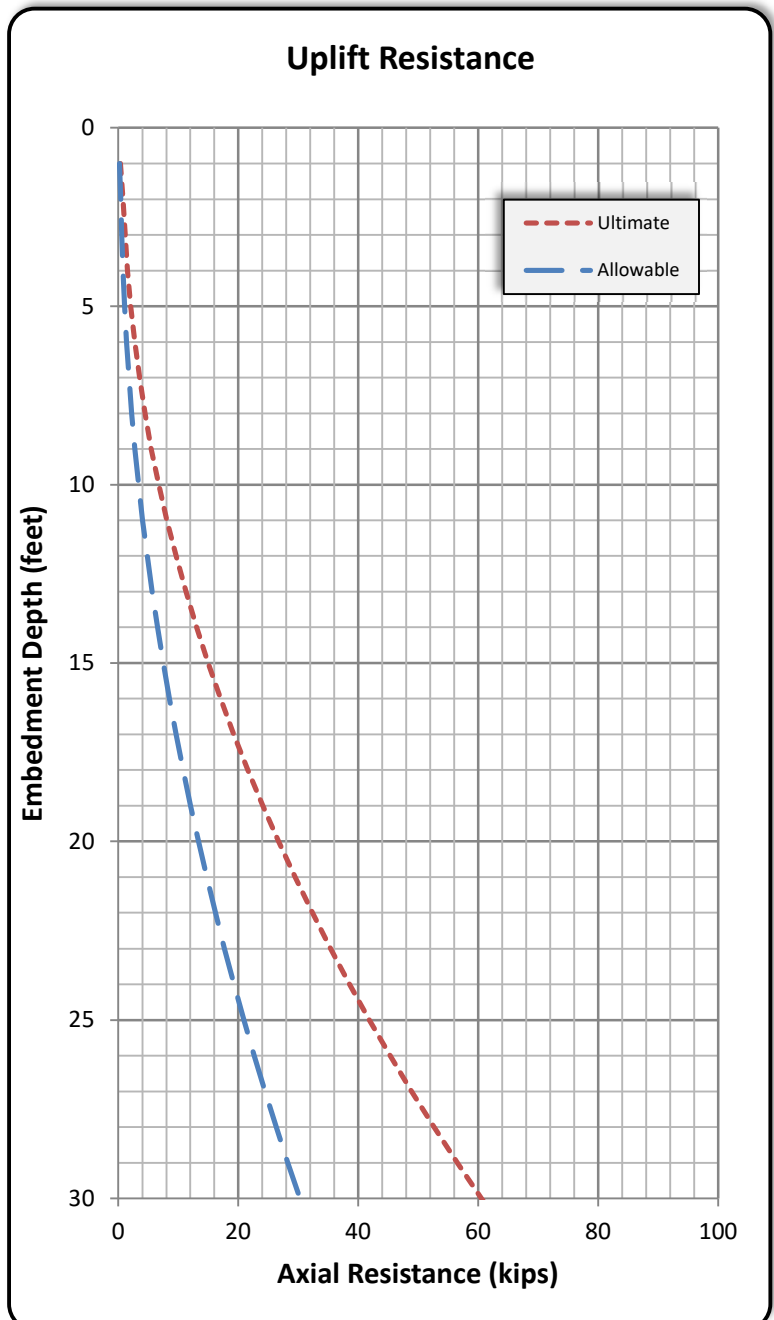
<b>Axial Pile Resistance</b>	
Luther Burbank Park Dock Repair Mercer Island, Washington	
	<b>Figure 4</b>

**AXIAL PILE RESISTANCE**  
**16 x 0.625-inch Open-End Steel Pipe Pile**

Figure 4 and Figure 5 present our estimate of ultimate and allowable pile axial pile resistance for the 16-inch and 24-inch diameter open ended pipe piles, respectively. The provided axial resistances are based on unplugged soil conditions, which in our opinion, is conservative with regards to pile design. The allowable resistances include a minimum factor of safety of about 1.5 for side friction and end bearing, and 2.0 for uplift. The allowable resistances apply to single piles. If piles are spaced at least three pile diameters on center, no reduction of axial capacity for group action is needed.

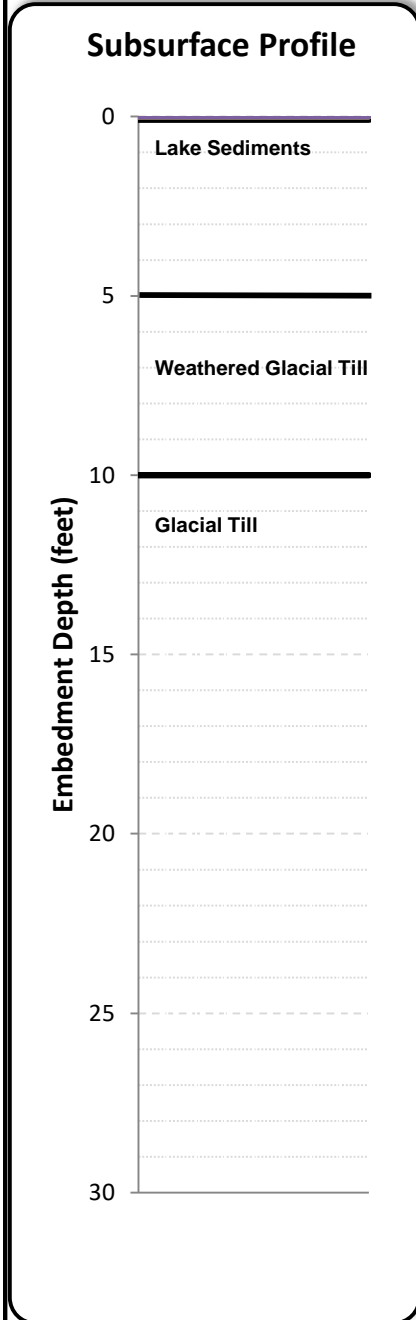
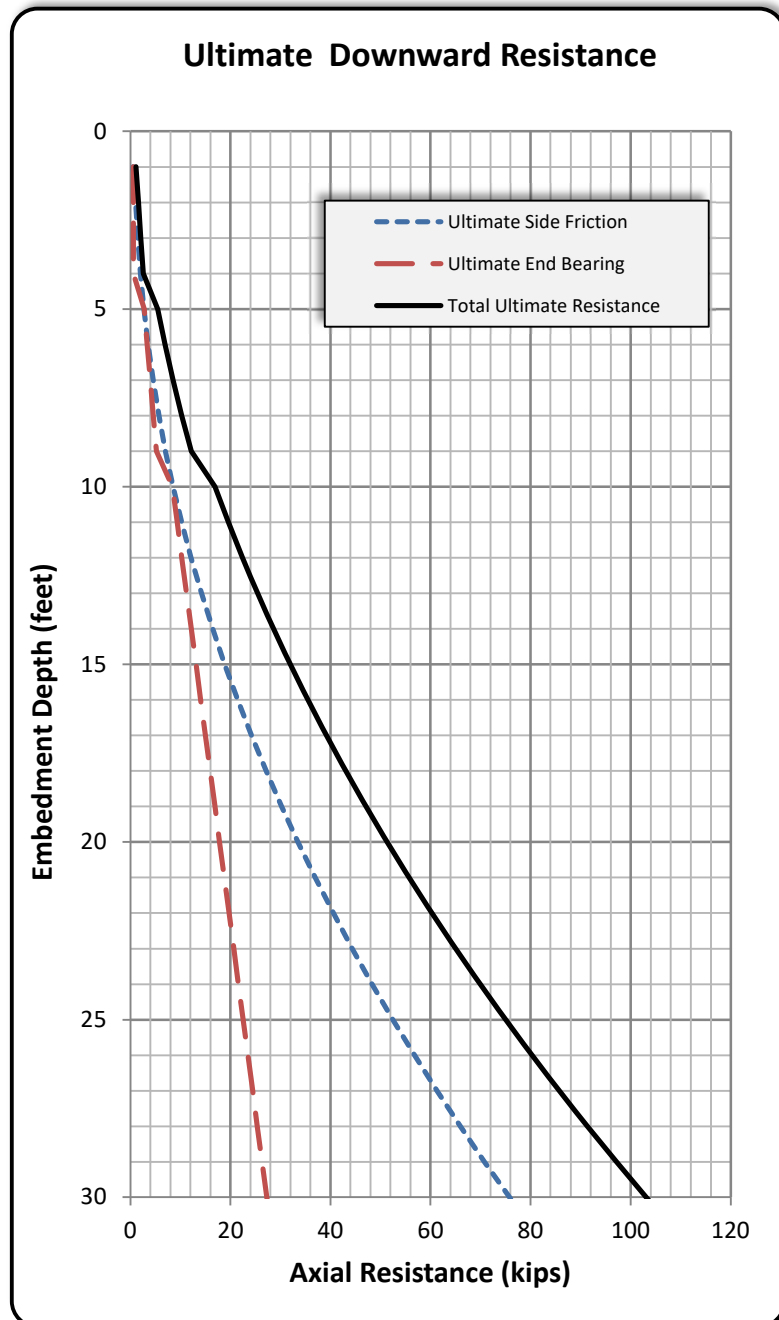
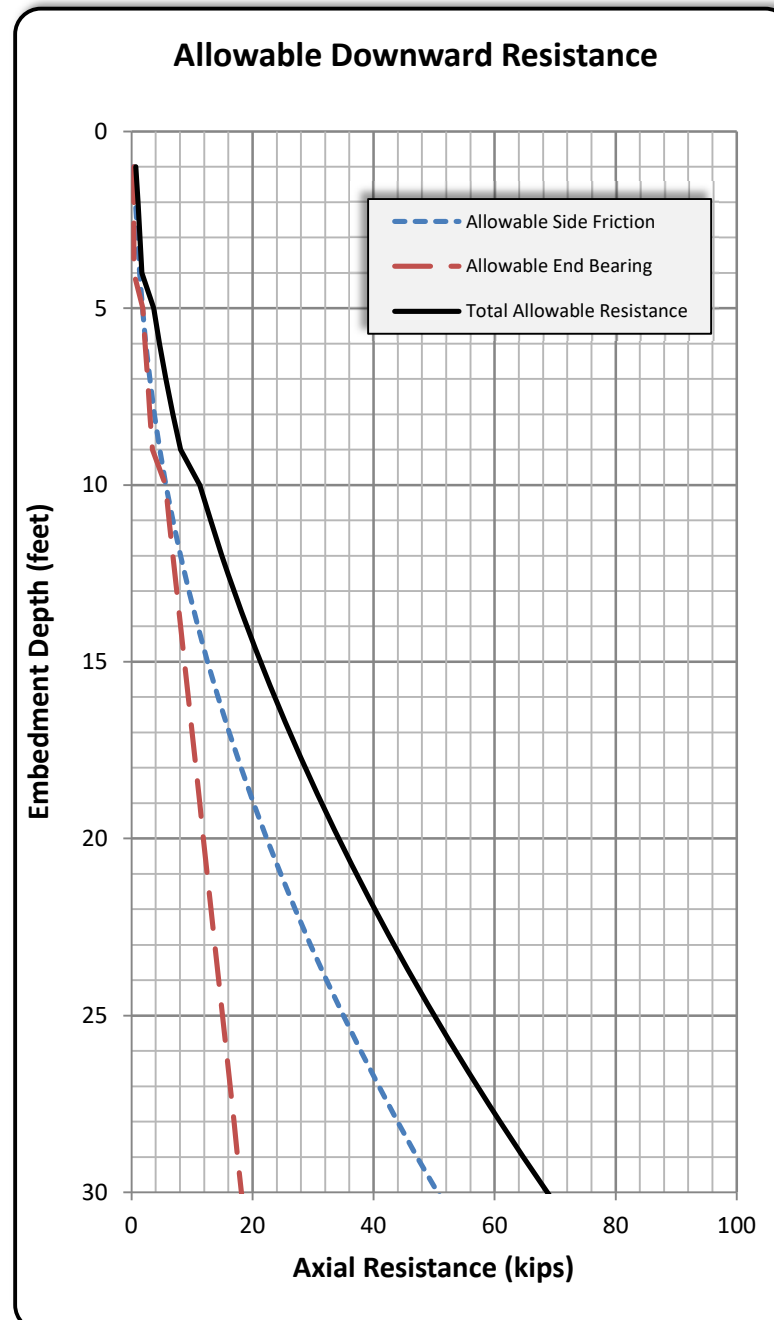
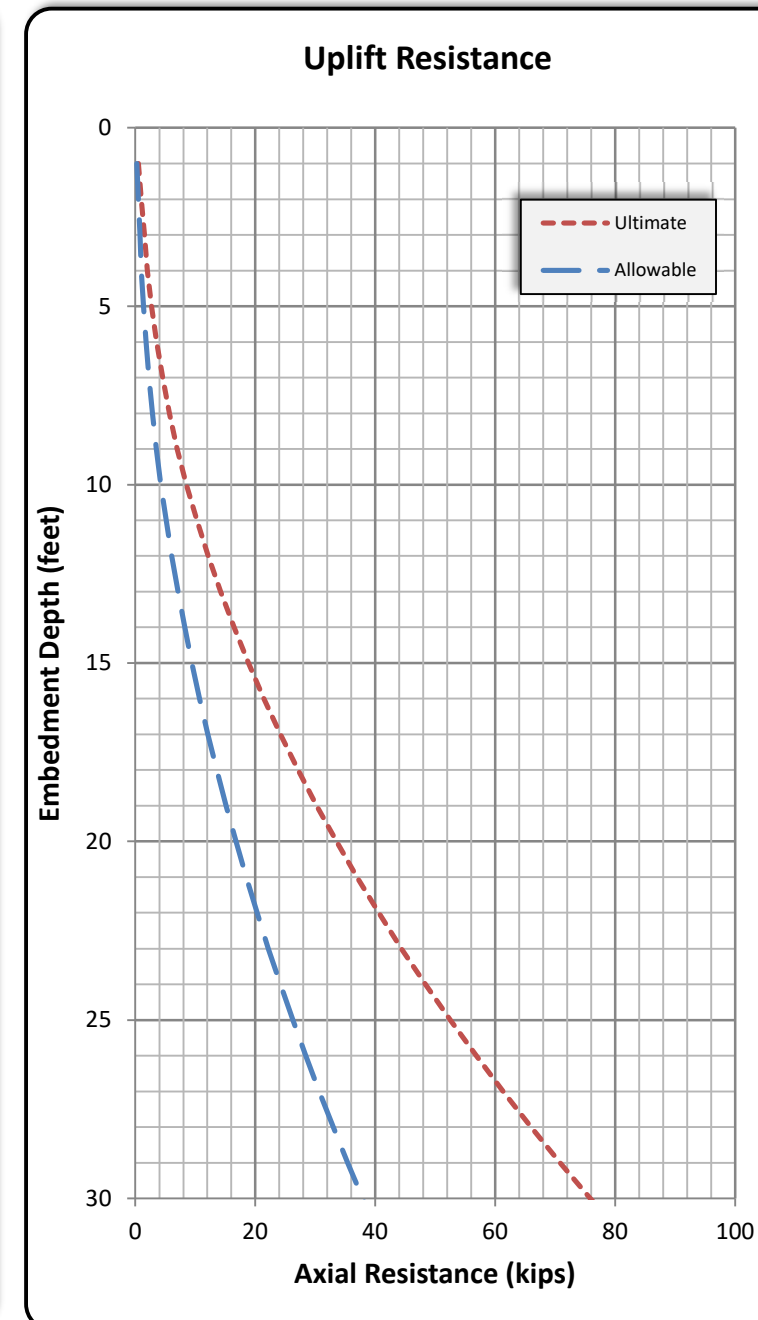
**Figure 5**

**AXIAL PILE RESISTANCE**  
24 x 0.625-inch Open-End Steel Pipe Pile
