October 2022
Luther Burbank Park Waterfront Improvements

Project Description

Prepared for City of Mercer Island

Prepared by
Anchor QEA, LLC
1201 3rd Avenue, Suite 2600
Seattle, Washington 98101

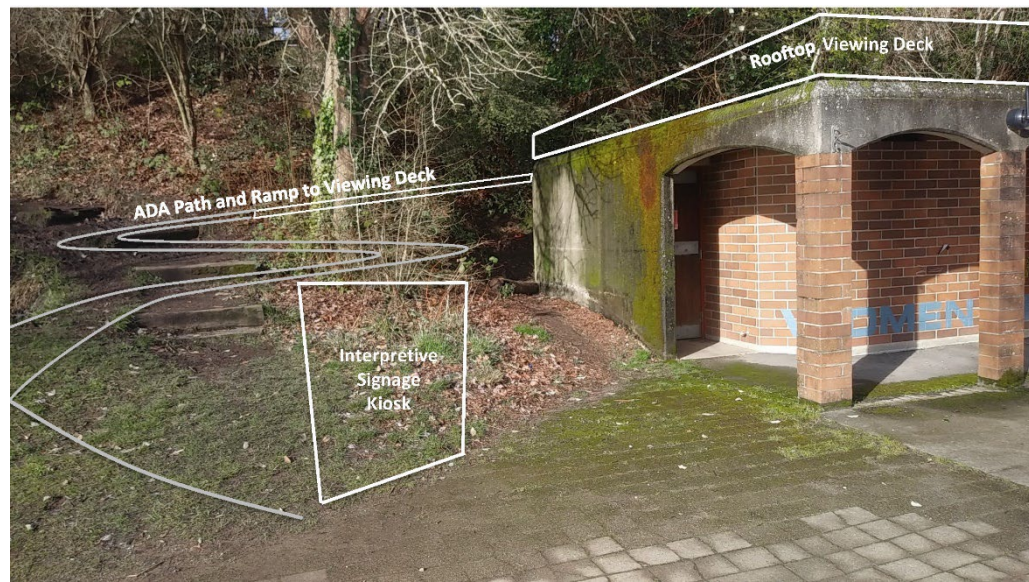
Diagram 1
Conceptual Sketch of Viewing Deck (South End) and ADA-Accessible Ramp Location

The Boiler Building restroom annex rooftop will be renovated to facilitate a new outdoor viewing deck. The viewing deck will be constructed with Bison wood-paneled deck-surfacing material on pedestals with a 1/2-inch maximum gap for ADA accessibility on top of the existing concrete roof. The existing rooftop elevation is 29 feet, and the rooftop itself is 40 feet by 21 feet in length and width. The new rooftop will be elevated to approximately 30 feet in height to match the future second level of the Boiler Building and will match the existing extent of the rooftop area. Amenities, such as a new guardrail, light fixtures, new signage displays, and site furnishings, will be installed. Diagrams 1 and 2 provide conceptual sketches of the rooftop viewing deck overlaid on photographs of the existing structure.

The Project includes several shoreline trail access improvements (on-grade pathway and ramp, north beach pathway). The new on-grade pathway south of the plaza will be an accessible, crushed rock surfaced pedestrian trail (Figure 5, Diagram 1). Approximately 42 cubic yards of terraced rock wall (375 sf) will be placed to accommodate ADA-accessible slopes along this pathway. An existing stormwater outfall will be temporarily removed and reinstalled during this construction.

A new structural ADA-accessible ramp is designed to provide access to the new viewing deck and will be located behind the Boiler Building restroom annex on the northwest side of the rooftop (see Diagram 1). Several footings will be installed to support the viewing deck access ramp, ranging from 3.5 to 5.5 feet deep and requiring excavation of approximately 20 cubic yards of soil total. The ramp will connect to the new on-grade crushed gravel pathway that will lead down to the plaza, dock, and future south shoreline trail. The on-grade pathway will also lead uphill to a new granite step feature that connects to an existing uphill trail network. Construction of the upland trail will be completed with standard heavy equipment including small excavators, small bulldozer, dump truck, and similar equipment.

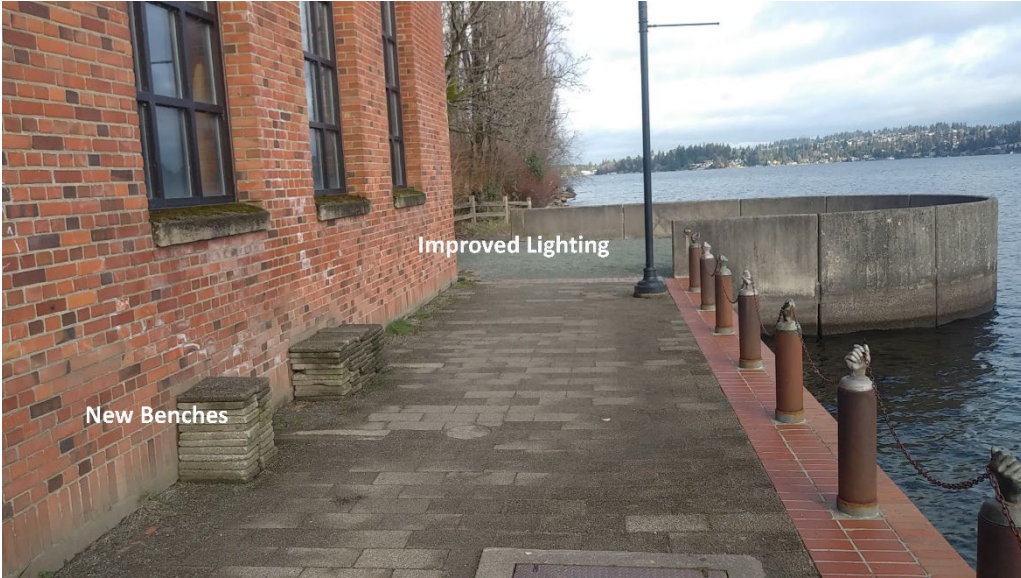
Diagram 3
Existing Plaza and East Side of Boiler Building with Approximate Locations of New Benches and Lighting (Looking North)

Plaza renovations for the Project include removing 5,205 sf of concrete pavers, brick pavers, concrete paving, and a small area of asphalt paving in front of the Boiler Building restroom annex under the breezeway (Figure 4). Approximately 2,595 sf of existing impervious surface will be replaced, including 2,015 sf of new concrete paving in the western portion of the plaza by the Boiler Building and 580 sf of gravel driveway paving (Figure 5). Approximately 2,410 sf of pervious pavers will be installed in the eastern part of the plaza (not included in impervious surface calculations). Two benches are proposed along the outside of Boiler Building in the plaza, and one picnic table is

proposed at southern end of the plaza. Diagrams 3 to 5 provide conceptual sketches of these improvements overlaid on photographs of existing conditions.

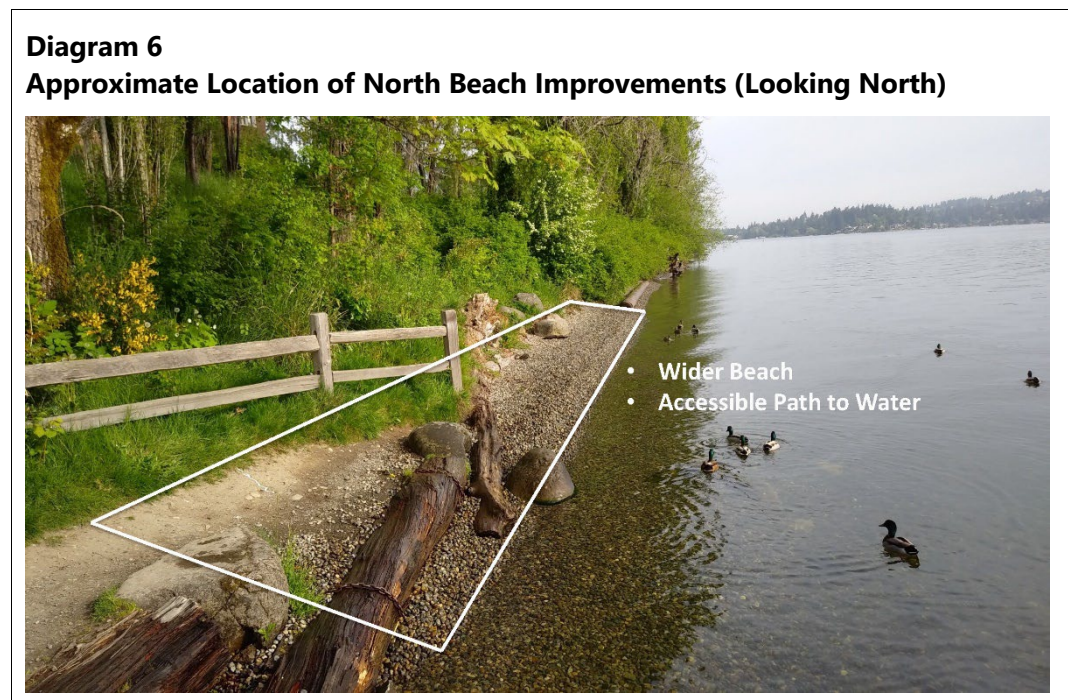
Diagram 6 provides a photograph of the existing north beach with the approximate location of nearshore habitat enhancements labeled.

In addition to improving public access and safety, the design includes shoreline and beach enhancements (Figure 5). The Project will expand the north beach by placing fish habitat gravel landward of the upland edge of the existing beach, relocate boulders and LWD along the shoreline, and enhance riparian vegetation. The beach expansion includes placing 45 cubic yards of habitat gravel and cobble underlayment (605 square feet) and relocating intermittent boulders and LWD along the existing beach and riparian buffer area. The expanded beach and riparian area will maintain nearshore habitat functions. The planting plan to replace removed riparian vegetation and trees is described in Section 3.3.

Habitat gravel will consist of naturally rounded material that complies with WDFW grain size criteria for Lake Washington. Gravel depth is a maximum of 2- to 3-foot thickness on the landward side, tapering on the waterward toe of placement (see sections in Figure 6). The material will be placed from the upland or by barge using a conveyor (e.g., telebelt or similar) to place the material precisely and evenly. All materials will be sourced from an approved off-site distributor.

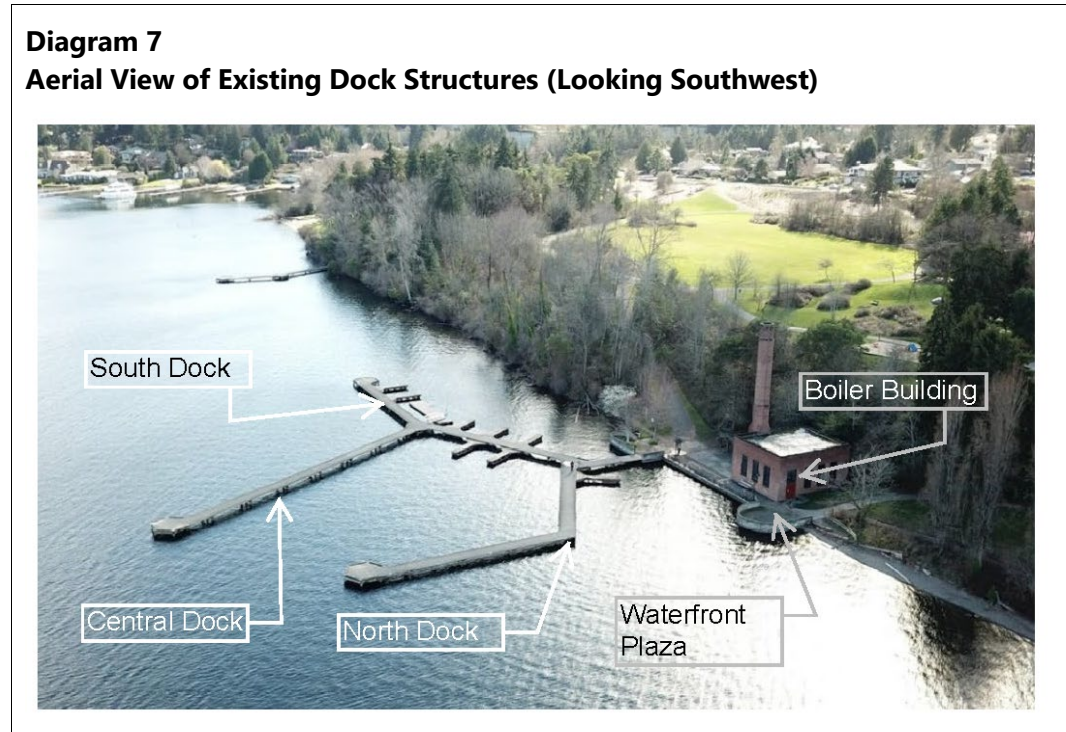
The in-water and overwater Project elements are described in this section and shown in Figures 3, 4, and 7 through 12. Diagram 7 shows an aerial overview of the existing dock structures.

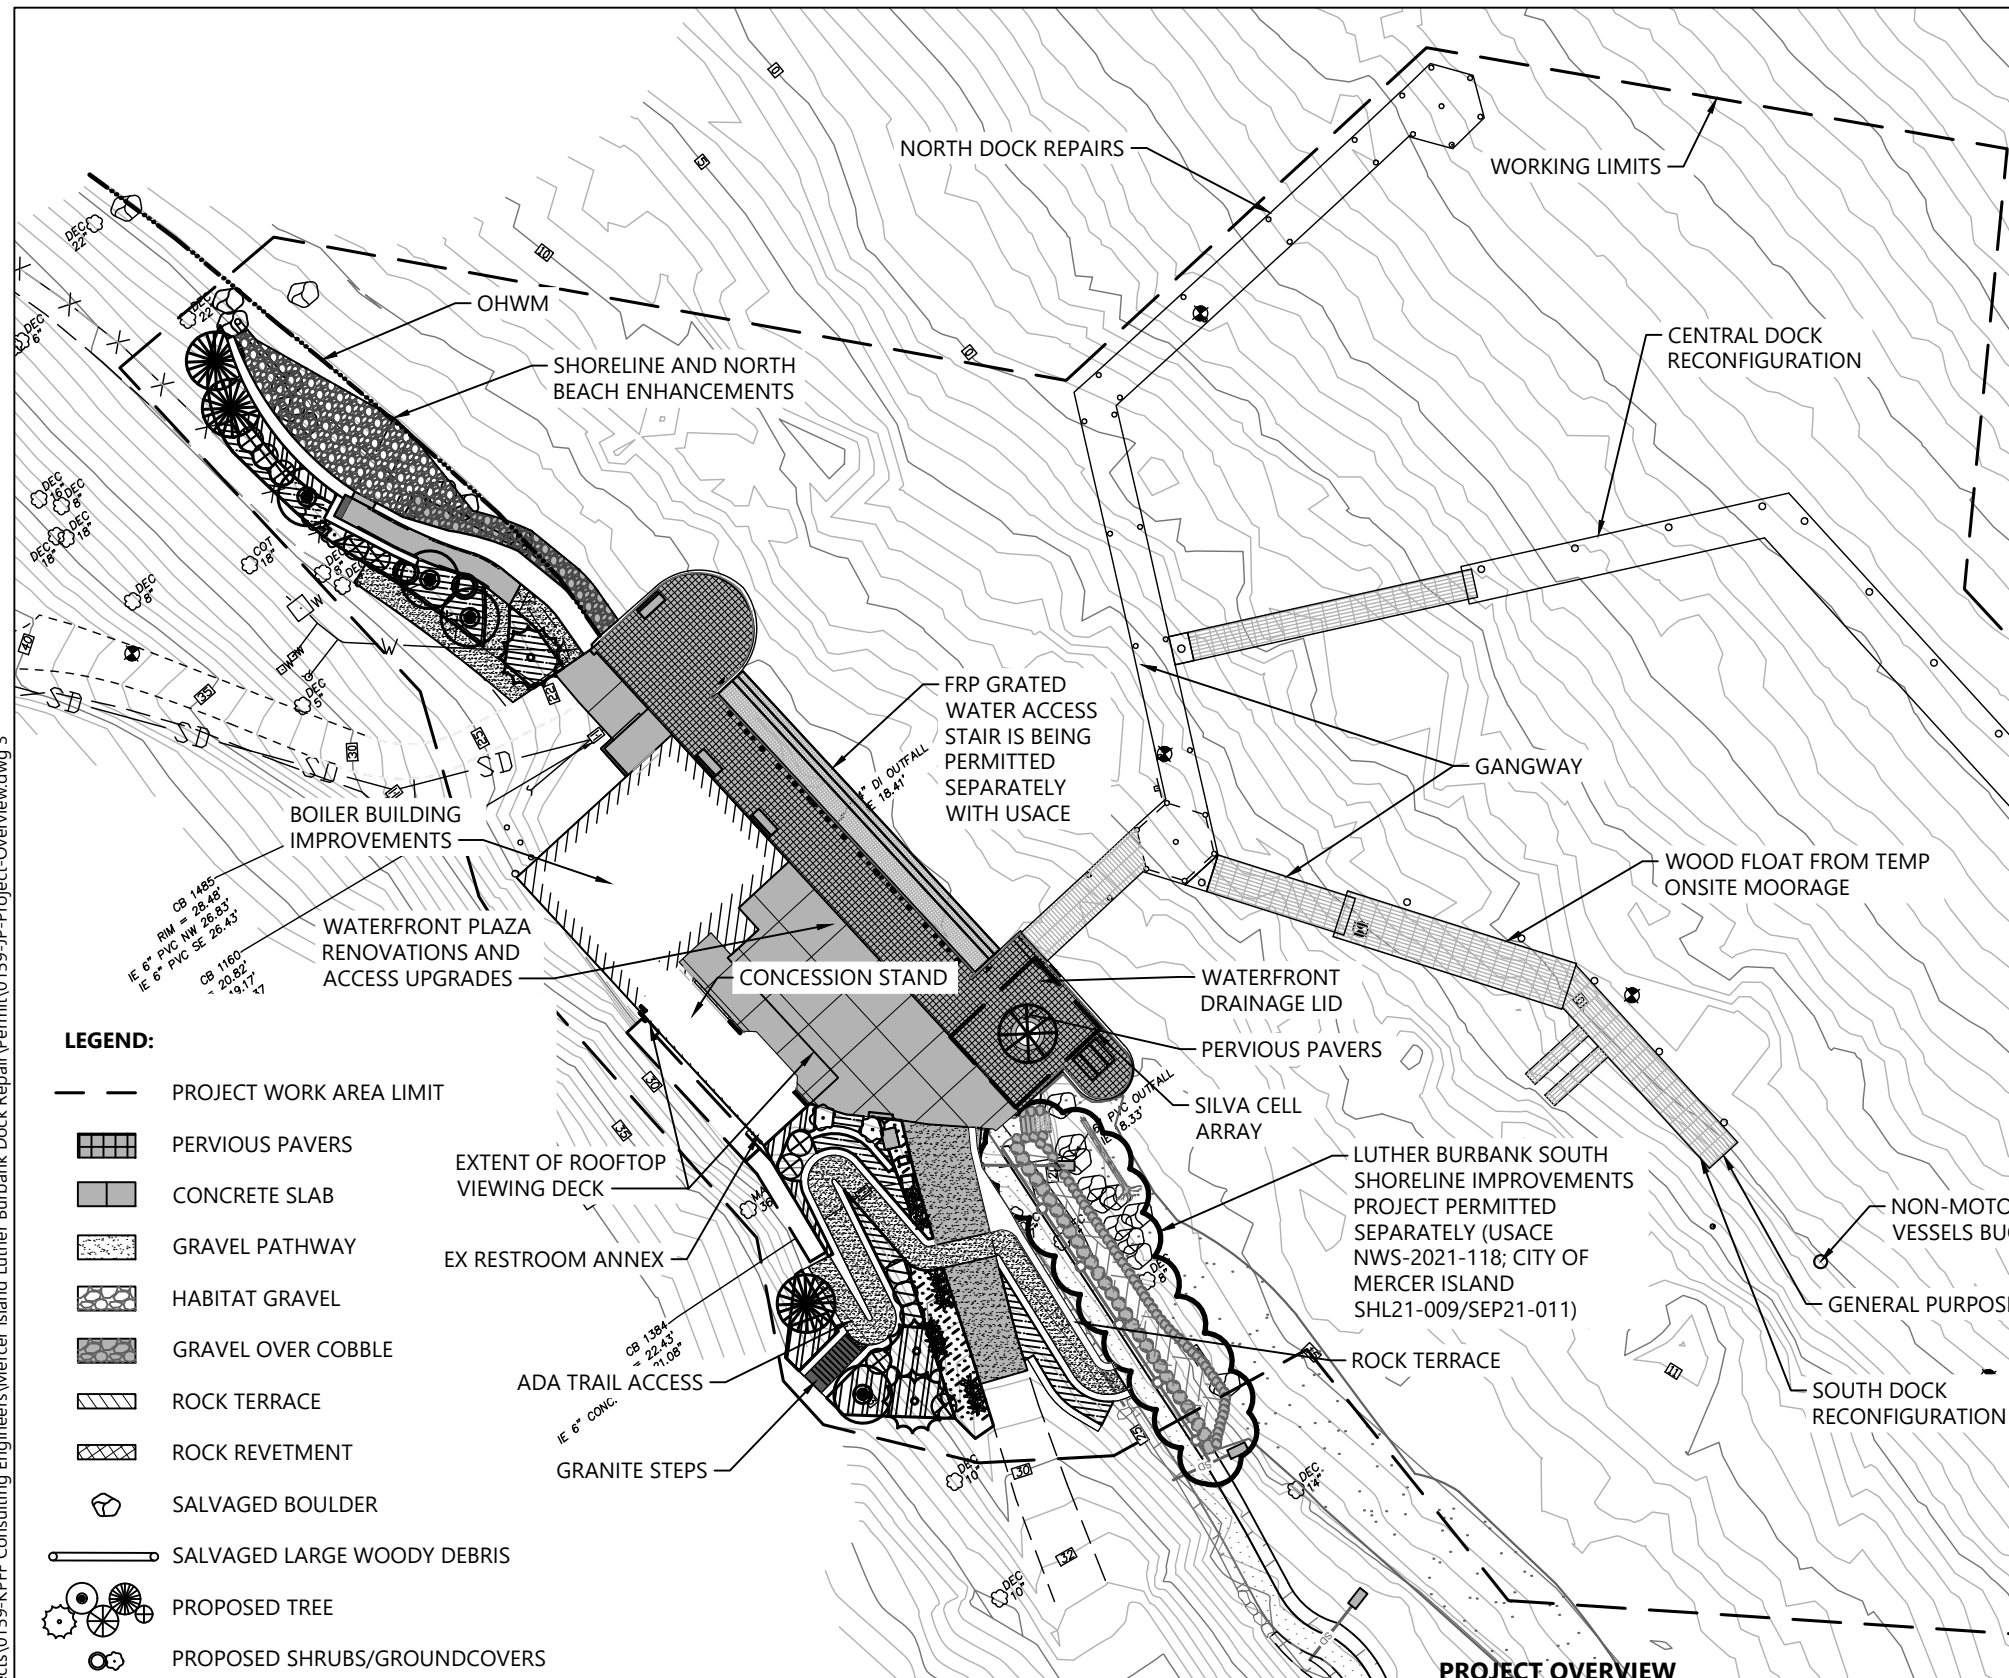
IN-WATER AND OVERWATER WORK SUMMARY				
PROJECT PORTION	ELEMENT	FEATURES REMOVED	FEATURES REPLACED	NET CHANGE
NORTH DOCK REPAIRS	IN-WATER PILES	ONE 12- TO 14-INCH CREOSOTE- TREATED TIMBER PILES	NOT APPLICABLE	NET DECREASE OF 1 IN-WATER PILE
	OVERWATER COVER	APPROXIMATELY 355 SF OF OVERWATER COVER (235 SF OF EXISTING CONCRETE DOCK; 120 SF OF ONE WOOD FINGER DOCK)	235 SF FRP GRATING	NET DECREASE OF 120 SF OVERWATER COVER
CENTRAL DOCK RECONFIGURATION	IN-WATER PILES	APPROXIMATELY TWENTY-SIX 12- TO 14-INCH CREOSOTE-TREATED TIMBER PILES	APPROXIMATELY 17 PILES (SIXTEEN 24-INCH STEEL PILES; ONE 16-INCH STEEL PILE)	NET DECREASE OF 9 IN-WATER PILES
	OVERWATER COVER	APPROXIMATELY 1,500 SF FIXED CONCRETE DOCK	APPROXIMATELY 3,160 SF OF NEW OVERWATER COVER (2,610 SF OF WAVE ATTENUATOR FLOAT, 175 SF OF TWO GRATED FINGER FLOATS, 375 SF OF GRATED GANGWAY)	NET INCREASE OF 1,660 SF OF OVERWATER COVER
SOUTH DOCK RECONFIGURATION	IN-WATER PILES	APPROXIMATELY 42 PILES (FORTY 12- TO 14-INCH CREOSOTE-TREATED TIMBER PILES; TWO 16-INCH CONCRETE ENCAPSULATED PILES)	APPROXIMATELY SIX 16-INCH STEEL PILES	NET DECREASE OF 36 IN-WATER PILES

OVERWATER COVER	APPROXIMATELY 2,810 SF EXISTING COVER (1,930 SF OF FIXED CONCRETE DOCK; 40 SF OF ALUMINUM RAMP; SEVEN 120-SF WOOD FINGER DOCKS)	APPROXIMATELY 713 SF OF NEW OVERWATER COVER (380 SF OF GENERAL-PURPOSE FLOAT, 90 SF OF 2 GRATED FINGER FLOATS, 225 SF OF GRATED GANGWAY, 18 SF OF CONCRETE GANGWAY ABUTMENT)	NET DECREASE OF 2,097 SF OF OVERWATER COVER
PUBLIC ACCESS STAIRS	IN-WATER PILES	NOT APPLICABLE	APPROXIMATELY 6 PIN PILES (6-INCH STEEL PILES)	NET INCREASE OF 6 IN-WATER PILES
	OVERWATER COVER	NOT APPLICABLE	APPROXIMATELY 552 SF OF GRATED OVERWATER COVER	NET INCREASE OF 552 SF OF OVERWATER COVER
TOTAL	IN-WATER PILES	APPROXIMATELY 69 PILES REMOVED	APPROXIMATELY 29 PILES INSTALLED	NET DECREASE OF 40 IN-WATER PILES
	OVERWATER COVER	APPROXIMATELY 4,665 SF OF EXISTING COVER REMOVED	APPROXIMATELY 4,660 SF OF NEW OVERWATER COVER INSTALLED	NET DECREASE OF APPROXIMATELY 5 SF OF OVERWATER COVER

The Project includes upland, shoreline, in-water, and overwater work along Lake Washington. Figure 3 provides an overview of the project components, and Figure 4 provides a demolition plan. Project details and construction methods are described in the following subsections.

The central dock is a fixed concrete structure (Figure 3). The existing dock will be entirely removed (Figure 4) and replaced in a new configuration.

The Project includes a new grated overwater platform as part of the goal to improve access to the waterfront (Figure 3). Portions of the “Handsome Bollards” chain will be removed to allow the public past the art feature and onto the platform where they can access the lake at water level. The platform will only provide access to the ordinary high water level and will not descend to the beach substrate. The platform will attach to the existing concrete bulkhead at the plaza as an overwater feature and will be of FRP grating material. The platform is being permitted separately with the U.S. Army Corps of Engineers but will be incorporated with the Project for other permit agencies.

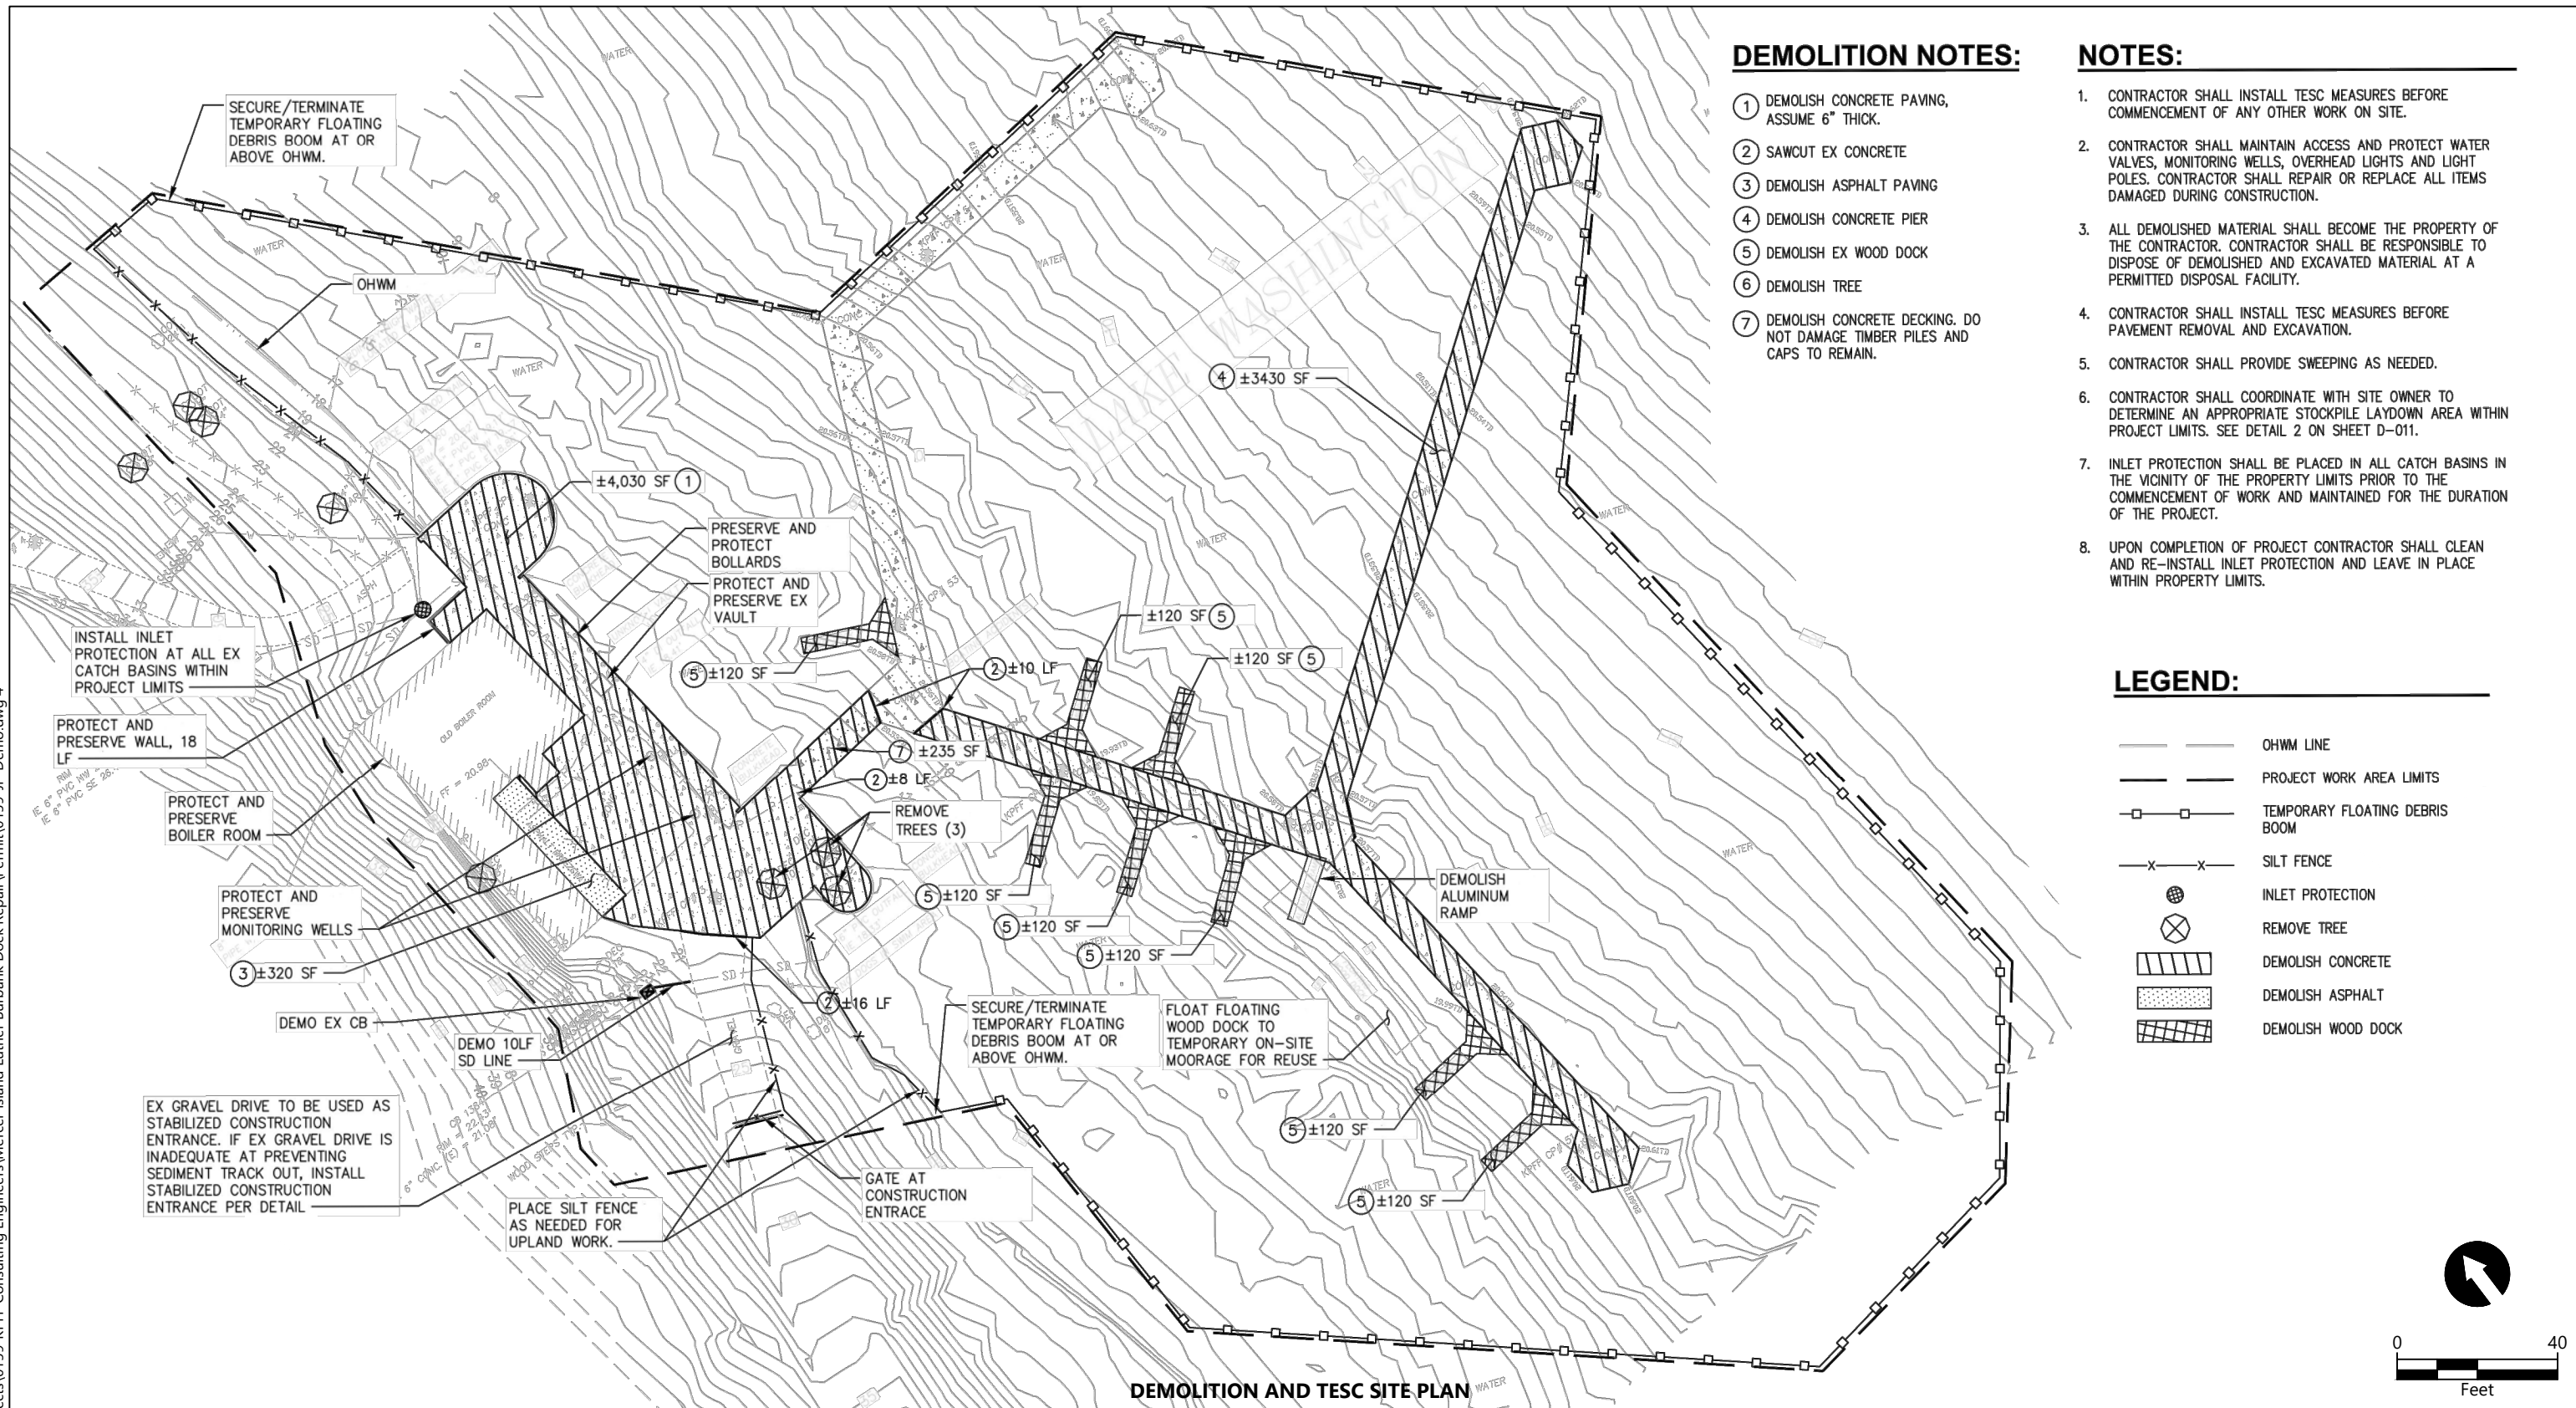
- ① DEMOLISH CONCRETE PAVING, ASSUME 6" THICK.
- ② SAWCUT EX CONCRETE
- ③ DEMOLISH ASPHALT PAVING
- ④ DEMOLISH CONCRETE PIER
- ⑤ DEMOLISH EX WOOD DOCK
- ⑥ DEMOLISH TREE
- ⑦ DEMOLISH CONCRETE DECKING. DO NOT DAMAGE TIMBER PILES AND CAPS TO REMAIN.

The Project proposes to retain and repair the northernmost segment of the dock (approximately 188 feet long and 8 feet wide; Figures 7 and 8). Approximately 235 sf of the existing concrete dock connecting to the waterfront plaza will be removed and replaced with fiberglass-reinforced plastic (FRP) grating. Approximately 120 sf of an existing wood finger dock will be removed (Figure 4).

The south dock is a fixed concrete structure that will be removed (Figure 4) and replaced in a new configuration.

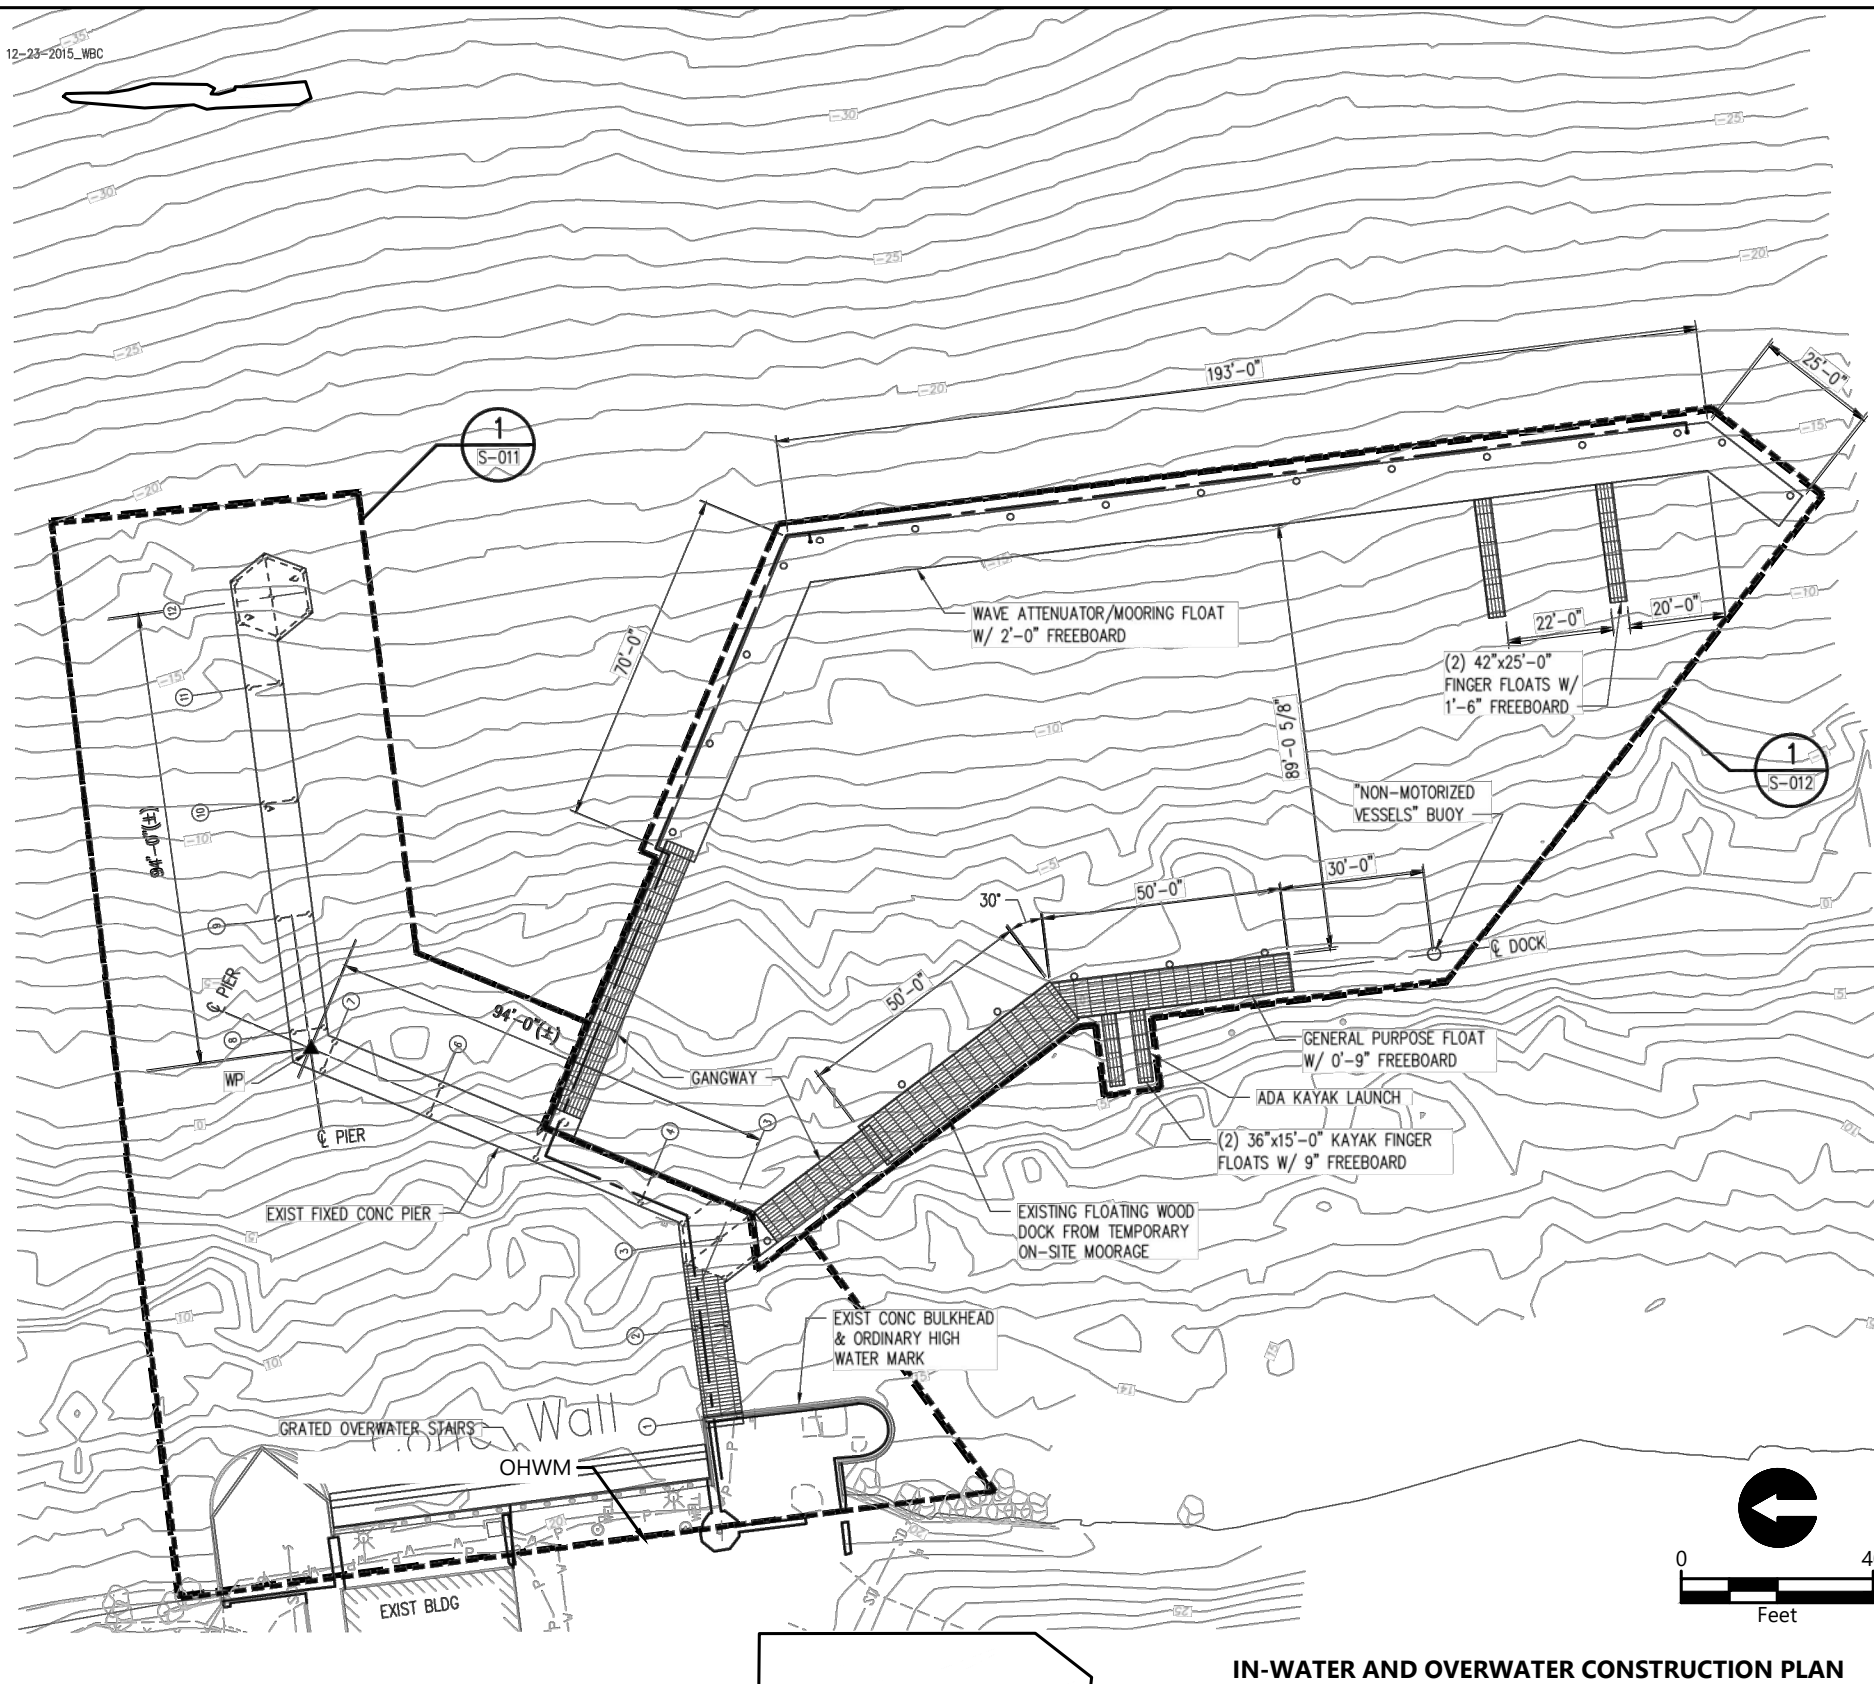
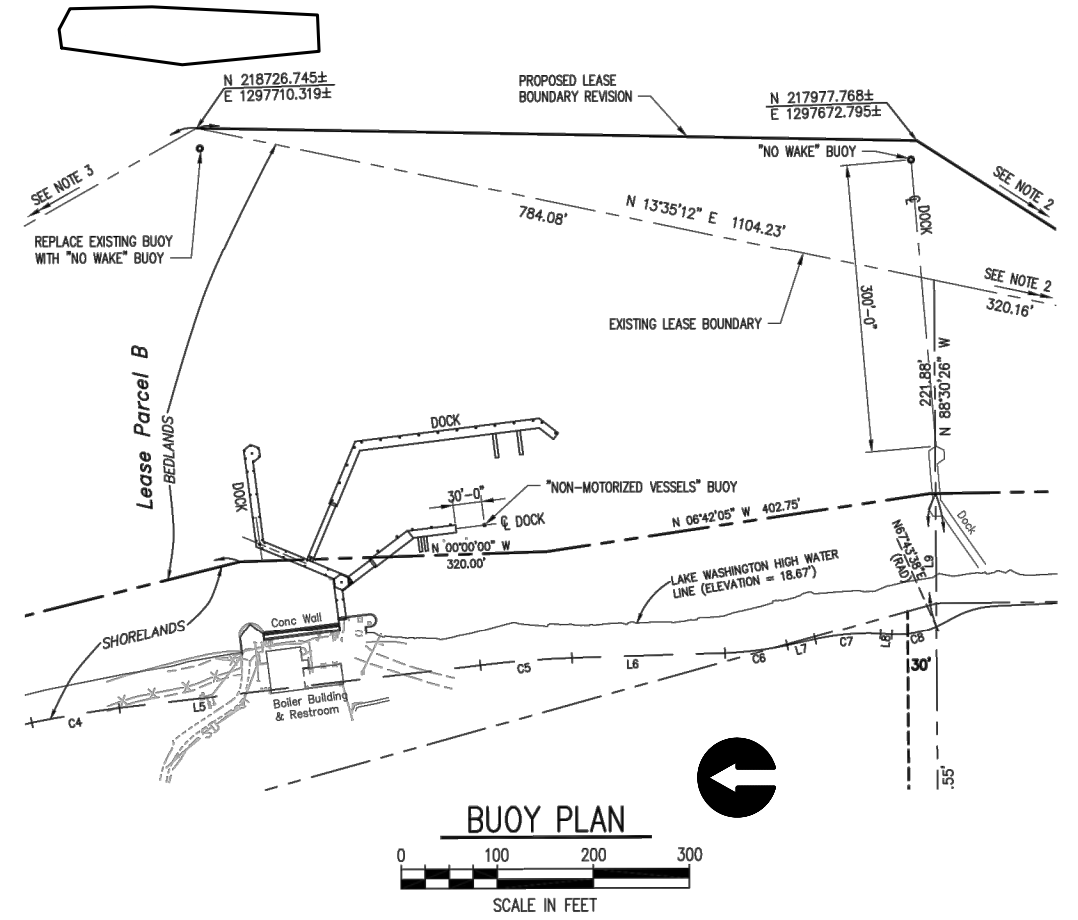
IN-WATER AND OVERWATER CONSTRUCTION PLAN

1. PROPOSED IMPROVEMENTS OVERWATER COVERAGE: ±4425 SF.
2. EXTENDS TO EXISTING BOUNDARY CORNER AT N 217653.411, E 1297450.919.
3. EXTENDS TO EXISTING BOUNDARY CORNER AT N 220320.192, E 1296873.931.

The reconfigured central dock will include a wave attenuator/mooring float attached to the existing fixed concrete dock by an ADA-compliant grated gangway (Figure 7). The wave attenuator/mooring float will be 10 feet wide with 2 feet of freeboard. To provide adequate wave attenuation, the float material will be concrete, with light penetration options where possible. The bulk of the structure is located as far off shore as practical in approximately 36 to 38 feet of water to reduce the effect of shading on the lake bottom. The float will attach to 16 new steel piles (24-inch diameter; Figures 10 and 11). Attached to the inside of the wave attenuator/mooring float will be two new grated finger floats, each 25 feet long with 1.5 feet of freeboard (Figure 7). Elevation and section views of the central dock are provided in Figures 10 and 11.

To reduce the risks created by passing vessels, the City will replace one buoy and add two new buoys in the lake. Two will be “no wake” buoys located east and southeast of the docks, and one will be a “nonmotorized vessel” buoy located near the south dock (Figure 7).

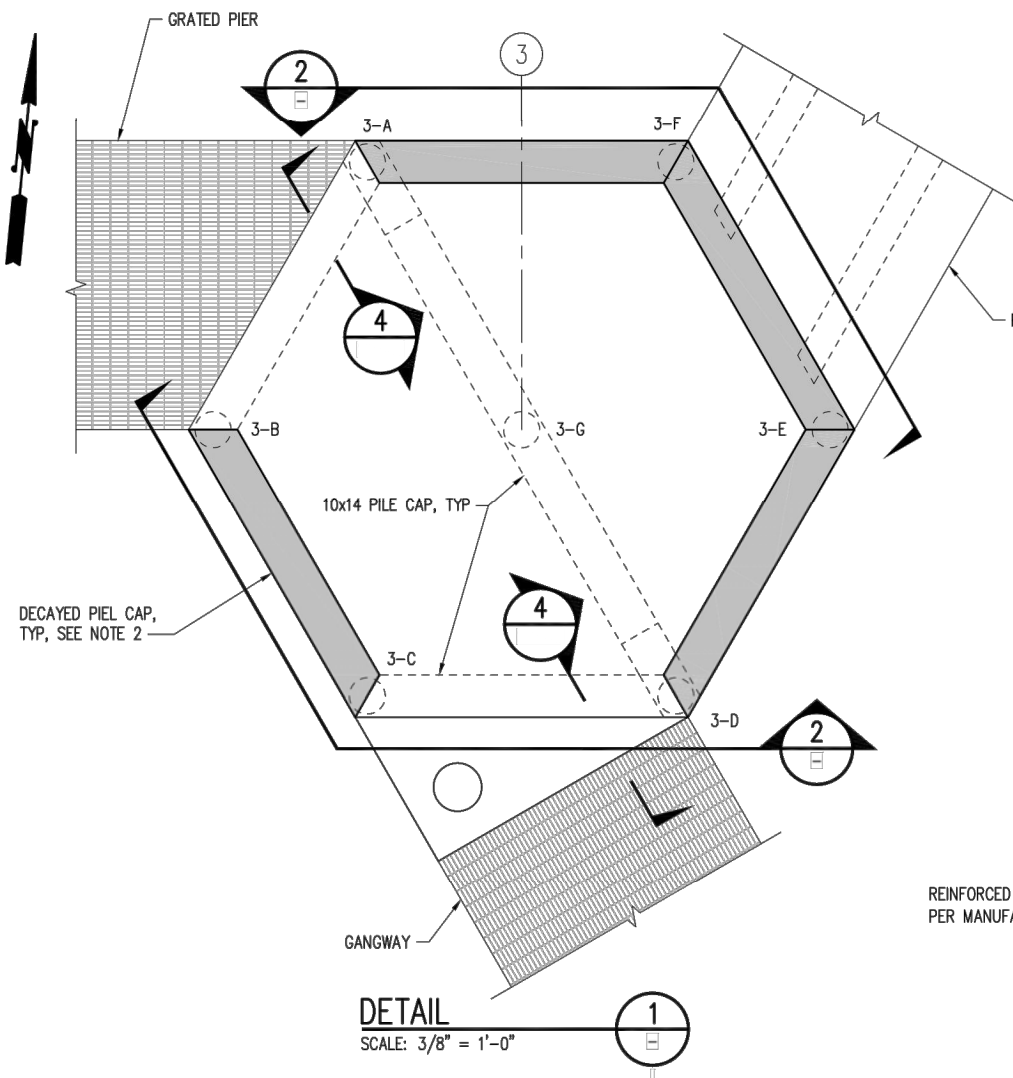
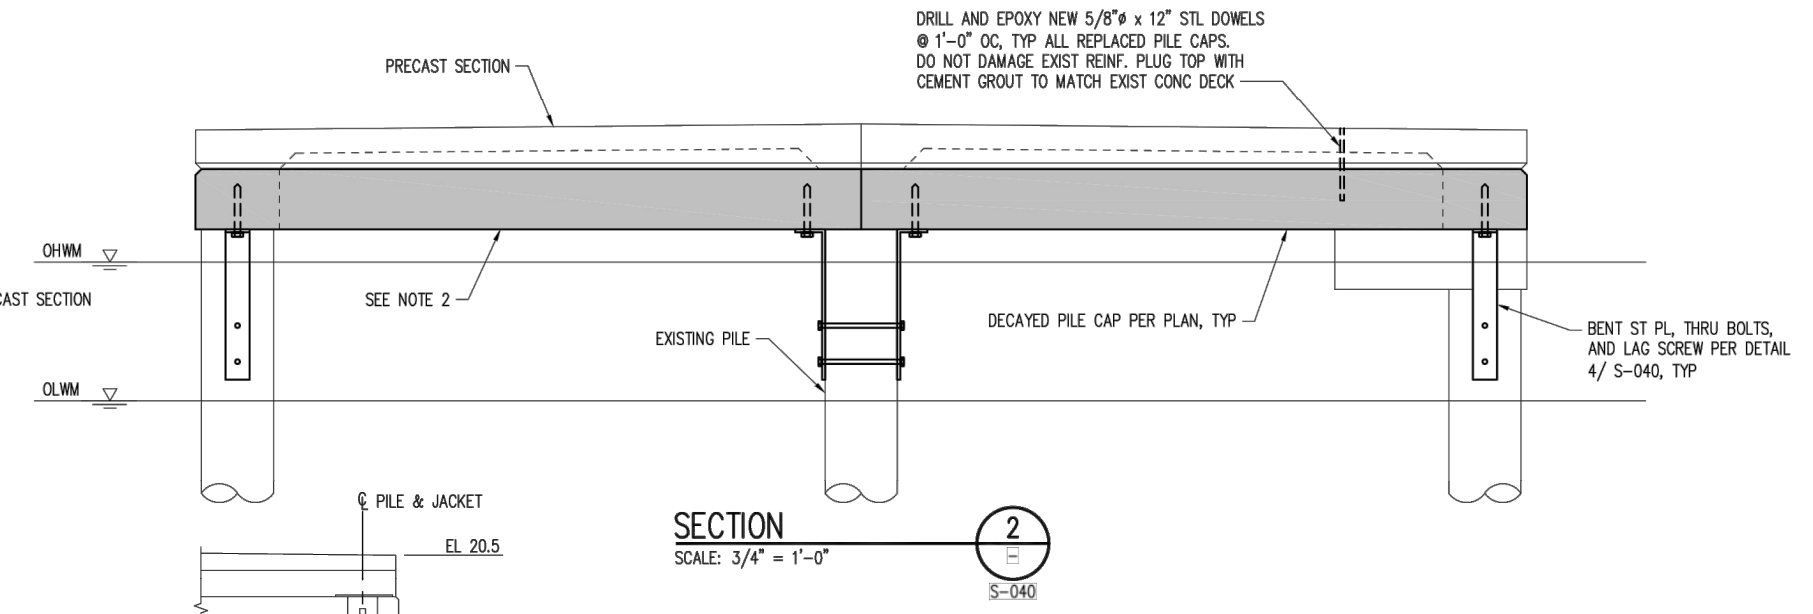
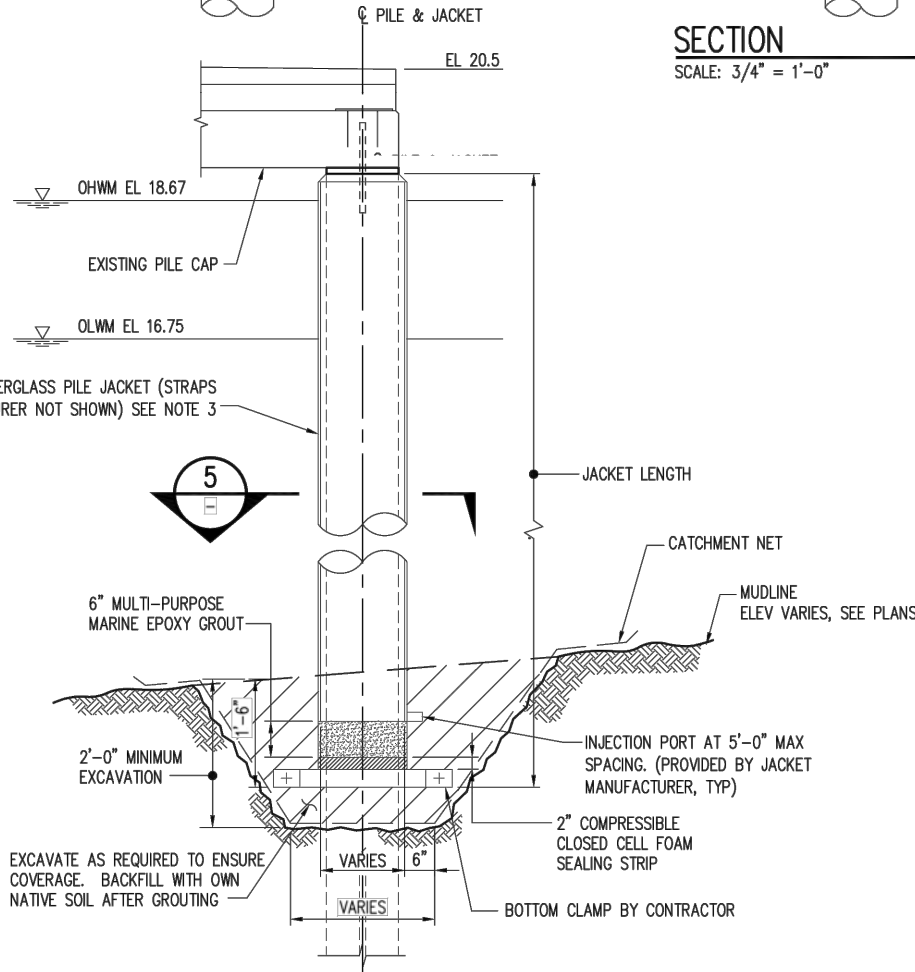
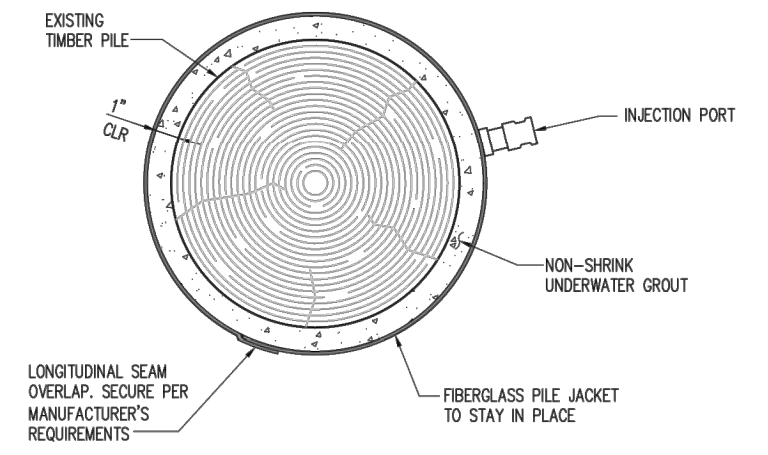
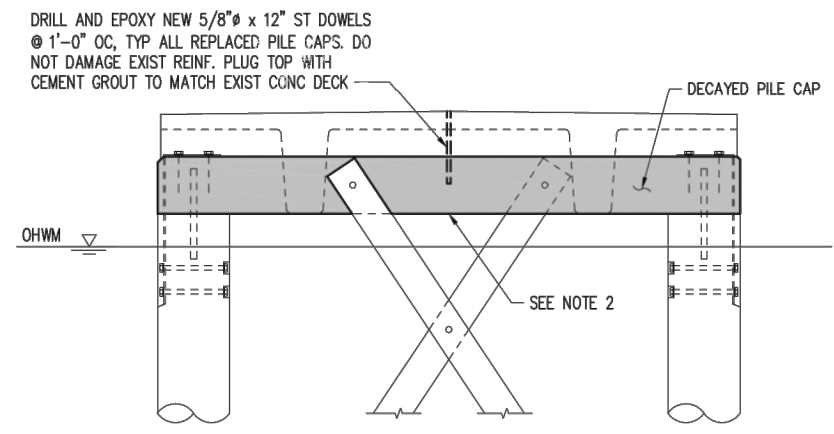
- NOTES:**
- SEE DRAWINGS S-030 THRU S-032 FOR EXISTING CONDITIONS.
 - EXTRACT DECAYED PILE CAPS FULL LENGTH WITHOUT DAMAGING EXISTING CONC DECK AND TIMBER PILES, AND REPLACE WITH TREATED 10x14 TIMBERS. REPLACE CONNECTING HARDWARE SHOWN IN EXISTING CONDITIONS UNO.
 - PLACE JACKETS AROUND ALL (38) PILES, INCLUDING PILES REPAIRED PER DETAIL 6/S-040.

As part of the north dock repairs, 38 creosote-treated timber piles will be wrapped with fiberglass jackets (Figure 8). The area around the bottom of each pile will be excavated a minimum of 2 feet deep to allow the jacket to be extended below the mudline. A marine epoxy grout will be injected between the pile and the jacket. The jackets will isolate the creosote-treated piles from the water to prevent further leaching of creosote into the water column, reducing a source of water pollution into the lake.
