October 2022
Luther Burbank Park Waterfront Improvements

Project Description

Prepared for City of Mercer Island

Prepared by
Anchor QEA, LLC
1201 3rd Avenue, Suite 2600
Seattle, Washington 98101

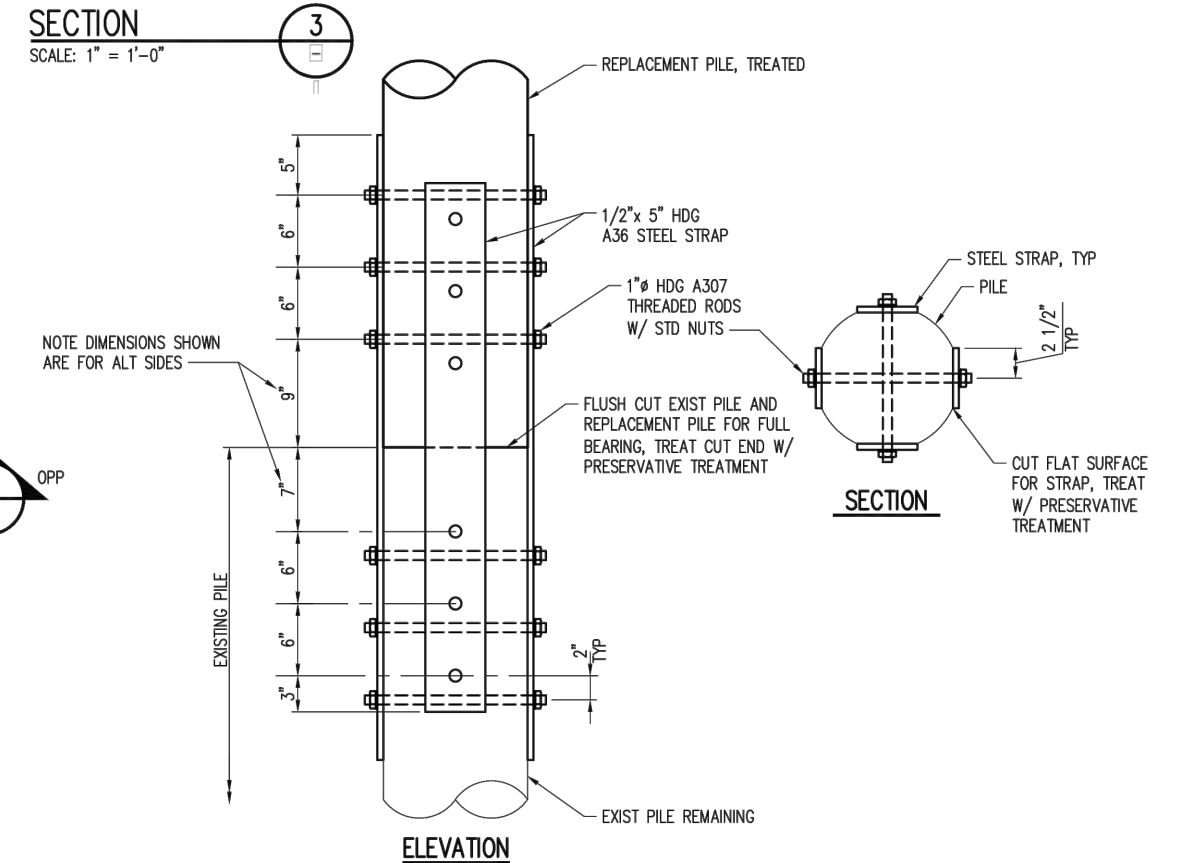
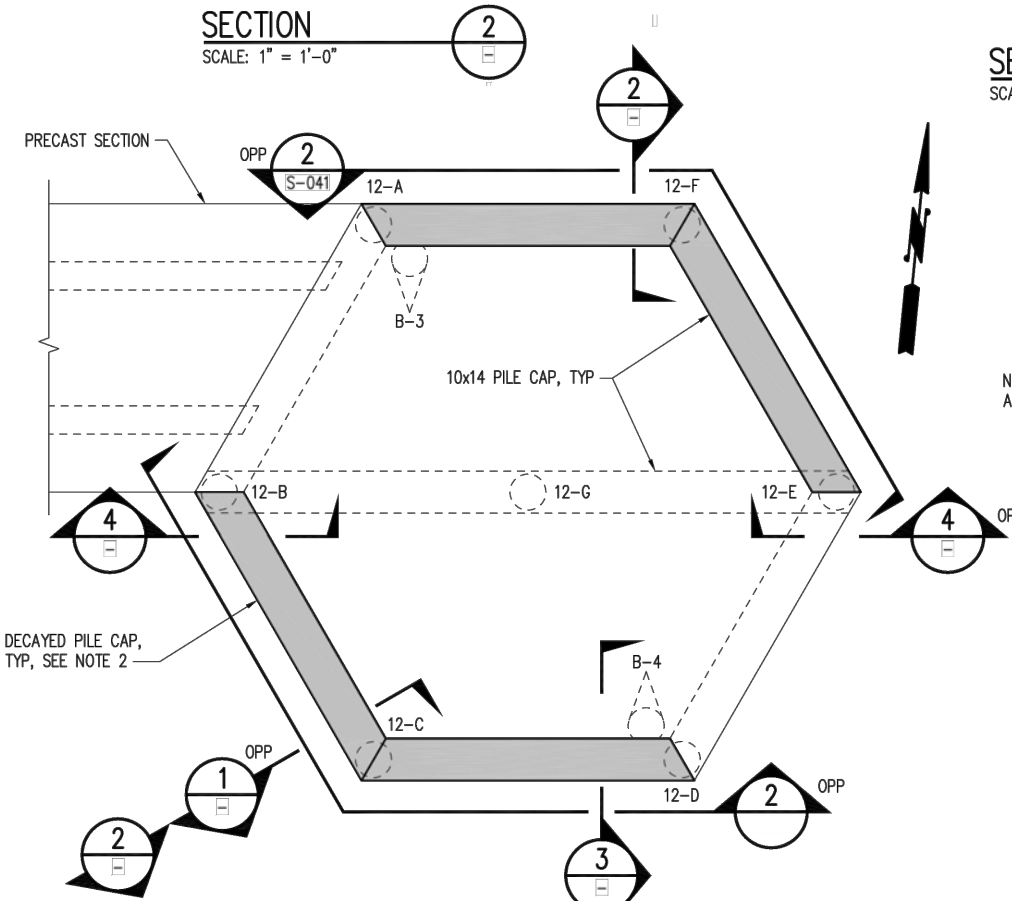
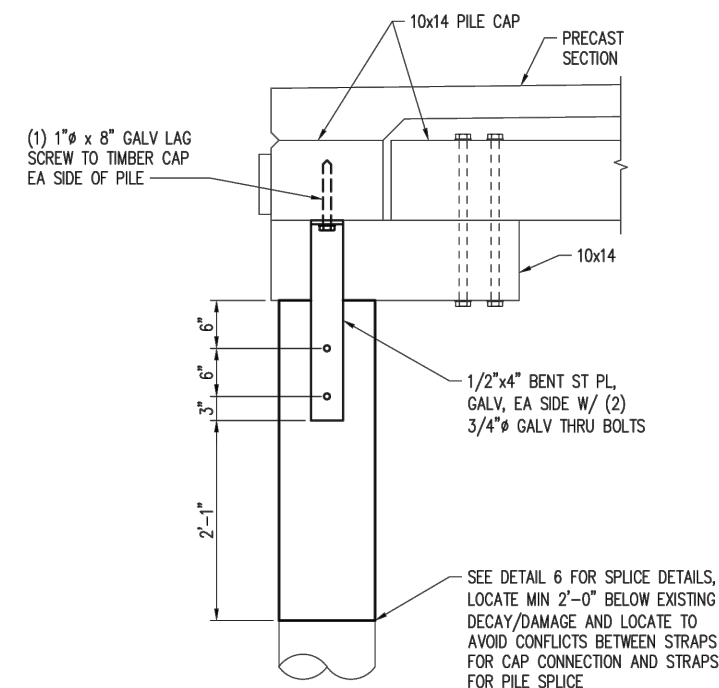
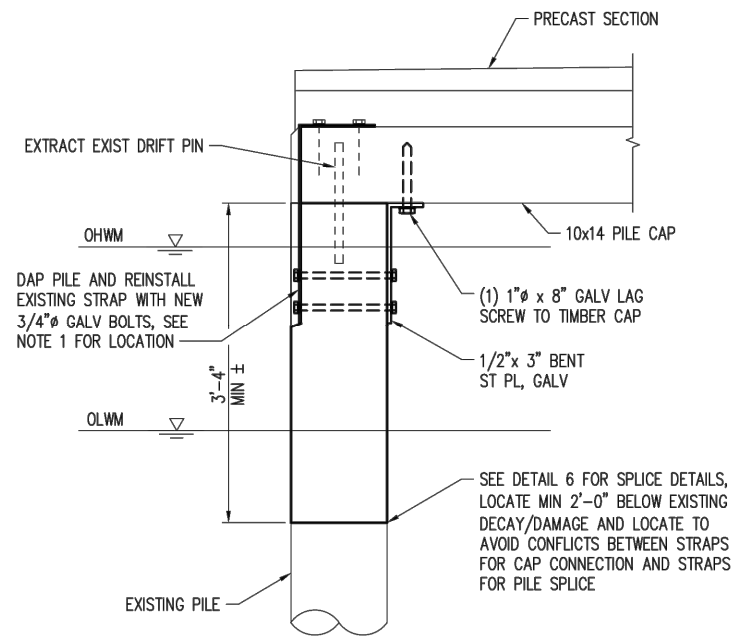
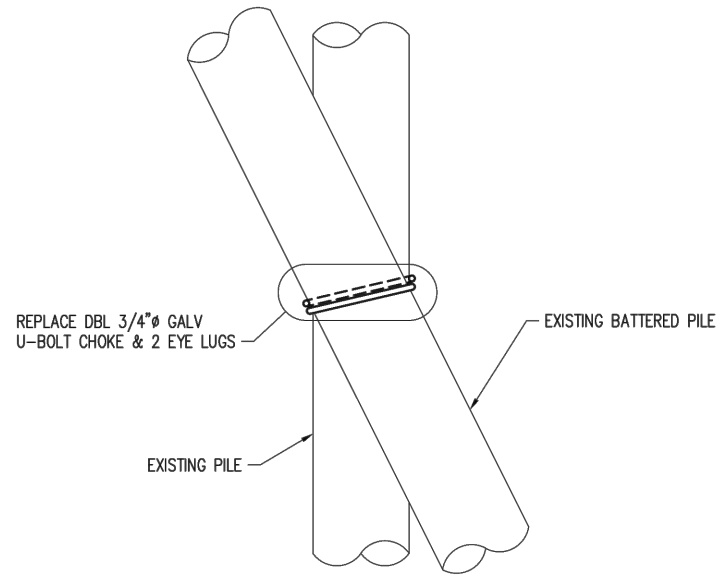
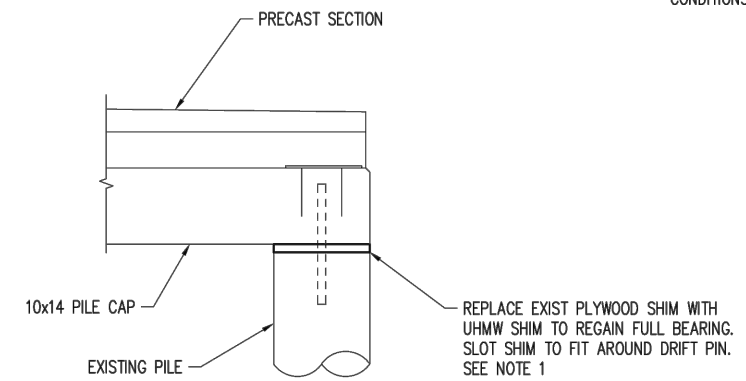
- SEE DRAWINGS S-030 THRU S-032 FOR EXISTING CONDITIONS.
- EXTRACT DECAYED PILE CAPS FULL LENGTH WITHOUT DAMAGING EXISTING CONC DECK AND TIMBER PILES, AND REPLACE WITH TREATED 10x14 TIMBERS. REPLACE CONNECTING HARDWARE SHOWN IN EXISTING CONDITIONS UNO.

Some timber piles supporting the north dock have decayed and need repair. The project includes removing and replacing the top portion of up to five decayed timber piles with ACZA-treated timber. The damaged portions of the pile will be cut away, and a new timber section will be attached to the remaining pile with steel straps (Figure 9).

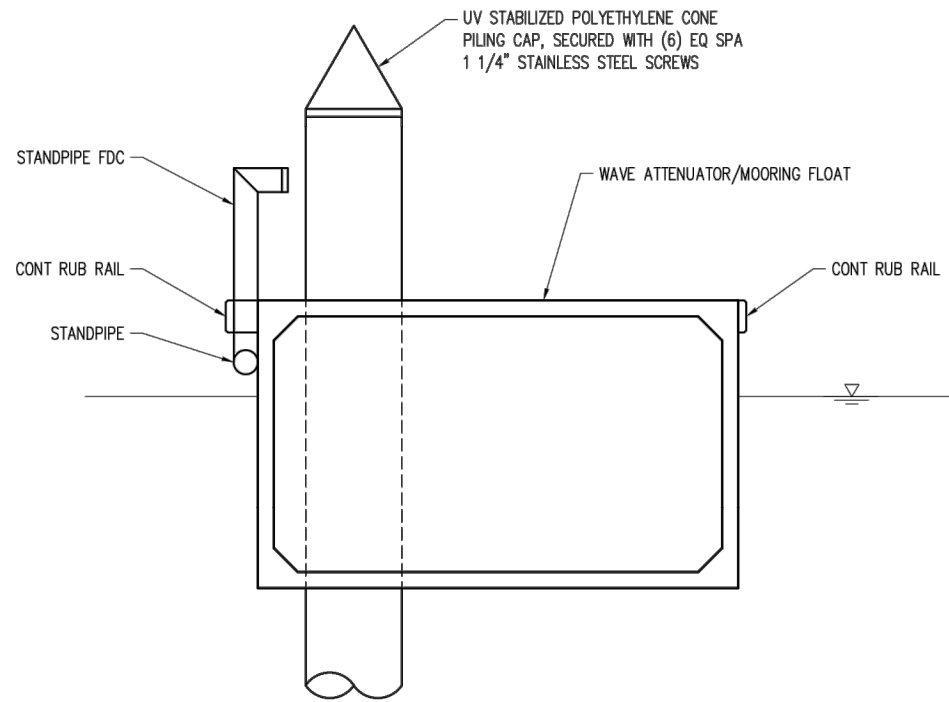
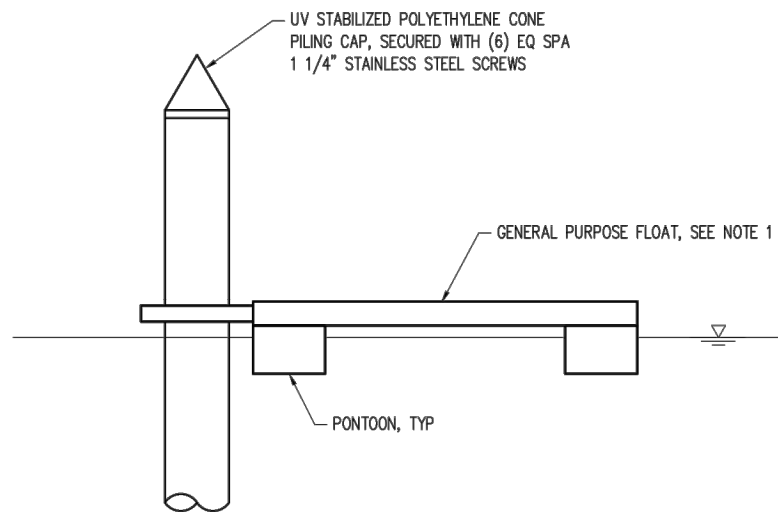
NOTE: 40% MINIMUM LIGHT TRANSMISSION IS REQUIRED

The reconfigured central dock will include a wave attenuator/mooring float attached to the existing fixed concrete dock by an ADA-compliant grated gangway (Figure 7). The wave attenuator/mooring float will be 10 feet wide with 2 feet of freeboard. To provide adequate wave attenuation, the float material will be concrete, with light penetration options where possible. The bulk of the structure is located as far off shore as practical in approximately 36 to 38 feet of water to reduce the effect of shading on the lake bottom. The float will attach to 16 new steel piles (24-inch diameter; Figures 10 and 11). Attached to the inside of the wave attenuator/mooring float will be two new grated finger floats, each 25 feet long with 1.5 feet of freeboard (Figure 7). Elevation and section views of the central dock are provided in Figures 10 and 11.
