April 2023  
Luther Burbank Park Waterfront Improvements

# Critical Areas Study

Prepared for City of Mercer Island

# LUTHER BURBANK PARK COMPREHENSIVE WATERFRONT IMPROVEMENTS CITY OF MERCER ISLAND PUBLIC WORKS DEPARTMENT

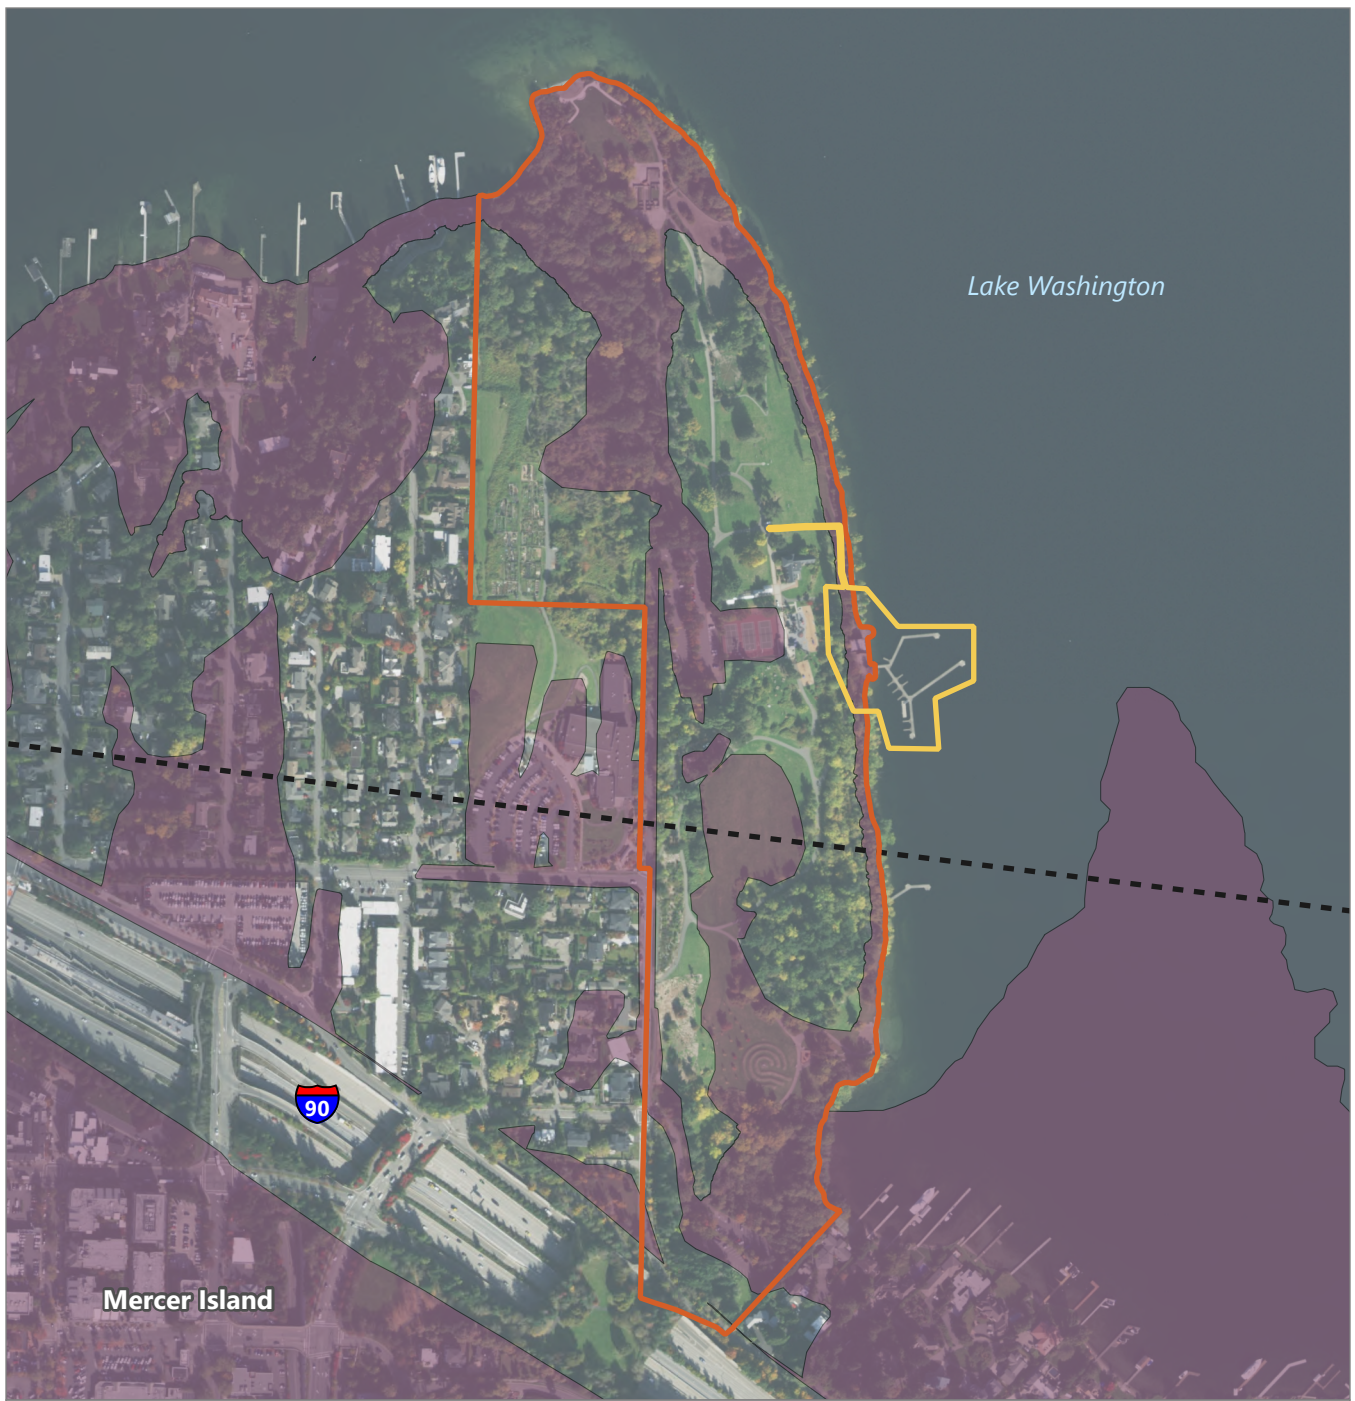
- Project Area
- Park Boundary
- Seismic Hazard Area
- Fault Line (Seattle Fault Zone)

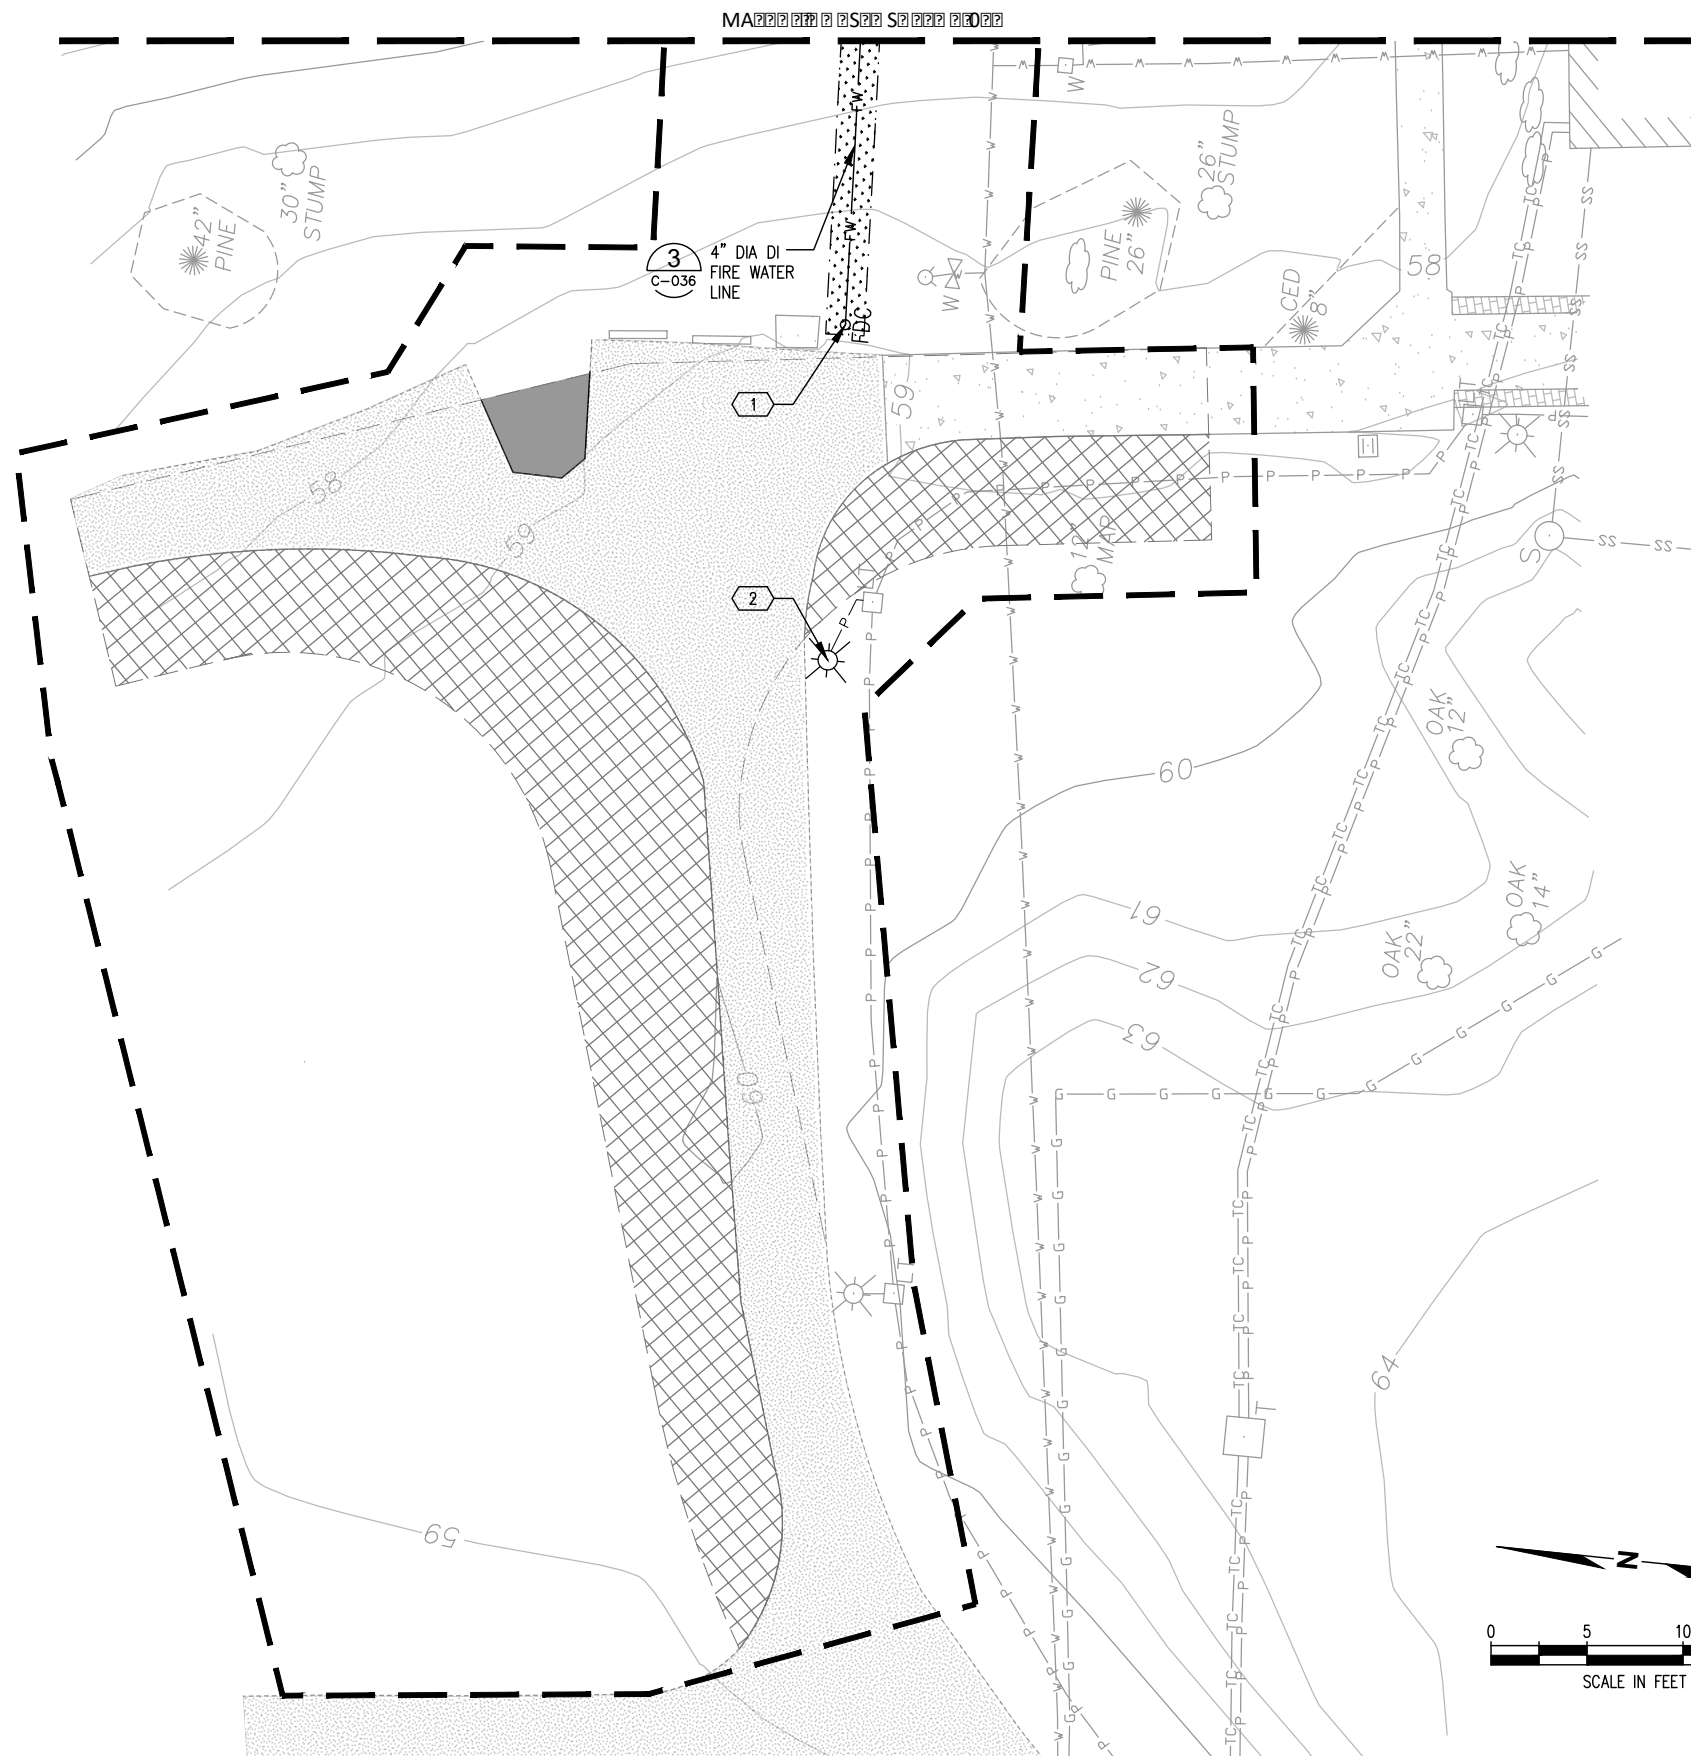
- 1 FDC ASSEMBLY C-035
- 2 REINSTALL LIGHT POLE, FOUNDATION PER STRUCTURAL
- 3 4" DIA DI FIRE WATER LINE C-036

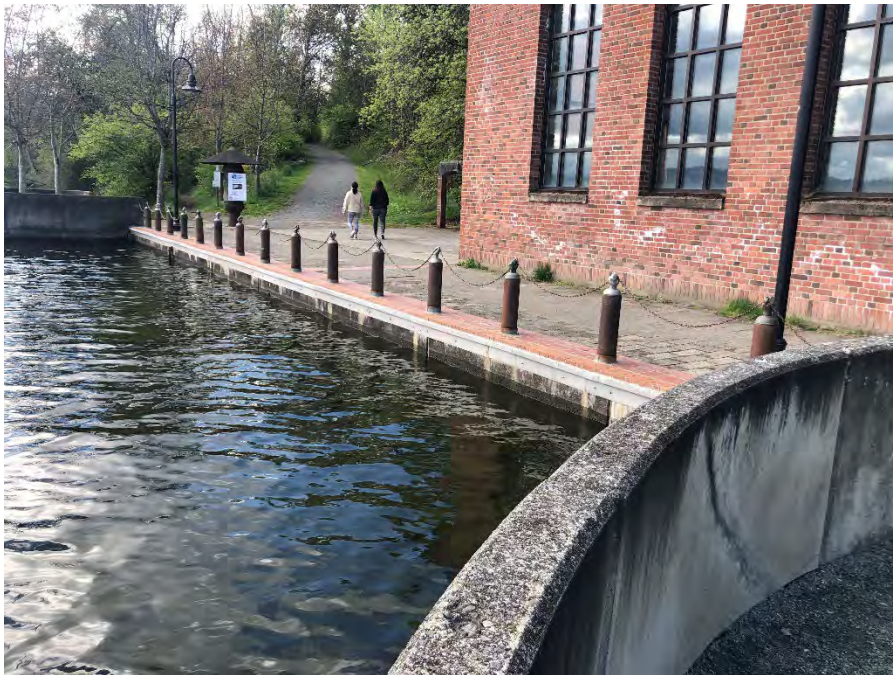
Photograph 4. Handsome Bollards chain and existing bulkhead in front of Boiler Building (April 2021).

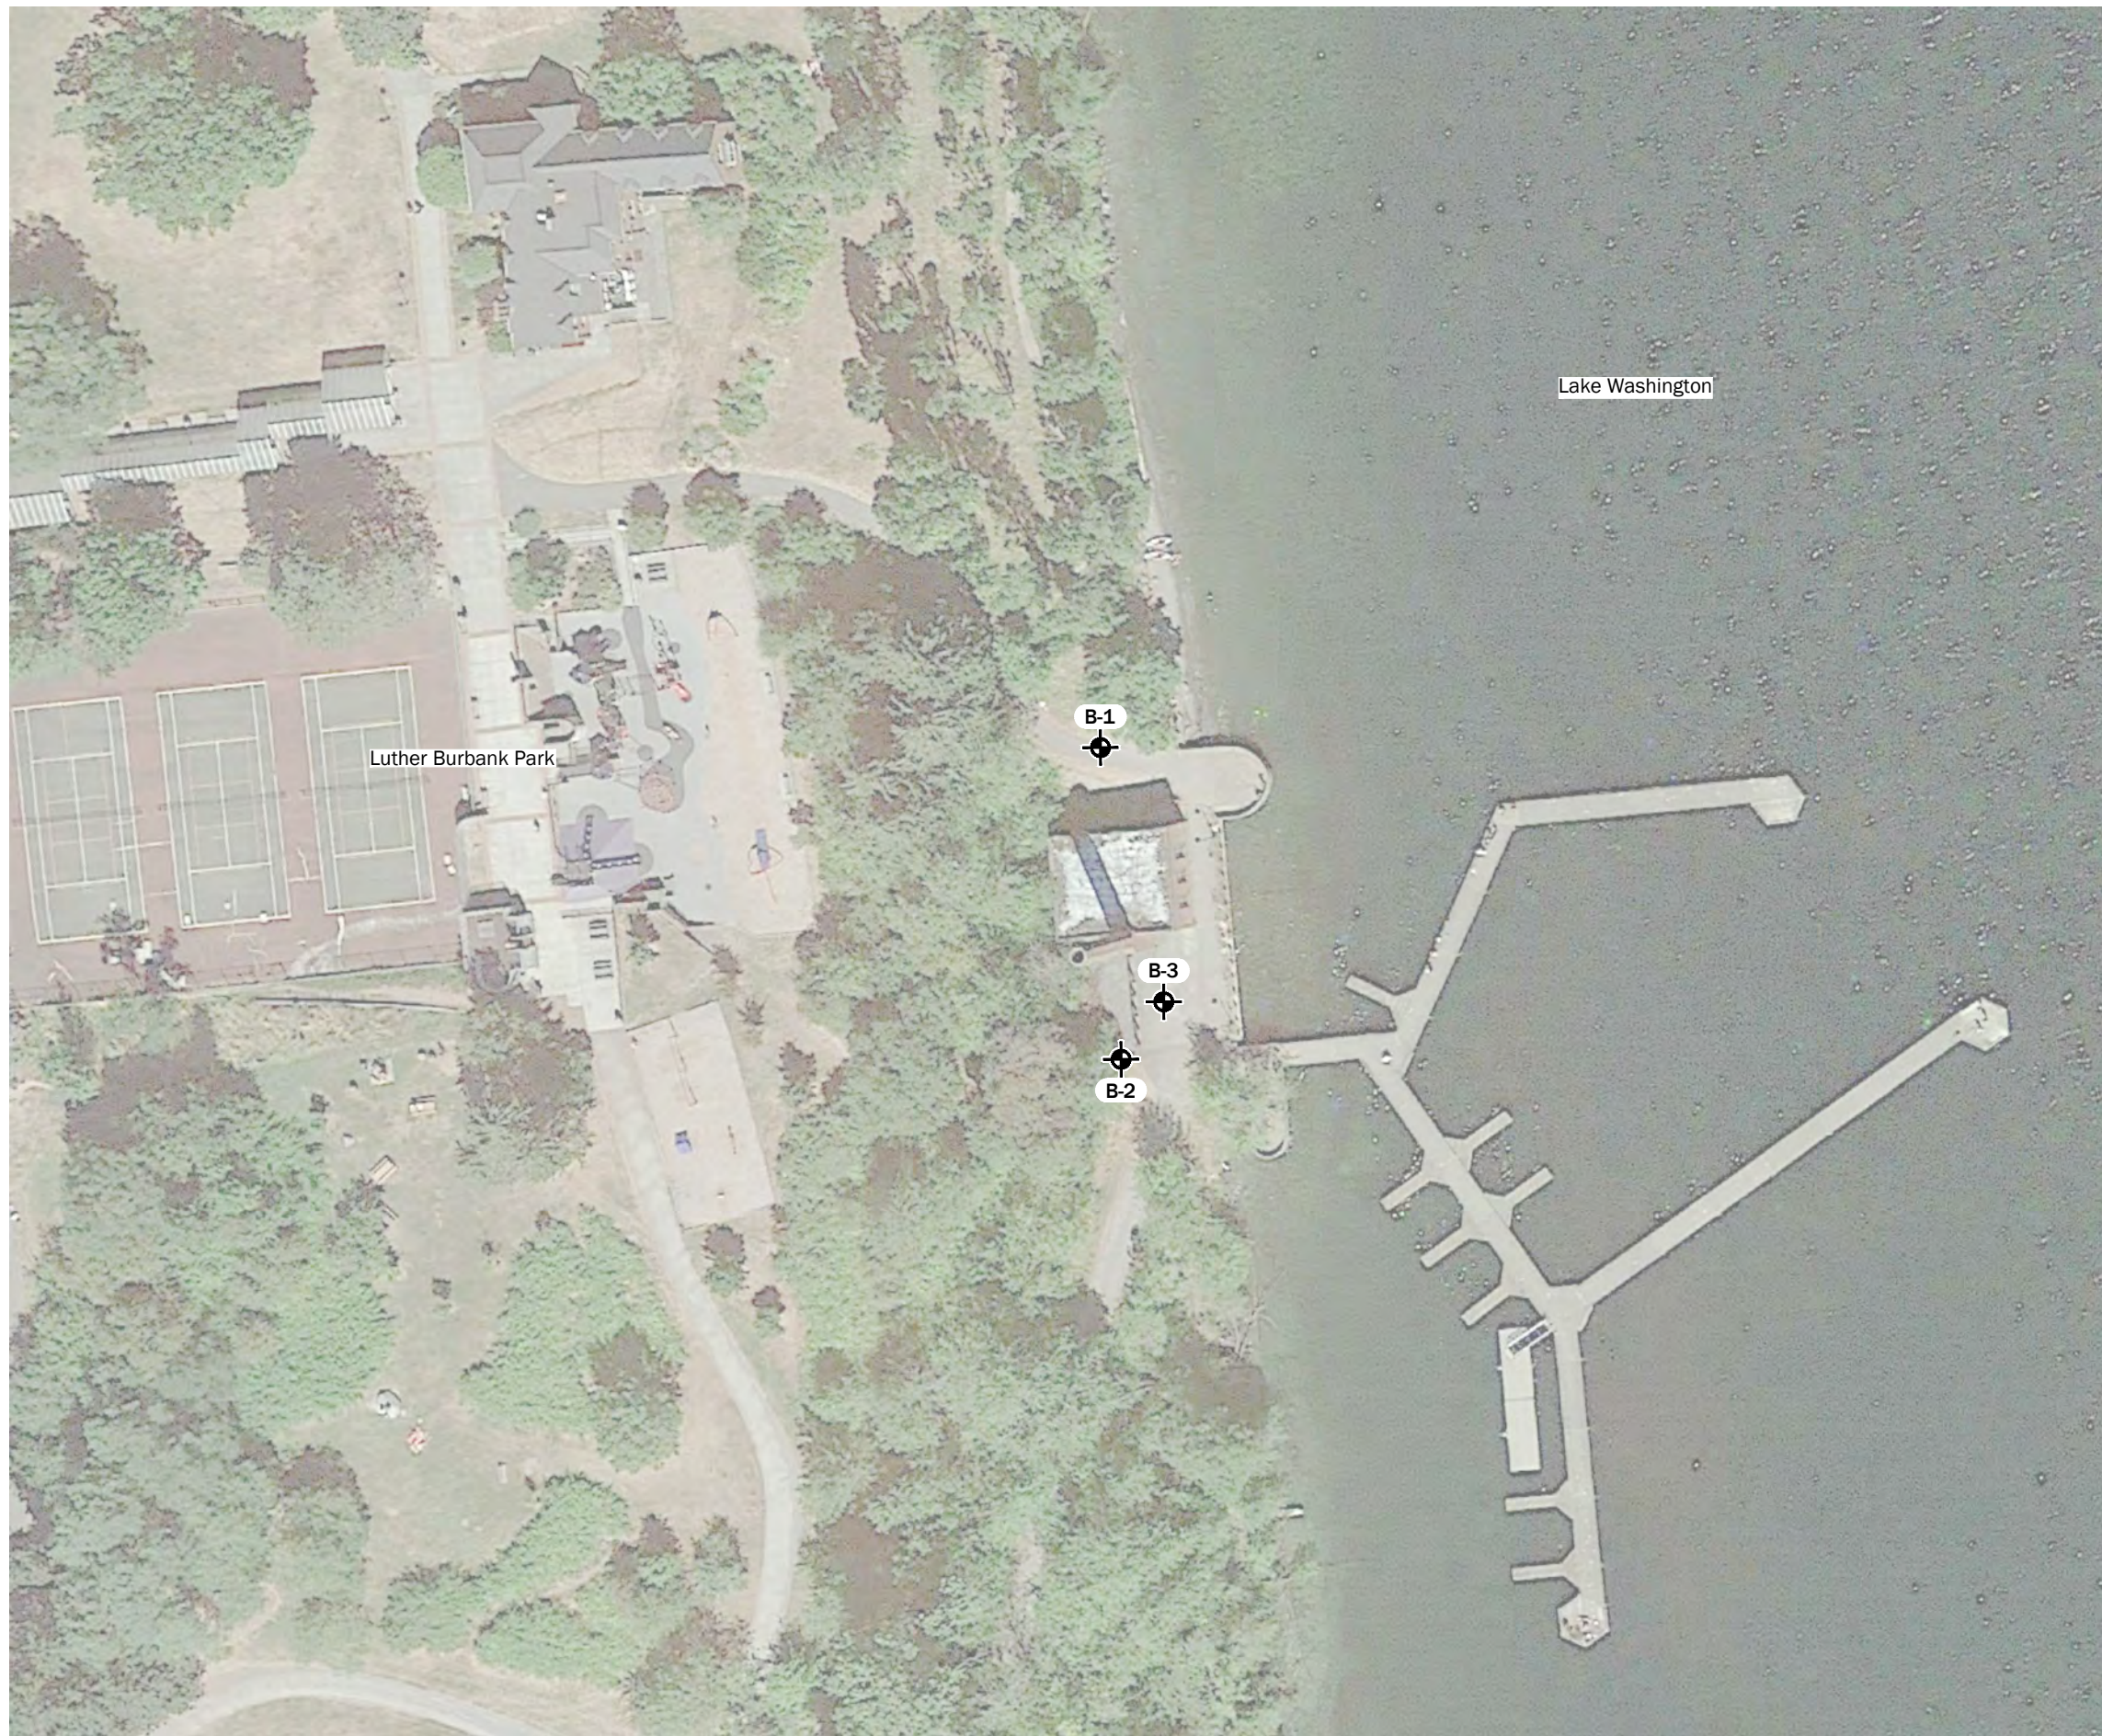
Soil conditions at the project site were explored by advancing three borings on April 1, 2022. The approximate locations of our explorations are shown on Figure 2. The explorations were located in the field using a GPS device. The locations of the explorations shown on the Site Plan (Figure 2) should be considered approximate.

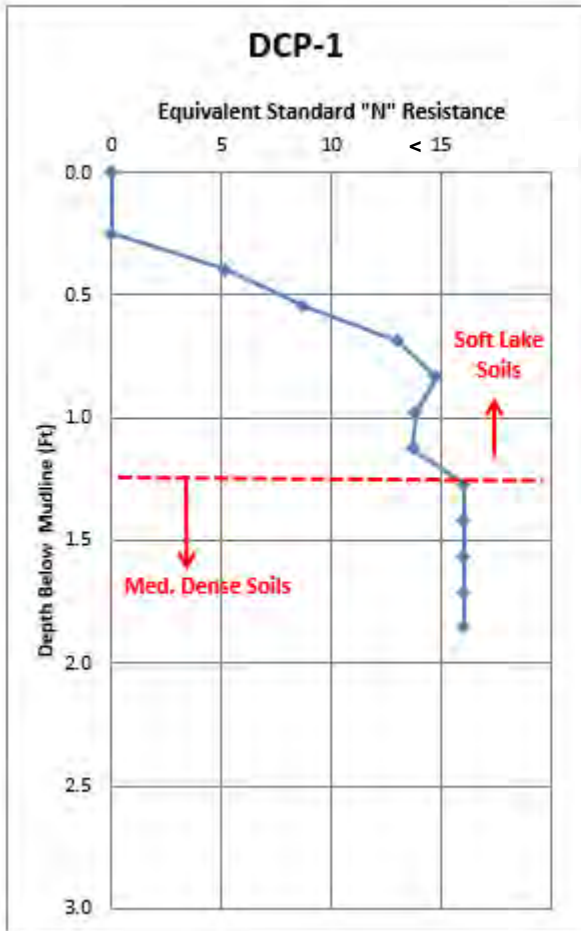
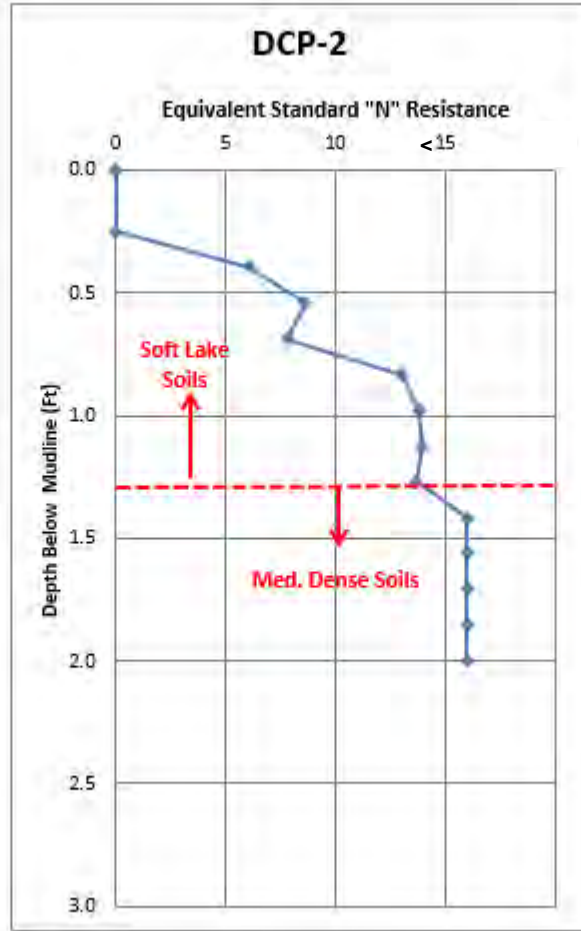
Figure 3

**DCP Logs**
