April 2023  
Luther Burbank Park Waterfront Improvements

## Project Description

**Prepared for**  
City of Mercer Island  
Public Works Department  
9611 SE 36th Street  
Mercer Island, Washington 98040

**Prepared by**  
Anchor QEA, LLC  
1201 3rd Avenue, Suite 2600  
Seattle, Washington 98101

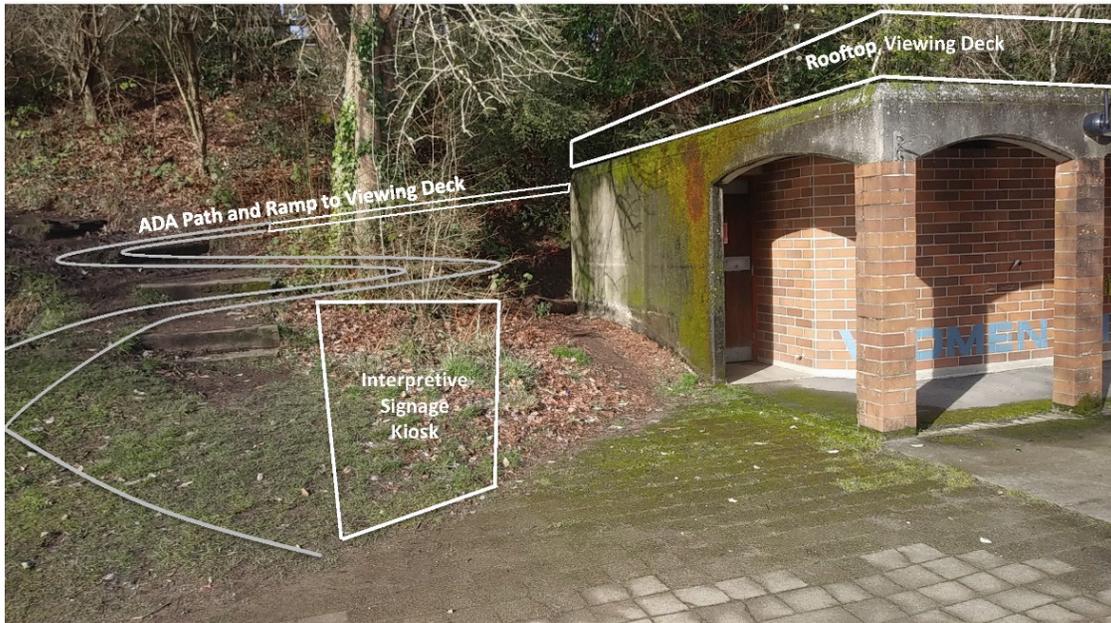
**Diagram 1**  
**Conceptual Sketch of Viewing Deck (South End) and ADA-Accessible Ramp Location**

The Boiler Building restroom annex rooftop will be renovated to facilitate a new outdoor viewing deck. The viewing deck will be constructed with Bison wood-paneled deck-surfacing material on pedestals with a 1/2-inch maximum gap for ADA accessibility on top of the existing concrete roof. The existing rooftop elevation is 29 feet, and the rooftop itself is 40 feet by 21 feet in length and width. The new rooftop will be elevated to approximately 30 feet in height to match the future second level of the Boiler Building and will match the existing extent of the rooftop area. Amenities, such as a new guardrail, light fixtures, new signage displays, and site furnishings, will be installed. Diagrams 1 and 2 provide conceptual sketches of the rooftop viewing deck overlaid on photographs of the existing structure.

The Project includes several shoreline trail access improvements (on-grade pathway and ramp, north beach pathway). The new on-grade pathway south of the plaza will be an accessible, crushed rock surfaced pedestrian trail (Figure 5, Diagram 1). Approximately 42 cubic yards of terraced rock wall (375 sf) will be placed to accommodate ADA-accessible slopes along this public access trail. An existing stormwater outfall will be temporarily removed and reinstalled during this construction.

A new structural accessible walkway is designed to provide access to the new viewing deck and will be located behind the Boiler Building restroom annex on the northwest side of the rooftop (see Diagram 1). Piles will be driven to support the viewing deck access walkway. To eliminate the need to excavate for footings; 4" diameter steel piles, will be driven into the ground. A footing drain will also be installed below grade along the length of the back of the boiler building, this will be an 18" x 20" gravel filled trench, including a perforated or slotted pipe to collect and divert surface and shallow groundwater away from the building. The access walkway will connect to the new on-grade crushed gravel pathway that will lead down to the plaza, dock, and future south shoreline trail. The on-grade pathway will also lead uphill to a new granite step feature that connects to an existing uphill trail network. Construction of the upland trail will be completed with standard heavy equipment including small excavators, small bulldozer, dump truck, and similar equipment.

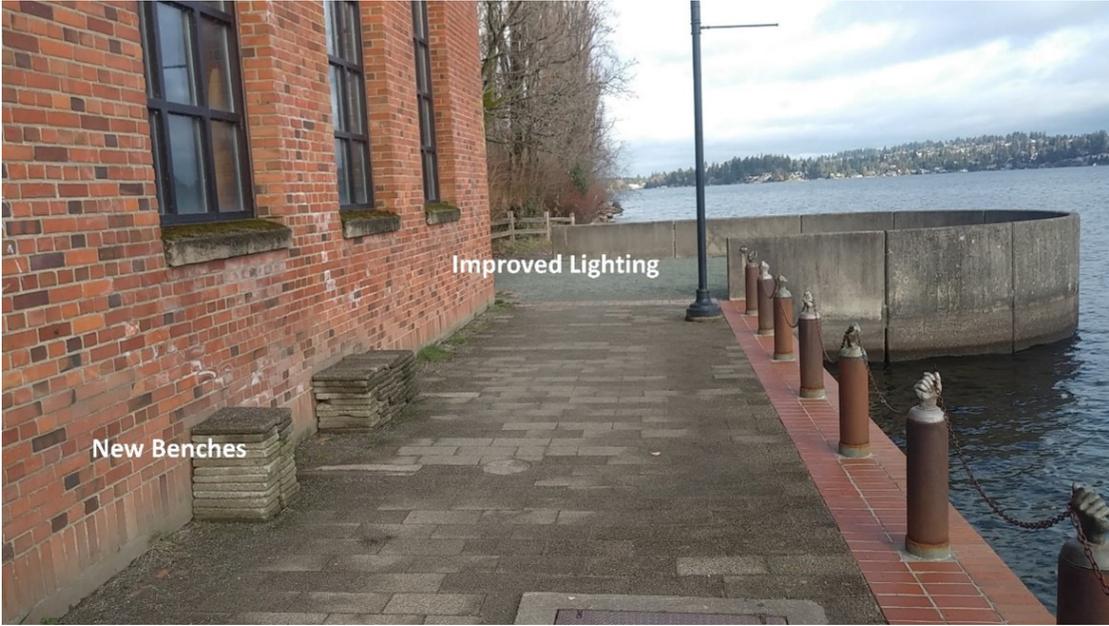
**Diagram 3**  
**Existing Plaza and East Side of Boiler Building with Approximate Locations of New Benches and Lighting (Looking North)**

Plaza renovations for the Project include removing 5,205 sf of concrete pavers, brick pavers, concrete paving, and a small area of asphalt paving in front of the Boiler Building restroom annex under the breezeway (Figure 4). Approximately 2,595 sf of existing impervious surface will be replaced, including 2,015 sf of new concrete paving in the western portion of the plaza by the Boiler Building and 580 sf of gravel driveway paving (Figure 5). Approximately 2,410 sf of pervious pavers will be installed in the eastern part of the plaza (not included in impervious surface calculations). Two benches are proposed along the outside of Boiler Building in the plaza, and one picnic table is proposed at southern end of the plaza. Diagrams 3 to 5 provide conceptual sketches of these improvements overlaid on photographs of existing conditions.

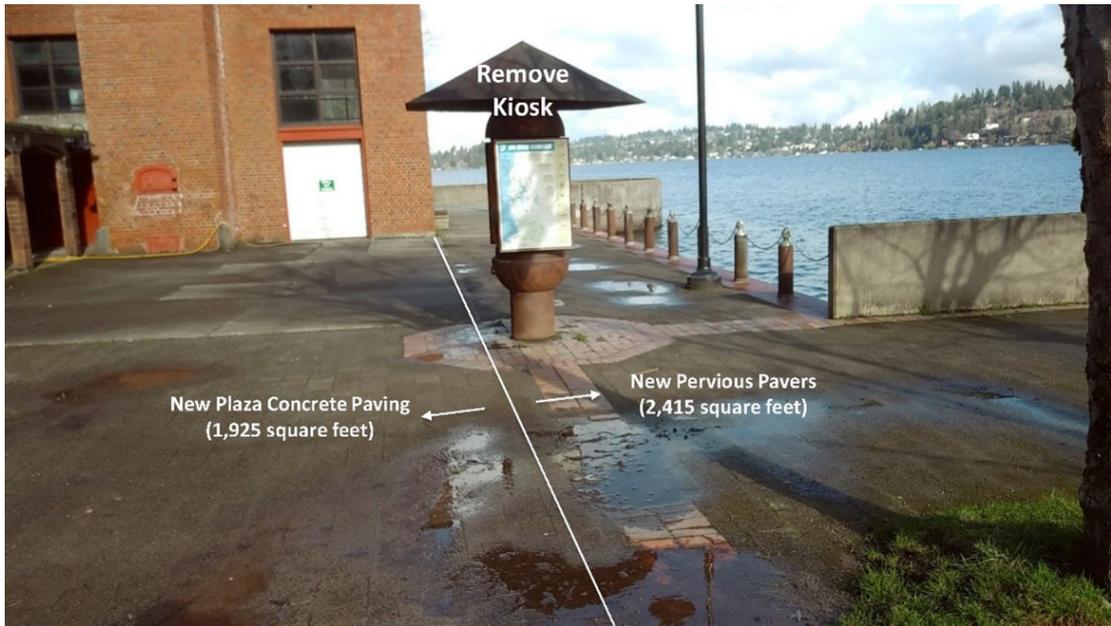
**Diagram 4**

**Approximate Locations of New Paving at South End of Plaza (Looking North)**

Approximately 2,410 sf of concrete and brick pavers at the plaza will be replaced with pervious pavers along the eastern edge of the plaza. The pervious pavers will abut the new concrete paving on the western portion of the plaza and will end at the waterfront edge (Diagram 4). A silva cell system will be installed under the south end of the plaza to provide biofiltration of stormwater (Diagram 5). A new outfall from this system will be installed in the bulkhead south of the pedestrian plaza. A vegetated conveyance swale will be installed along the resurfaced gravel maintenance driveway.

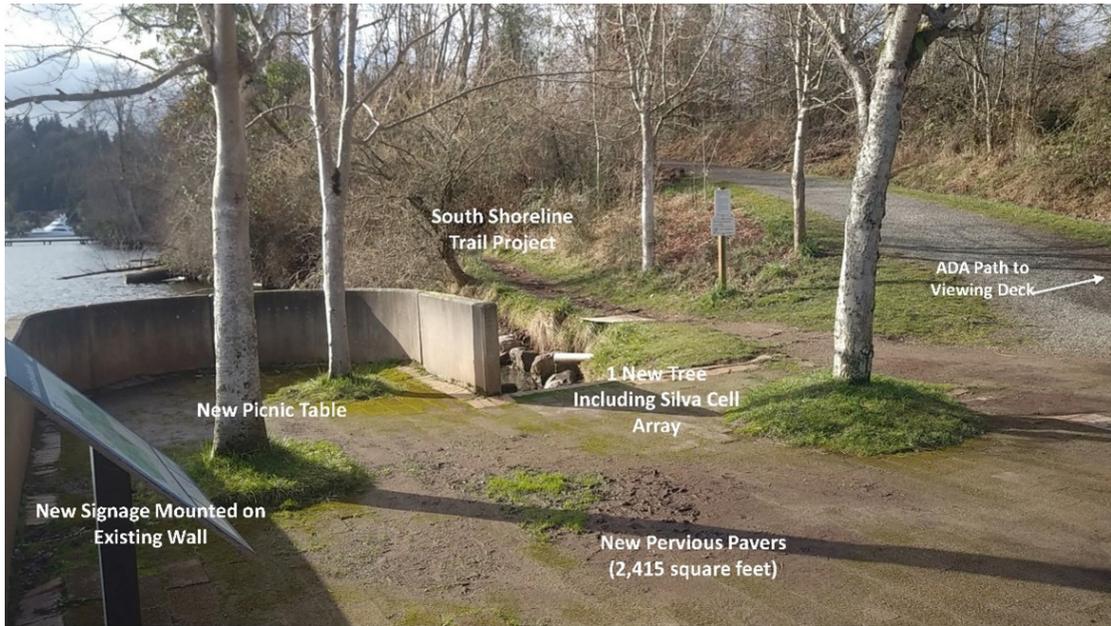
**Diagram 5**

**Locations of New Pervious Pavers and Silva Cell at South End of Plaza (Looking South)**

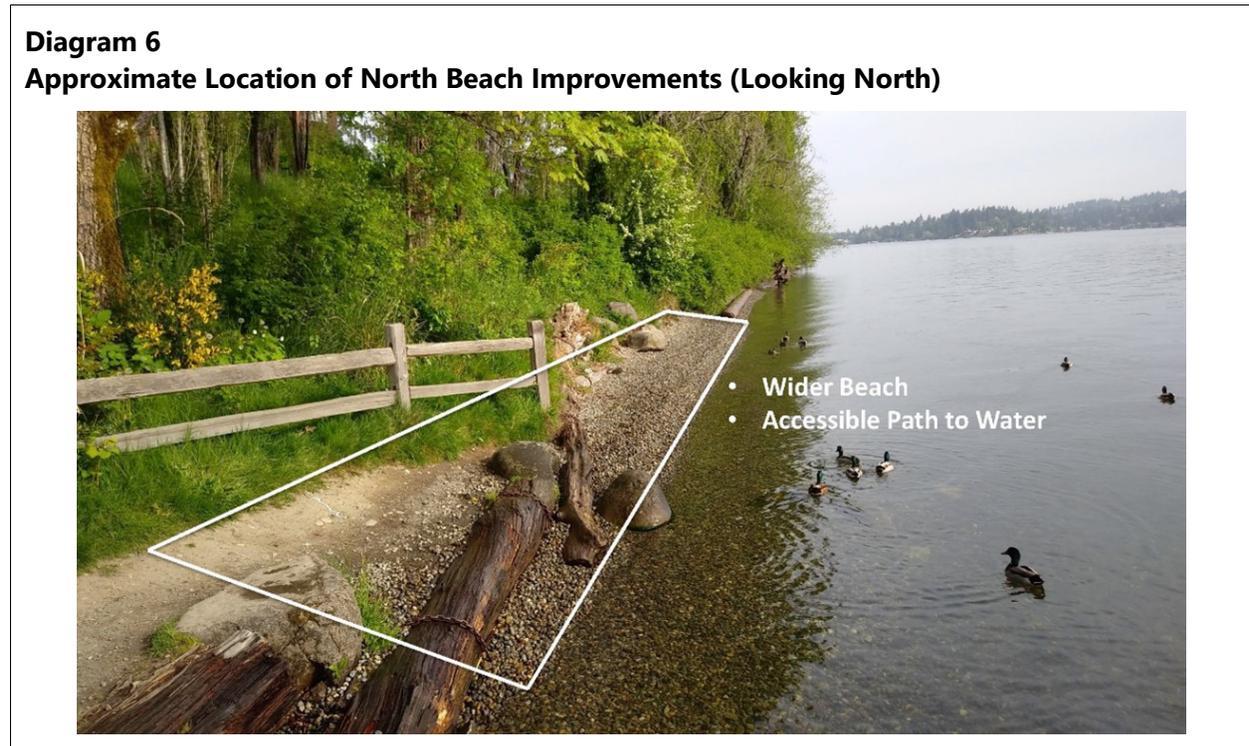
Diagram 6 provides a photograph of the existing north beach with the approximate location of nearshore habitat enhancements labeled.

In addition to improving public access and safety, the design includes shoreline and beach enhancements (Figure 5). The Project will expand the north beach by placing fish habitat gravel landward of the upland edge of the existing beach, relocate boulders and LWD along the shoreline, and enhance riparian vegetation. The beach expansion includes placing 45 cubic yards of habitat gravel and cobble underlayment (605 sf) and relocating intermittent boulders and LWD along the existing beach and riparian buffer area. The expanded beach and riparian area will maintain nearshore habitat functions. The planting plan to replace removed riparian vegetation and trees is described in Section 3.3.

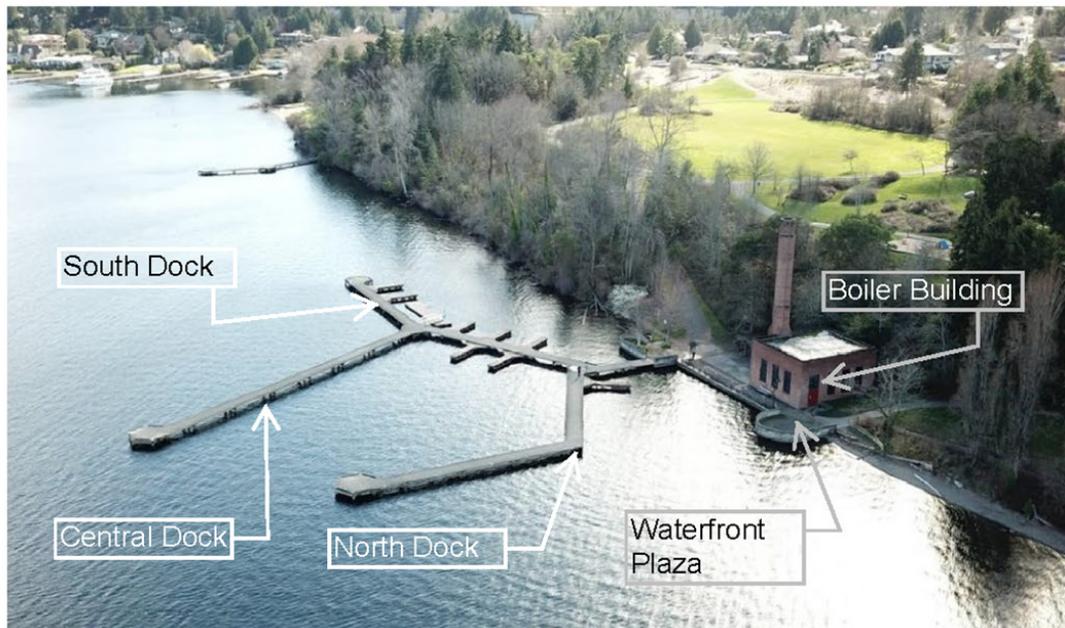
**Diagram 7**  
**Aerial View of Existing Dock Structures (Looking Southwest)**

The in-water and overwater Project elements are described in this section and shown in Figures 3, 4, and 7 through 12. Diagram 7 shows an aerial overview of the existing dock structures.
