October 27<sup>th</sup> 2022

G-5781

Subject:       **Geotechnical Engineering Investigation**  
Proposed New Deck and Stairs  
6671 E Mercer Way  
Mercer Island, Washington

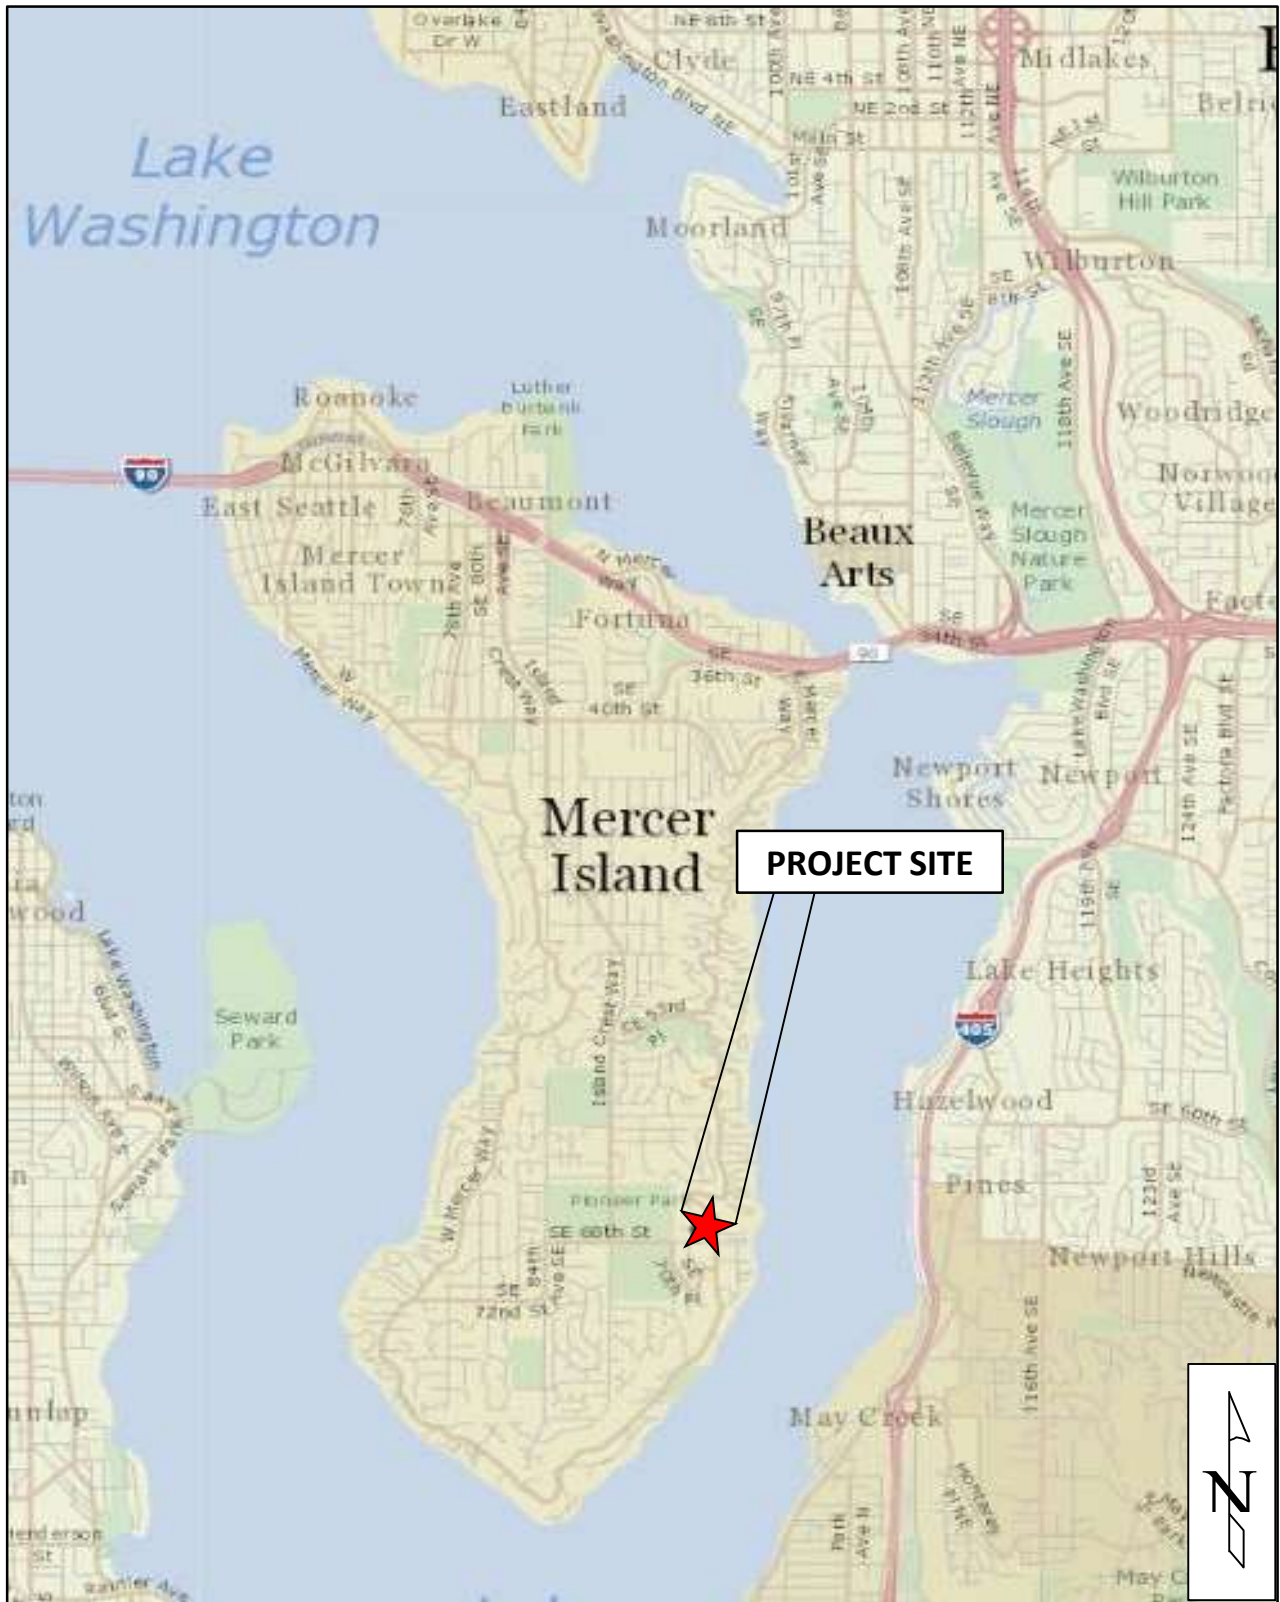
SCALE	NONE	DATE	10/27/2022	MADE	SH	CHKD	WC	JOB NO.	G-5781	PLATE	1
-------	------	------	------------	------	----	------	----	---------	--------	-------	---

Source: King County iMap, 2021

**SITE LOCATION MAP**  
**PROPOSED NEW GARAGE**  
**6671 E MERCER WAY**  
**MERCER ISLAND, WASHINGTON**

The project site is located in South-east Mercer Island, Washington, as illustrated in *Plate 1 – Site Location Map*. The parcel is rectangular shaped and slopes from the north-west to the south-east corners of the property at the lowest elevation. The parcel consists of 16,553 square feet and is bounded by other single family residential properties to the south, east, west and Hillside Lane to the north. The existing single-family residence was built in 1978 and has one story and a finished basement with approximately 2,760 square feet of total living space. A second story deck with stairs is attached to the south side of the existing house and a small hot tub and
