## GEOTECHNICAL ENGINEERING INVESTIGATION

Proposed Single Family House  
5425 96th Ave SE  
Mercer Island, Washington  
Parcel#: 1438700145

August 8, 2022  
Project No. 2DF0422984

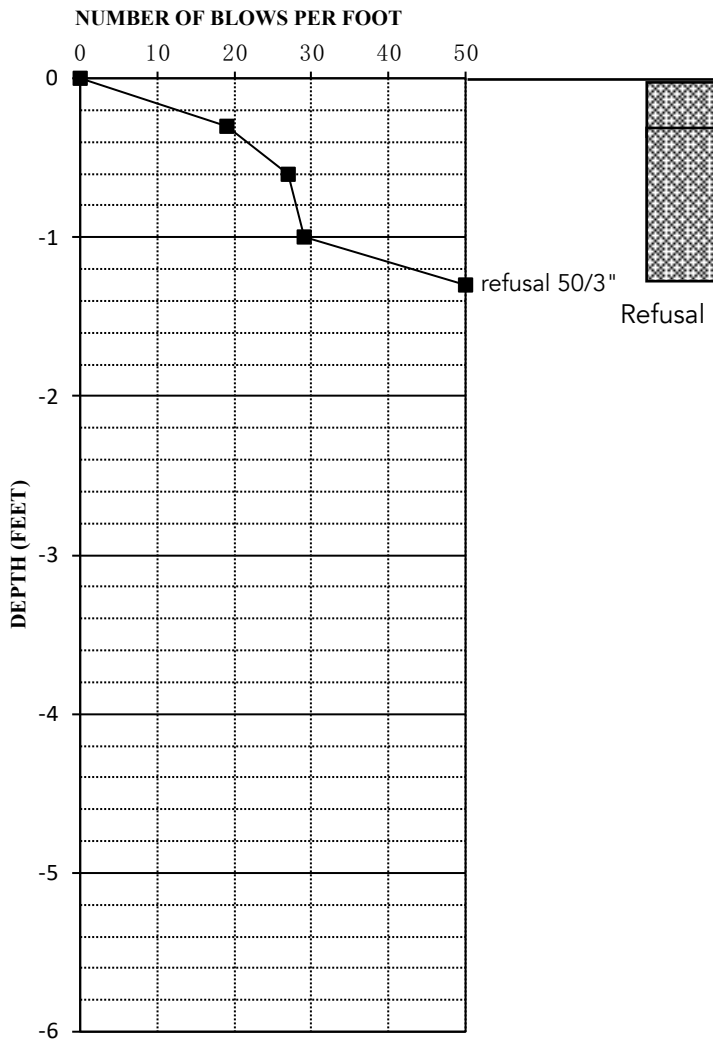
SOIL DESCRIPTION AND CLASSIFICATION

X,Y =  
 Surface Elevation = 101'  
 Surface Conditions = Ground Cover

**SILTY SANDS WITH GRAVEL (SM)**

**SILTY SANDS WITH GRAVEL (OUTWASH)**

Subsurface soil and ground water conditions were investigated by conducting three (3) DCP tests to maximum 7.6' depth on June 29, 2022. Test locations are shown on the site plan (Figure 2). Test logs are presented in the Appendix of this report as Figures 4 through 6. Descriptions of soil symbols and classifications used in this report are also presented in the Appendix (Figure 3). Site soils are generalized in the schematic and summarized as follows:

Descriptions of subsurface conditions are based on observations made at the site at the time of the field investigation. DCP test logs are presented in Figures 4 through 6. The soils observed at the site were classified using the USCS (Unified Soils Classification System ) in accordance with ASTM D-2488-69 and ASTM D 2487. This classification system is also presented in the Appendix (Figure 3).

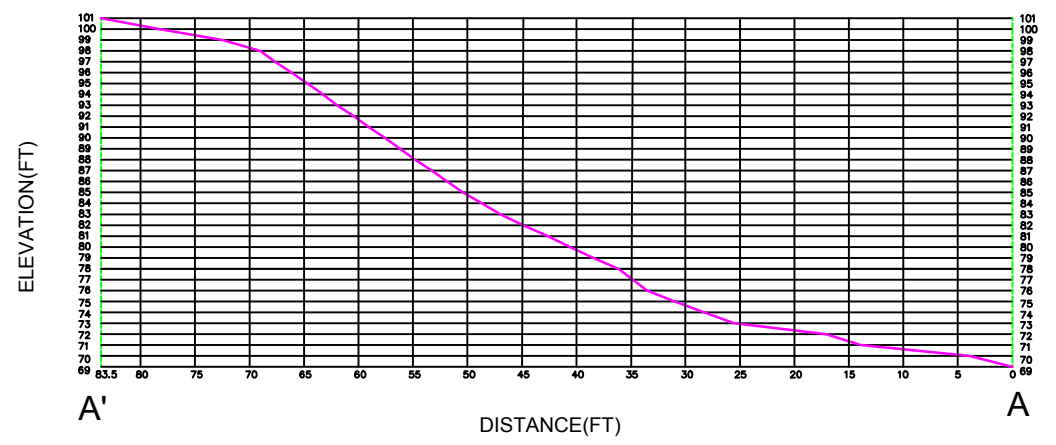
Note: Property Lines and Topography based on the Survey From CHADWICK and WINTERS LAND SURVEYING and MAPPING

Single Family House Development  
5425 96th Ave SE  
Mercer Island, WA  
Parcel Number: 1438700145

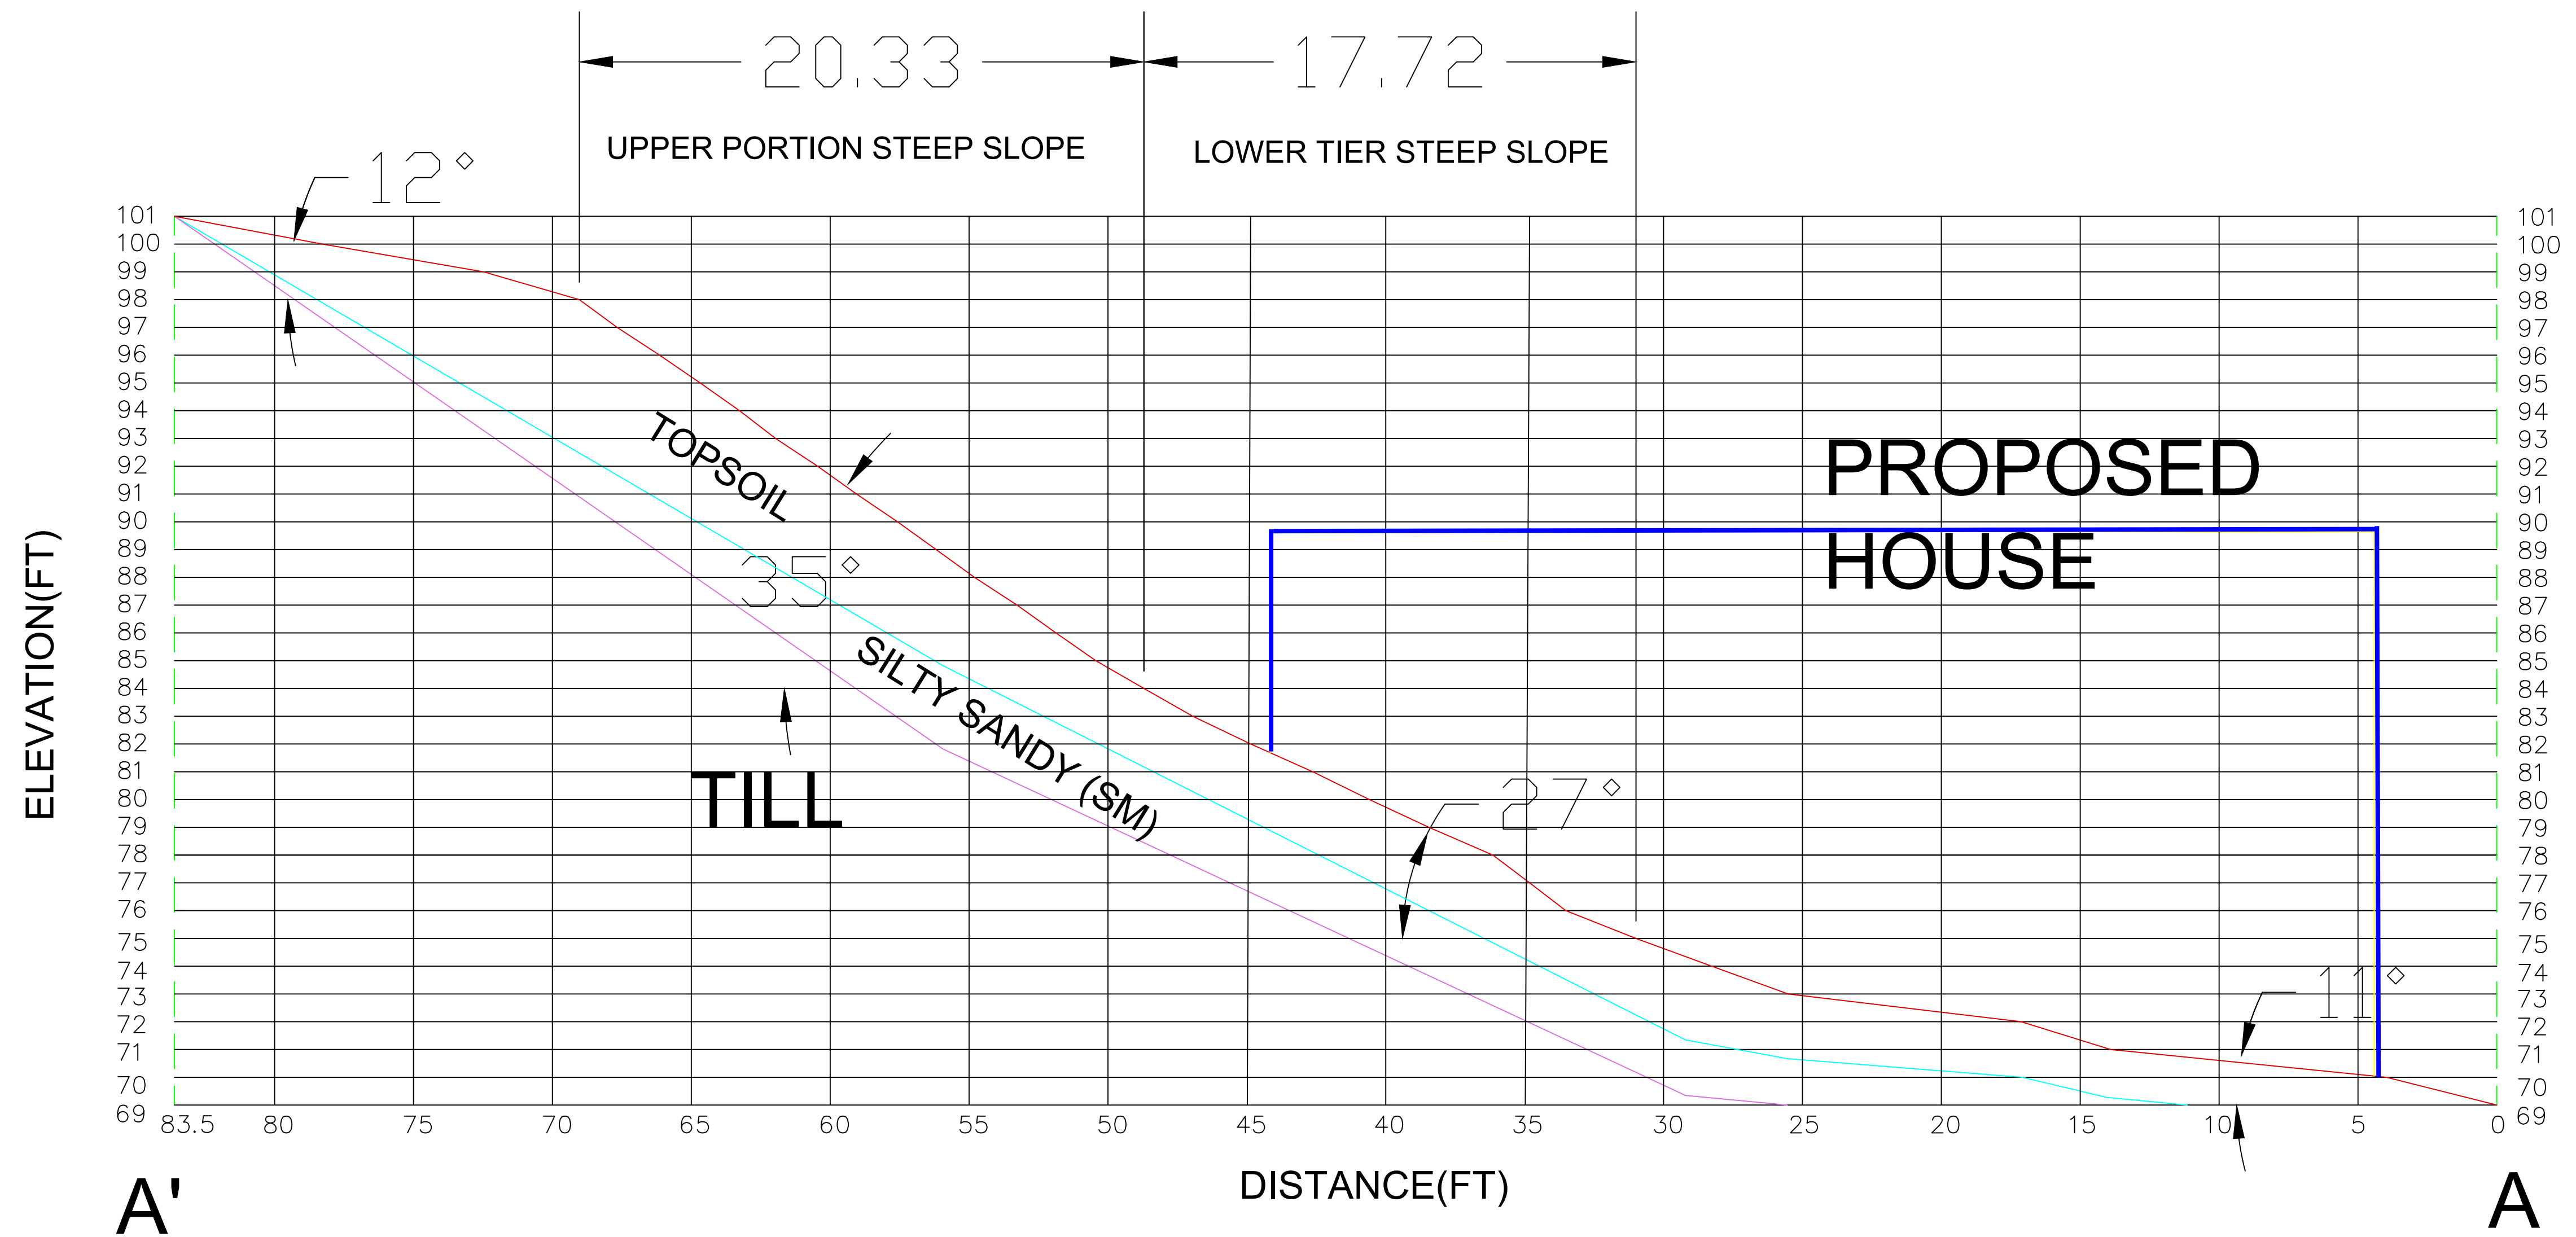
Note: Property Lines and Topography based on the Survey From CHADWICK and WINTERS LAND SURVEYING and MAPPING

Single Family House Development  
5425 96th Ave SE  
Mercer Island, WA  
Parcel Number: 1438700145
