ZHANGE RESIDENCE

STORM DRAINAGE REPORT

9433 SE 54TH ST, WA

Job No. BL22-306

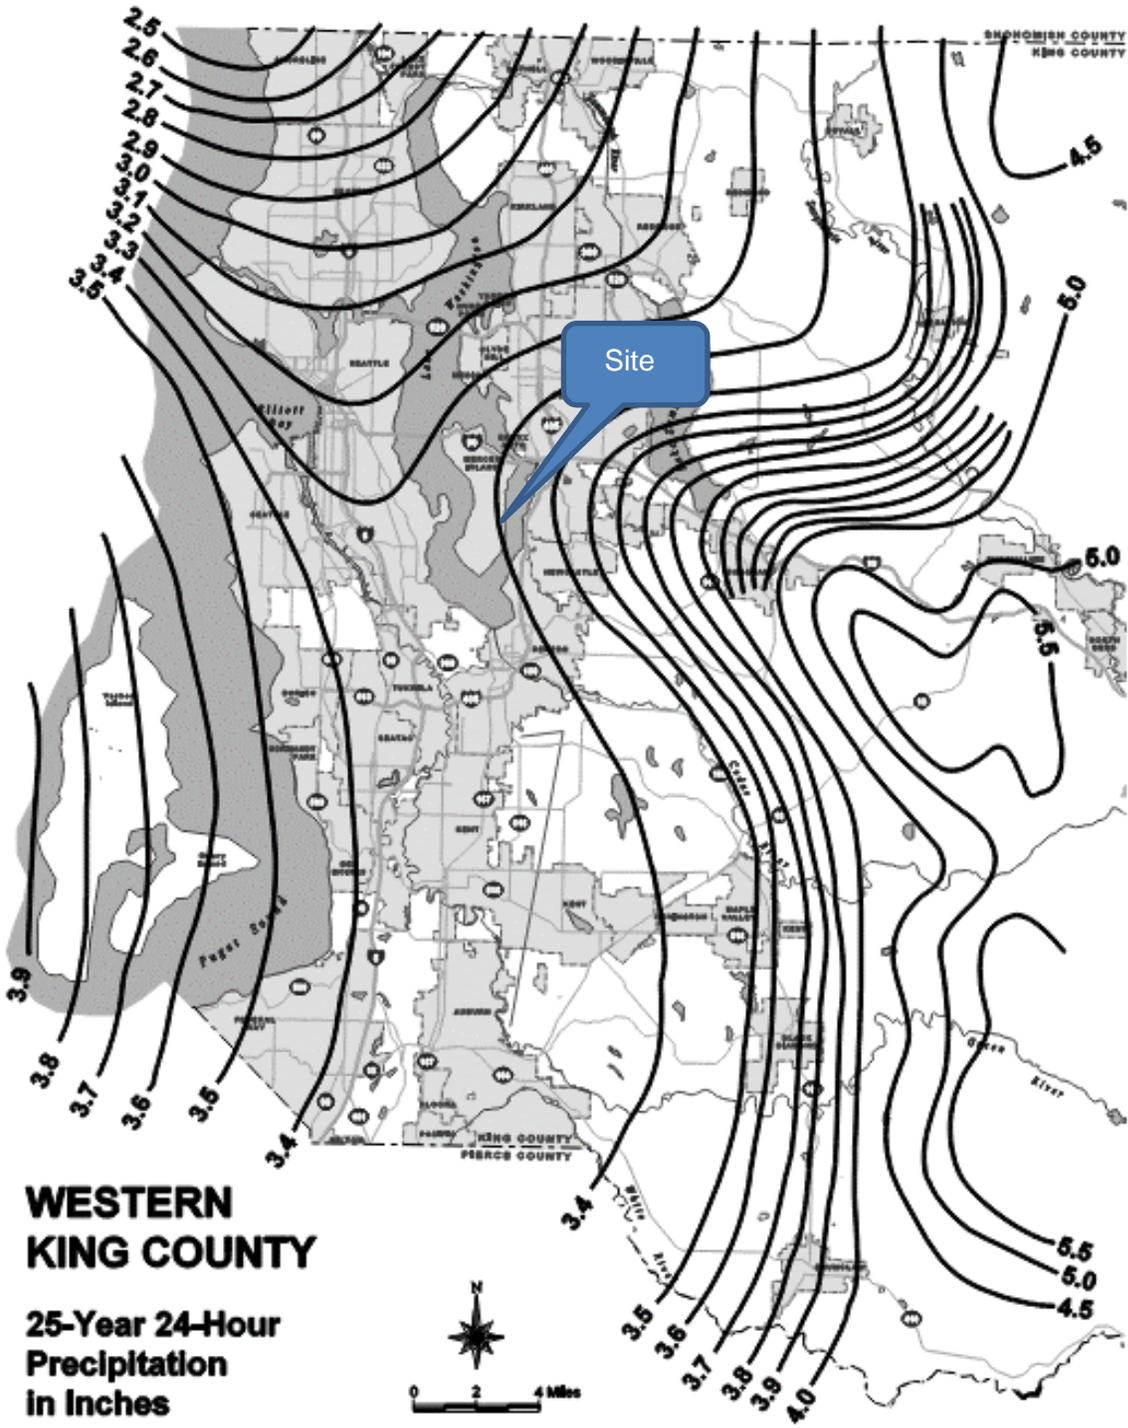
FIGURE 3.2.1.C 25-YEAR 24-HOUR ISOPLUVIALS

**WESTERN
KING COUNTY**
**25-Year 24-Hour
Precipitation
in Inches**

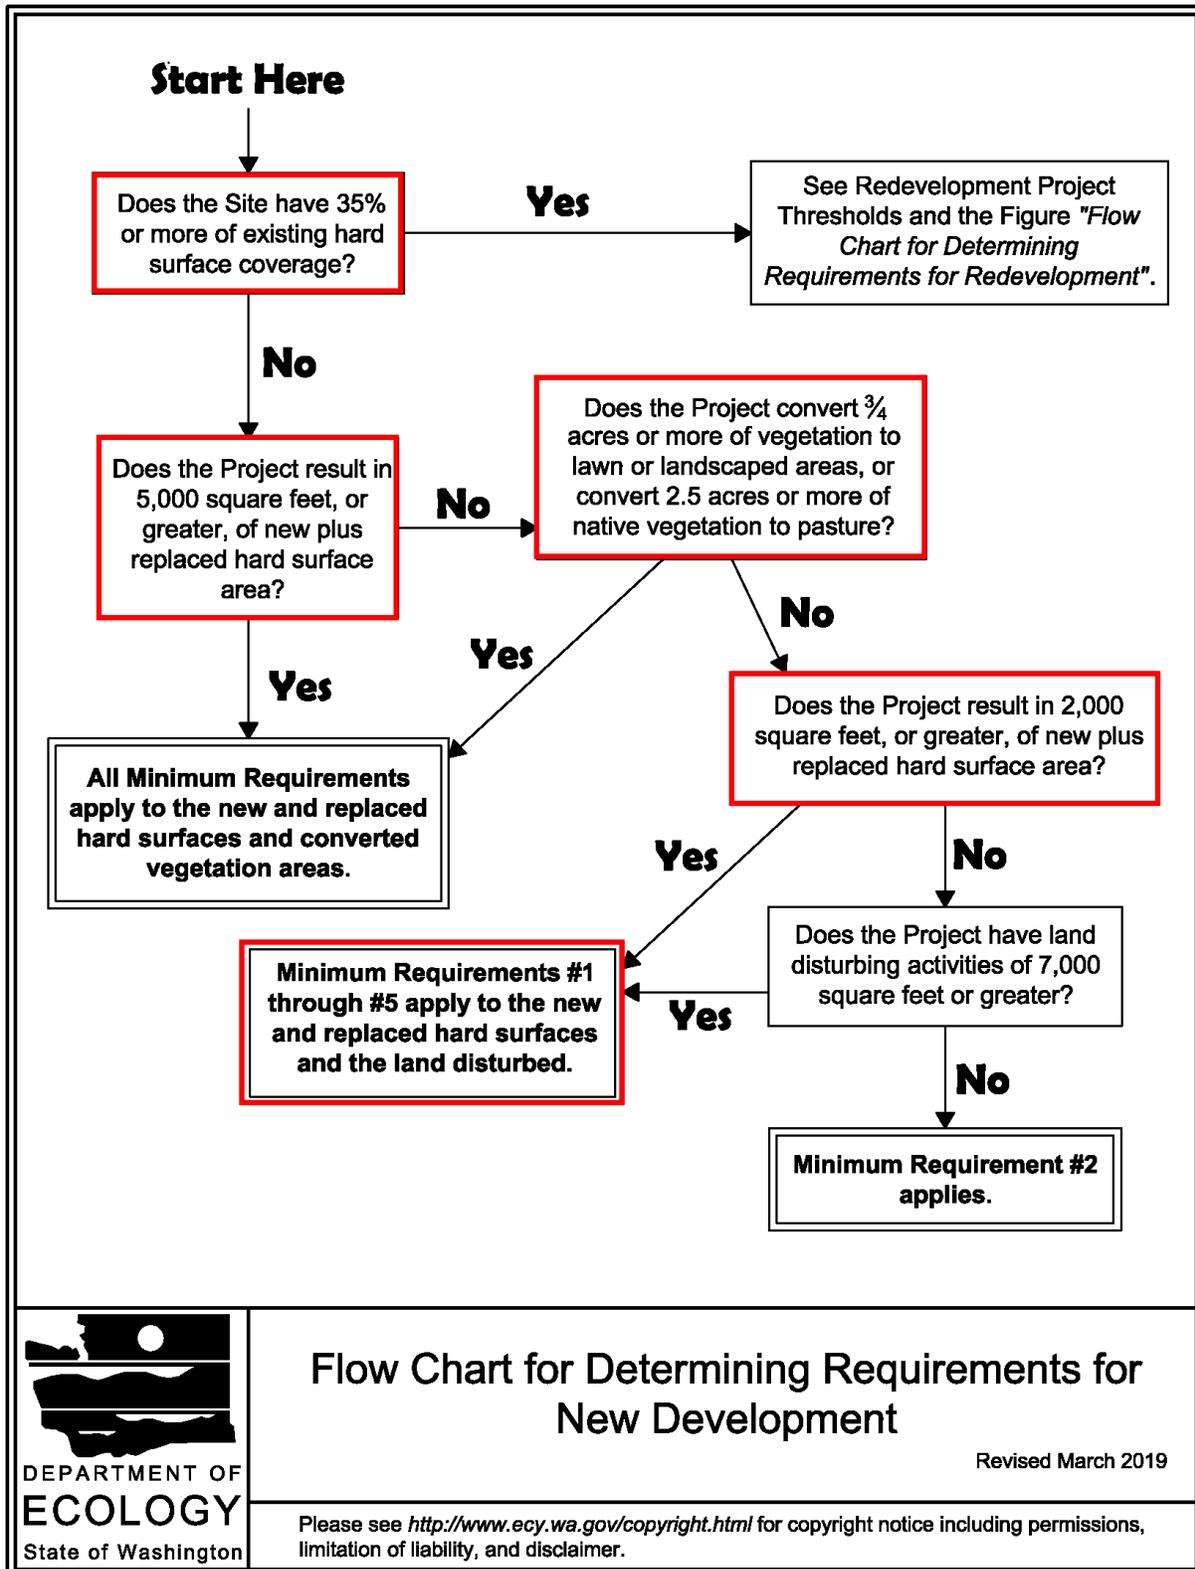
Figure I-3.1: Flow Chart for Determining Requirements for New Development

Flow Chart for Determining Requirements for New Development

than 5,000 sf of new plus replaced hard surface area (4,744 sf). Therefore, minimum Requirements 1-5 are applicable to the site. Refer to Figure I-2.4.1 on the following page for more information on determining the drainage requirements.

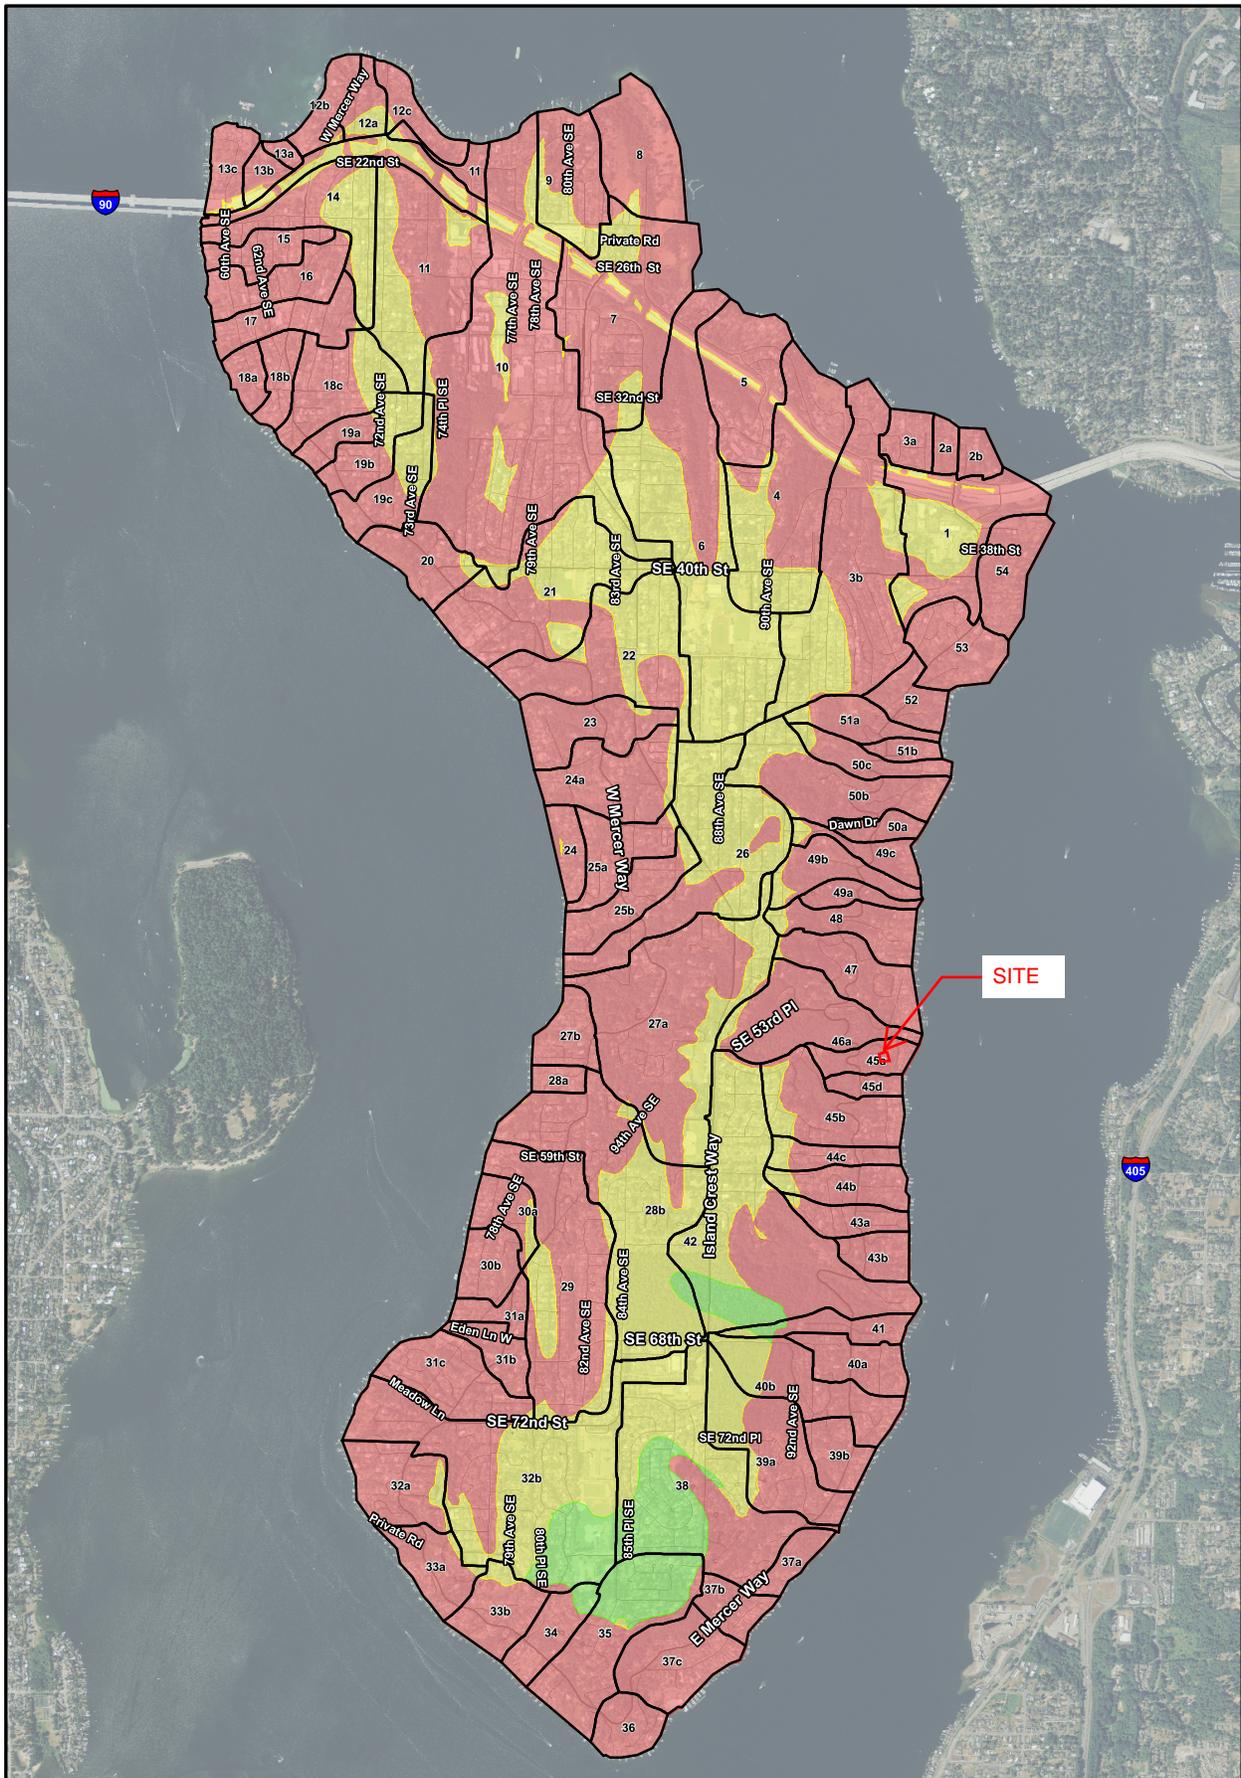
Legend

- Infiltrating LID facilities may be feasible, and soil has high infiltration potential
- Infiltrating LID facilities may be feasible, and soil has moderate infiltration potential
- Infiltrating LID facilities are not permitted
- Storm drainage basin

1. Dispersion (BMP T5.30) or Downspout Full Infiltration Systems (BMP T5.10A): Infiltration is considered infeasible per the LID Infiltration Feasibility on Mercer Island Map. Dispersion is also infeasible because the required vegetated flow path cannot be maintained on-site due to steep slopes.
2. Rain Gardens (BMP T5.14A) or Bioretention (BMP T7.30): These systems are not because infiltration is considered infeasible per the LID Infiltration Feasibility on Mercer Island Map.
3. Downspout Dispersion Systems (BMP T5.10B): These systems are not feasible as the required vegetated flow path cannot be maintained on-site due to steep slopes.
4. Perforated Stub-out Connections (BMP T5.10C): Perforated Stub-out Connection is infeasible per the LID Infiltration Feasibility on Mercer Island Map.

1. Full Dispersion (BMP T5.30): Full Dispersion is not feasible for the site as the required vegetated flow path cannot be maintained on-site due to steep slopes.
2. Permeable Pavement (BMP T5.15), or Rain Gardens (BMP T5.14A), or Bioretention (BMP T7.30): Not required for projects which are exempt from Minimum Requirement #7. Additionally, these facilities are not appropriate for the site due to unsuitable soils for infiltration per the LID Infiltration Feasibility on Mercer Island Map

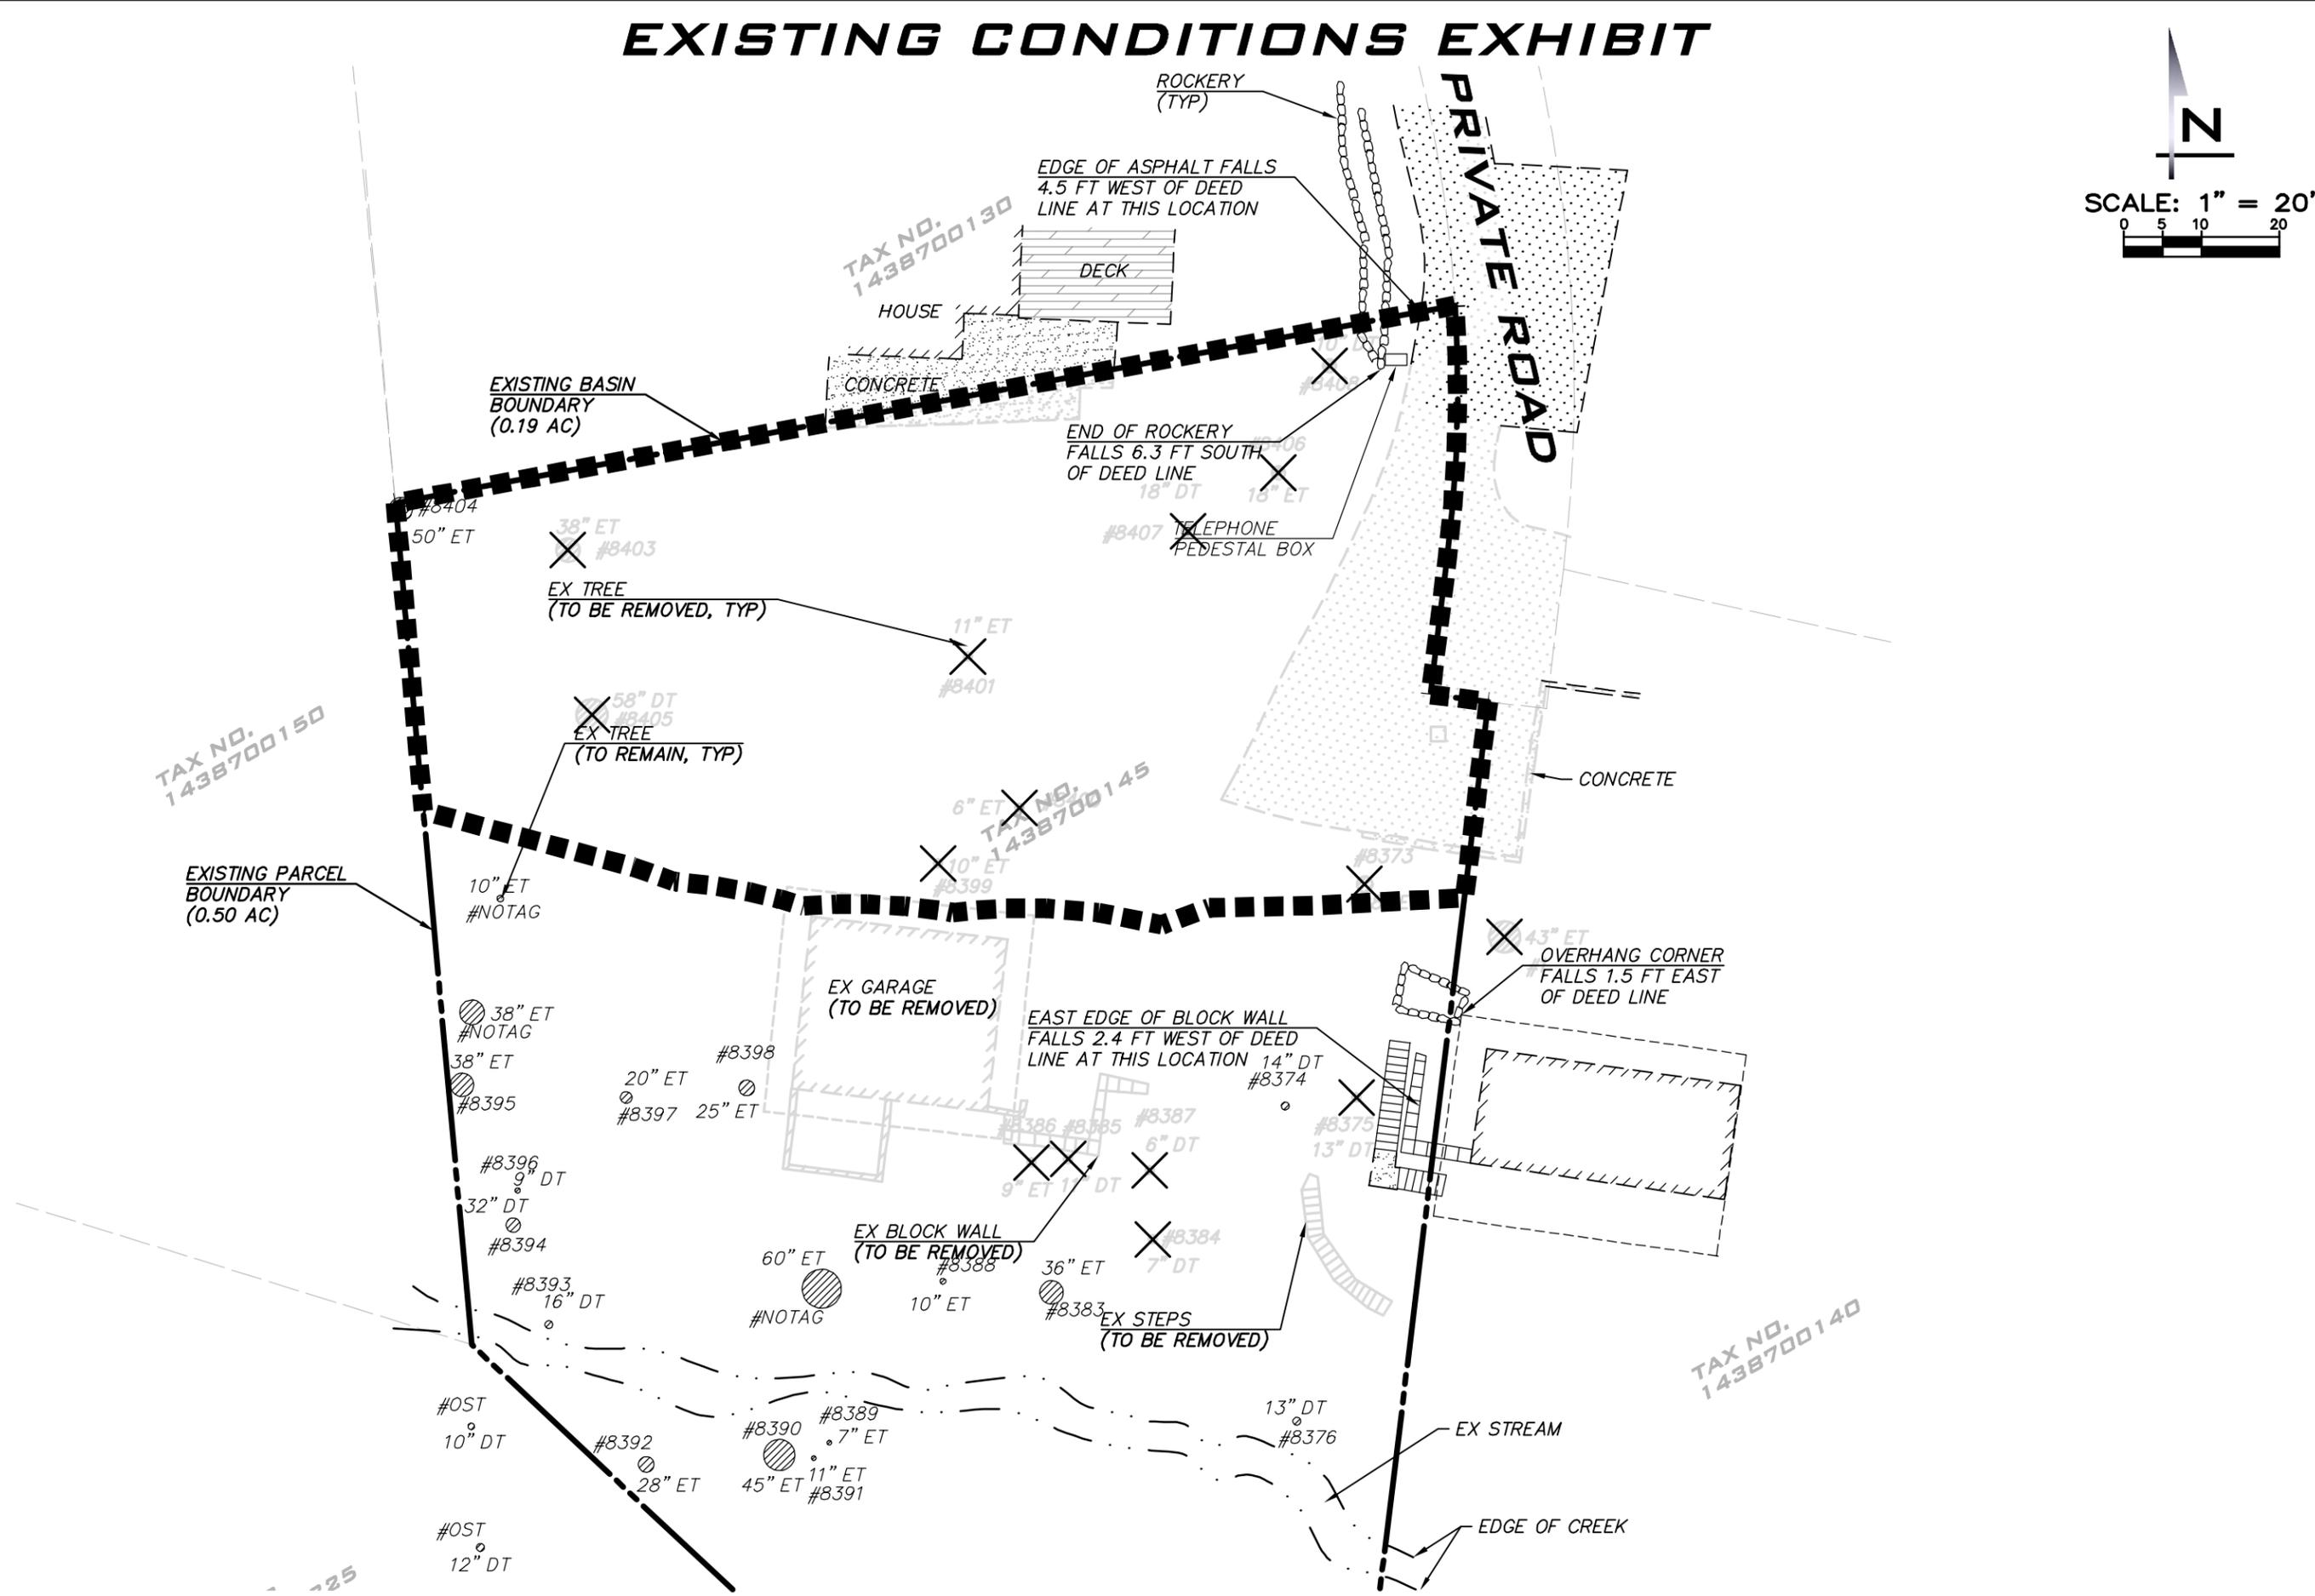
SCALE	AS NOTED
PROJECT MANAGER	YANNICK METS, PE
DESIGNED BY	JULIAN ADLER
DRAWN BY	CODY COUCH, EIT
PLOT DATE	July 20, 2023
JOB NUMBER: 22-306	
FIGURE: EC

EXISTING CONDITIONS EXHIBIT ZHANG RESIDENCE STORM DRAINAGE REPORT

The existing parcel and project basin boundary area is 21,666 sf. Approximately 12,936 sf of this will be left undisturbed. The existing site contains a garage and general tree cover associated with undeveloped areas. The existing on-site basin, generally sheet flows south from the northern portion of the site and north from the southern portion of the site combining in the stream near the center of the site. The stream conveys runoff before entering a 12" concrete pipe that continues to convey flows east to Lake Washington. Please see the Existing Conditions Exhibit in Section 1 of this report.

The total existing roof area for the garage is 925 sf. Other impervious surfaces include a 1,081 sf driveway, and 85 sf of block and concrete walls. The total existing impervious area is 2,091 sf. The remaining 19,575 sf of the site is landscaped with lawn and trees and contains a stream that runs through the southern third of the site. Please see the Existing Conditions Exhibit in Section 1 of this report.

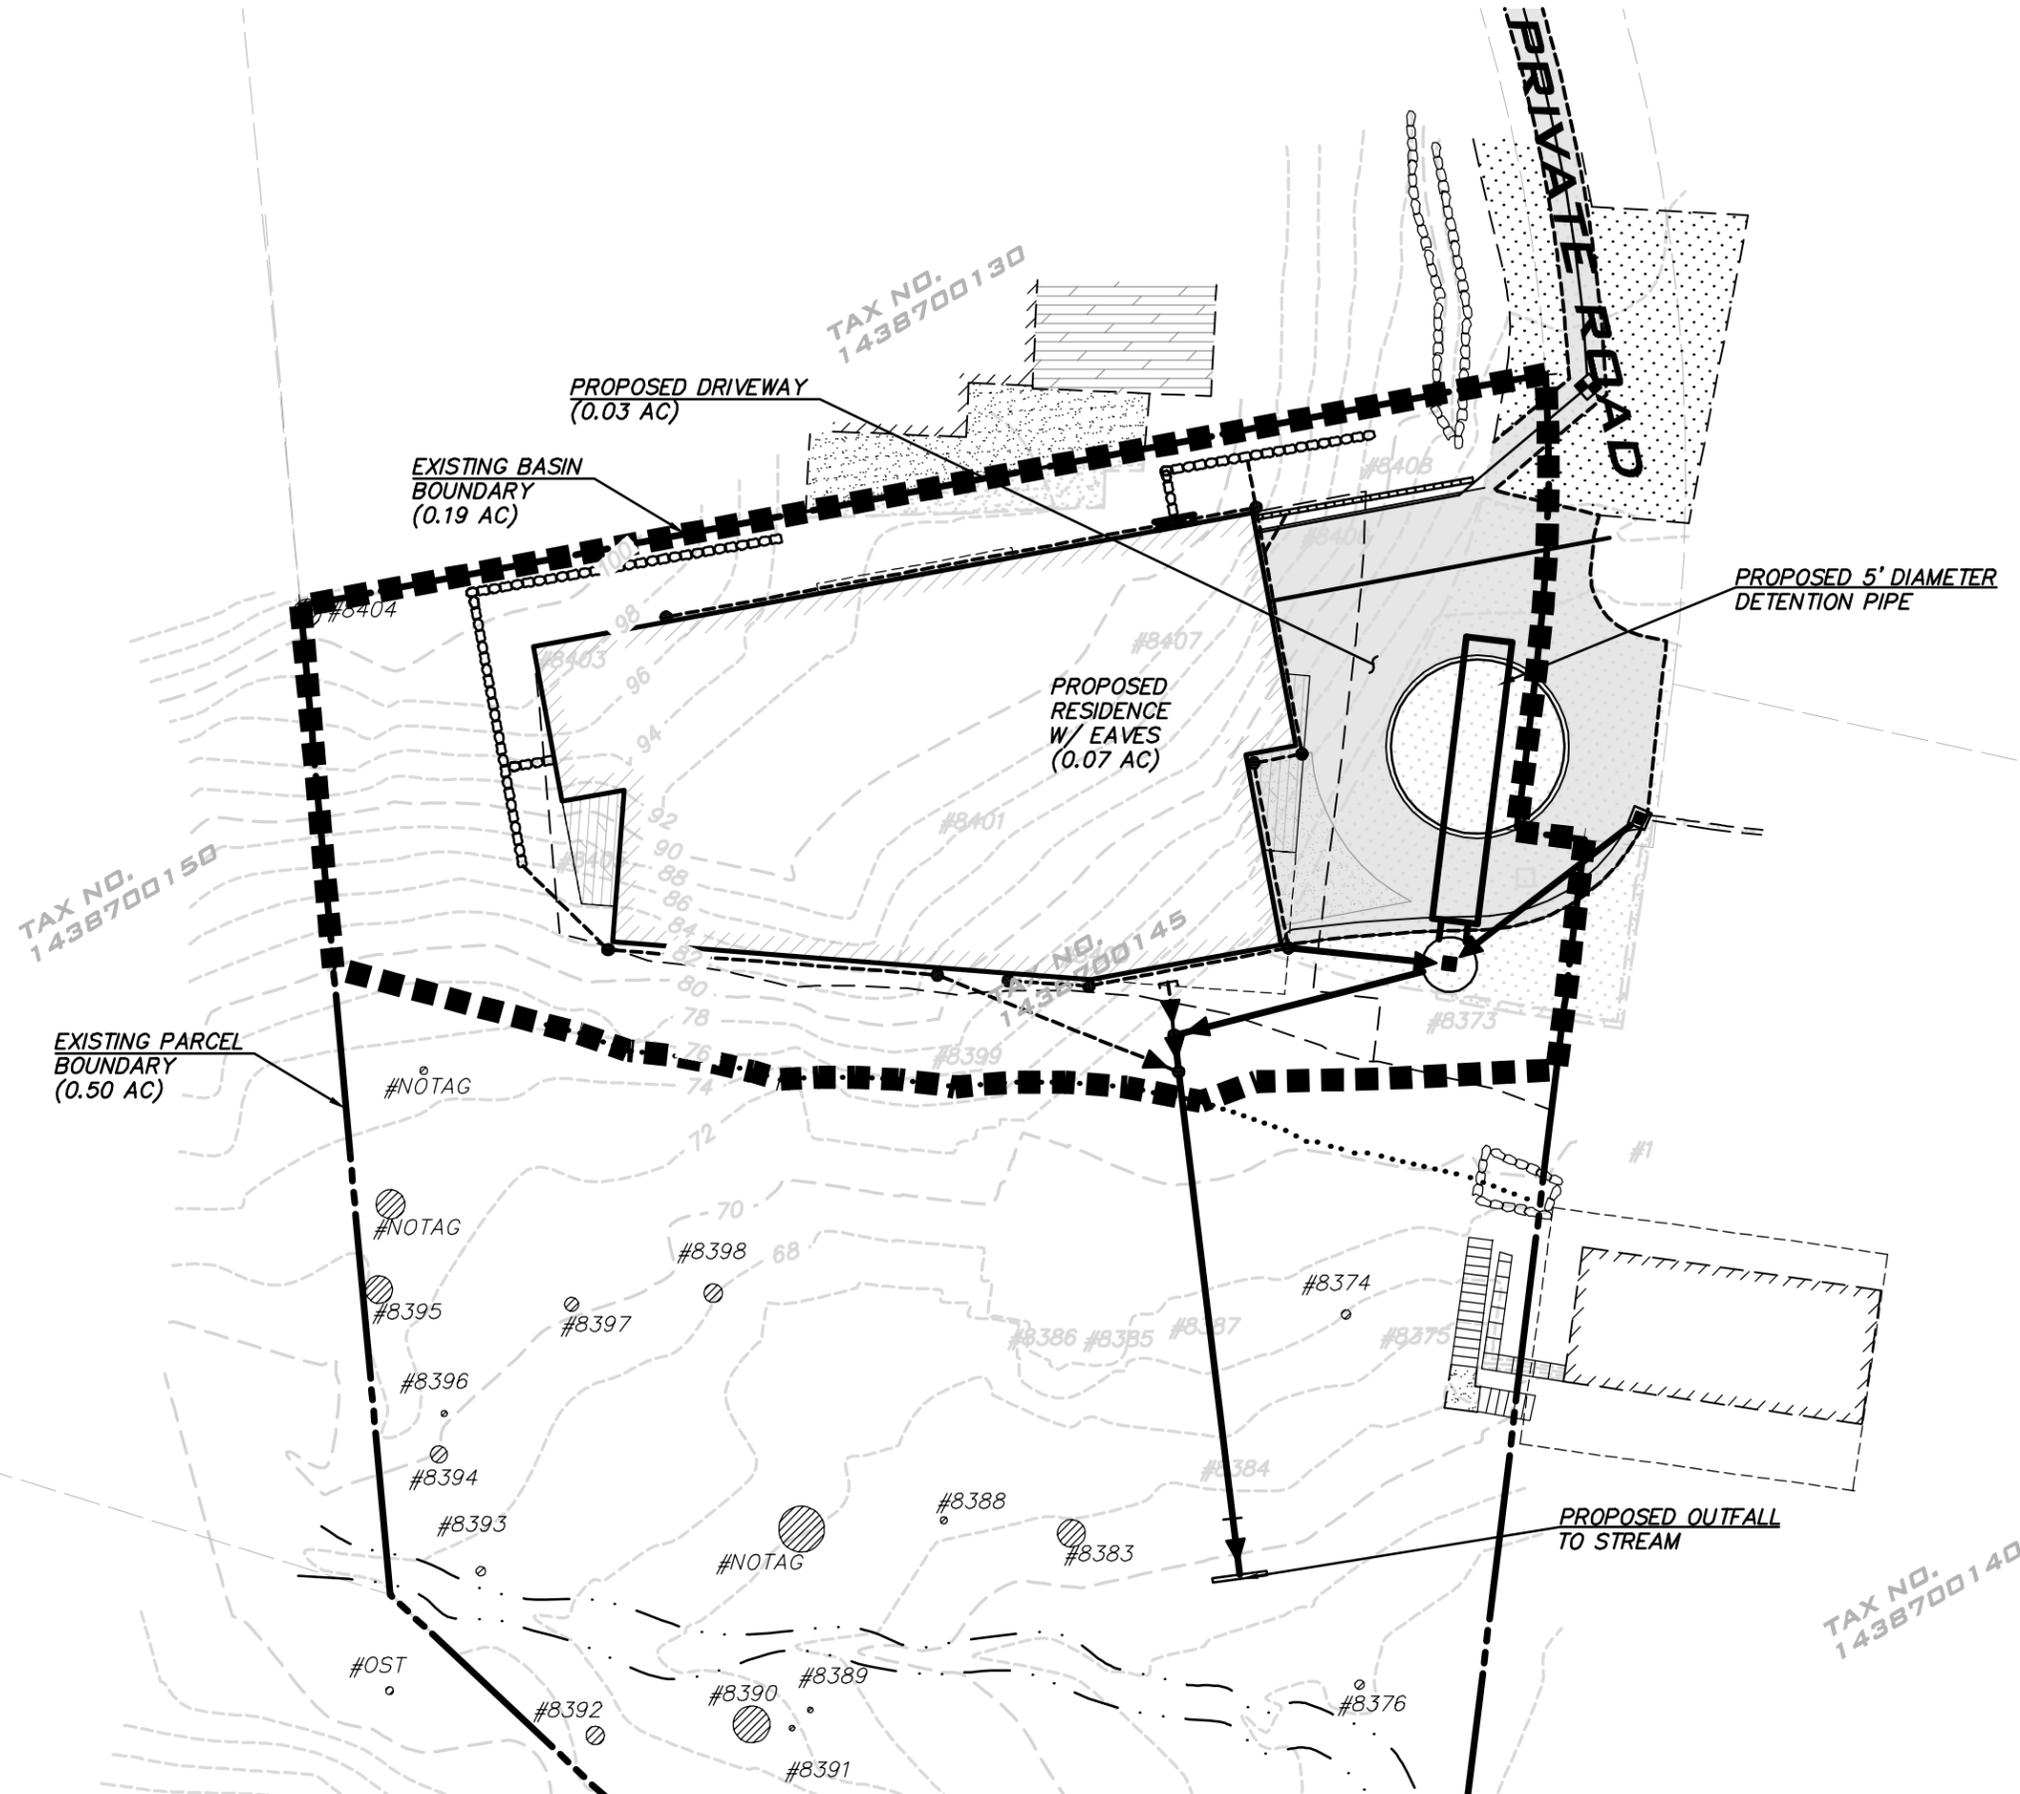
DEVELOPED CONDITIONS EXHIBIT ZHANG RESIDENCE STORM DRAINAGE REPORT

In the developed condition, roof and on-site driveway runoff will be collected and routed to a detention pipe located between the proposed house and the east property line. The pipe will discharge runoff to a diffuser tee north of the on-site stream. Please see the Developed Conditions Exhibit in Section 1 of this report. A Level I Downstream Analysis is included in Section 3 of this report.

The proposed roof area will be 3,176 sf, eaves included. The existing driveway will be removed and replaced by an asphalt driveway which will be 1,232 sf. New walkways and deck area (hardscape) will be 276 sf. The total impervious surface area, including hard surfaces, will be 4,760 sf. All disturbed pervious areas (3,657 sf) will be compost amended and landscaped. There are also on-site existing trees that will be retained. Approximately 560 sf of driveway area north of the project site is tributary to the proposed detention pipe. This area will not be disturbed and will be offset by a small portion of the proposed residence's roof area (not to exceed 560 sf) bypassing the detention pipe and connecting directly to the proposed outfall location. The table below provides a summary of proposed site conditions:

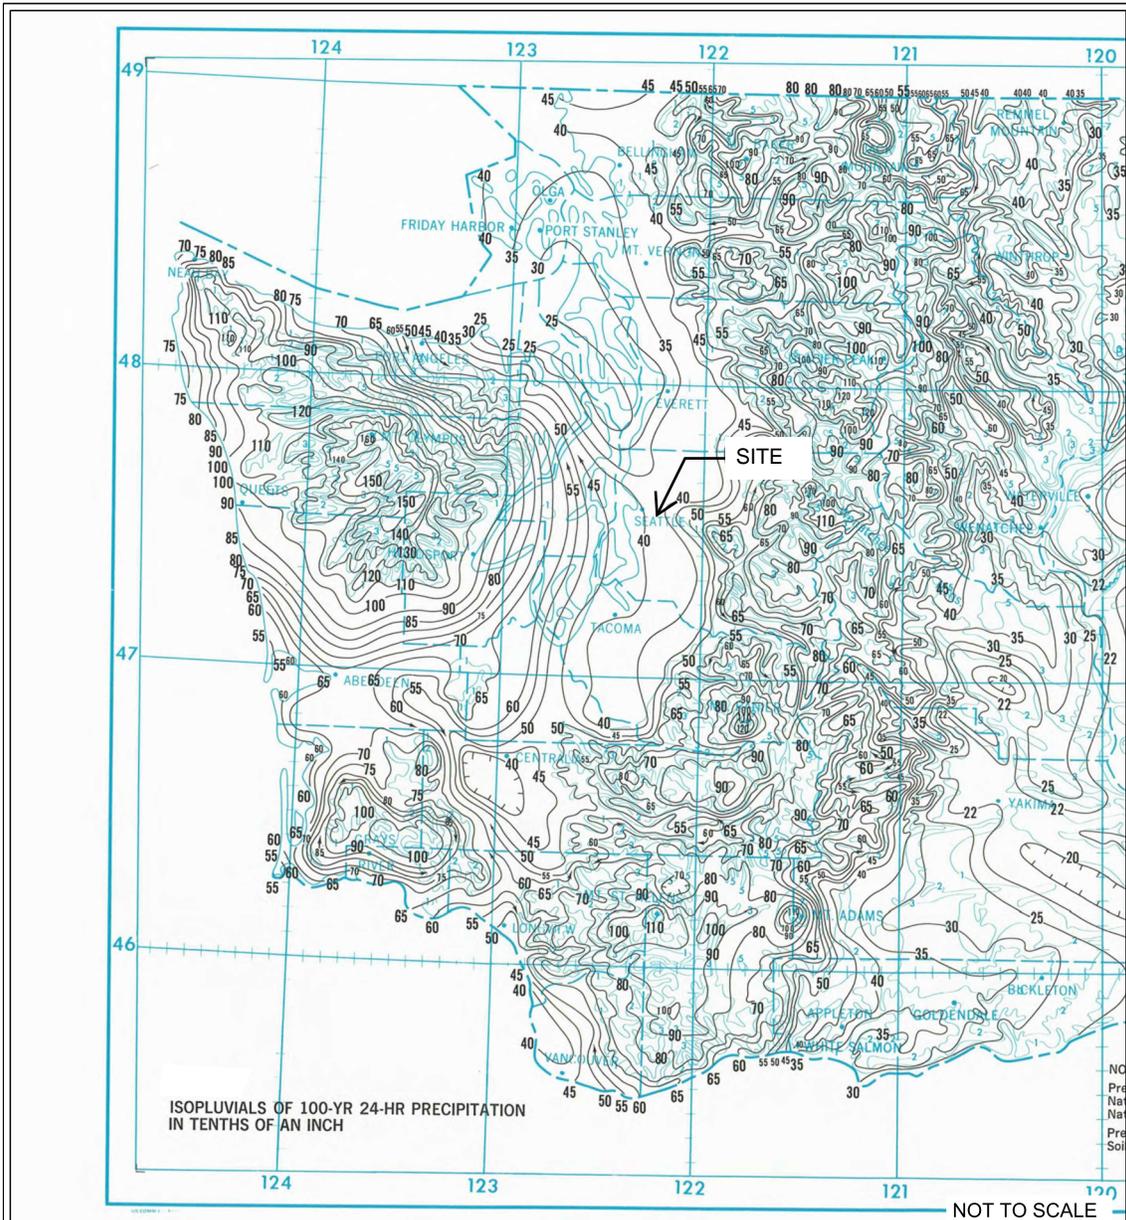
Figure III-A.3 Western Washington Isopluvial 100-year, 24 hour

**Figure III-A.3
Western Washington Isopluvial
100-year, 24 hour**

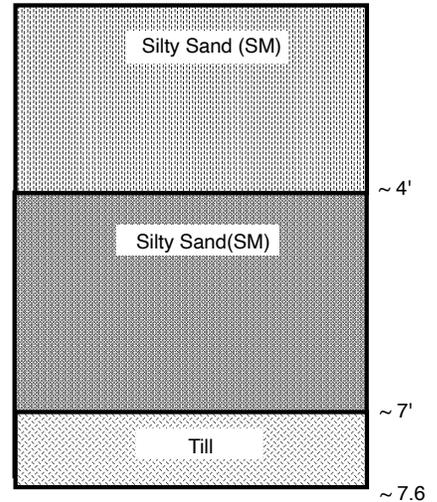
- a. Silty Sand (SM)
- b. Silty Sand with gravel (SM)
- c. Silty Fine Sand with gravel (Till)

a. Silty Sand (SM)

A layer of loose silty which varies in thickness from 0” - 4’ generally blankets the slope. The more closer to the top of slope, the shallower of this loose silty sand is.

Subsurface soil and ground water conditions were investigated by conducting three (3) DCP tests to maximum 7.6' depth on June 29, 2022. Test locations are shown on the site plan (Figure 2). Test logs are presented in the Appendix of this report as Figures 4 through 6. Descriptions of soil symbols and classifications used in this report are also presented in the Appendix (Figure 3). Site soils are generalized in the schematic and summarized as follows:

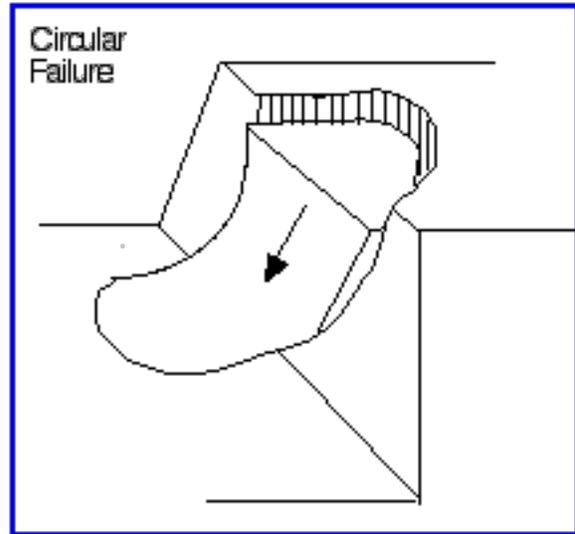
The possible mode of slope failure at this site has to be considered for the slope stability analysis. Modes of slope failure are best categorized according to controlling geological structures. For instance, such structures can be bedrock, faults, or high strength soil layers interbedded with low strength layers. As

discussed above, for this analysis we are considering the failure of the sand unit itself. Therefore, there is no significant controlling structure and the material is assumed as homogeneous soil with the internal parameters listed in Table 1. Soil slope failures are characterized to fail in a circular mode according to Hoek and Bray (1981). This will be the assumed failure mode for this site, depicted here.

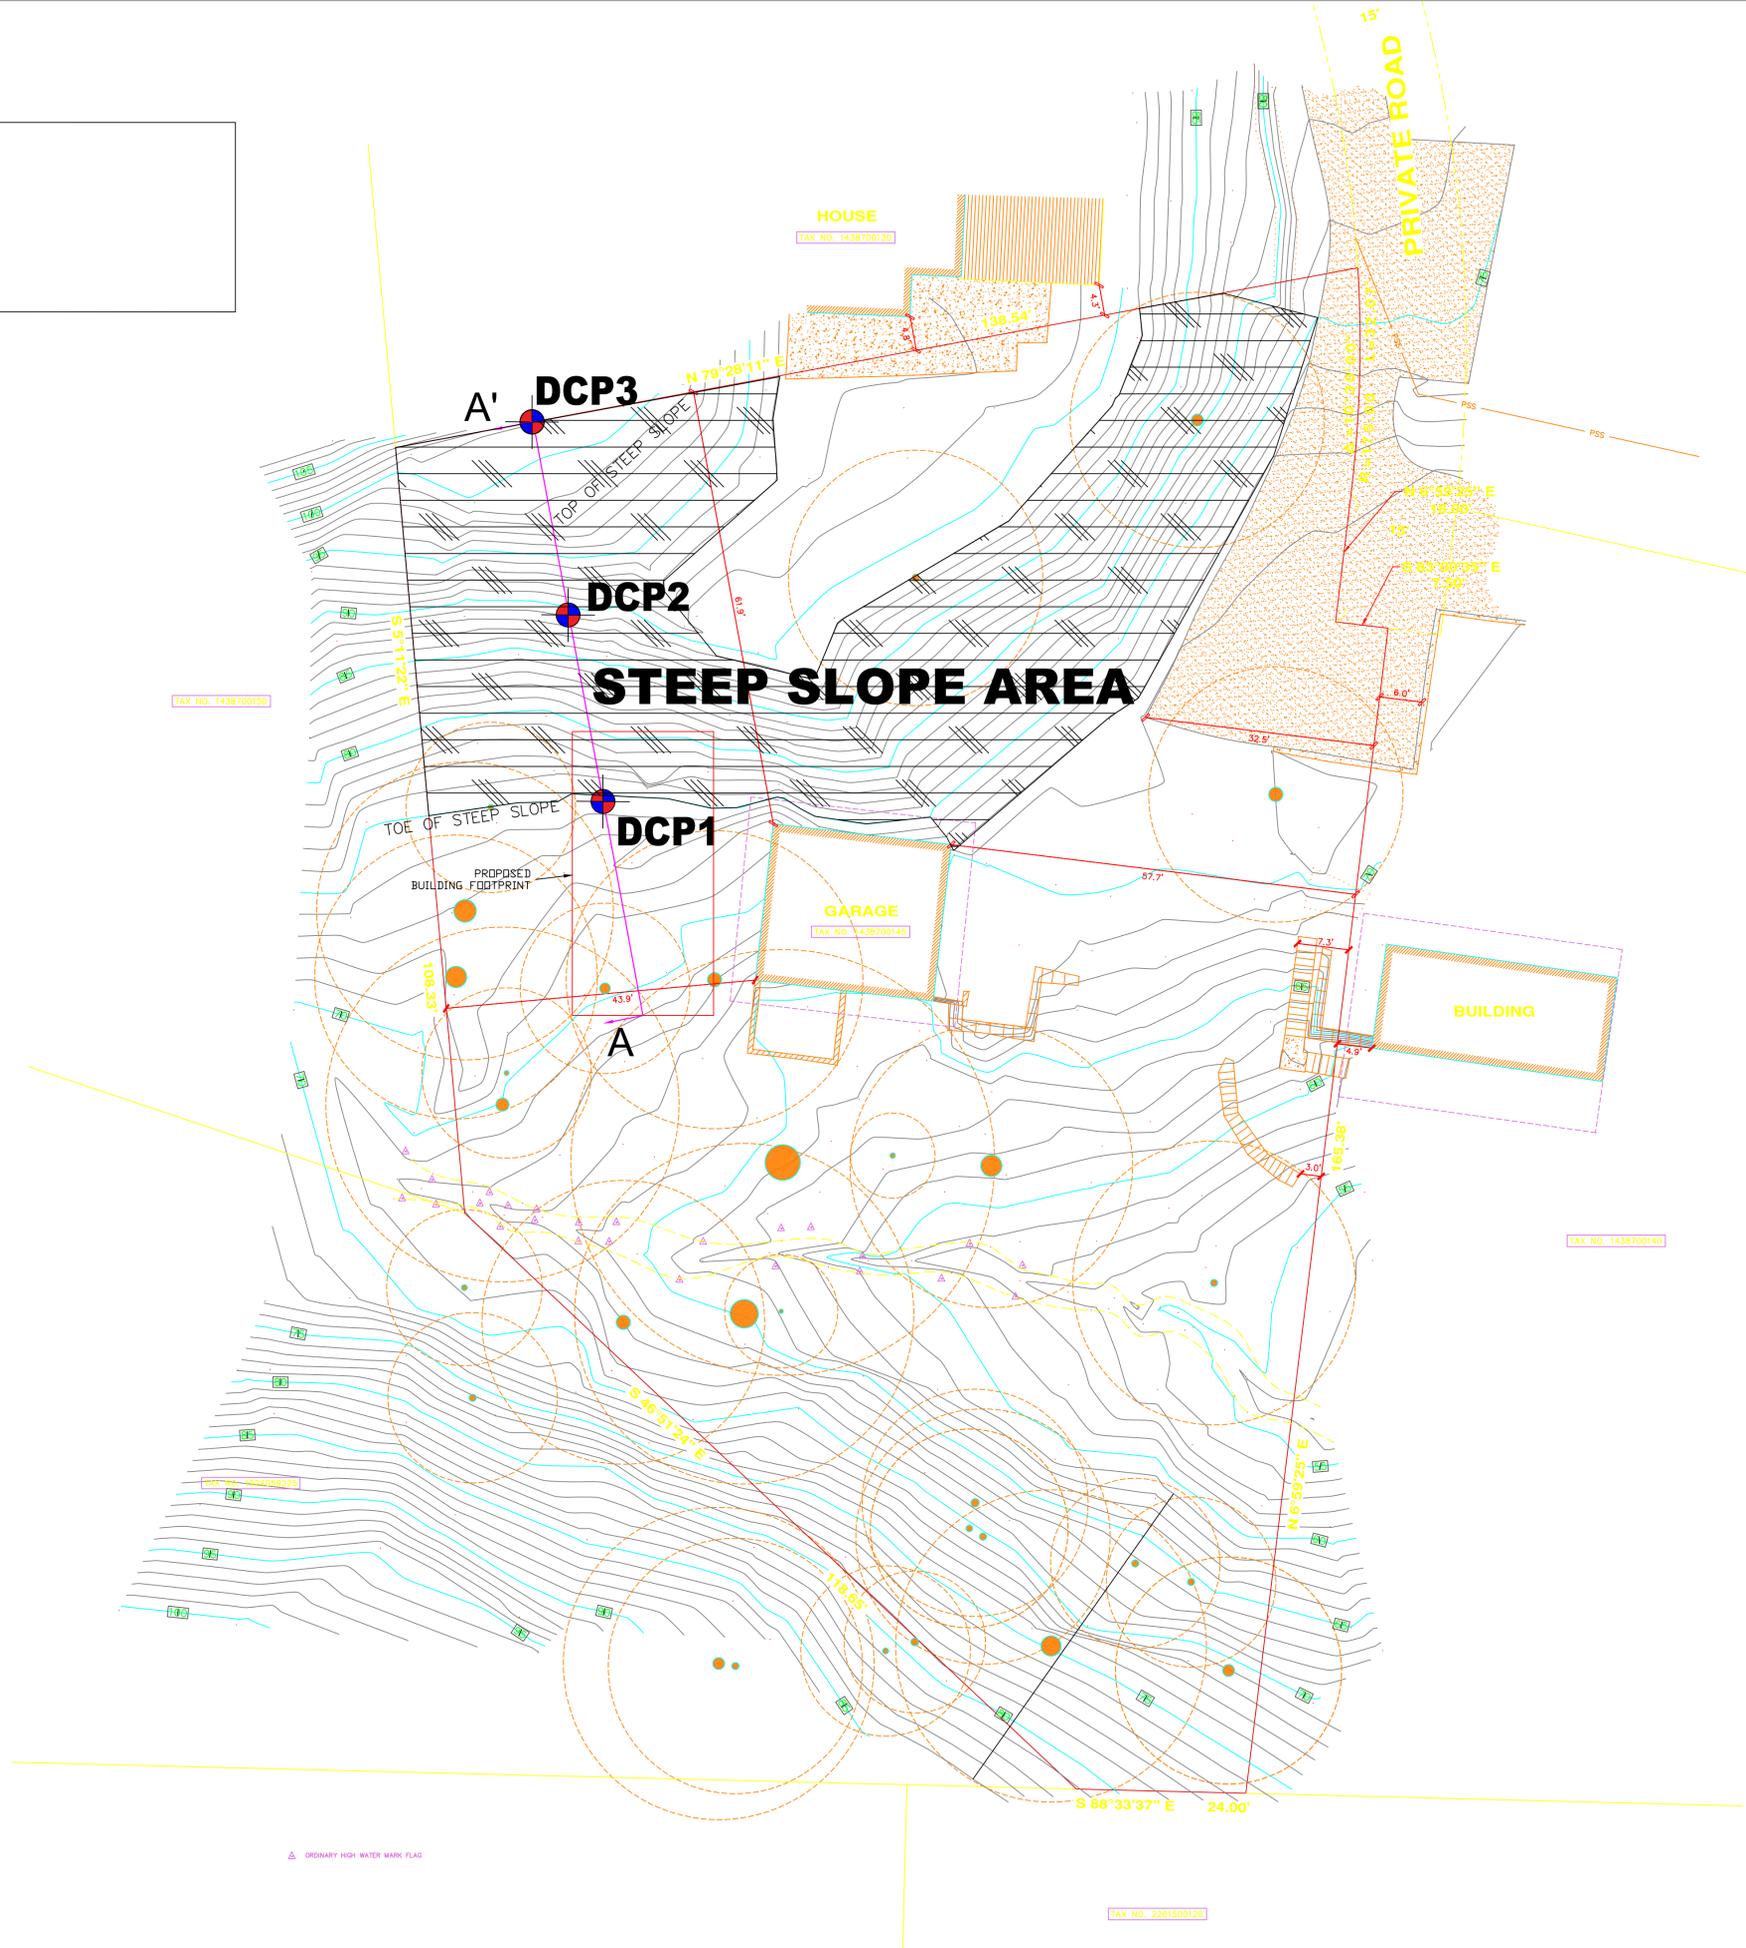
Figure 2 SCALE: 1"=12'

SITE PLAN

At request of Bin Zhang, Merit Engineering, Inc. has conducted a geotechnical engineering investigation for the proposed development of the site, located at immediate west of 5425 96th Ave SE, in Mercer Island, Washington 98040 (Parcel #1438700145). The project area and vicinity is shown in Figure 1 and the site plan with proposed new single family house and test locations in Figure 2 in the Appendix.

Subsurface conditions at the site were investigated by conducting three (3) DCP tests on June 29, 2022. DCP test locations were determined by a representative of Merit Engineering Inc. as shown approximately on the Site Plan (Figure 2) presented in the Appendix of this report. Tests were conducted near the adjacent to the building footprint to generalize subsurface soil conditions. Depths referred to in this report are relative to the existing ground surface at the time of this field investigation.

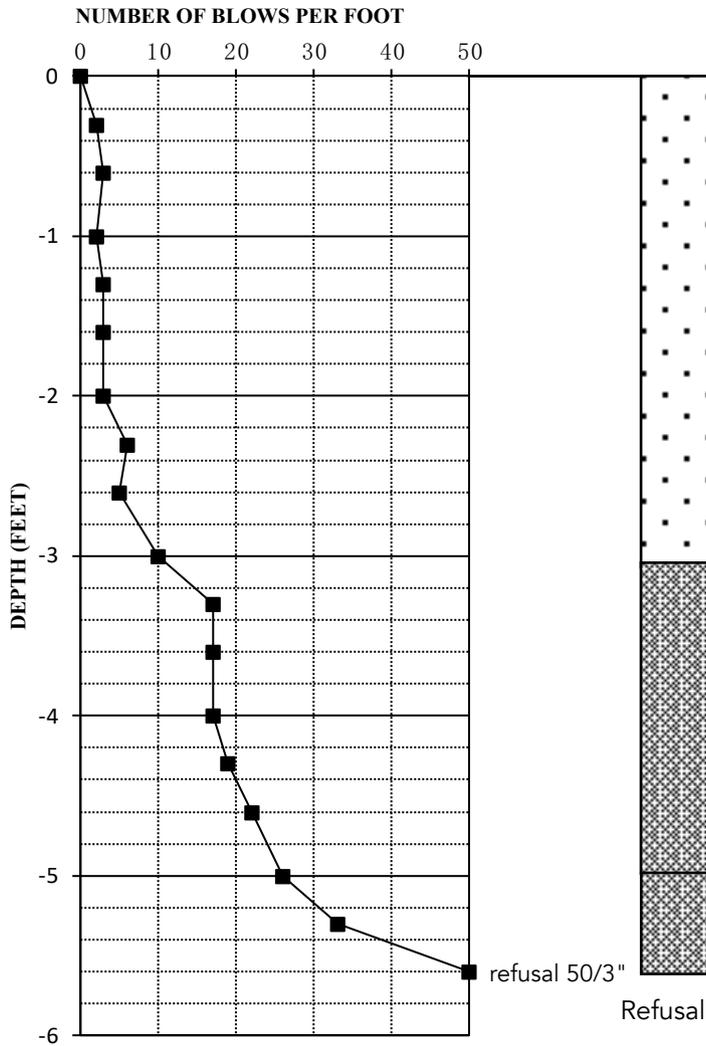
Figure 4

SOIL DESCRIPTION AND CLASSIFICATION

X,Y =
 Surface Elevation = 62'
 Surface Conditions = Ground Cover

LOOSE SILTY SANDS

SILTY SANDS WITH GRAVEL (SM)

Descriptions of subsurface conditions are based on observations made at the site at the time of the field investigation. DCP test logs are presented in Figures 4 through 6. The soils observed at the site were classified using the USCS (Unified Soils Classification System) in accordance with ASTM D-2488-69 and ASTM D 2487. This classification system is also presented in the Appendix (Figure 3).

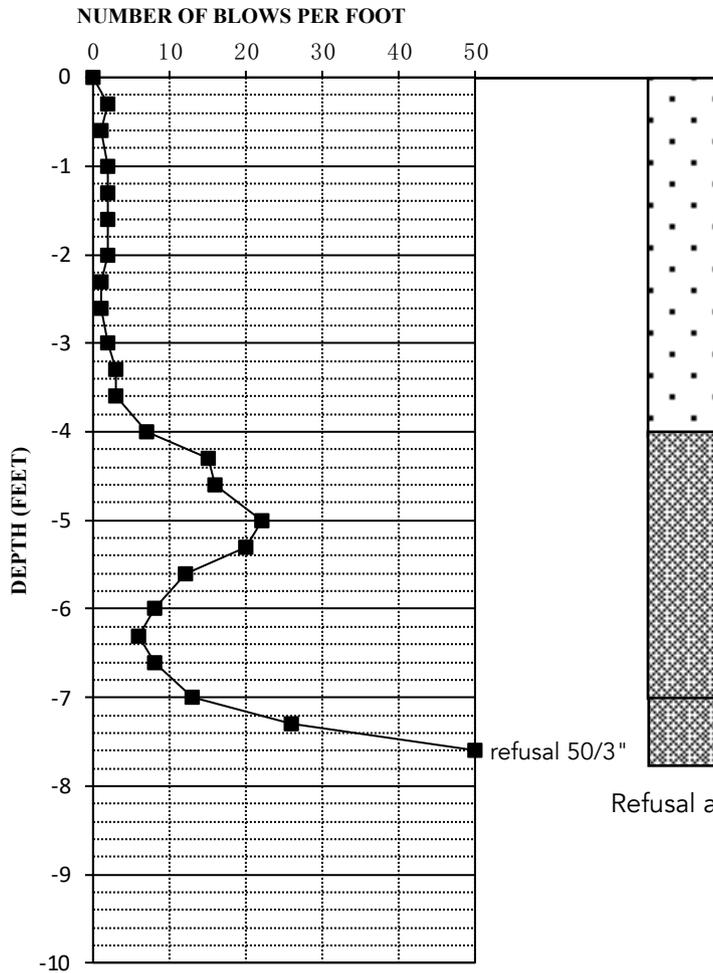
SOIL DESCRIPTION AND CLASSIFICATION

X,Y =
 Surface Elevation = 92'
 Surface Conditions = Ground Cover

LOOSE SILTY SANDS

SILTY SANDS WITH GRAVEL (SM)

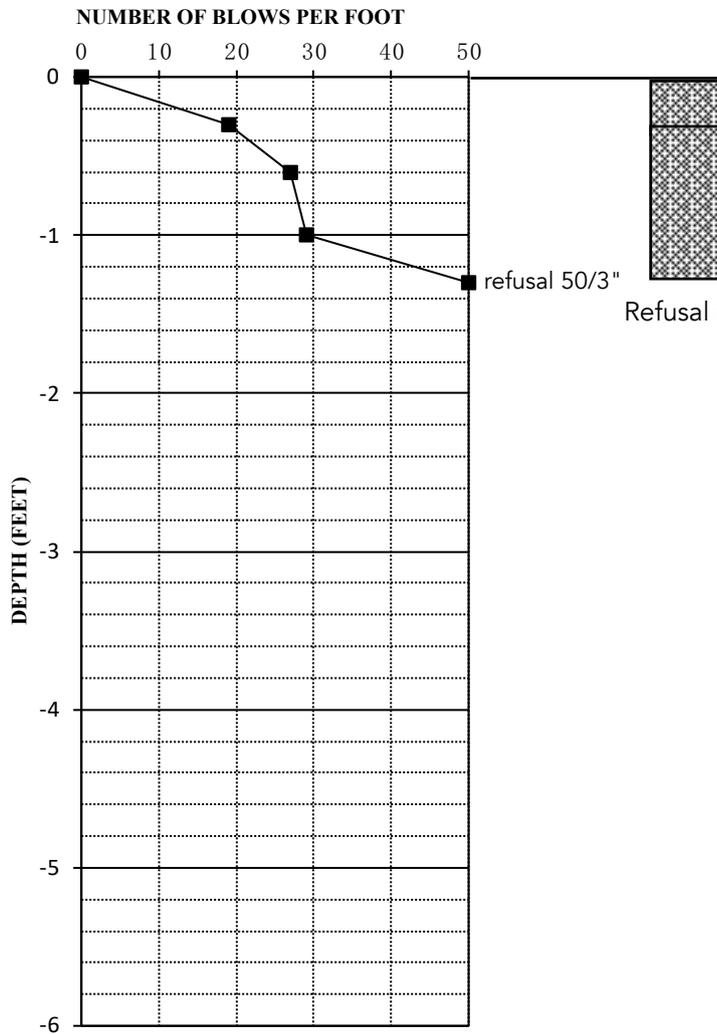
SOIL DESCRIPTION AND CLASSIFICATION

X,Y =
 Surface Elevation = 101'
 Surface Conditions = Ground Cover

SILTY SANDS WITH GRAVEL (SM)

SILTY SANDS WITH GRAVEL (OUTWASH)
