ZHANGE RESIDENCE

STORM DRAINAGE REPORT

9433 SE 54TH ST, WA

Job No. BL22-306

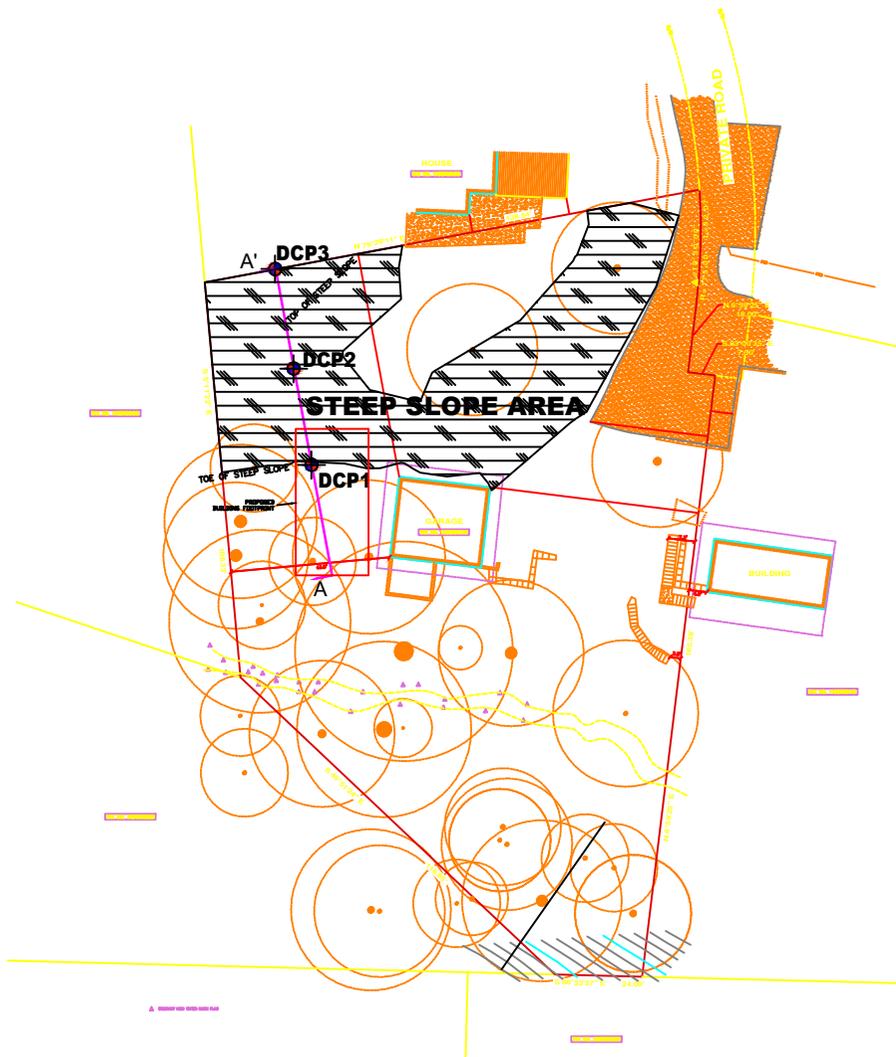
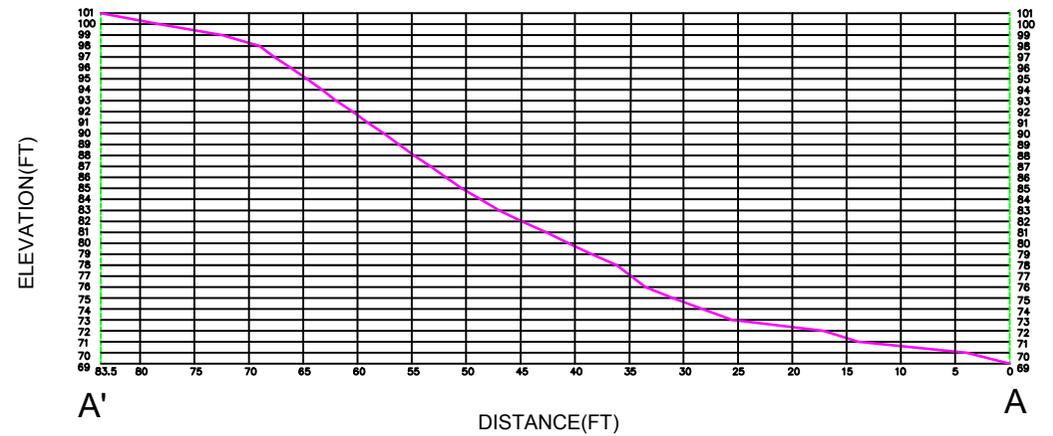
Note: Property Lines and Topography based on the Survey From CHADWICK and WINTERS LAND SURVEYING and MAPPING

Single Family House Development
5425 96th Ave SE
Mercer Island, WA

Figure 2 Site Plan
Figure 3 Soil Classification
Figures 4 -6DCT Tests
Figures 7 -8STABLE Computer Model Results
Figures 9 -10Property Cross Sections

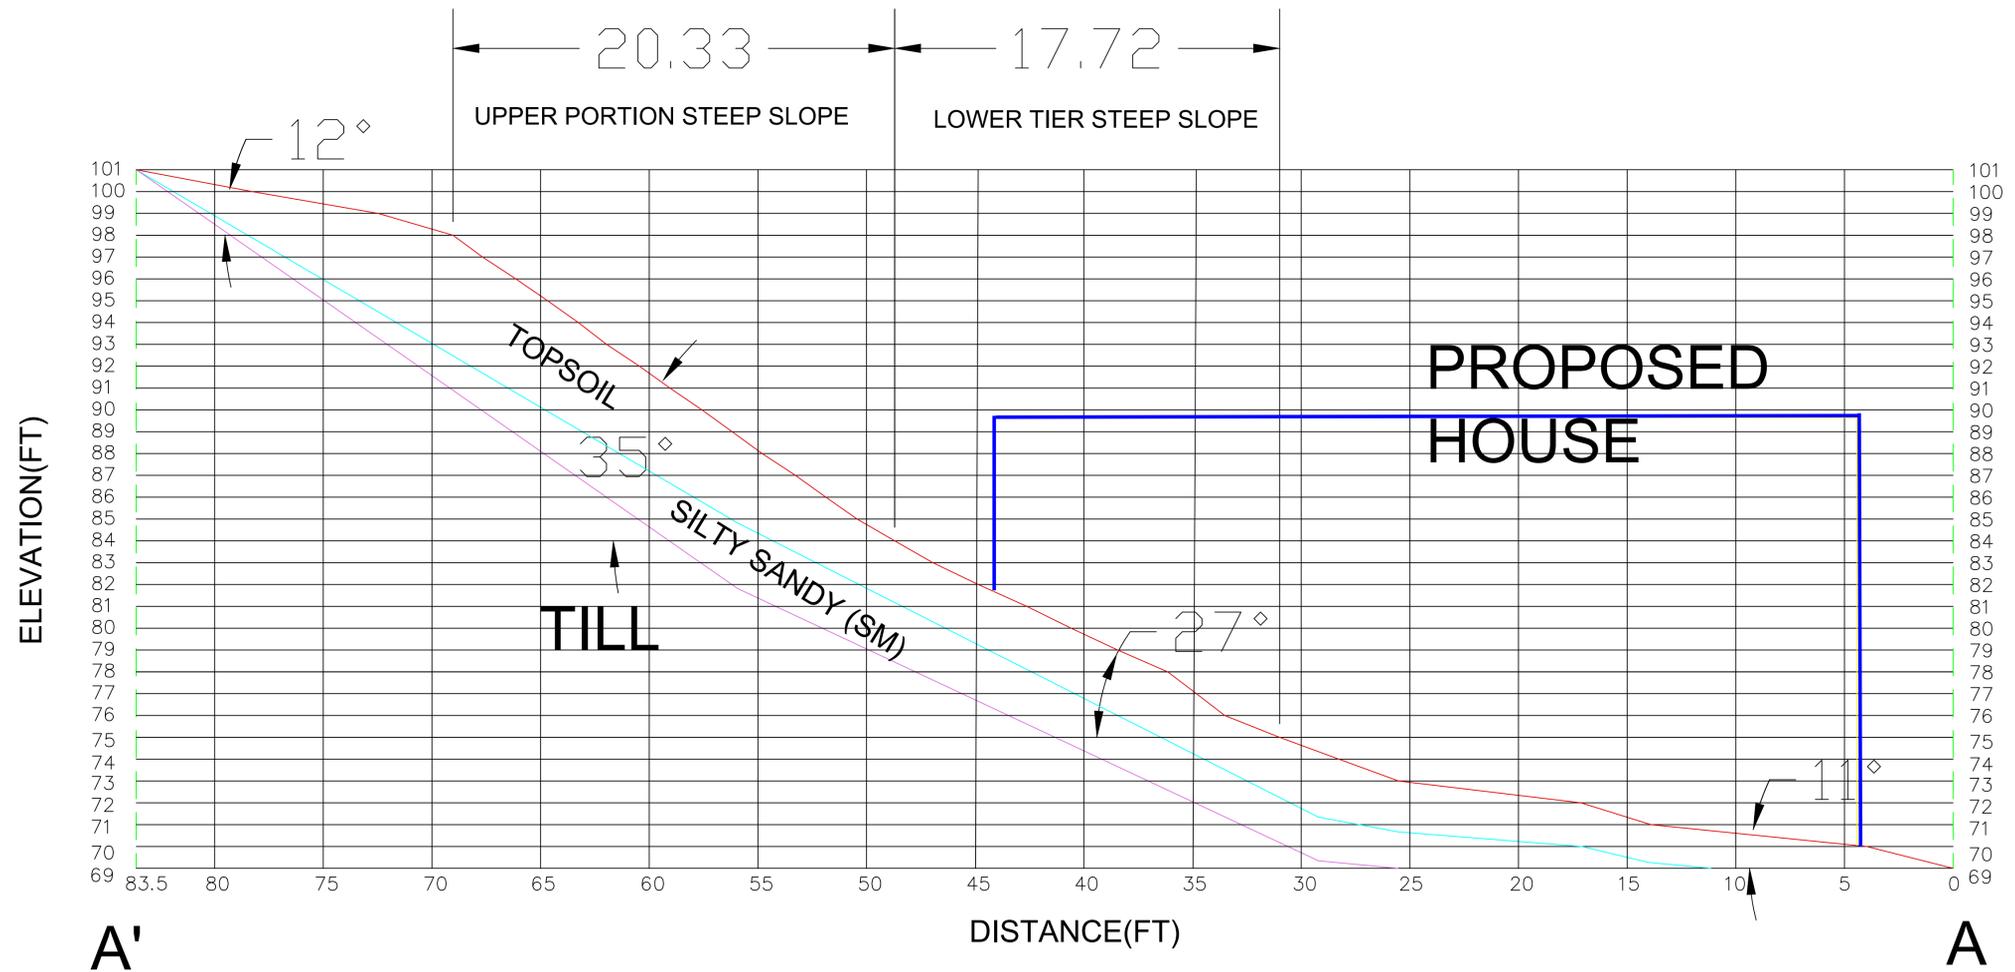
Note: Property Lines and Topography based on the Survey From CHADWICK and WINTERS LAND SURVEYING and MAPPING

Single Family House Development
5425 96th Ave SE
Mercer Island, WA
Parcel Number: 1438700145
